***Appendix B***  
***2008 Site Photos***

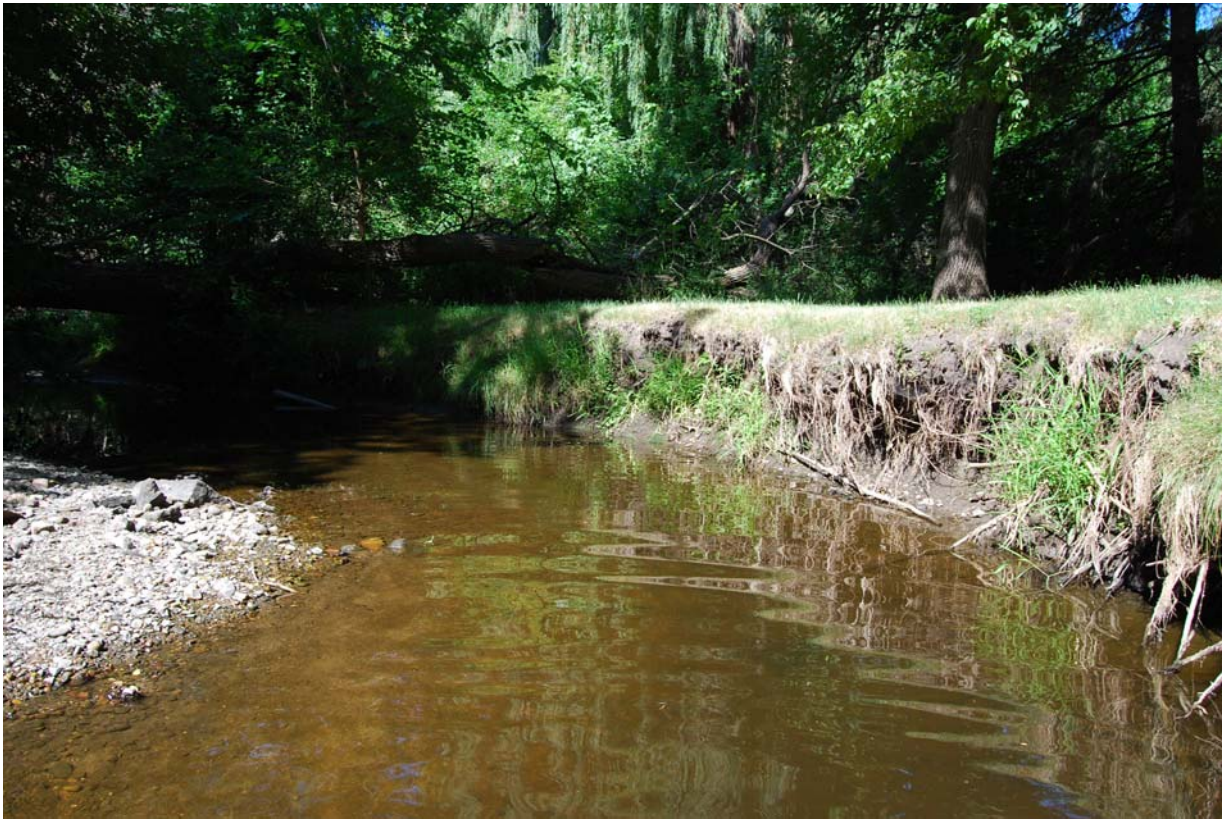
**Stream bank erosion and existing vegetation at Site 5.**

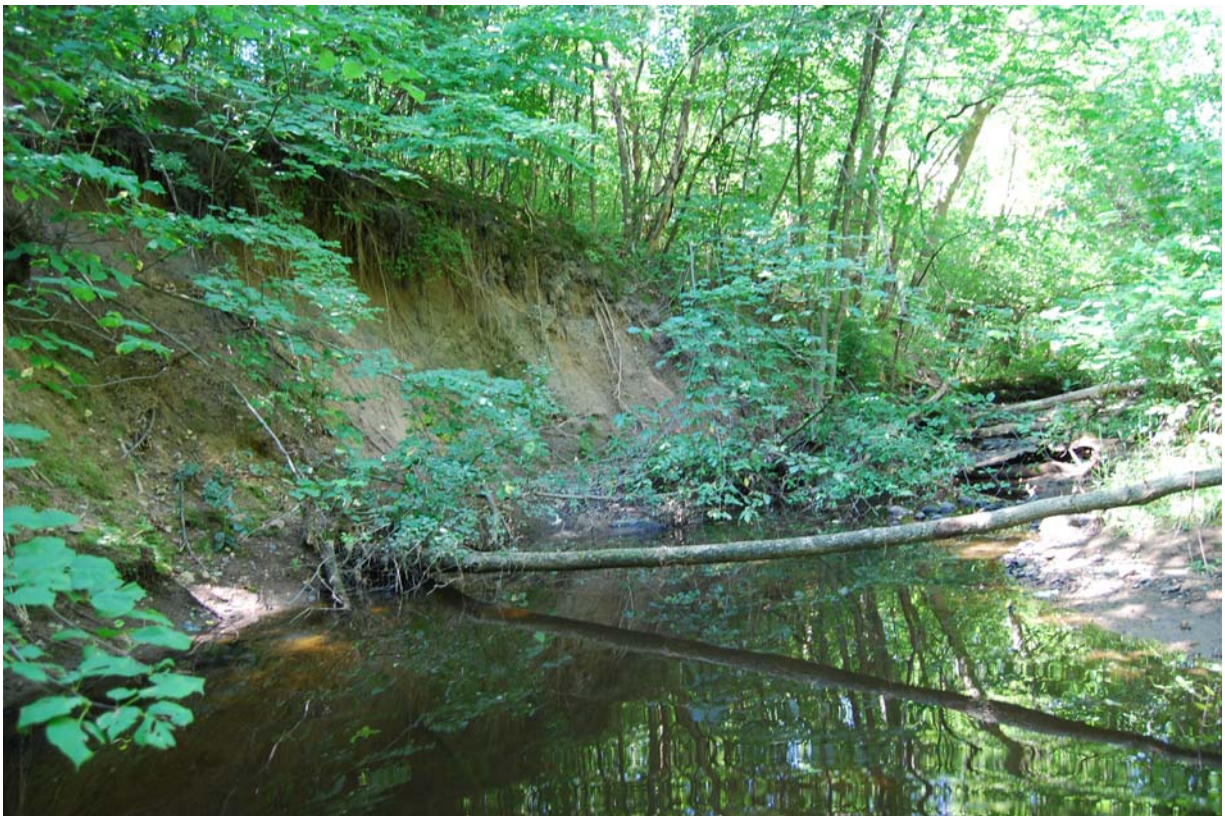
**Stream bank erosion and existing vegetation at Site 8.**

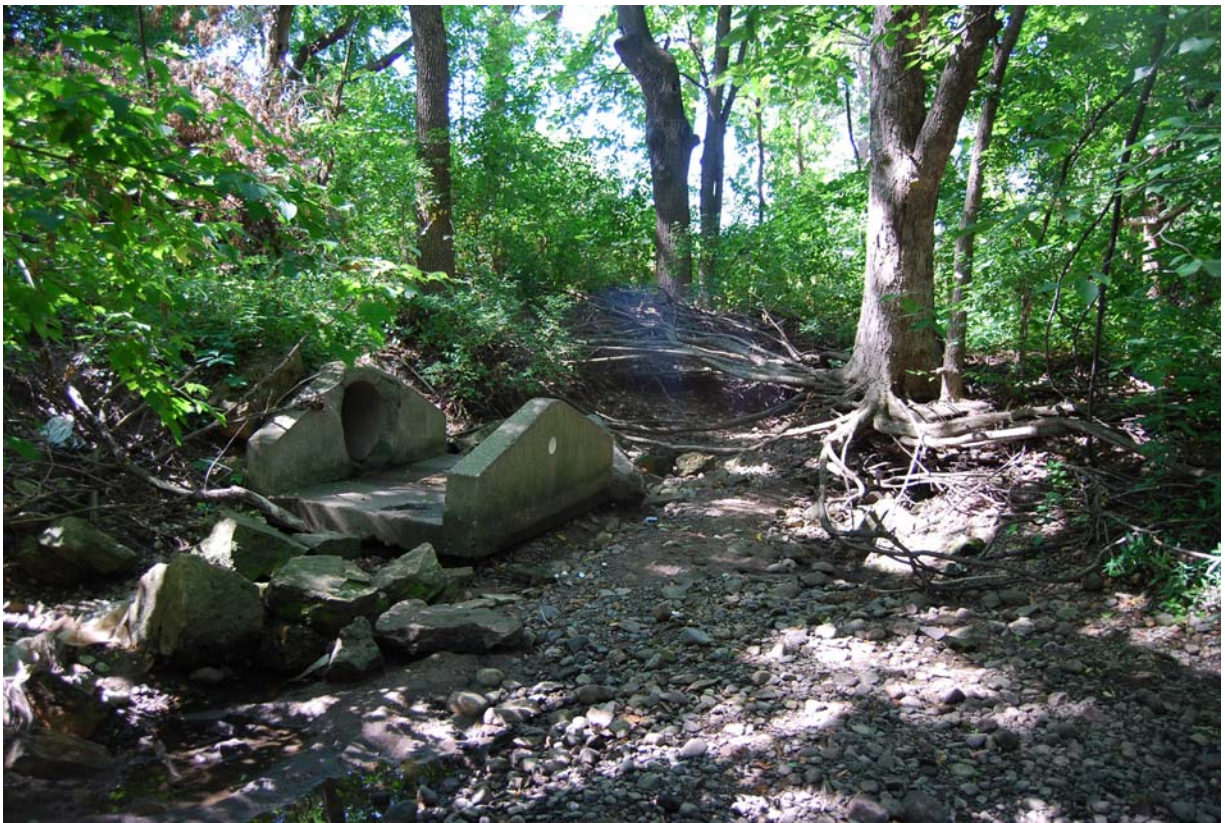
**Stormsewer outlet and bank erosion at Site 14.**

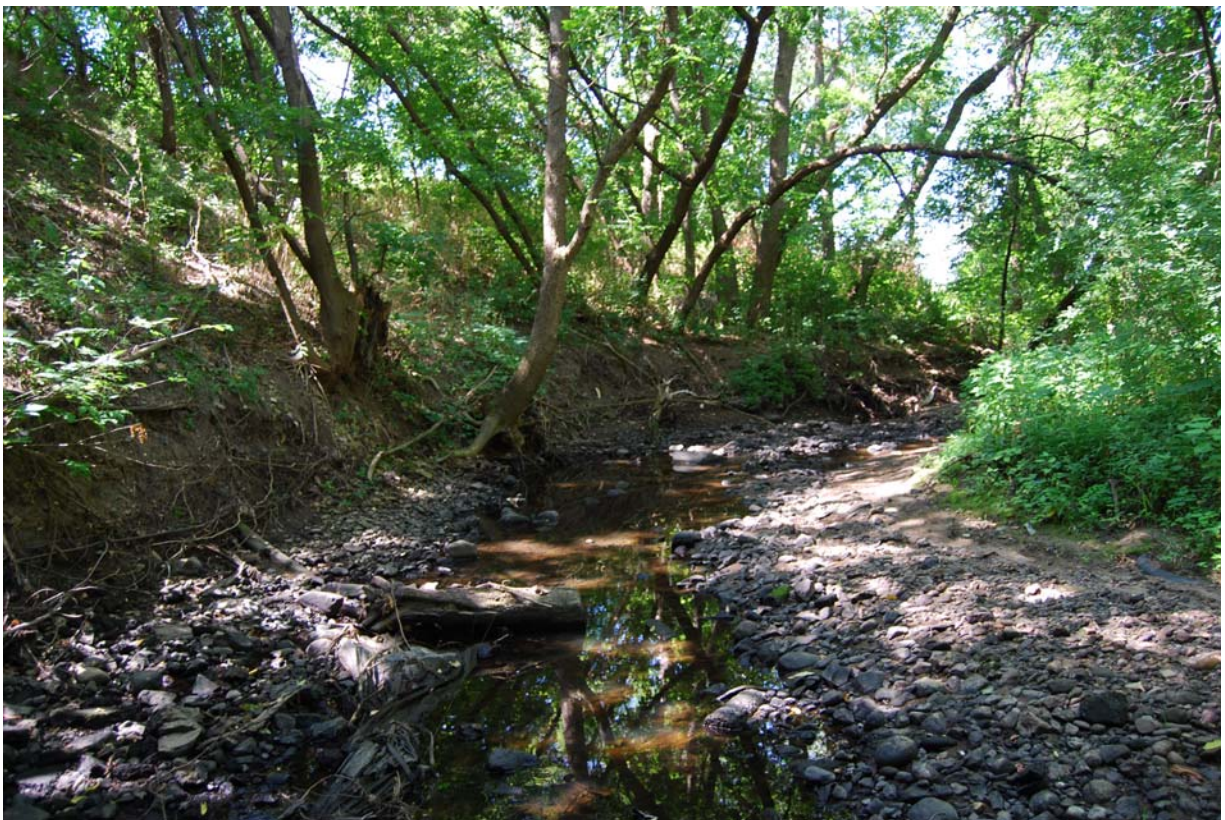
**Stream bank erosion and existing vegetation at Site 15.**
