Technical Memorandum

Subject: Preliminary Investigation of South Shore Drive Flooding

Date: August 30, 2019 **Project:** 23270051.45

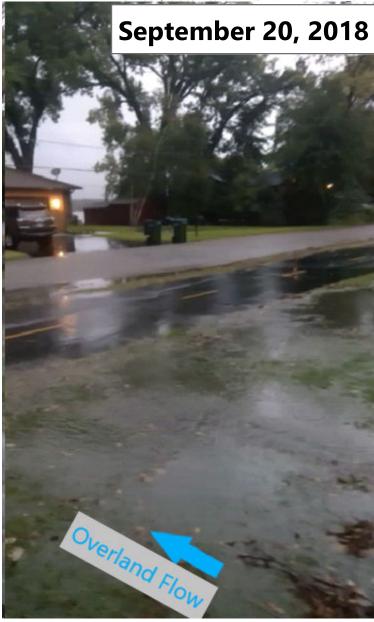
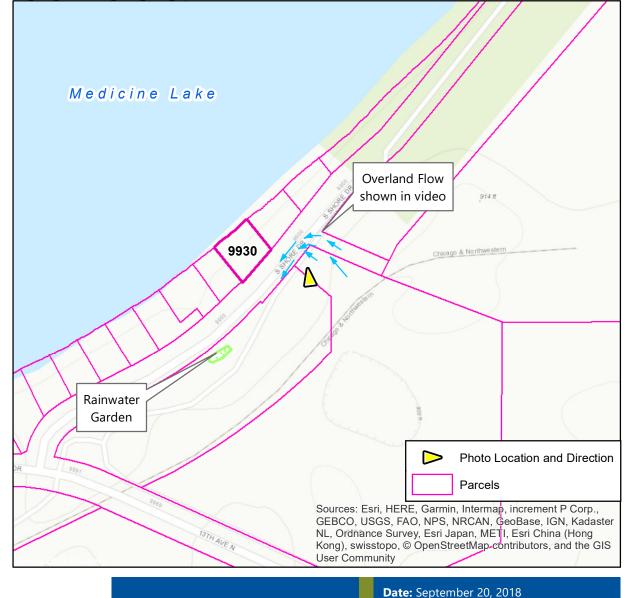
FIGURE 2

Specifically, the resident captured a video showing overland flow from the south side of South Shore Drive flow onto the roadway and toward the rainwater garden. Figure 2 shows a screen capture from the video, including the video location. Figure 3 shows photos of flooding on South Shore Drive.

Comment: Photo shows runoff moving from south of South Shore Drive onto the roadway.

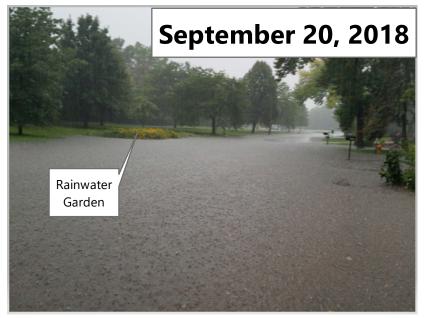
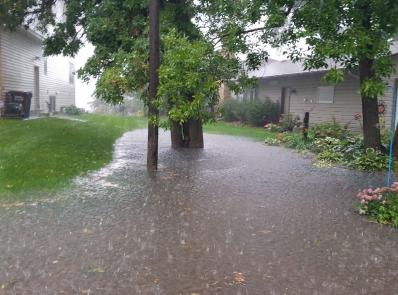
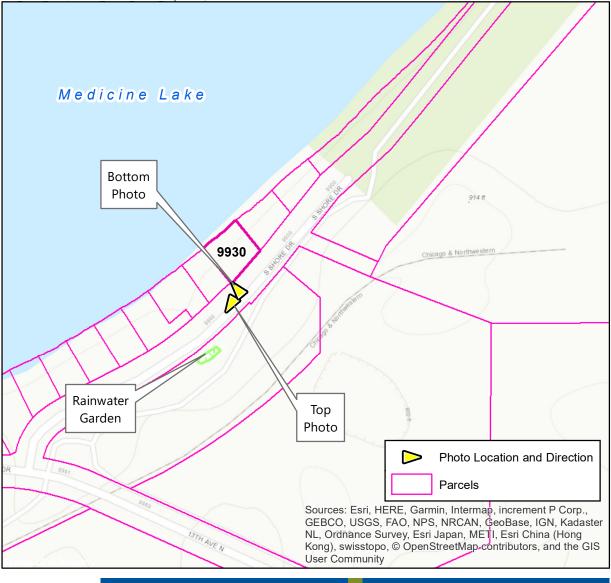
FIGURE 3

Date: September 20, 2018 Comment: Photo shows flooding of South Shore Drive and rainwater garden.

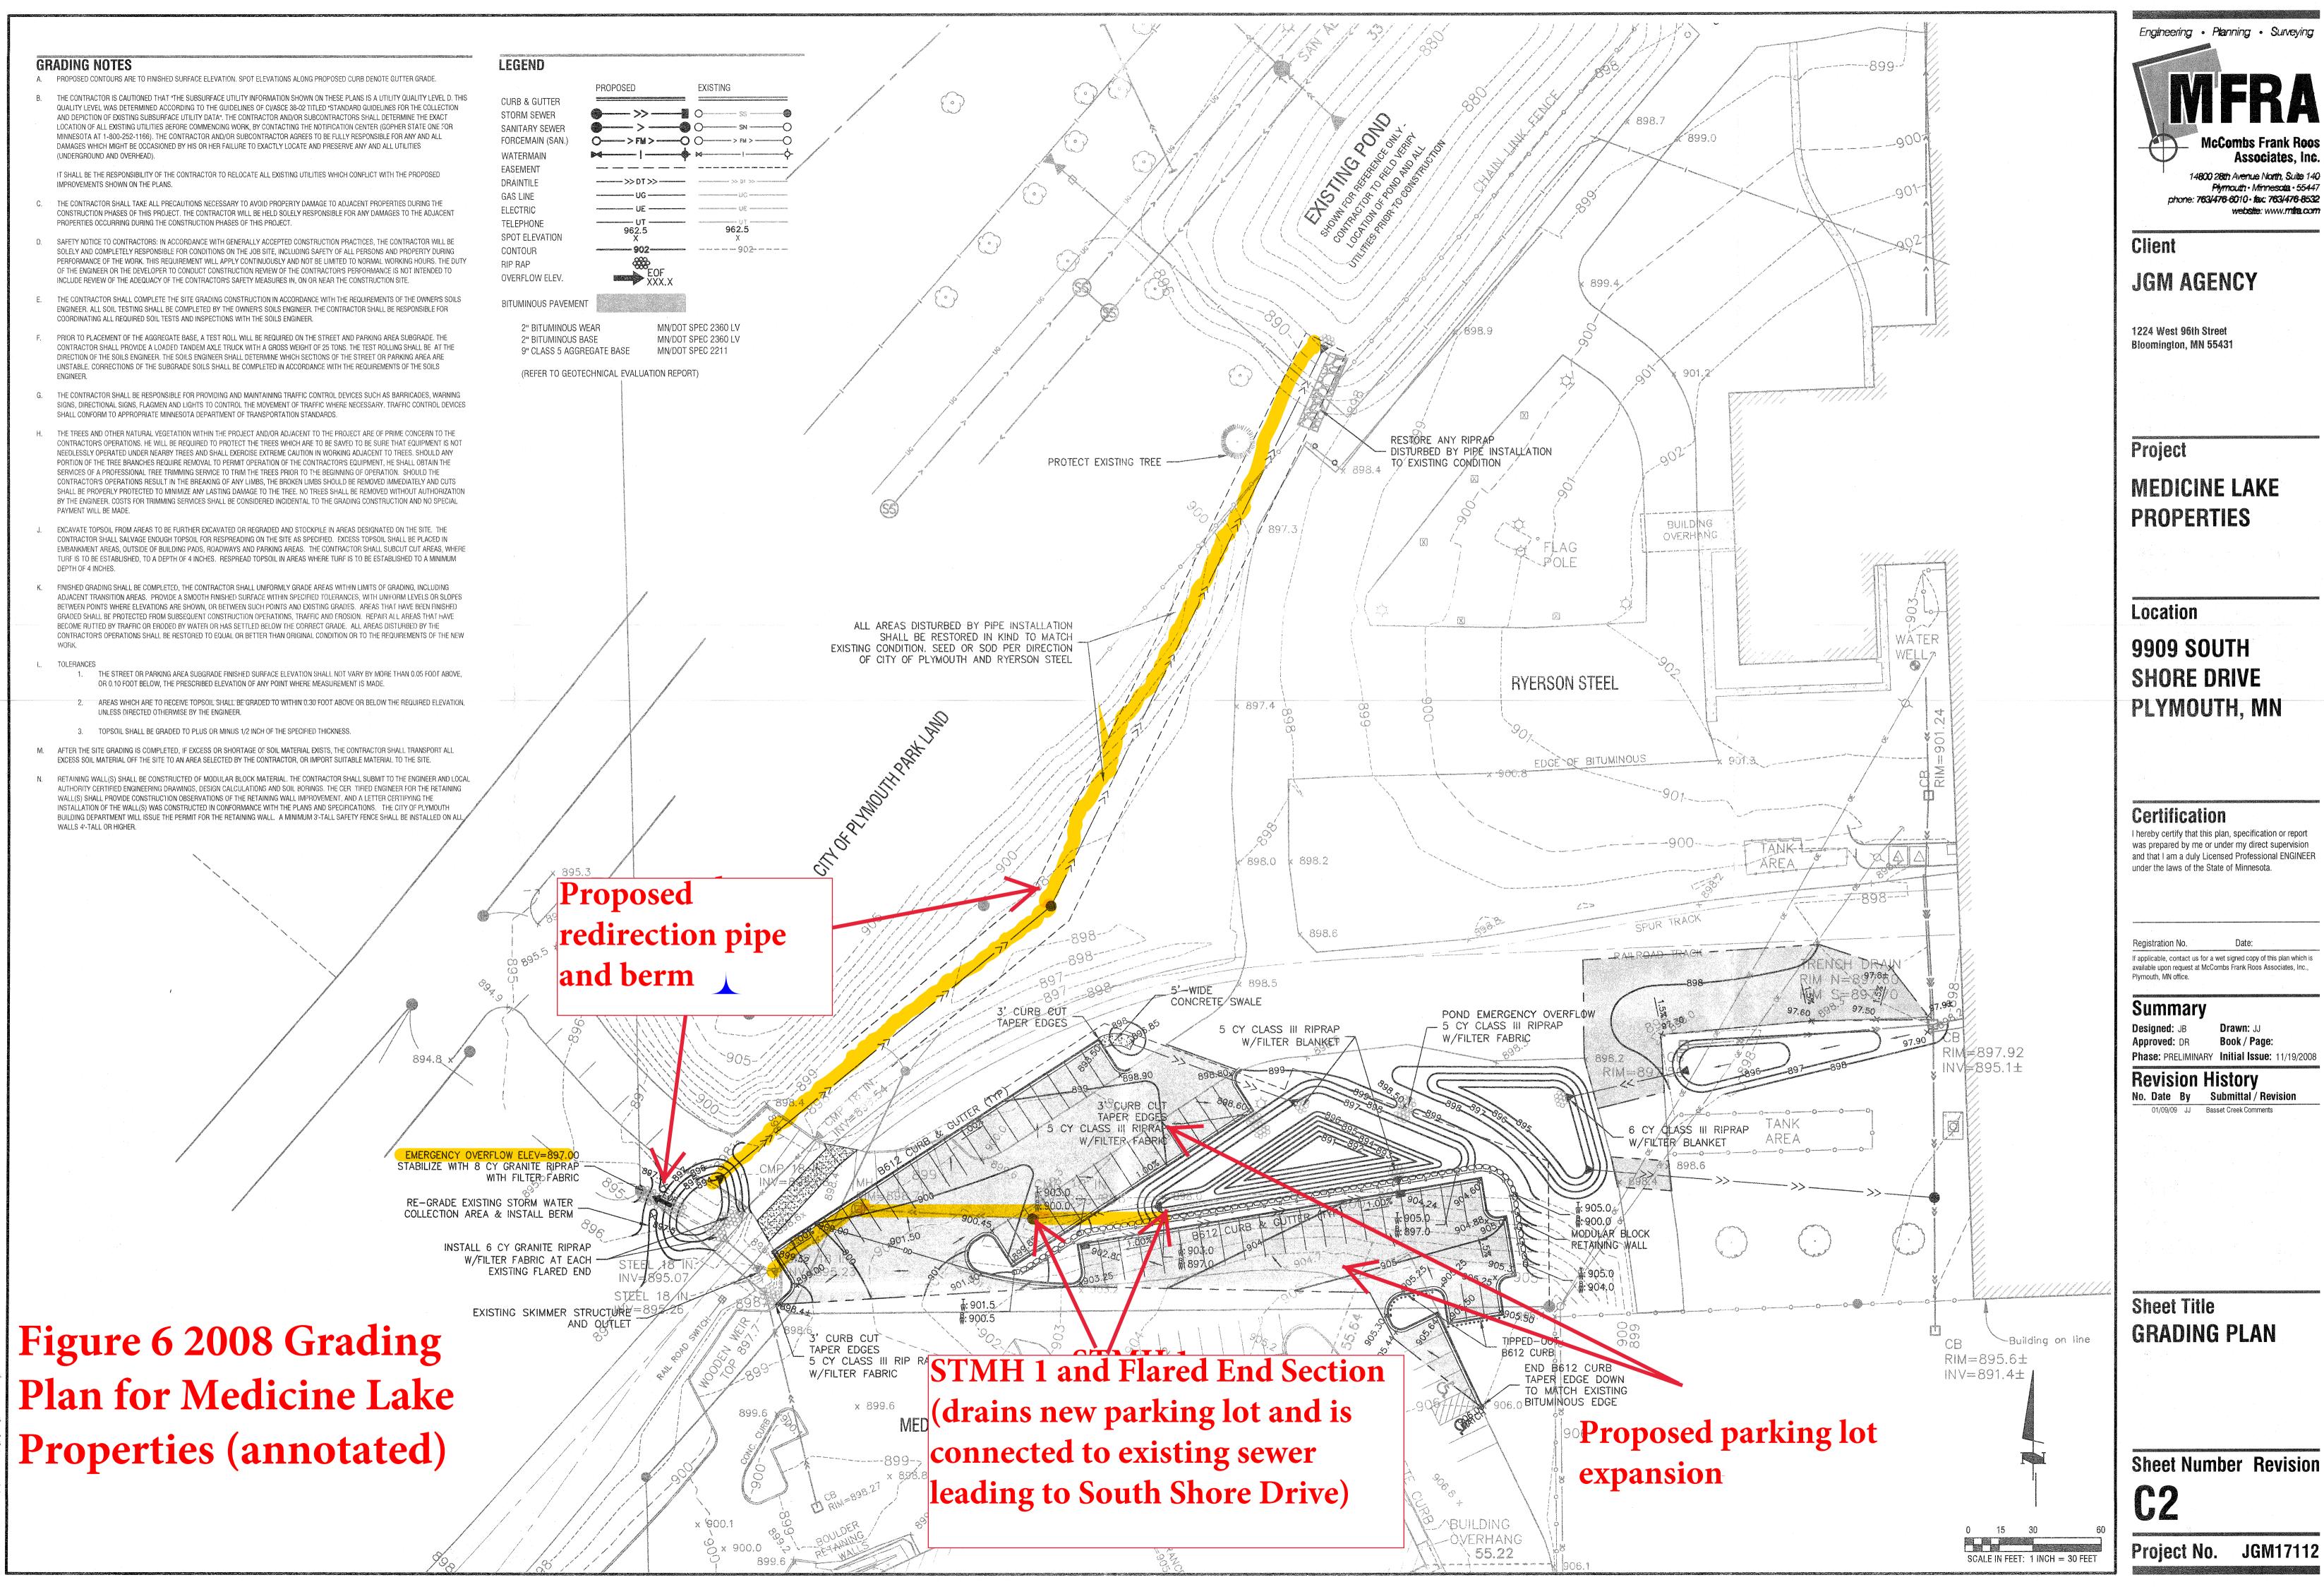
Sheet Title **GRADING PLAN**

Based on the 2018 aerial image, it appears the site was not constructed as approved in 2009. Figure 8 shows the 2018 aerial image, and it can be compared to the 2008 application shown on Figure 6. Differences between the 2018 aerial image and the 2008 application include:

- Only about half of the approved parking lot expansion was constructed
- The proposed stormwater retention basins do not appear to have been constructed
- The proposed removal of approximately 9,000 square feet of impervious did not occur (however this drains away from South Shore Drive)

- The newly-constructed parking lot likely incorporated the drainage features shown in the development review plan—STMH 1 and the flared end section (shown on Figure 6). STMH 1 and the flared end section connect to an existing storm sewer system that drains toward South Shore
