# Memorandum

**To:** Bassett Creek Watershed Management Commission (BCWMC)  
**From:** Barr Engineering Co. (Barr) (Josh Phillips, Gabby Campagnola, Jim Herbert)  
**Subject:** Item 4D: Bassett Creek 2025 Flood Control Project Inspection - BCWMC November 19, 2025 Meeting Agenda  
**Date:** November 13, 2025  
**Project:** 23270051.65 1080 001

## 4D Bassett Creek 2025 Flood Control Project Inspection

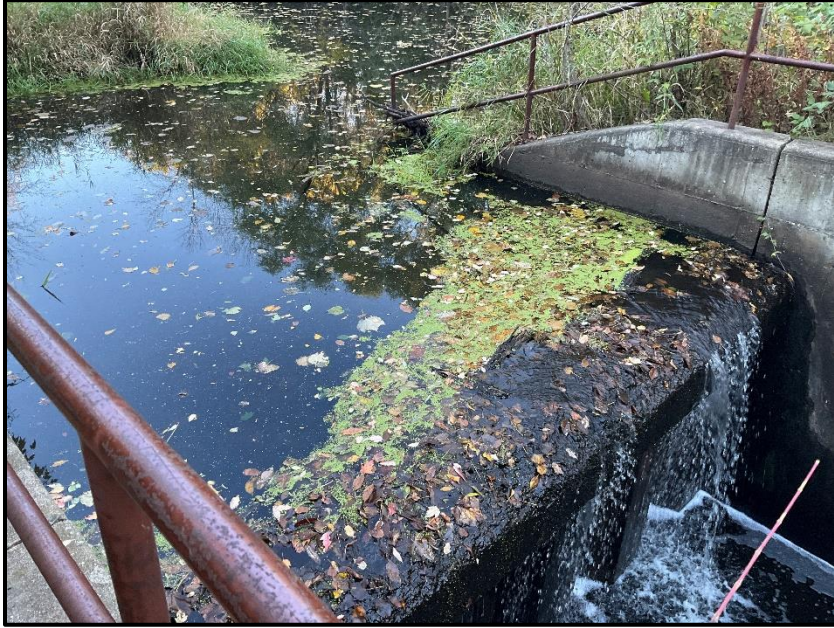
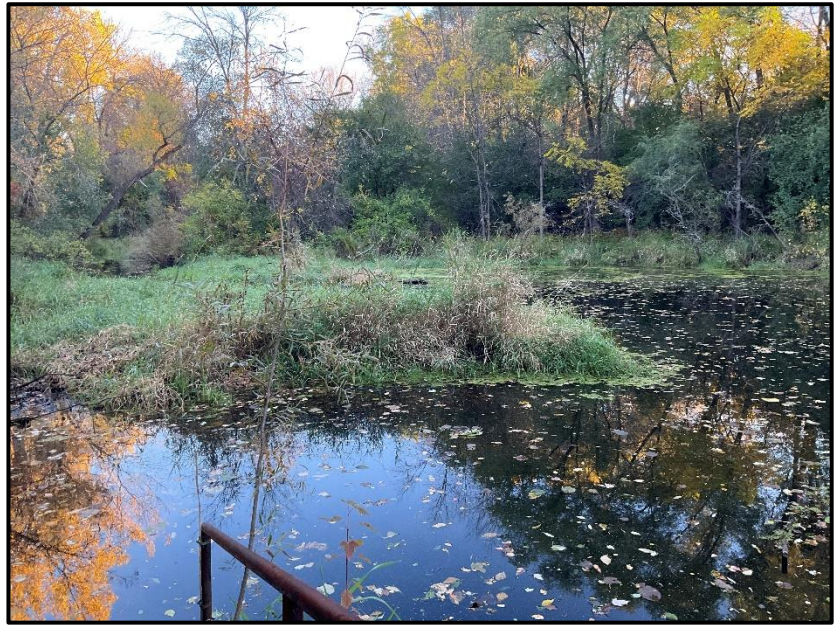
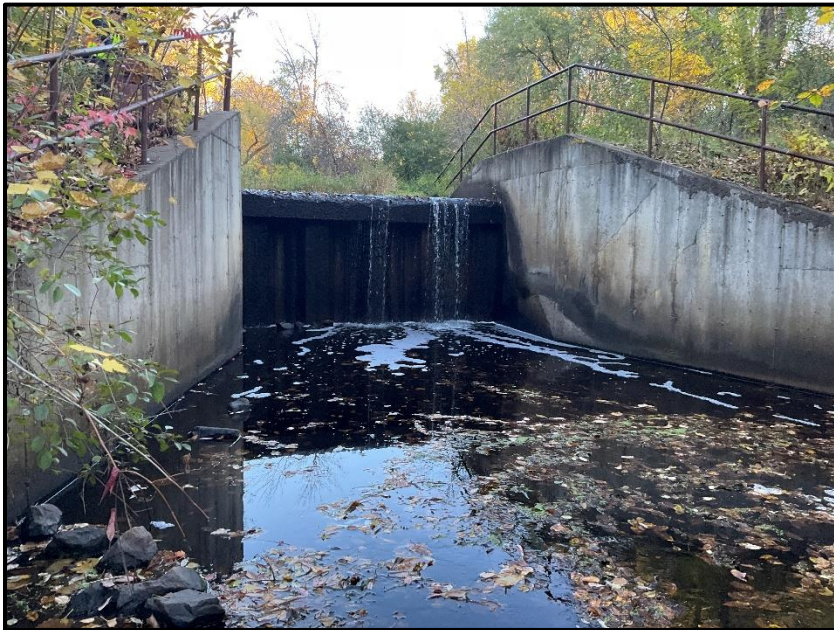
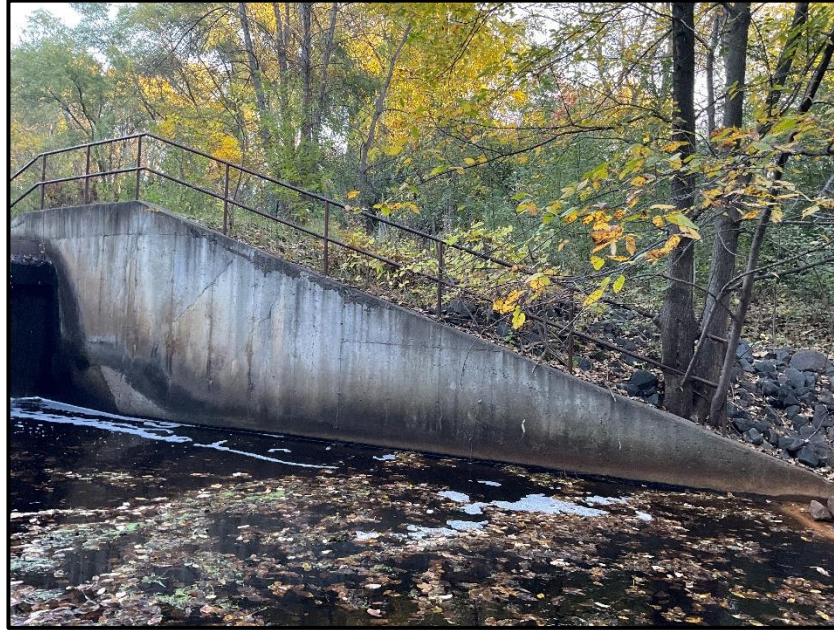
# Plymouth Creek Fish Barrier (Plymouth)

- a. The structure appeared to be in satisfactory condition.
- b. The water level was at 0.28 at the staff gage and the water was 0.05 feet over the weir at the time of the inspection.

- c. Sediment has accumulated in the pool upstream of the structure and formed a delta, which was overgrown with vegetation. The deposited sediment was generally creating a meander in the creek toward the east (left) bank. Deposited sediment in the upstream pool has been noted since 2005.

- d. The railings at the upstream end of the structure, on the east (left) and west (right) sides, have rusted off below the weir level. This is consistent with previous inspections and has been noted since 2015.

- f. The top downstream edge of the concrete pile cap forming the weir has deteriorated along its entire length. Deterioration includes loss of cement paste and fines resulting in exposed aggregate. The weir appears to be functioning properly and controlling water to the design elevation.

- g. Three cracks were observed on the downstream west (right) wing wall. This is consistent with previous inspections and has been noted since 2004.
- h. Seven diagonal cracks were observed on the downstream east (left) wing wall. Three of the cracks are more prominently defined, closed cracks. Observation of the three prominent cracks is consistent with previous inspections and has been noted since 2002. The other four cracks are generally closed hairline cracks and less noticeable.

- i. A 15-inch diameter tree was observed growing adjacent to the downstream east (left) wing wall and through the railing.
- j. Small trees and shrubs were observed growing on the embankment and downstream channel banks, including some near the wing walls and railings.

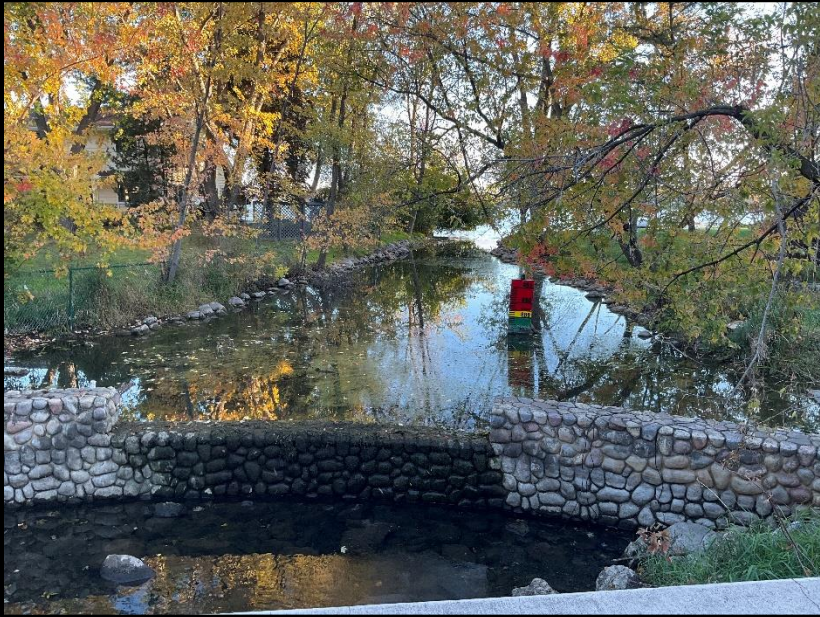
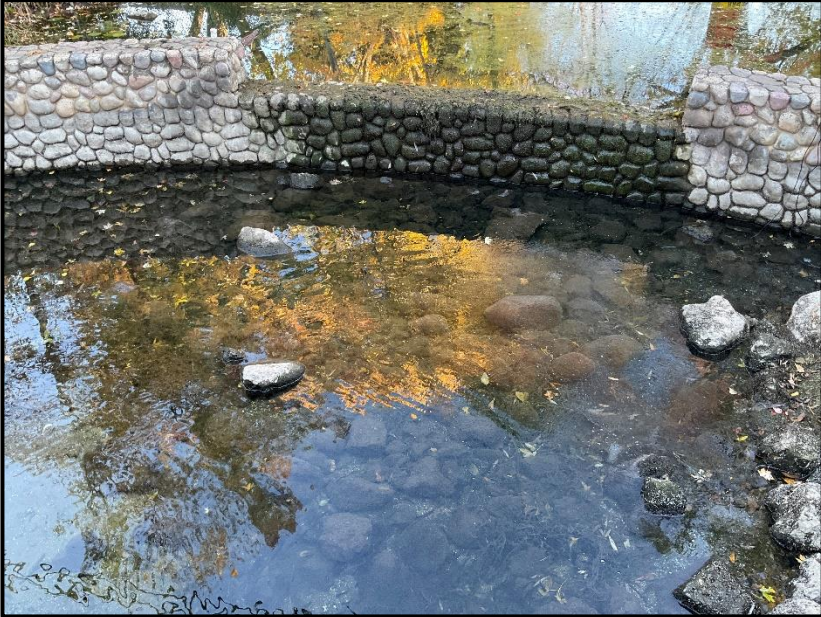
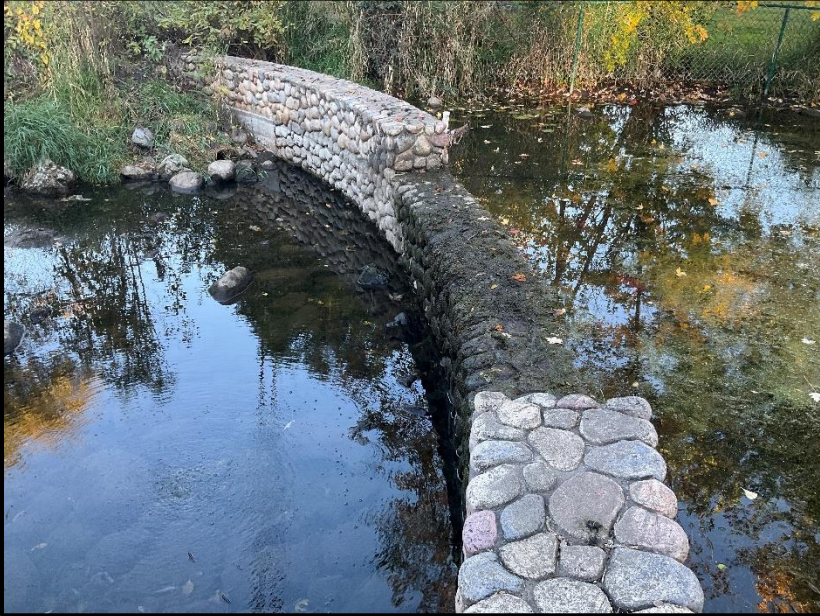
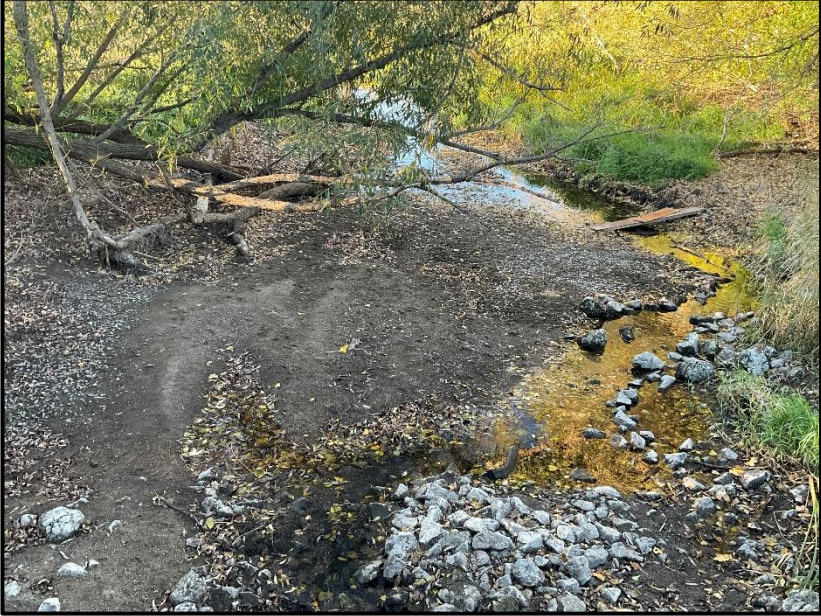
Medicine Lake Outlet (Plymouth)

- a. The channel between Medicine Lake and the outlet structure was clear of debris.
- b. The water level was below the weir at the time of the inspection and the staff gauge was measured at 888.0 feet
- c. The outlet structure appeared to be in satisfactory condition.
- d. Although not part of the flood control project, the storm sewer outfall for local drainage from South Shore Drive in the west (right) bank was partially full of sediment.
- e. Woody vegetation was observed at each end of the dam where it ties into the banks.
- f. In late May 2019, City of Plymouth staff observed water flowing over the east side, but not the west side, of the Medicine Lake Outlet Structure. The city performed a baseline survey of the dam in the summer of 2019 and found that the east side of the dam was 0.15 feet lower than the west side. Future surveys can be performed to compare against the baseline.

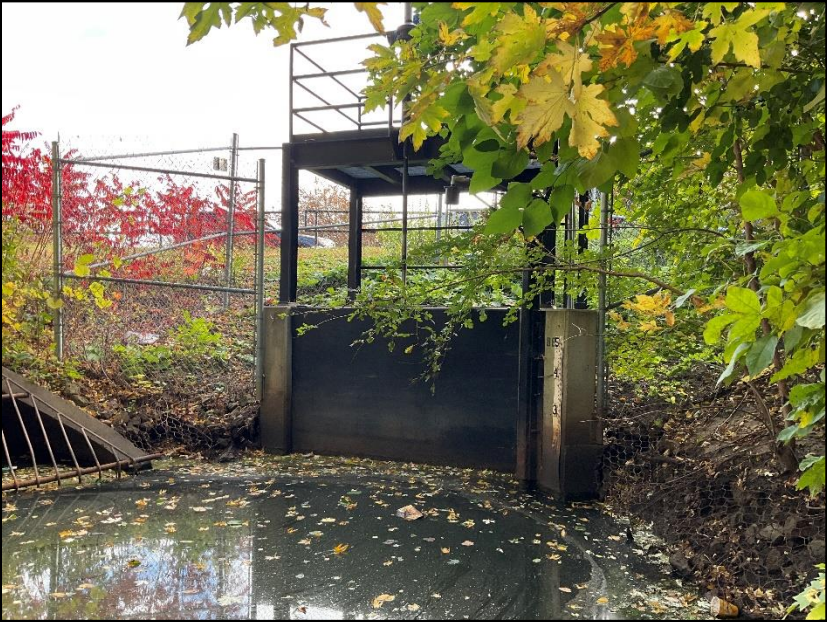
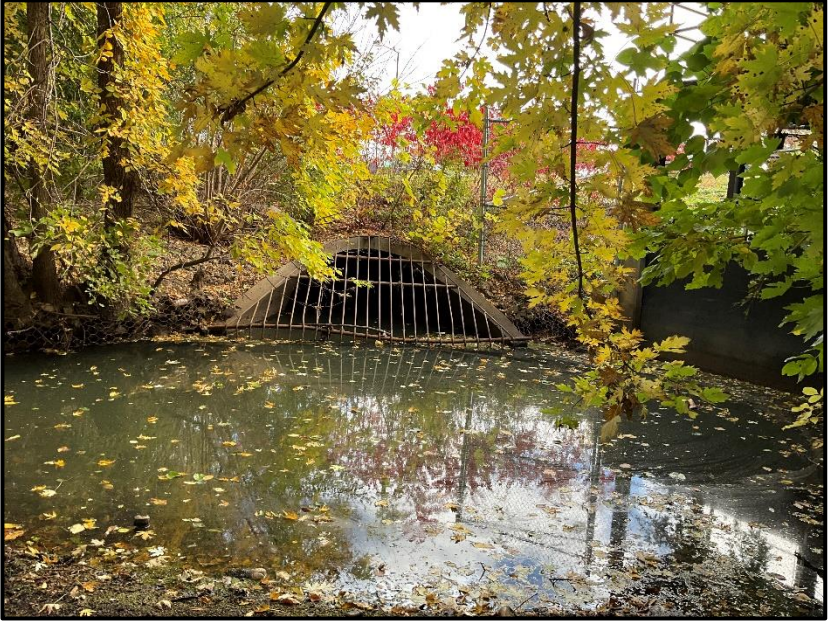
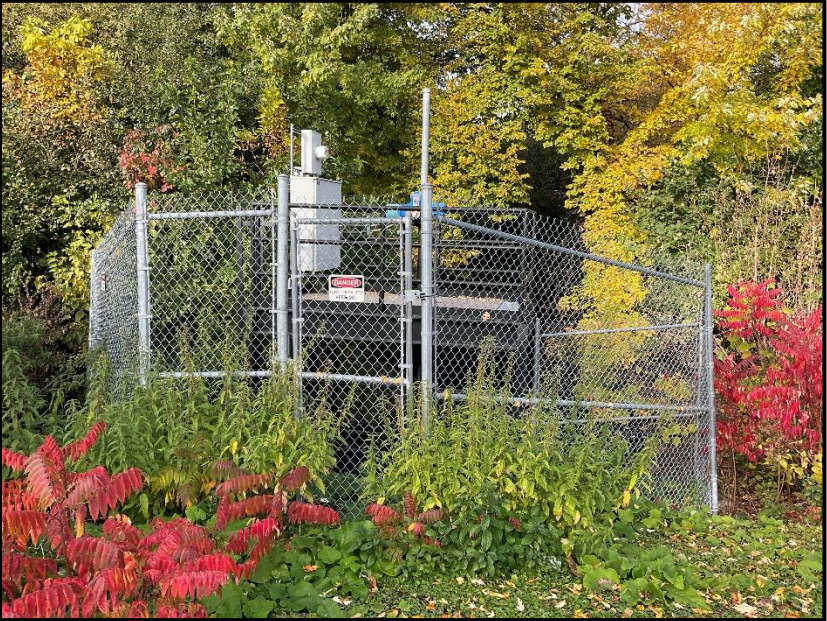
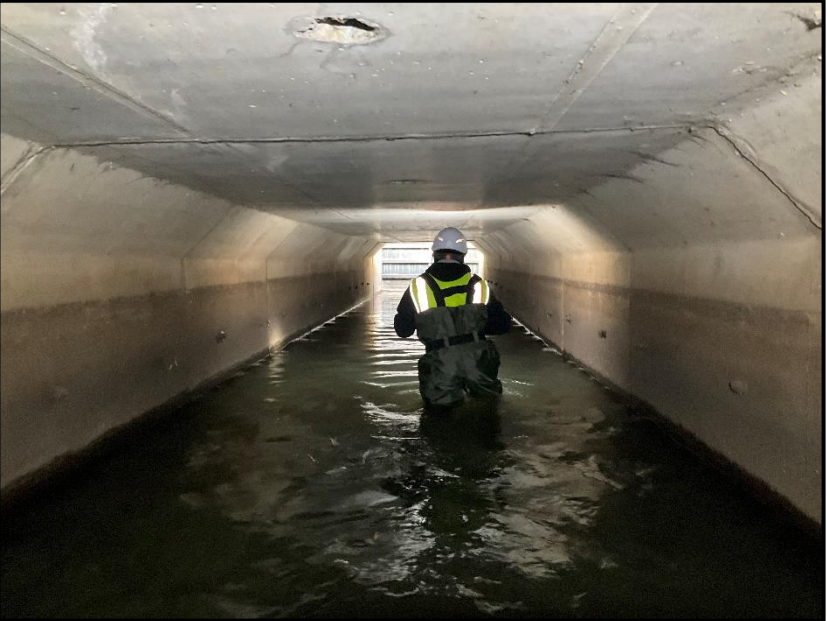
Wisconsin Avenue Control Structure (Golden Valley)

- a. The water level was below the lowest staff gauge reading upstream and downstream of the box culvert.
- b. The flood gate was fully closed (down) at the time of the inspection and appeared to be in satisfactory condition.

- c. Deposited sediment was observed in the bottom of the box culvert, ranging from 2-6 inches deep. The deposited sediment is consistent with previous inspections and has been noted since 2006.

- d. Several gabion baskets located both upstream and downstream of the box culvert show signs of deterioration or damage, resulting in the displacement of riprap from the baskets at various points. Although the gabion baskets are no longer functioning as installed, no significant erosion was observed. There is evidence of some minor erosion near the staff gauge and left bank upstream of large culvert.

- e. Cracks were observed along the crown of the box culvert.
- f. Upstream of the gate, the left bank has begun to scour, and deposition is occurring on the right bank.

- g. Scour of the creek bed was observed downstream of box culvert. The scour appeared to start at the end of the box culvert and continued for roughly 40 feet.

- h. The railings at the upstream and downstream ends of the box culvert were in satisfactory condition.
- i. Vegetation may be blocking the sensor for the gate valve.

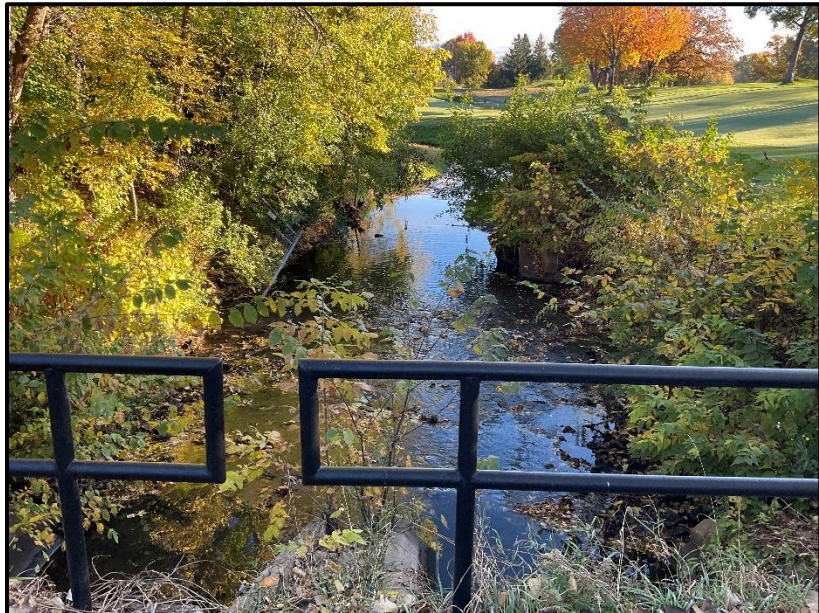
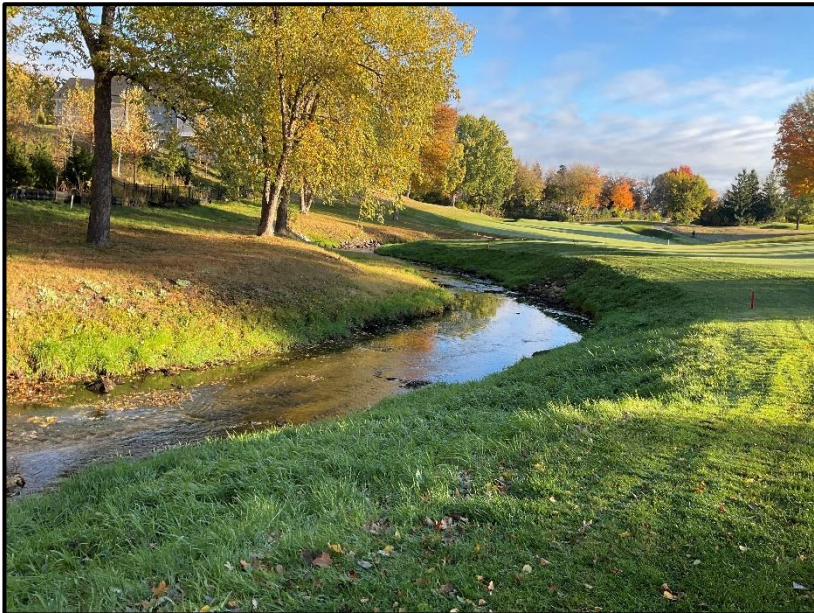
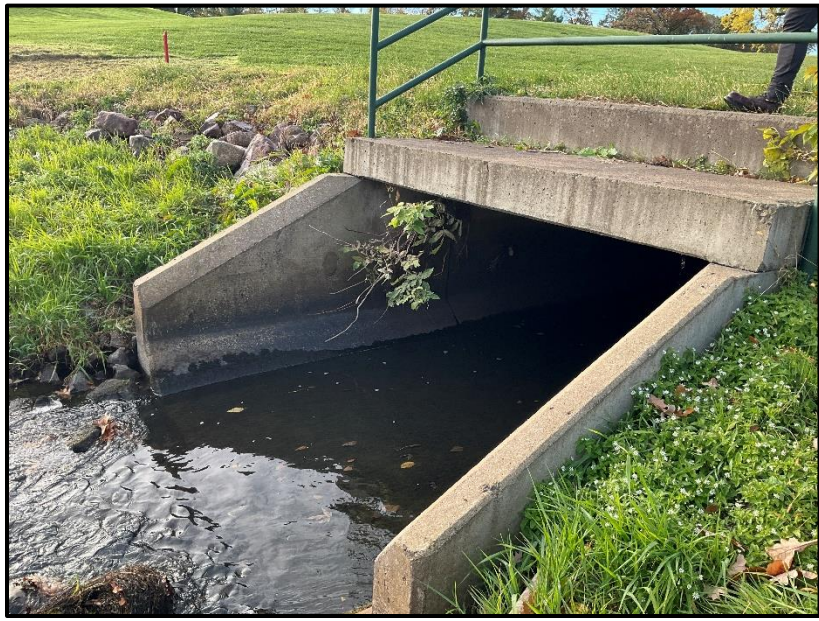
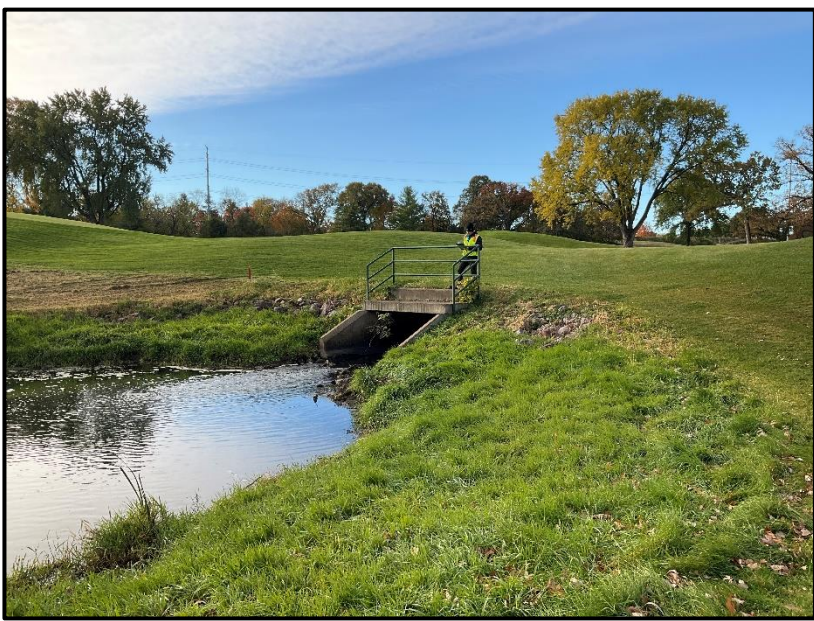
Golden Valley Country Club (Golden Valley)

- a. The channel and riprap armoring from Pennsylvania Avenue to the box culvert appeared to be in satisfactory condition.
- b. The box culvert, joints, and railings appeared to be in satisfactory condition.

- c. The overflow weir (earth berm) appeared to be in satisfactory condition and has been maintained by the Golden Valley Country Club staff as manicured fairway turf.

- d. Some sediment deposition was observed on both inside banks of the bends upstream of the box culvert. This is consistent with previous inspections but was more visible this year due to lower water levels.

- e. Some sediment deposition in various areas of the creek was observed. This was more visible due to low water levels.
- f. A tree is growing into the downstream side of the box culvert. The tree is growing through the last joint on the top right of the culvert.

- g. Near Pennsylvania avenue, a large chunk of concrete was observed in the channel near the right bank. At roughly the same cross section of the creek, a fence was observed on the left bank. The fence starts on the hill of the left bank and extends to be partially in the creek.

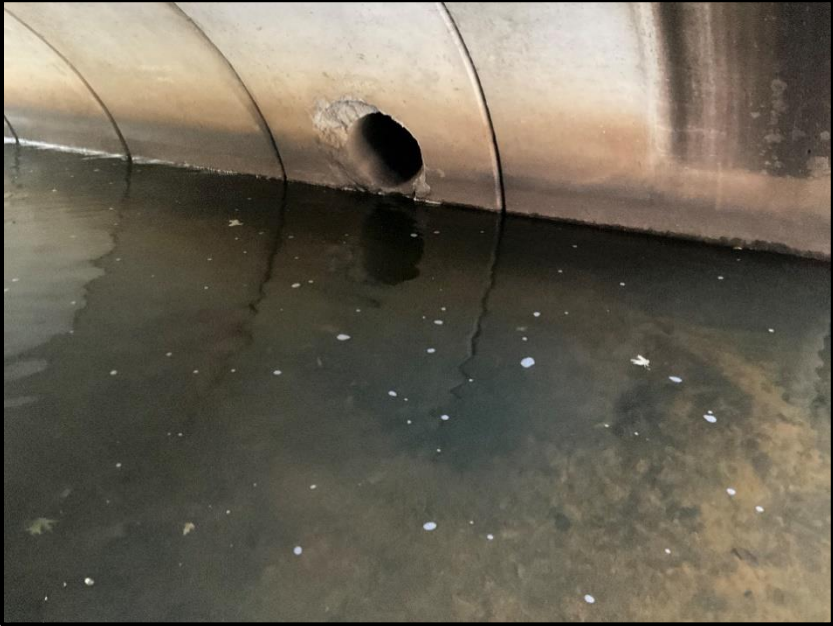
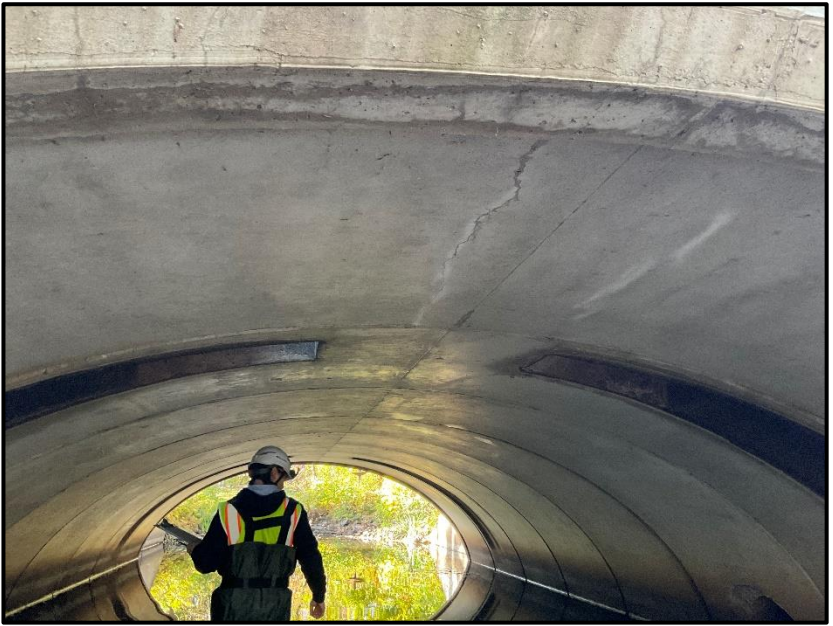
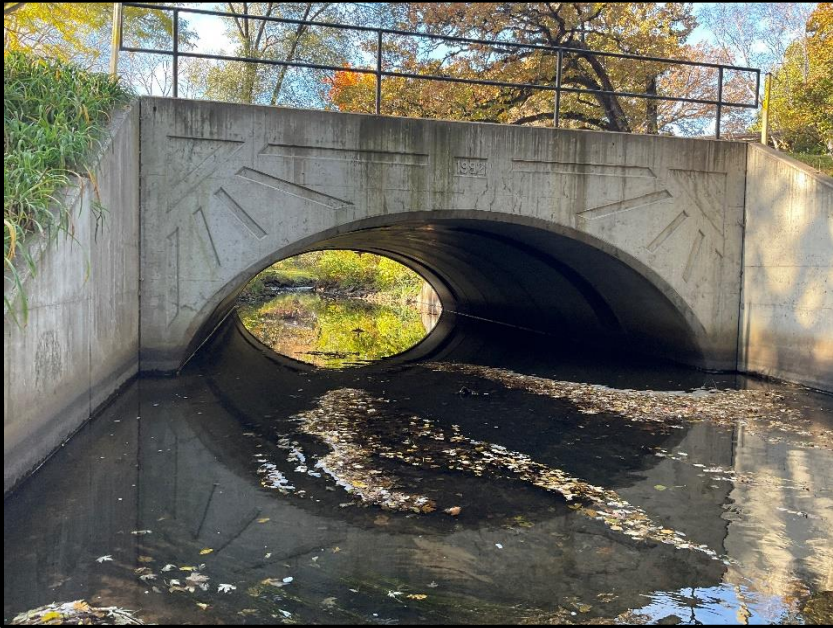
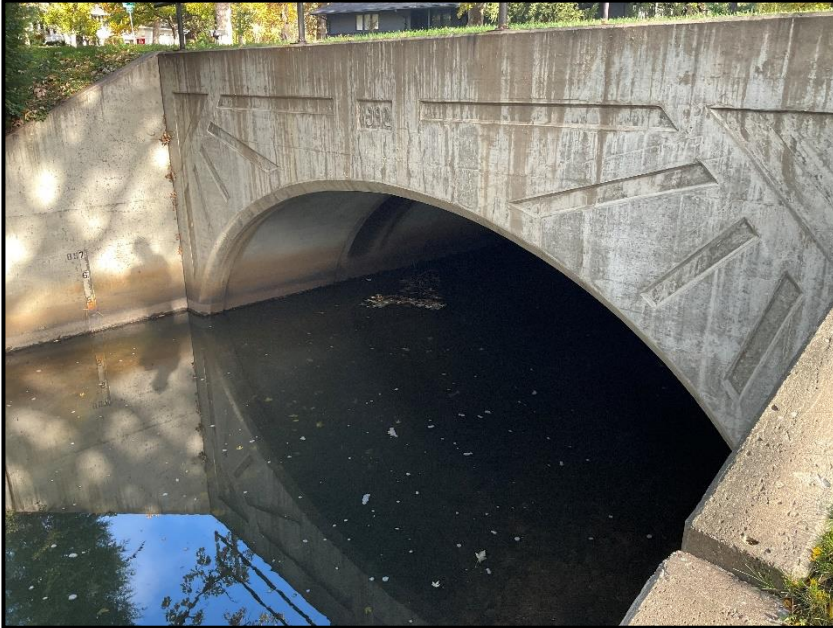
Westbrook Road Crossing (Golden Valley)

- a. The concrete Bebo arch (Type A25/90) appeared to be in satisfactory condition.
- b. The water level at the staff gauge was measured at 853.65 feet.
- c. Creek bottom is primarily 2-3 inches of river rock through the BEBO arch.
- d. A scour hole was observed by the inlet pipe.
- e. Longitudinal hairline cracks were observed on the top of sections of the Bebo arch, extending across the entire section (pre-cast section) width. The cracks are approximately 2 feet off-center of the structure. These cracks are consistent with previous inspections and have been noted since 2002.
- f. Spalled concrete was observed at multiple locations upstream and downstream of the arch culvert at the top of the wing walls and head wall. This is consistent with previous inspections and has been noted since 2007.
- g. The railings appeared to be in satisfactory condition.

- h. Riprap armoring was in good condition upstream and downstream of the BEBO arch.

- Monitor cracks in the BEBO arch.
- Monitor joint gap at pressure points.
- Monitor spalled concrete at wing walls, head walls, and catch basin.

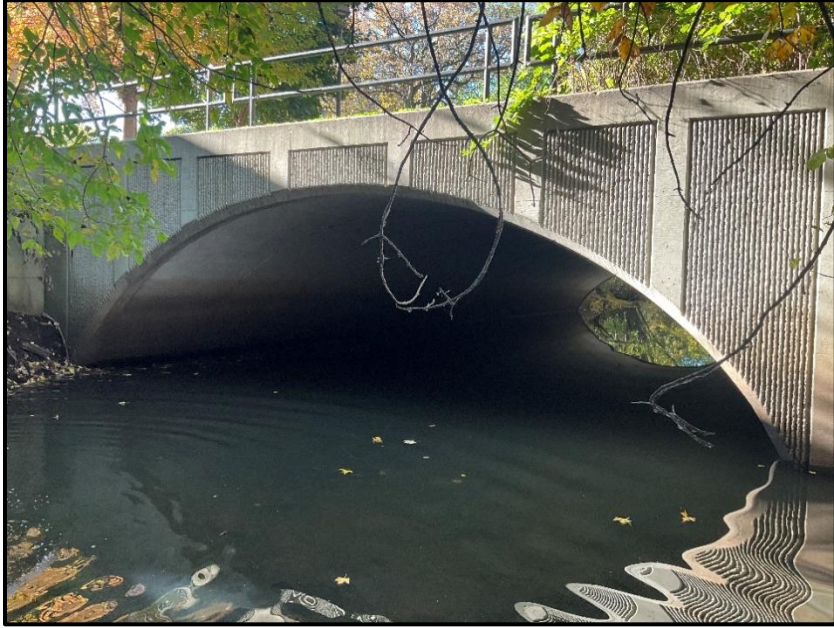
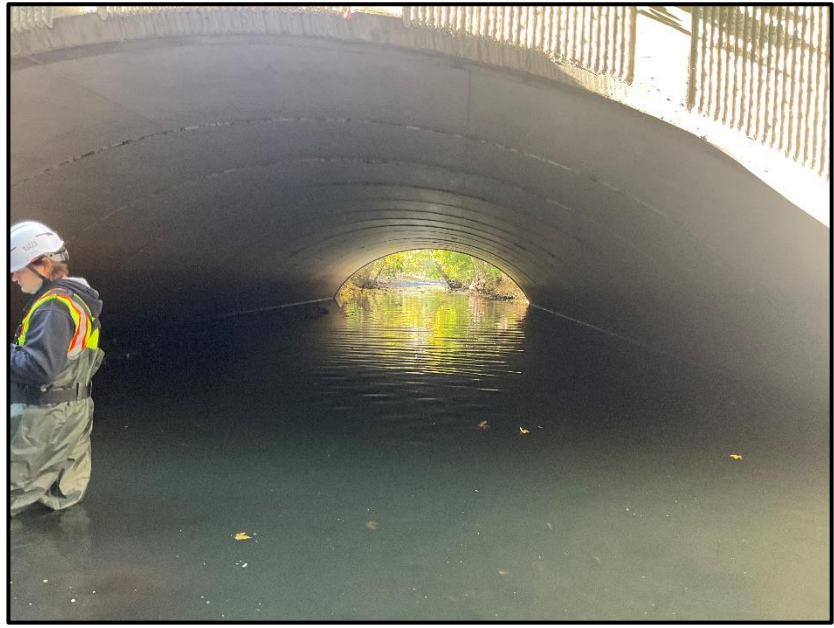
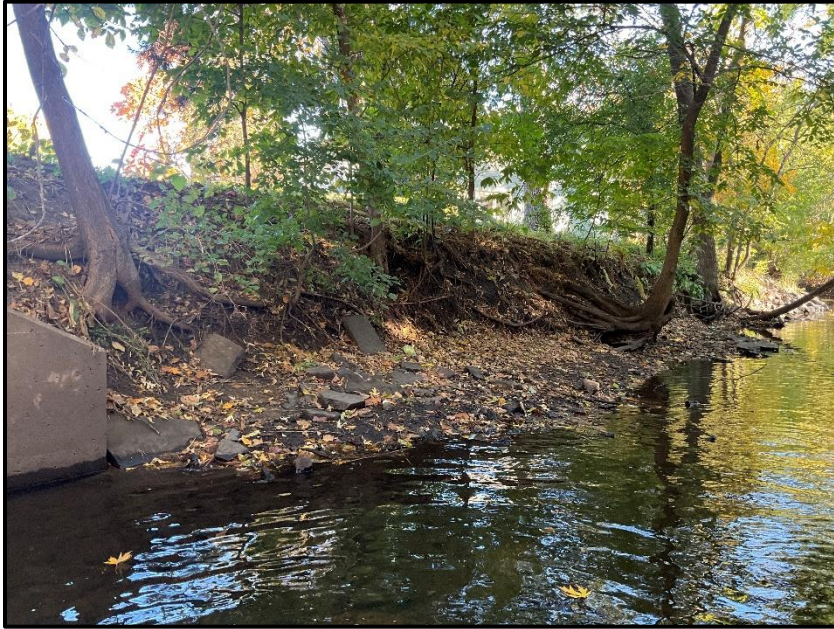
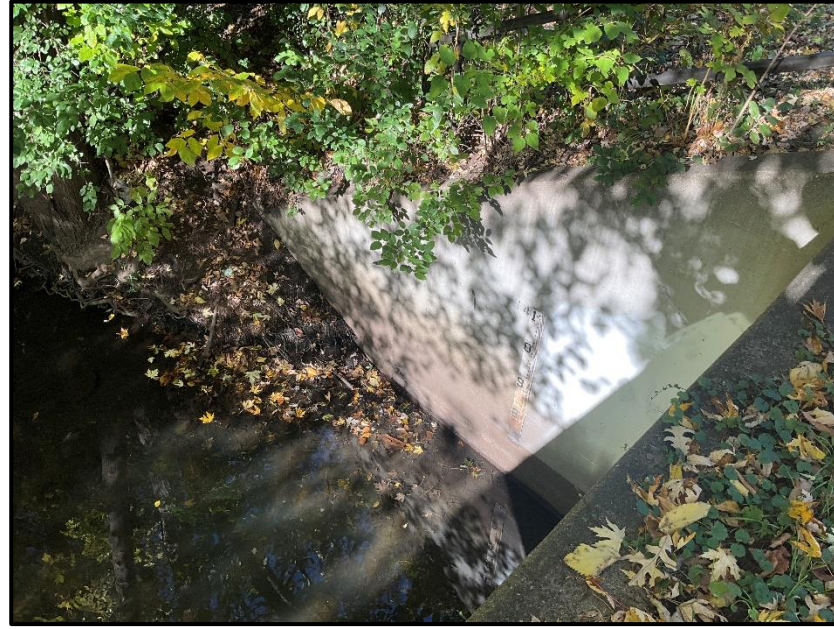
# Regent Avenue Crossing (Golden Valley)

- a. The concrete Bebo arch appeared to be in satisfactory condition.
- b. The water level was below the bottom of the staff gauge and not measured.
- c. The concrete is cracking and starting to spall at the top of the upstream left wing wall.

- d. Spalled concrete was observed at the middle joint of the upstream north (left) wing wall. This is consistent with previous inspections and has been noted since 2002.

- e. A crack was observed at the upstream north (left) wing wall. The crack was near the top of the wing wall and travels at a 45-degree angle down to the headwall. This is consistent with previous inspections and has been noted since 2002.

- f. A crack was observed at the downstream south (right) wing wall. The crack was near the top of the wing wall and travels at a 45-degree angle down to the headwall. This is consistent with previous inspections and has been noted since 2002.

- g. Minor erosion was observed on the upstream side of the left bank and downstream side of the north (left) wing wall. This area is included in the project extents for the BCWMC's Main Stem Restoration Project from Reagent Avenue to Golden Valley Road as part of the 5-year Capital Improvement Program.

- j. The railings appeared to be in satisfactory condition.

- Monitor spalled concrete at the upstream north (left) wing wall.
- Monitor cracks at the upstream north (left) wing wall, upstream south (right) wing wall, and downstream south (right) wing wall.
- Monitor creek bottom for scour and deposition.

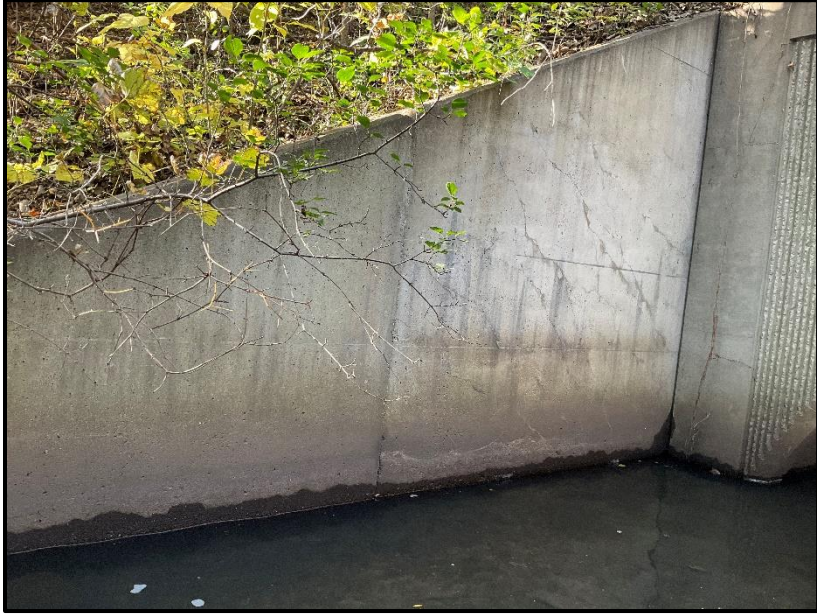
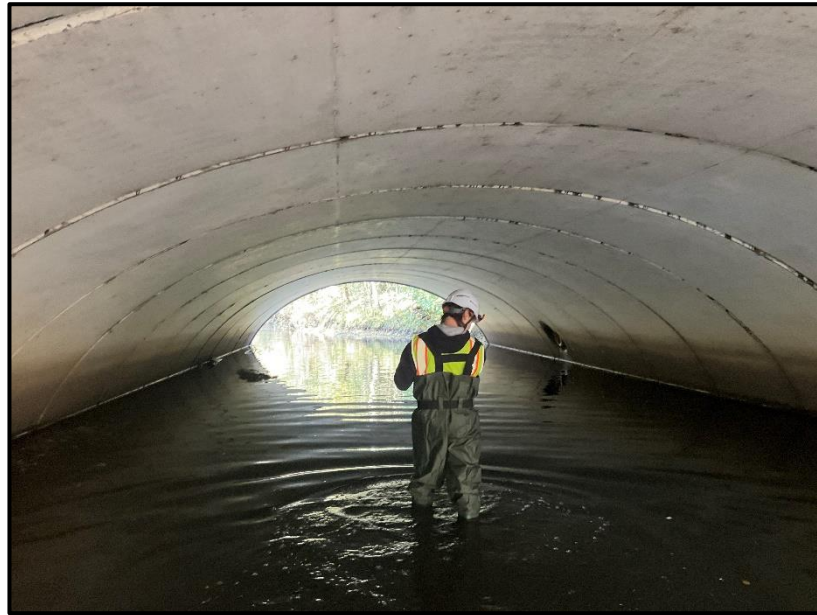
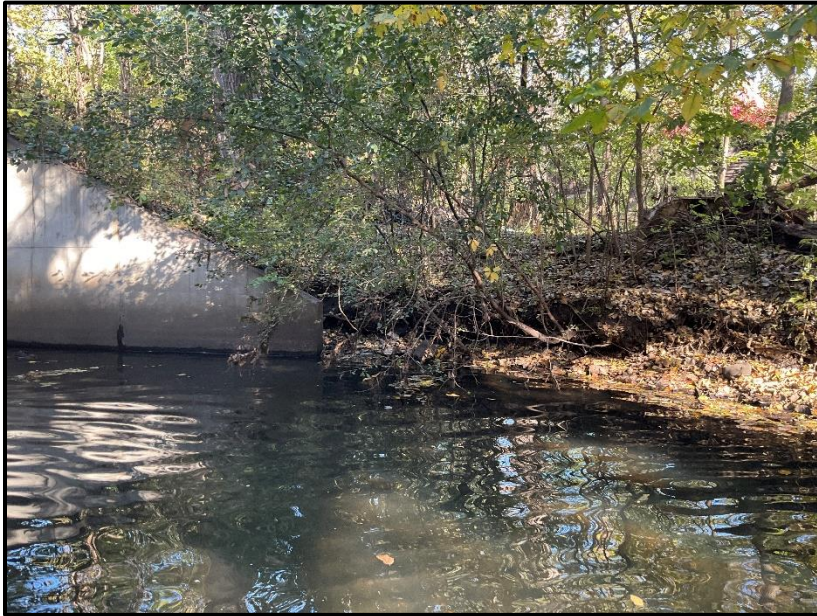
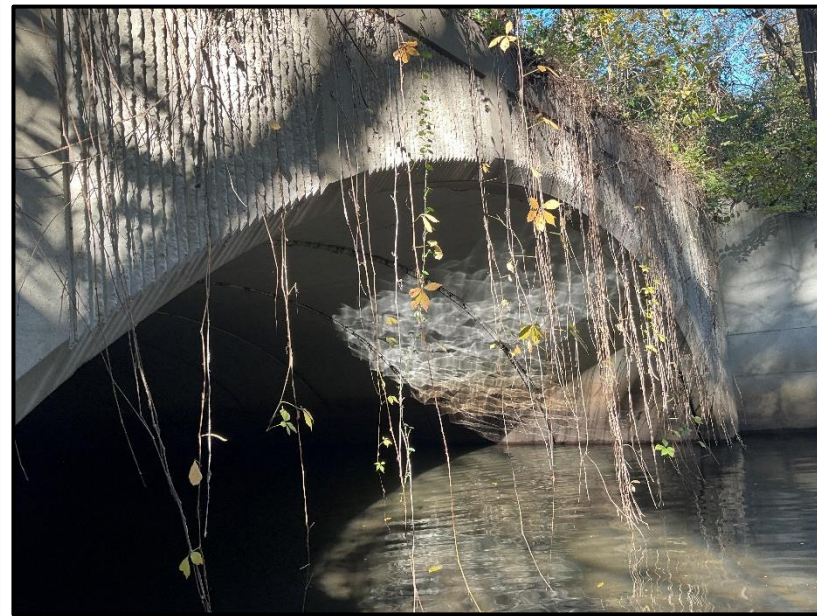
**Noble Avenue Crossing (Golden Valley)**

- a. The concrete Bebo arch appeared to be in satisfactory condition.
- b. Longitudinal hairline cracks were observed throughout the length of the top of the BEBO arch, extending across the entire (pre-cast) section width. The cracks were either in the

center of the structure or approximately 2 feet off-center of the structure. This is consistent with previous inspections and has been noted since 2002.

- c. Spalled concrete and exposed plastic joint material were observed approximately 2 feet either side of center throughout the length of the top of the BEBO arch. The cement paste covering the plastic joint material has separated and exposed the plastic. This is consistent with previous inspections and has been noted since 2002.

- d. Fractured and spalled concrete was observed at the downstream north (left) wing wall. This is consistent with previous inspections and has been noted since 2002.

- e. Multiple cracks and spalling were observed at the top of downstream north (left) wing wall. The cracking is consistent with previous inspections and has been noted since 2007.

- g. Minor bank erosion and scour was observed on both sides of the downstream wing walls. This is consistent with previous inspections and has been noted since 2002.
- h. Flows appeared to be scouring the north (left) side of the creek bottom.
- i. The paint on the railings is peeling.
- j. The City of Golden Valley installed riprap in 2018 to reinforce the bank and minimize continued erosion at the outside edge of the upstream south (right) wing wall; however, some erosion has perpetuated upstream.
- k. The creek bottom varies from 2-3 inch river rock on the downstream end to gravelly sand on the upstream end. The BEBO arch can be best accessed for inspection on the north (right) side from the downstream end.

- Monitor cracks and spalled concrete in the BEBO arch and wing walls.
- Monitor bank erosion at downstream wing walls and upstream of installed riprap at upstream south (right) wing wall.
- Monitor creek bottom for scour and deposition.

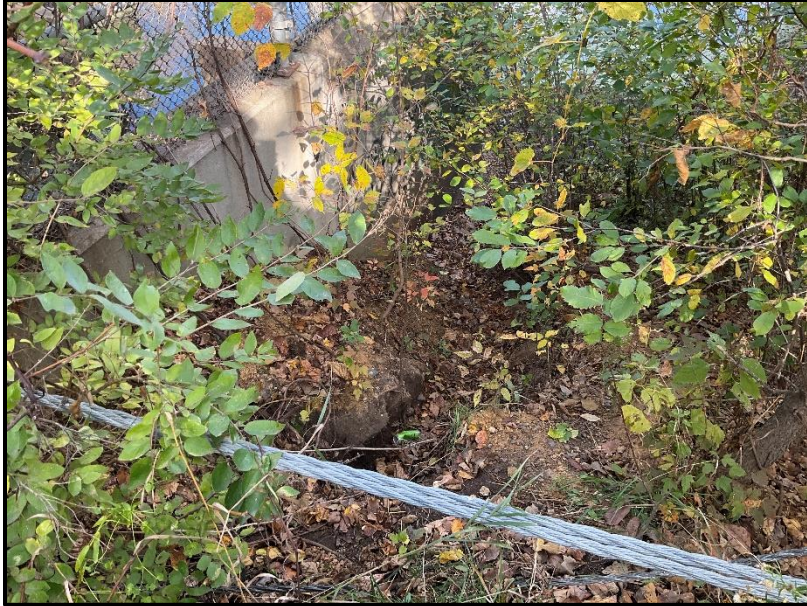
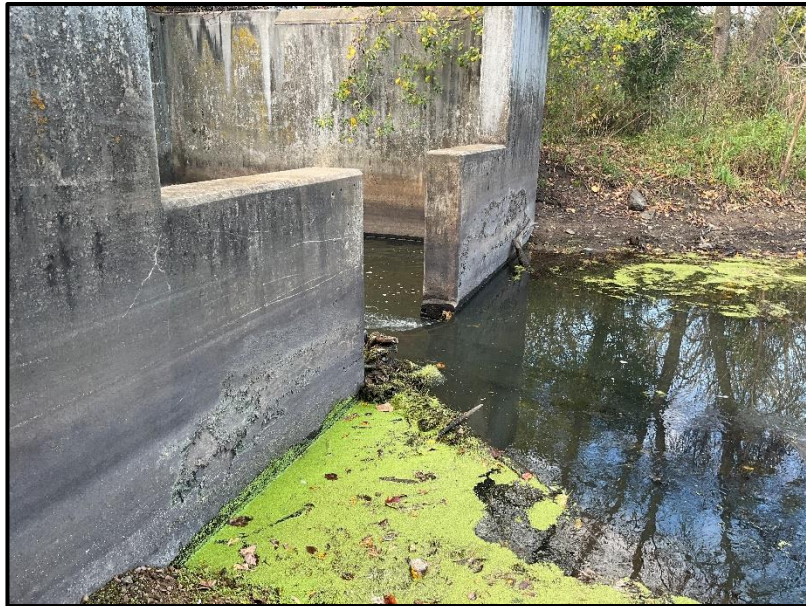
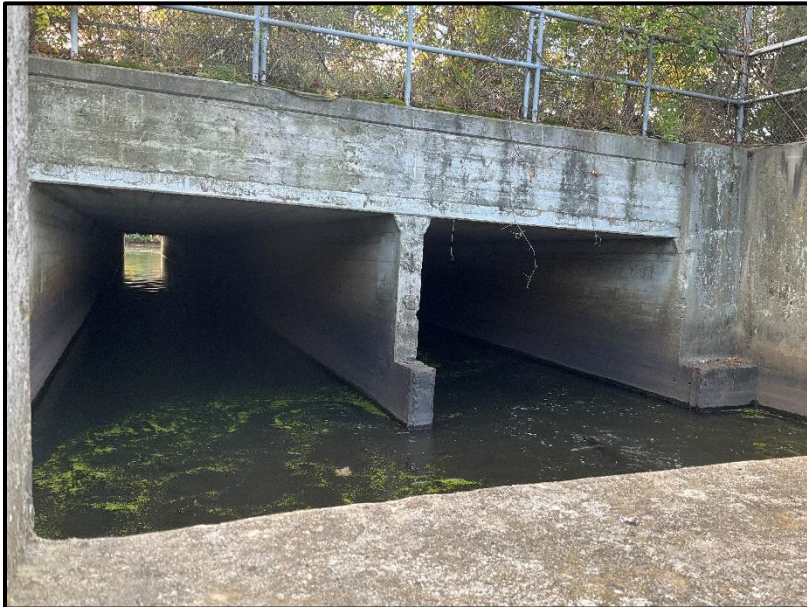
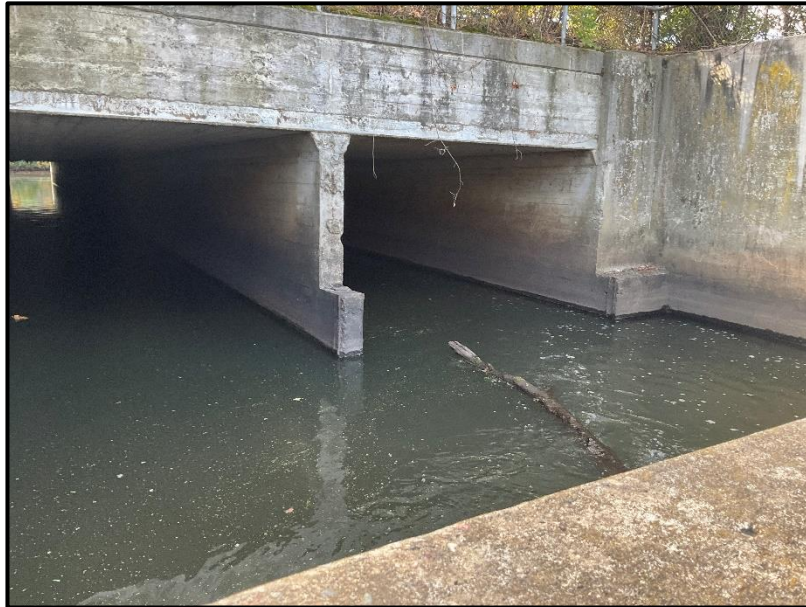
**Highway 55 Control Structure (Golden Valley)**

- a. The concrete control structure appeared to be in satisfactory condition. The double box culvert was not inspected.
- b. A hairline crack was observed in the east (left) wall of the inlet structure, although it appears that the crack may have been previously sealed with caulk. The crack is positioned in the middle of the wall extending full height. This is consistent with previous inspections and has been noted since 2002.

- c. Erosion was observed around the east (left) side of the structure, likely from road runoff. In the summer of 2021, Minnesota Department of Transportation (MnDOT) crews placed class 5 aggregate on the east (left) side of the structure to access the upstream end of the structure to perform repairs of the double box culvert below Highway 55. The new class 5 aggregate has nearly completely eroded away.

- d. MnDOT crews also drilled holes into the structure to install brackets and a temporary plate to block flows through the structure so they could perform repairs. MnDOT removed the plate, brackets, and bolts, but did not fill or repair the bolt holes.

- e. Downed trees are located near the left corner on the upstream side of the structure.
- f. In 2021, 2022, 2024, and 2025, a piece of rebar and relatively small mass of concrete were observed extending into the lower west (right) side of the opening of the low flow weir. A steel threaded rod extended approximately 2 inches from the south face of concrete on the east (left) side of low flow weir.

- Protect the sides of the structure with armoring (rock or riprap) or reinforced vegetation to limit additional erosion. Alternatively, divert road runoff away from the structure.
- Sawcut and remove rebar and concrete chunk on east (left) side of low flow weir.
- Sawcut steel rod to be flush to concrete along south face of concrete on the east (left) side of the low flow weir.
- Repair chain link fence.
- Remove the tree that is lodged in the low flow weir.

- Monitor hairline crack in the control structure.

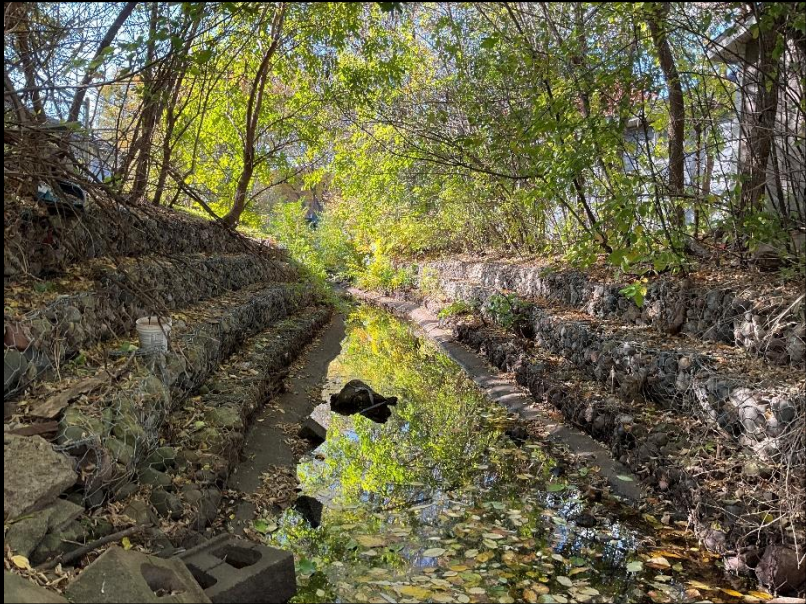
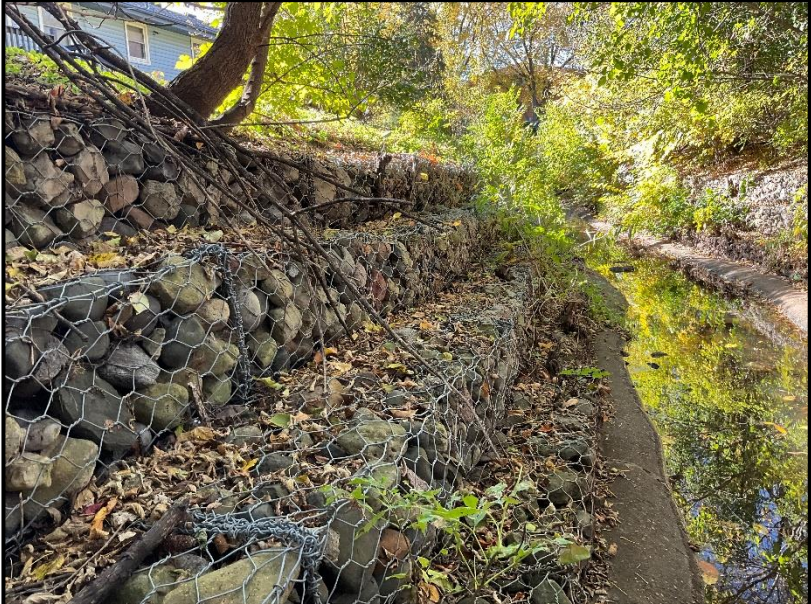
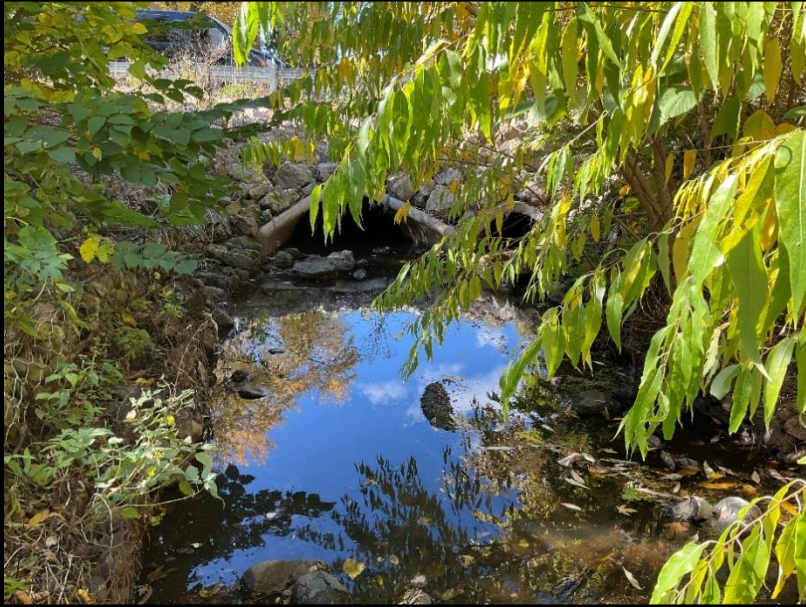
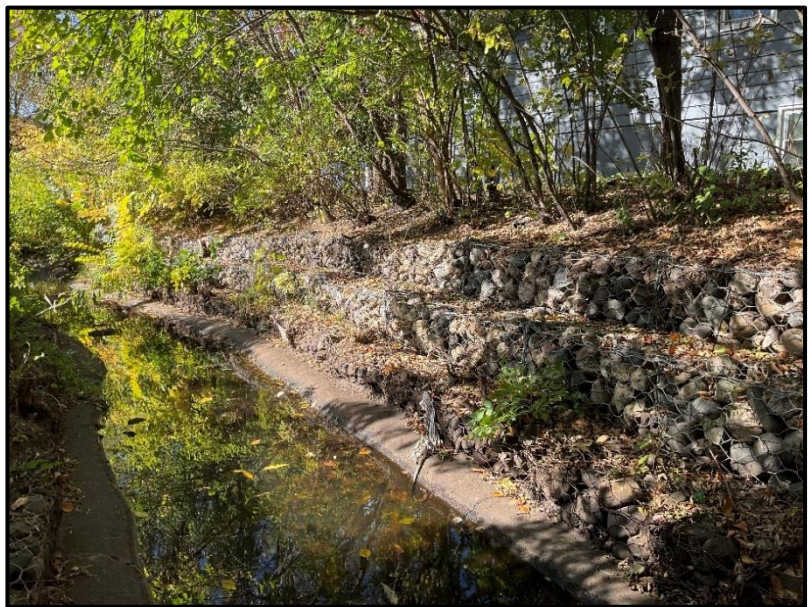
Markwood Open Channel (Crystal)

- a. The channel appeared to be in satisfactory condition.
- b. Vegetation growth was observed along the side slopes of the channel. Some areas appeared to have been cleared since the previous year's inspection.

- c. Erosion was observed along the toe of the north (left) and south (right) banks. This is consistent with previous inspections and has been noted since 2006.

- d. The retaining wall along the channel at 7010 36th Avenue is failing and falling into the channel, potentially impacting high flows and causing erosion.

- e. Other downstream retaining walls and fences along the channel were leaning toward the channel and, in some cases, appeared to be failing. This is consistent with previous inspections and has been noted since 2009.

- f. The City of Crystal's corrugated metal pipe (CMP) storm sewer, discharging into the channel between 6833 and 6825 Markwood Drive, was in poor condition. The pipe bottom was corroded and there was erosion and undercutting around the pipe end. The pipe was exposed approximately 10 feet, measured on the downstream side.

- g. Cinder blocks were observed in the creek.
- h. Bank erosion was observed along the right bank downstream of the gabion section.
- i. While recent vegetation clearing appeared to have occurred along the gabion baskets section, the clearing could only be done above the top of the baskets and vegetation is still growing through the baskets. It was unclear if herbicide was used to prevent regrowth, but this vegetation may continue to pose a risk of damage to the gabion baskets.

- Every 1-2 years, clear woody vegetation to maintain flow capacity, protect the gabion baskets from damage, and allow access through the open channel. Consider clearing vegetation every other year. Chemically treat stumps with Garlon 3A herbicide (or other specialty herbicide for use in wetland sites and waterways) to prevent regrowth.
- Although not part of the flood control project, the city should consider repairing or replacing the CMP storm sewer.
- Although not part of the flood control project, repair the failing retaining wall and/or stabilize the area at 7010 36<sup>th</sup> Avenue to prevent erosion and potential obstruction of channel flows.

- Monitor remaining retaining walls and fences for potential failure and obstruction of flow through the channel.
- Monitor erosion along the toe of the channel banks.
