# Memorandum

**To:** Bassett Creek Watershed Management Commission (BCWMC)  
**From:** Barr Engineering Co. (Barr) (Josh Phillips, Gabby Campagnola, Jim Herbert)  
**Subject:** Item 4D: Bassett Creek 2025 Flood Control Project Inspection - BCWMC November 19, 2025 Meeting Agenda  
**Date:** November 13, 2025  
**Project:** 23270051.65 1080 001

## 4D Bassett Creek 2025 Flood Control Project Inspection

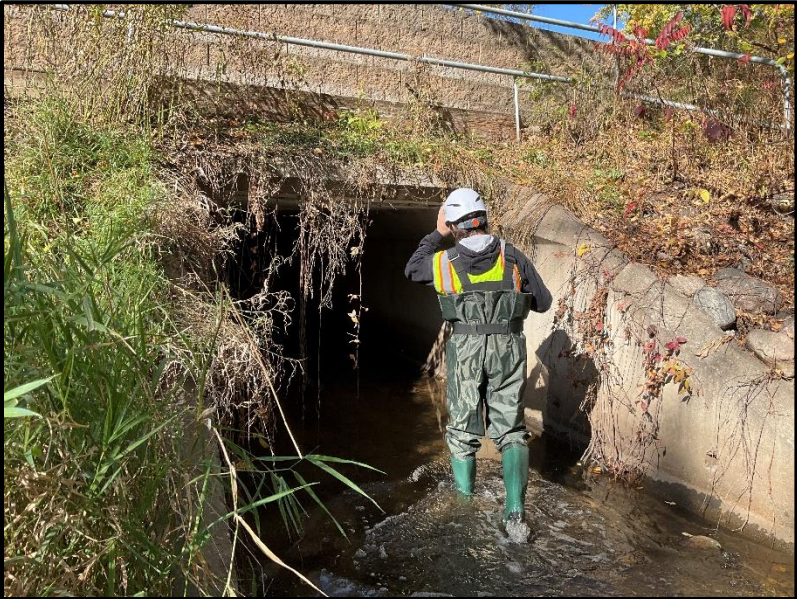
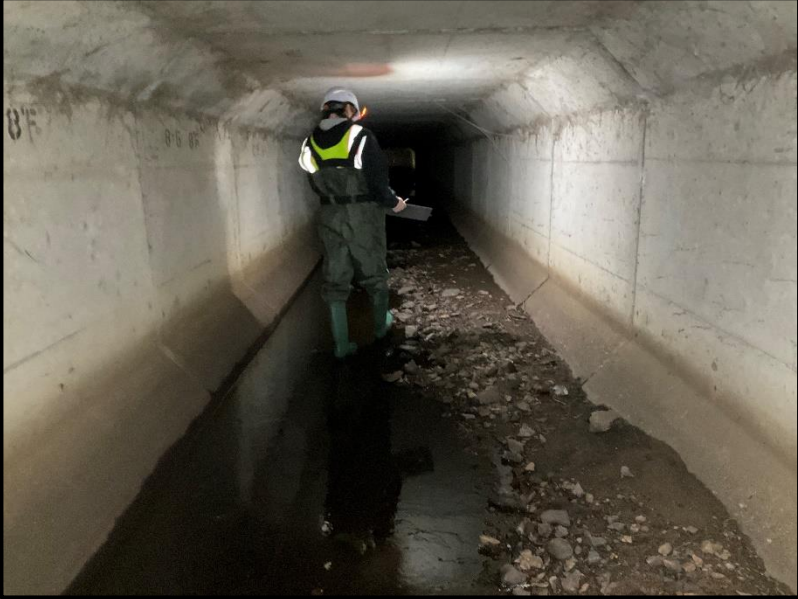
36th Avenue and Hampshire Avenue Crossing (Crystal)

- a. The concrete box culverts, joints and tie bars appeared to be in satisfactory condition.
- b. Some riprap has deposited in the box culverts.
- c. Sediment has deposited in the box culverts, mostly in the downstream half of the box culverts. This is consistent with previous inspections and has been noted since 2016.

- d. On both culverts, the fifth joint from the downstream end had a 2 ½ inch gap, which is a larger gap than the rest of the joints. This is consistent with previous inspections and has been noted since 2010.

- e. Various locations of spalled concrete and exposed reinforcing was observed through both culverts.
- f. Infiltration was observed into the north (left) culvert in 2019 and 2020 at the storm pipe connection upstream of the first culvert bend. However, infiltration was not observed into the culvert at this location from 2021 to 2025, potentially due to lower water levels and drier conditions.

- g. Approximately 6 inches of sediment was observed on the downstream side of both culverts.

- Remove deposited riprap in the box culverts and replace upstream.

- Monitor sediment in the box culverts.
- Monitor the joint gaps in the box culverts.
- Monitor spalled concrete, and exposed reinforcing in the culverts.

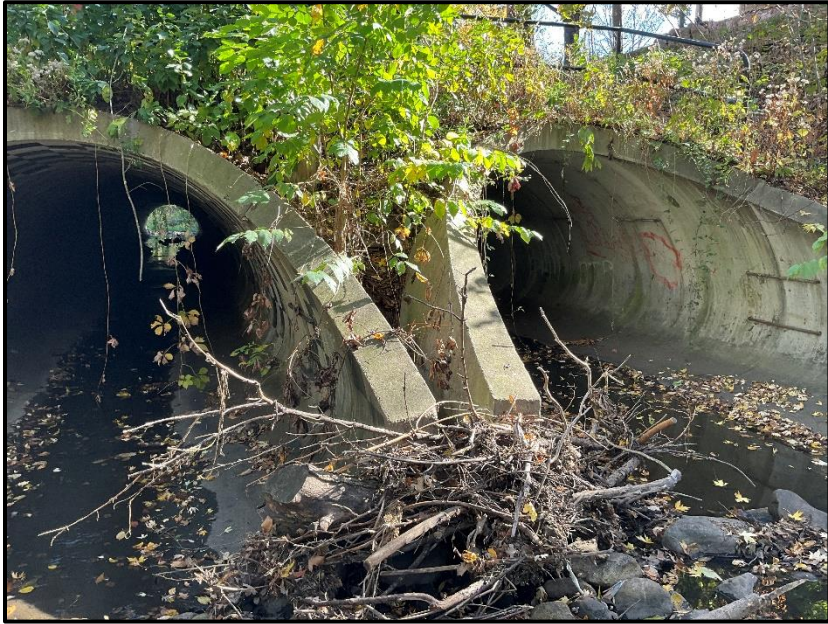
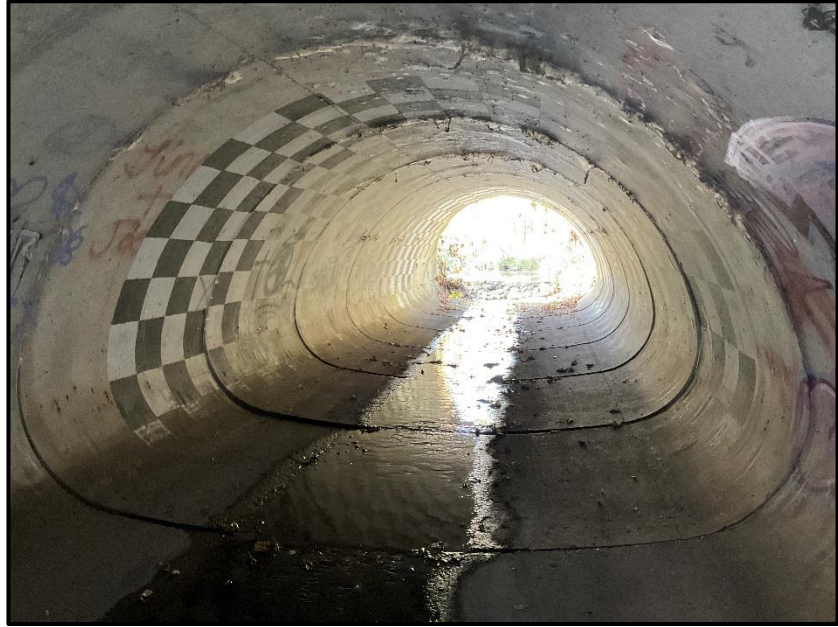
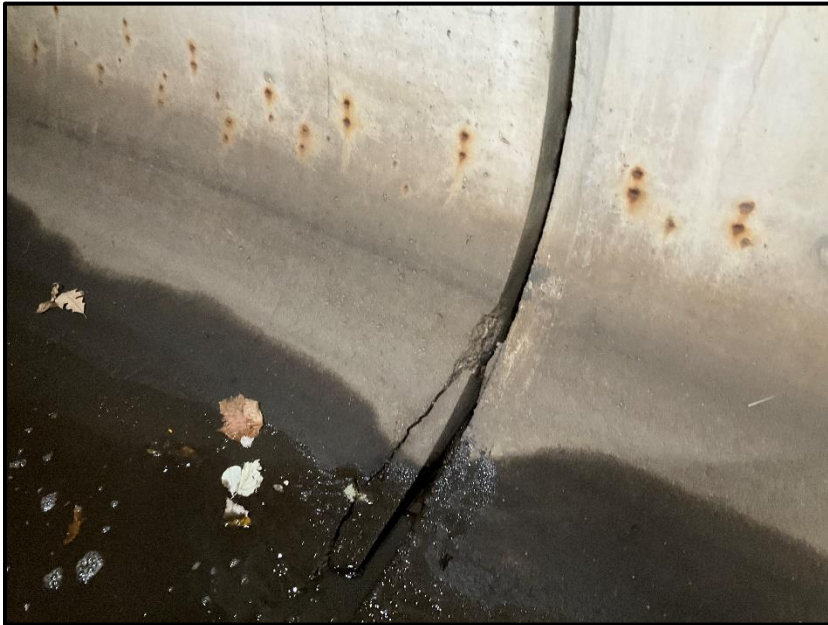
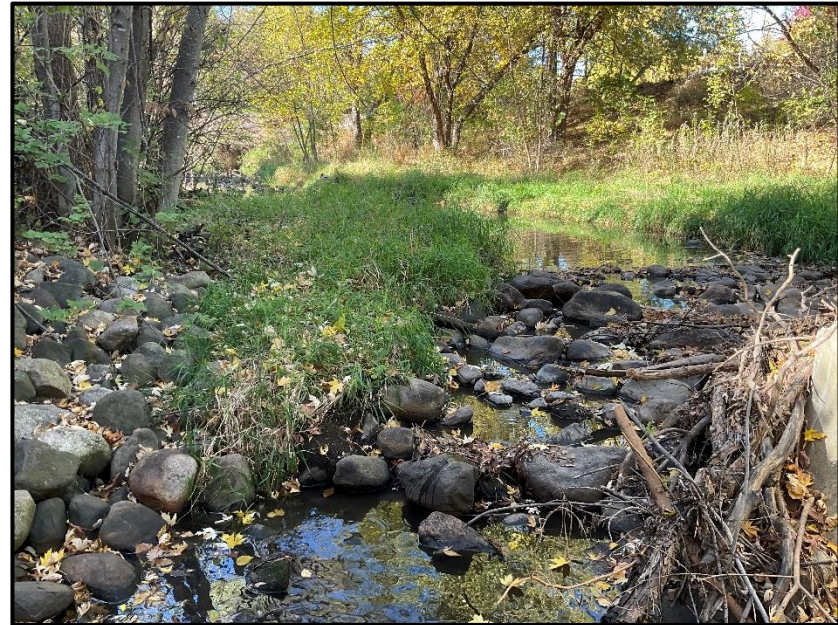
# Georgia Avenue Crossing (Crystal)

- a. The concrete arch culverts appeared to be in satisfactory condition.
- b. Cracking and spalling were observed in the south (right) arch culvert at the second and fourth joints at approximately the five o'clock position.
- c. Cracking was observed in multiple joints in the north (left) arch culvert at the five o'clock position and the seven o'clock position.
- d. Minor erosion was observed between the concrete arch culverts at the upstream end extending to nearly the first joint.
- e. Approximately two inches of sediment has accumulated downstream of the arch culverts, especially near the north (right) culvert and right bank.
- f. Sediment has accumulated on the right bank upstream of the arch culverts.
- g. Both arch culverts appeared to begin to change slope around mid-channel.

- Monitor cracking and spalling in the south (right) arch culvert.
- Monitor minor erosion between the concrete arch culverts on the upstream end.

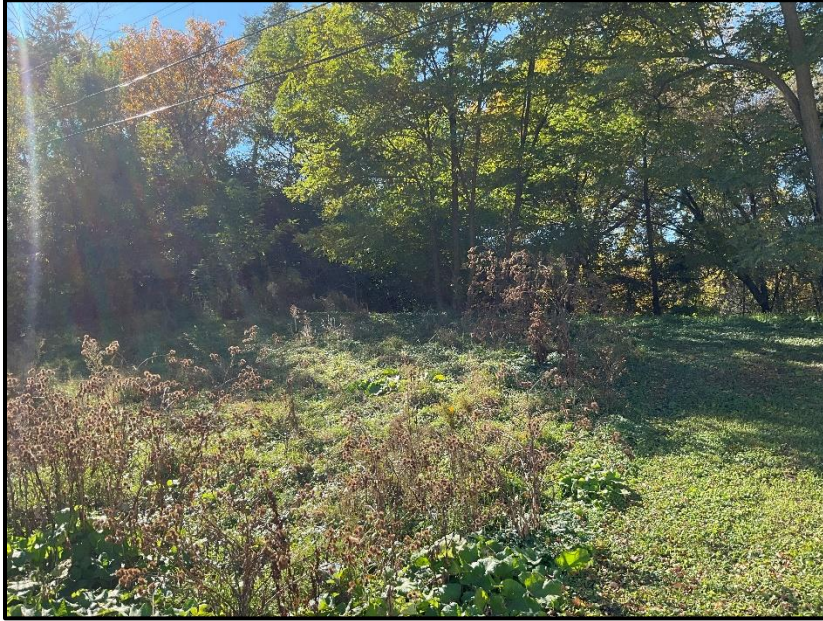
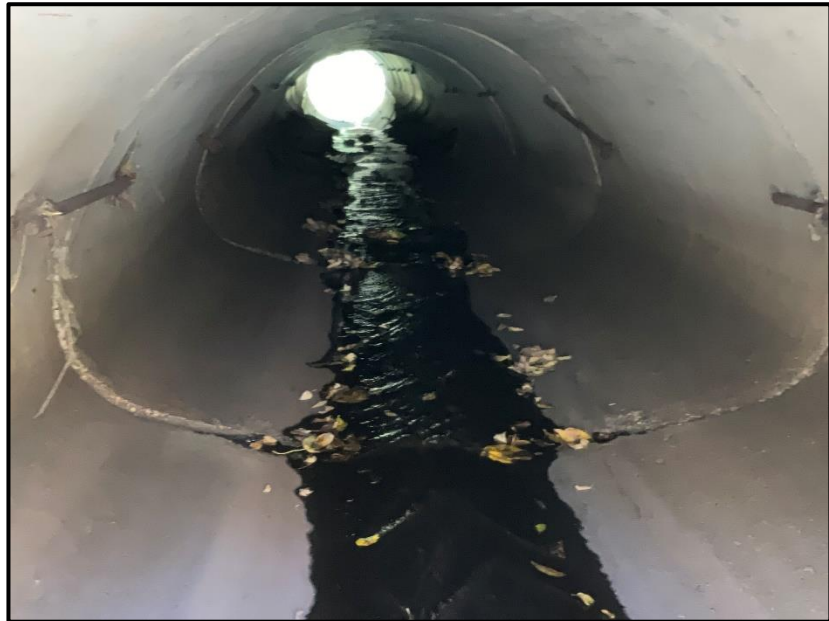
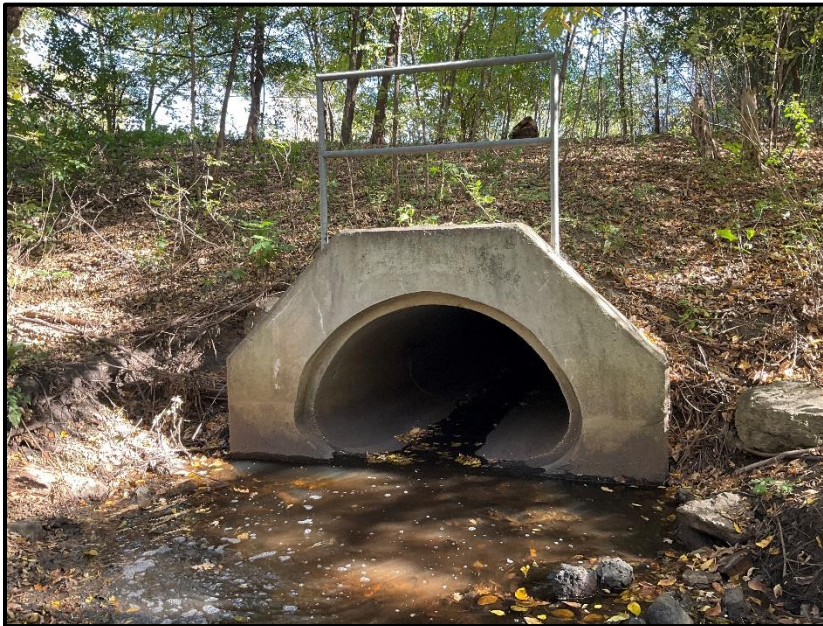
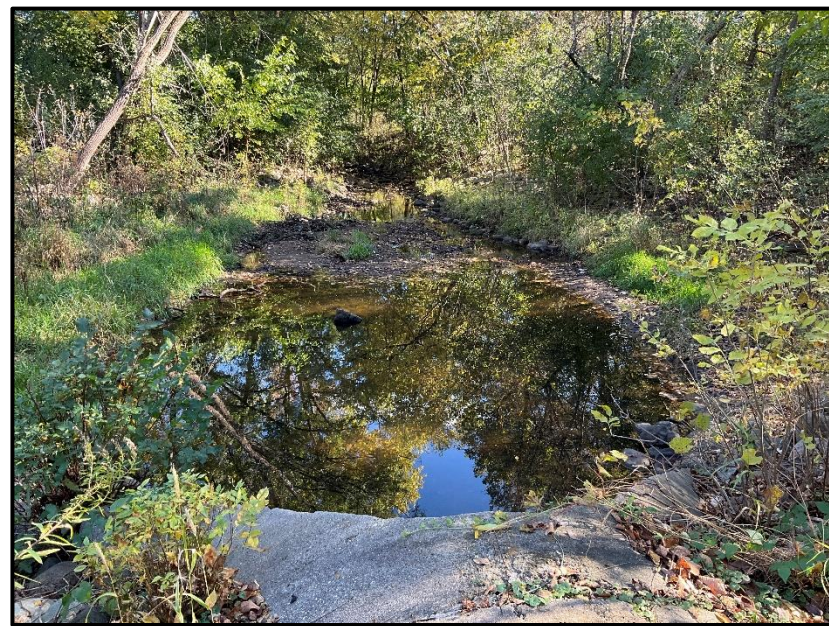
# Edgewood Embankment (Crystal)

- a. The concrete arch culvert appeared to be in satisfactory condition.
- b. The embankment appeared to be in satisfactory condition.
- c. No visible settlement or erosion was observed along the embankment.

- f. Spalled concrete was observed at four joints in the arch culvert.
- g. Spalled concrete was observed on the north (right) and south (left) side of the downstream flared end section of the arch culvert.

- Monitor spalled concrete at the fifth joint from the upstream end in the arch culvert.
- Monitor spalling on outlet structure.
- Monitor sediment accumulation in the pool downstream of the arch culvert.

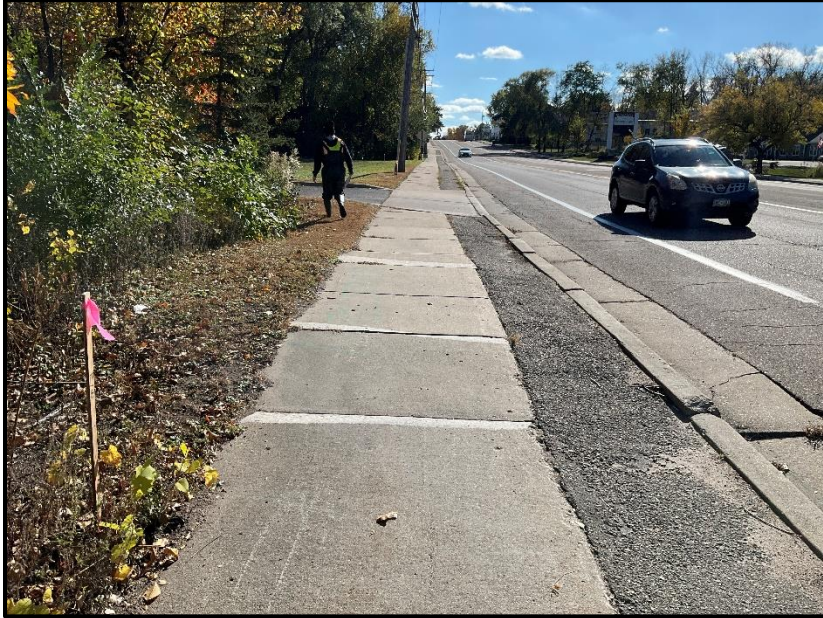
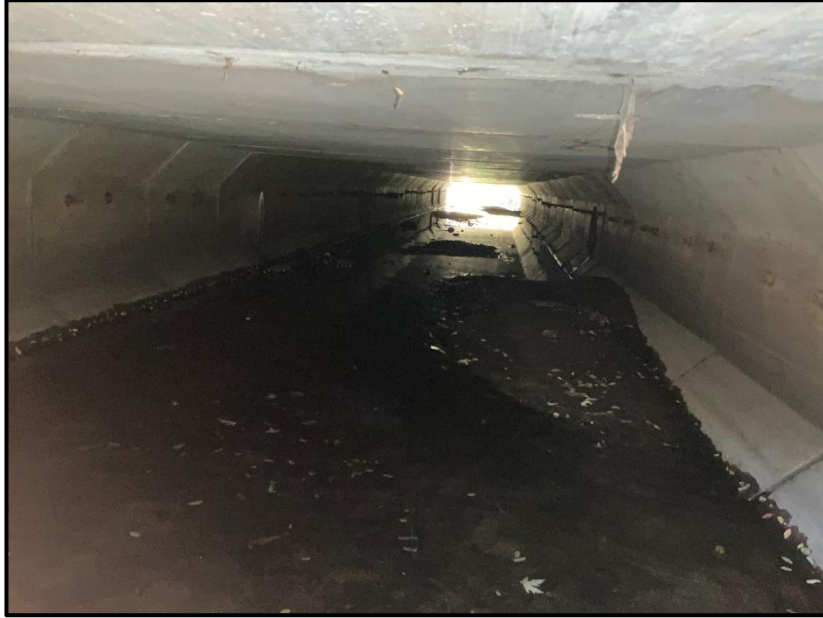
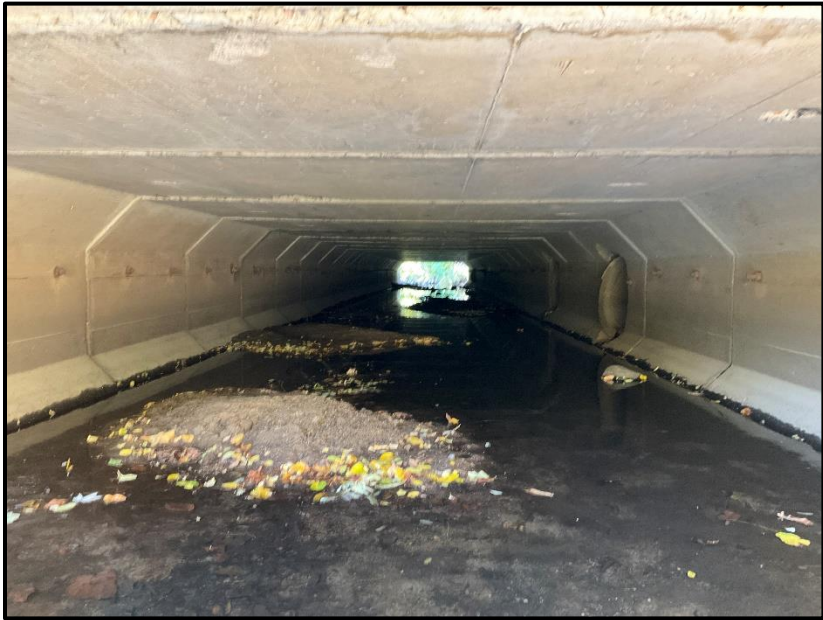
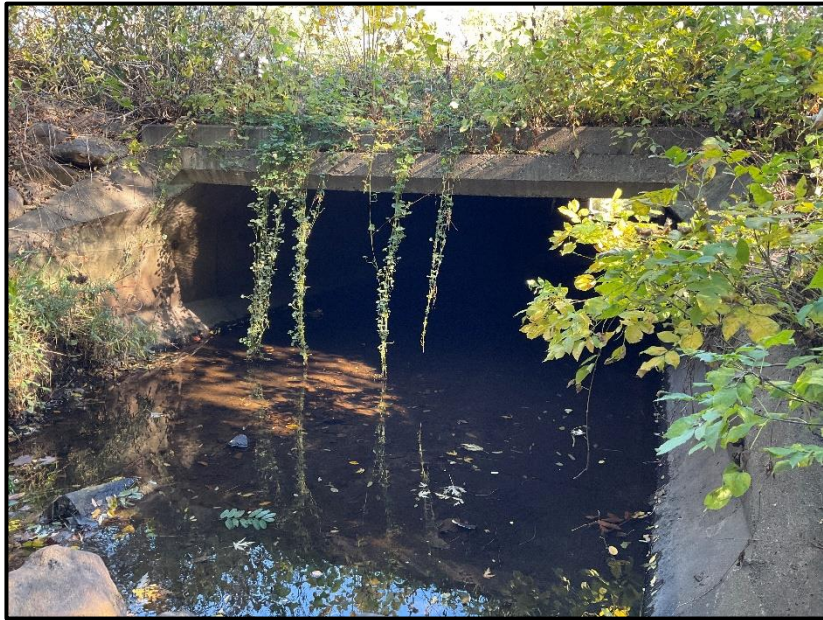
# Douglas Drive Crossing (Crystal)

- a. The concrete box culvert was not entered due to low clearance but appeared to be in satisfactory condition.
- b. The grouted riprap installed on each side of the box culvert outlet has started to deteriorate, and a gap has opened between the grout and the wall of the box culvert. This is consistent with previous inspections and has been noted since 2016.

- c. Spalled concrete was observed at the downstream north (left) wing wall.
- d. Sediment has deposited in the bottom of the box culvert, ranging from 0-8 inches deep.

- e. On the downstream end of the box culvert, settling was observed in the sidewalk on each side of the culvert.
- f. Spalled concrete was observed on the top of the box culvert on the downstream end.

- g. There are two reinforced concrete storm pipes in Douglas Drive that connect on the left (north) side and right (south side) of the box culvert. The reinforced concrete storm pipe on the right (south) side of the box culvert appeared to be significantly cracked.

- h. Although not part of the flood control project, the privately-owned CMP culvert downstream of the Douglas Drive crossing is in poor condition. Sagging of this culvert has been observed during inspections since 2009. The culvert is significantly bowing and settling has occurred on either side of the culvert, which is evident in the road pavement above the structure.

- Consider adding a railing along the sidewalk at the upstream and downstream end of the box culvert.
- Consider repairing the reinforced concrete storm pipes in Douglas Drive that connect to the box culvert on the right (south) side.
- Although not part of the flood control project, it is recommended that the city coordinate with the property owner to repair or replace the culvert downstream of Douglas Drive.

- Monitor deposited sediment in the box culvert.
- Monitor grouted riprap at the downstream end of the box culvert.
- Monitor spalled concrete at the downstream north (left) wing wall.
- Monitor settling in the sidewalk at the downstream end of the box culvert.

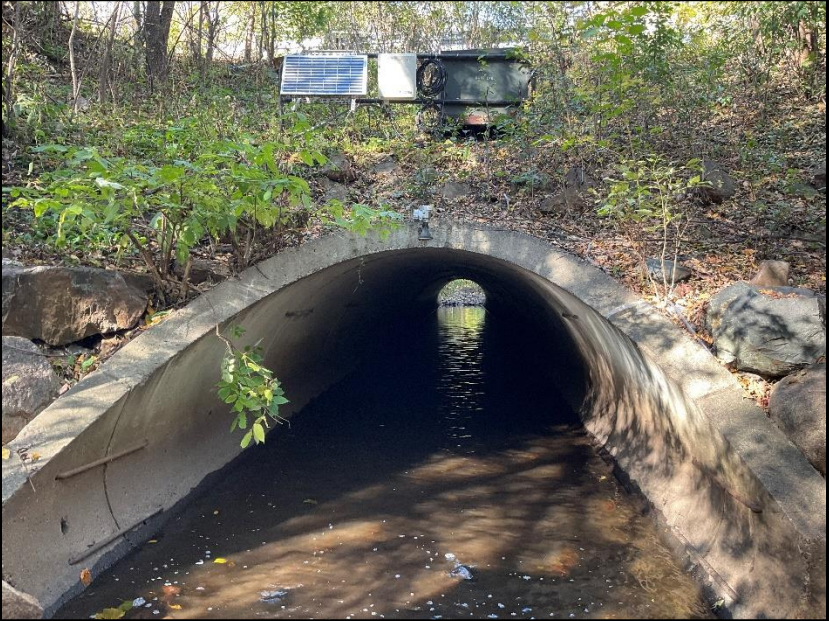
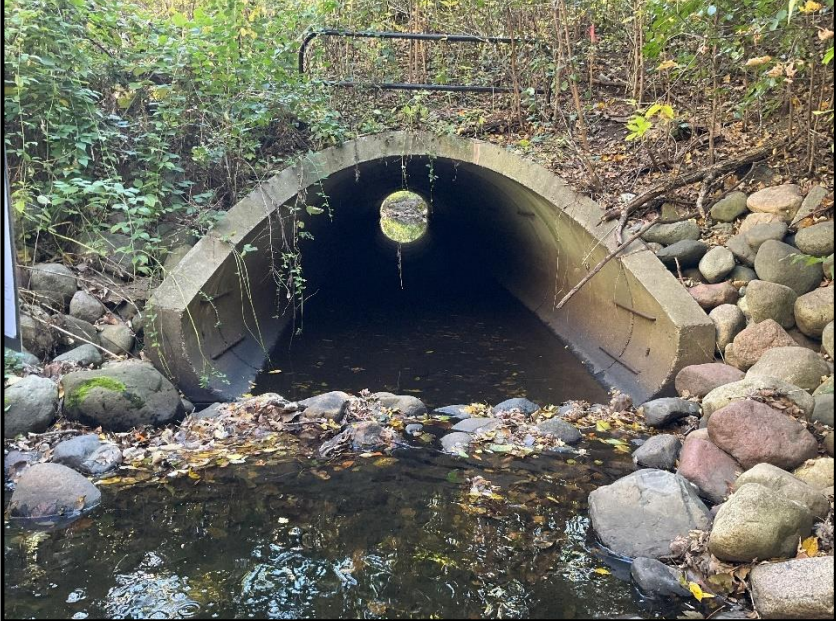
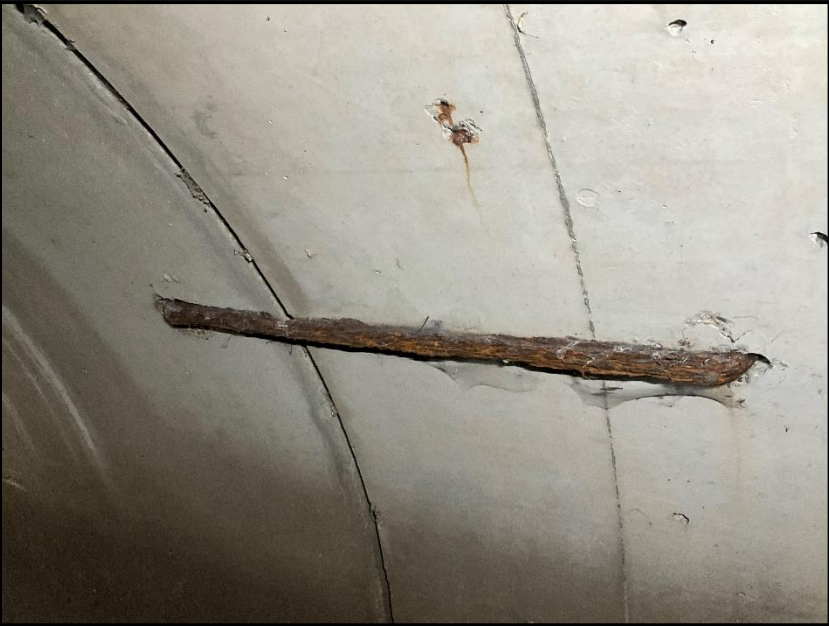
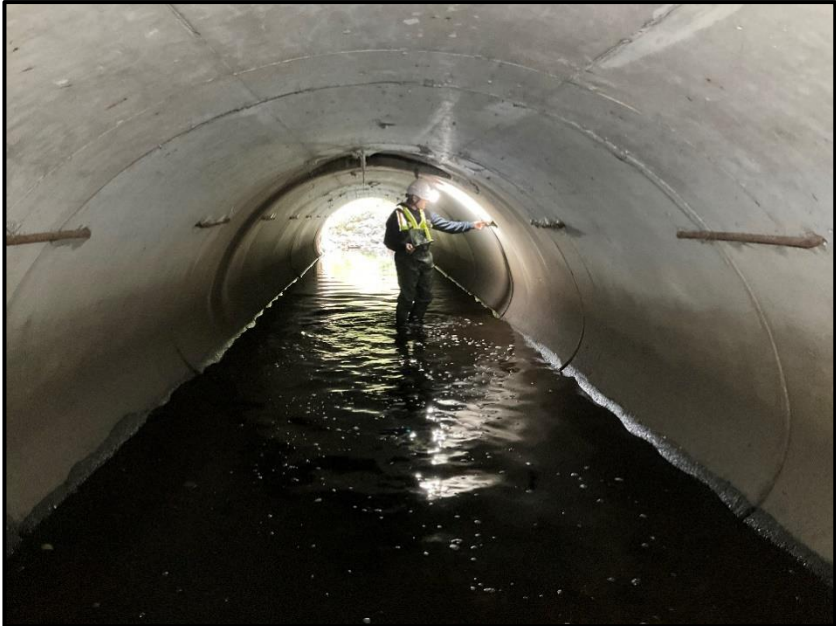
34th Avenue Crossing (Crystal)

- a. The concrete arch culvert appeared to be in satisfactory condition.
- b. Sediment has deposited in the bottom of the arch culvert, ranging from 1-6 inches deep. This is consistent with previous inspections and 0-12 inches of sediment has been noted in the culvert since 2002.
- c. The tie bars directly upstream and downstream of the manhole connection to the arch culvert were rusty and flaking. This is consistent with previous inspections and has been noted since 2008.
- d. One of the tie bars is down to ¼ inch diameter.
- e. An access trail to the creek has been cleared on the upstream side of the structure, from the roadway.
- f. BCWMC has a monitoring station at this site.
- g. A 6-inch tall riprap dam has formed or been established upstream of the current.

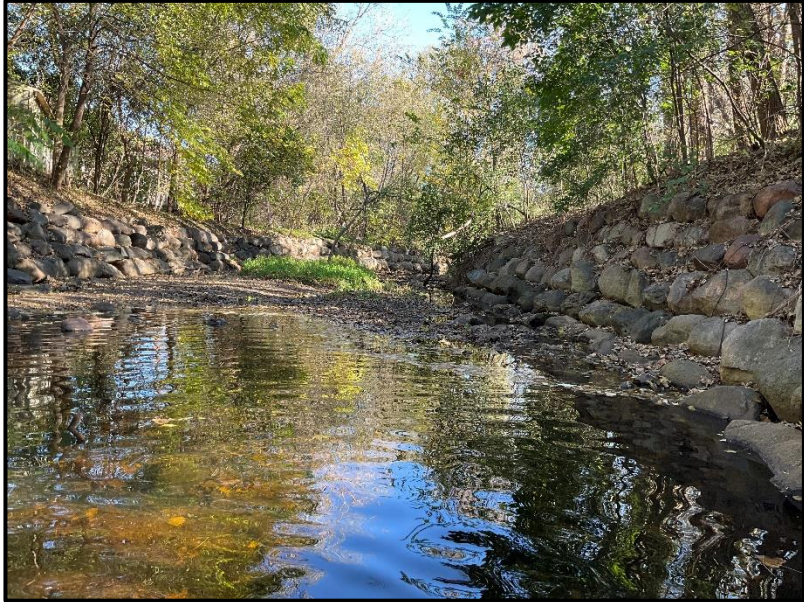
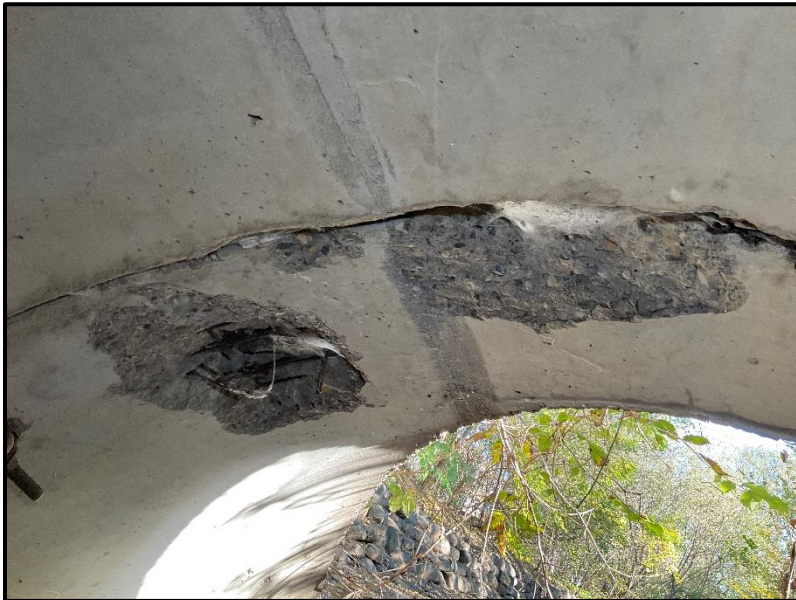
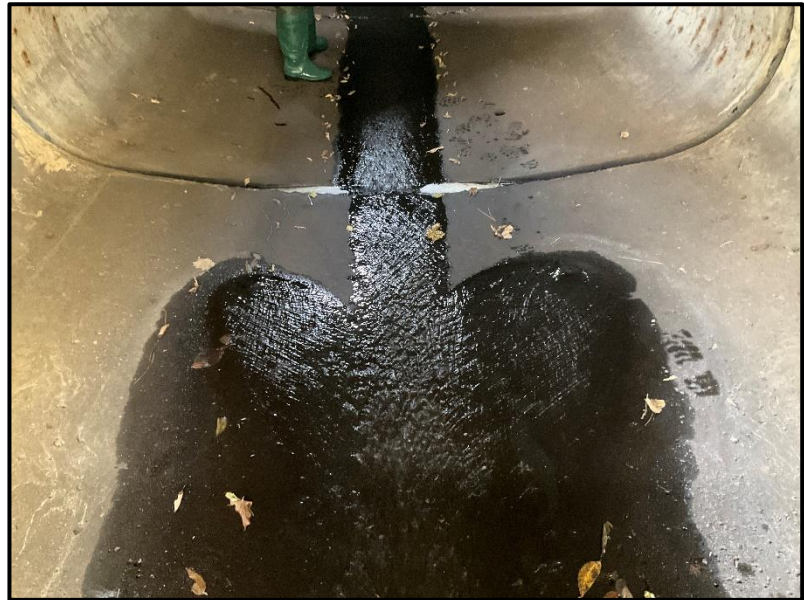
**Brunswick Avenue Crossing (Crystal)**

- c. Grout and grout repair appeared to be failing at all joints in both arch culverts. Fractured pieces of concrete and grout were observed at multiple joints in both arch culverts.

- d. Longitudinal and circumferential cracks were observed in both arch culverts.
- e. Strained and detached tie bars were observed in the north (left) arch culvert. One joint with broken tie bars was previously re-grouted by the City of Crystal, but the joint reopened and a 1.5-inch-gap in the joint was observed during the 2008 inspection. A 3-inch gap in the joint has been noted since 2009.

- f. At the 2<sup>nd</sup> and 5<sup>th</sup> joint from the downstream side of the north (left) arch culvert, broken tie bars on both sides of the arch culvert were observed.

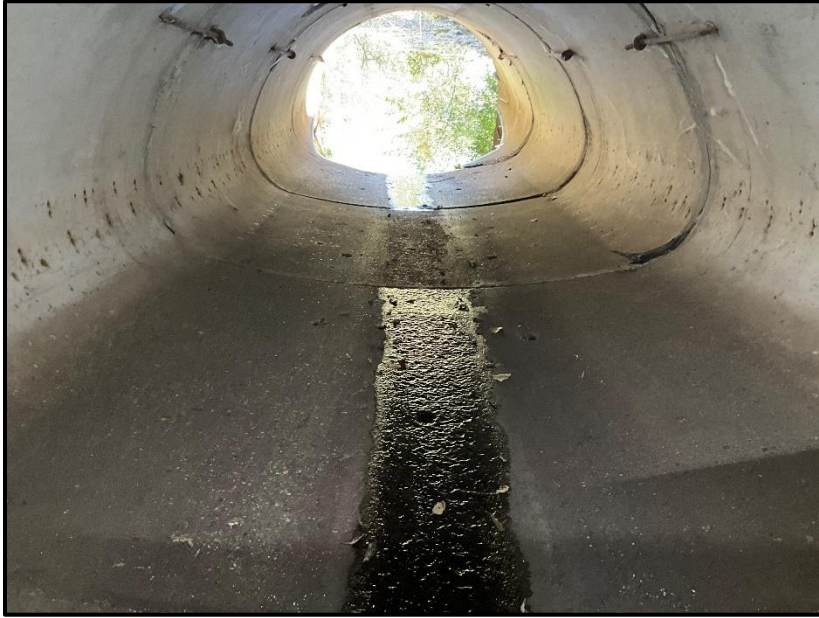
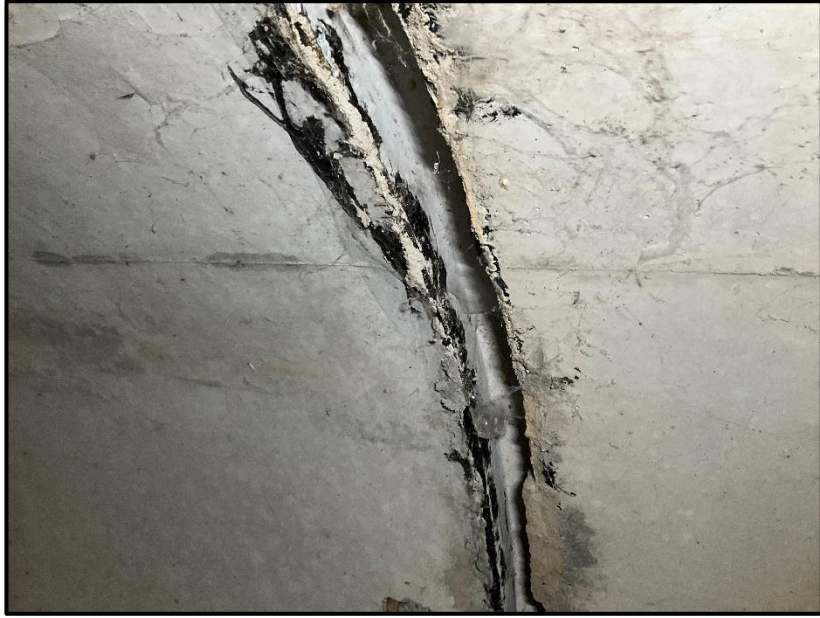
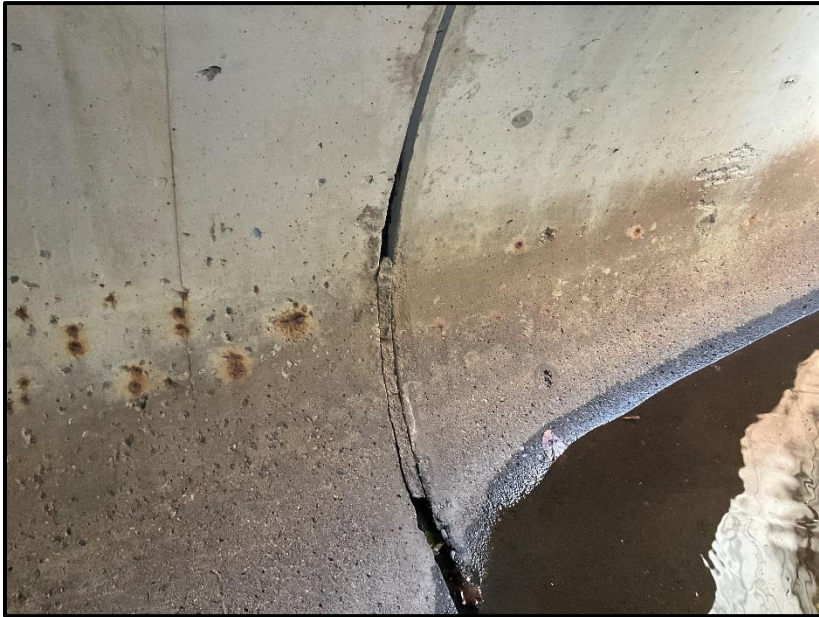
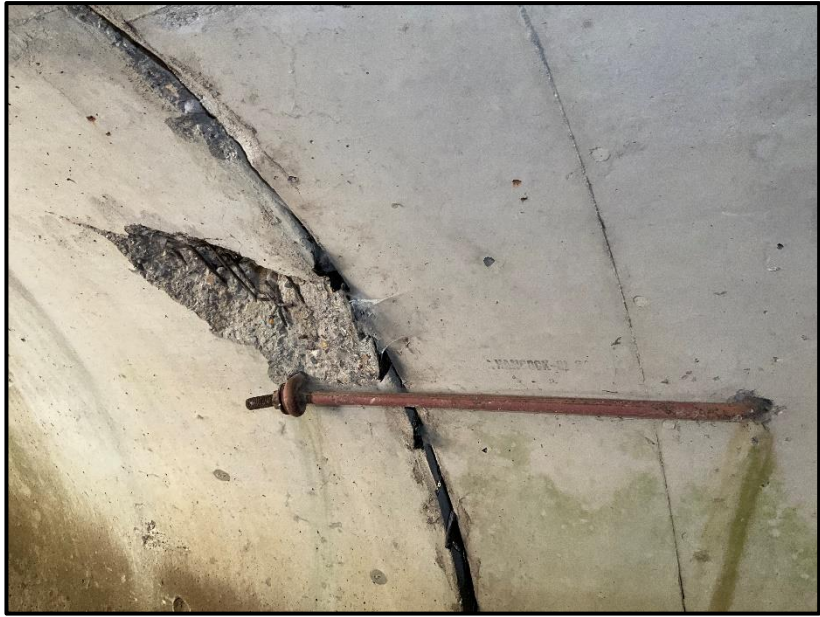
Brunswick Avenue Crossing (Crystal), continued

- g. Two holes were observed at the 2<sup>nd</sup> joint from the downstream side of the north (left) arch culvert. Water appeared to be seeping through 2<sup>nd</sup> downstream joint and coming out of the hole.

- h. A broken tie bar was observed in the south (right) arch culvert on the right side of the joint that is 5<sup>th</sup> from the downstream end.
- i. Spalled concrete and exposed reinforcing were observed from the furthest downstream joint to 4<sup>th</sup> joint from the downstream in the south (right) arch culvert.

- j. A large circumferential crack was observed at the 5<sup>th</sup> joint from the downstream end of the south (right) arch culvert, crack was located from 10 to 12 o'clock.

- k. Cracks and localized settling were observed in the road pavement above the structure.
- l. Sediment has deposited in the channel between the Brunswick Avenue crossing and the 32<sup>nd</sup> Avenue crossing and created two deltas in the channel. The channel was armored with boulder riprap in 2014. The sediment delta has been observed since 2017.
