To: Bassett Creek Watershed Management Commission (BCWMC)
From: Barr Engineering Co.: Josh Phillips, P.E., Jim Herbert, P.E., Joe Welna, P.E.
Subject: Item 4D: Bassett Creek Box Culvert Inspection Report: Inspection Date: November 2024 -
BCWMC February 20, 2025 Meeting Agenda
Date: February 13, 2025
Project: 23270051.65 1080 002

Bassett Creek Double Box Culvert Inspection Report

Prepared for
Bassett Creek Watershed Management Commission

Inspection Date: November 2024

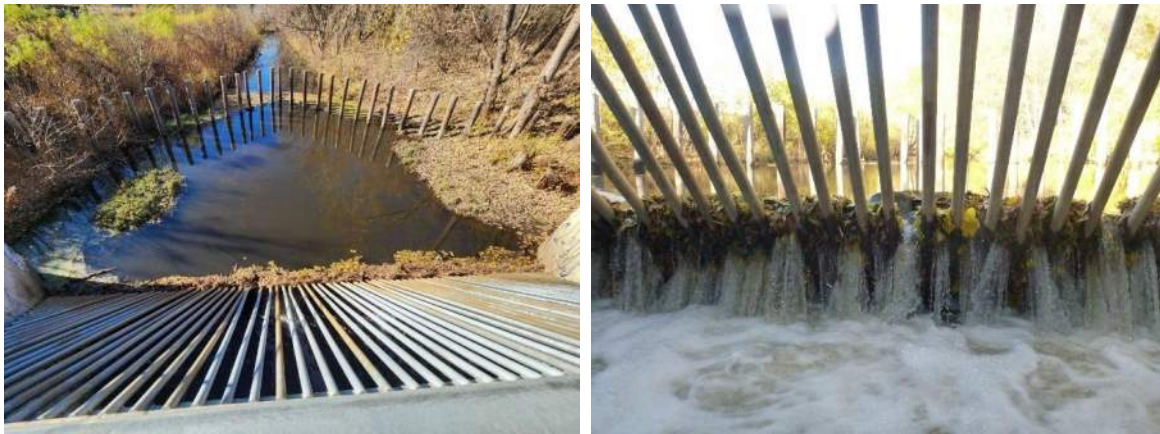
Figure 3-1 Trash Rack Debris Prior to Cleaning (Typical)

Debris routinely builds up on the trash rack at the inlet of the Box Culvert, as shown in Figure 3-1. Barr coordinated with the City of Minneapolis ahead of the inspection and the City removed accumulated debris in the trash rack to lower the upstream water level, as shown in Figure 3-2.

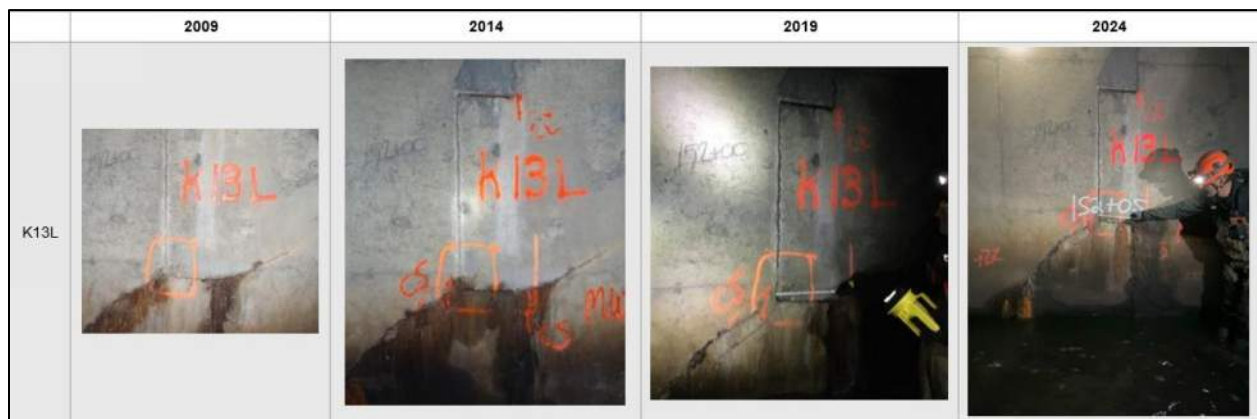
Figure 5-1 Shear Key 13 Comparison Photos

Qualitative evaluation of change in tunnel condition between the 2009, 2014, 2019, and 2024 inspections was performed by comparing representative photos of the same area of concern. Because the majority of significant defects was observed at the shear keys, special emphasis was made in comparing them. Noticeable changes were observed over the 15-year duration in some areas. For example, at shear key 13, varying degrees of infiltration were observed between the inspections, with minor infiltration observed in 2009, more significant infiltration in 2014, and less infiltration in both 2019 and 2024, as shown in Figure 5-1. A comprehensive qualitative comparison of the 2009, 2014, 2019, and 2024 inspection photos for the left box culvert shear keys is provided in Appendix C. Because defects and observations were fairly consistent between the left and right box culverts, this comparison is considered representative of both tunnels.

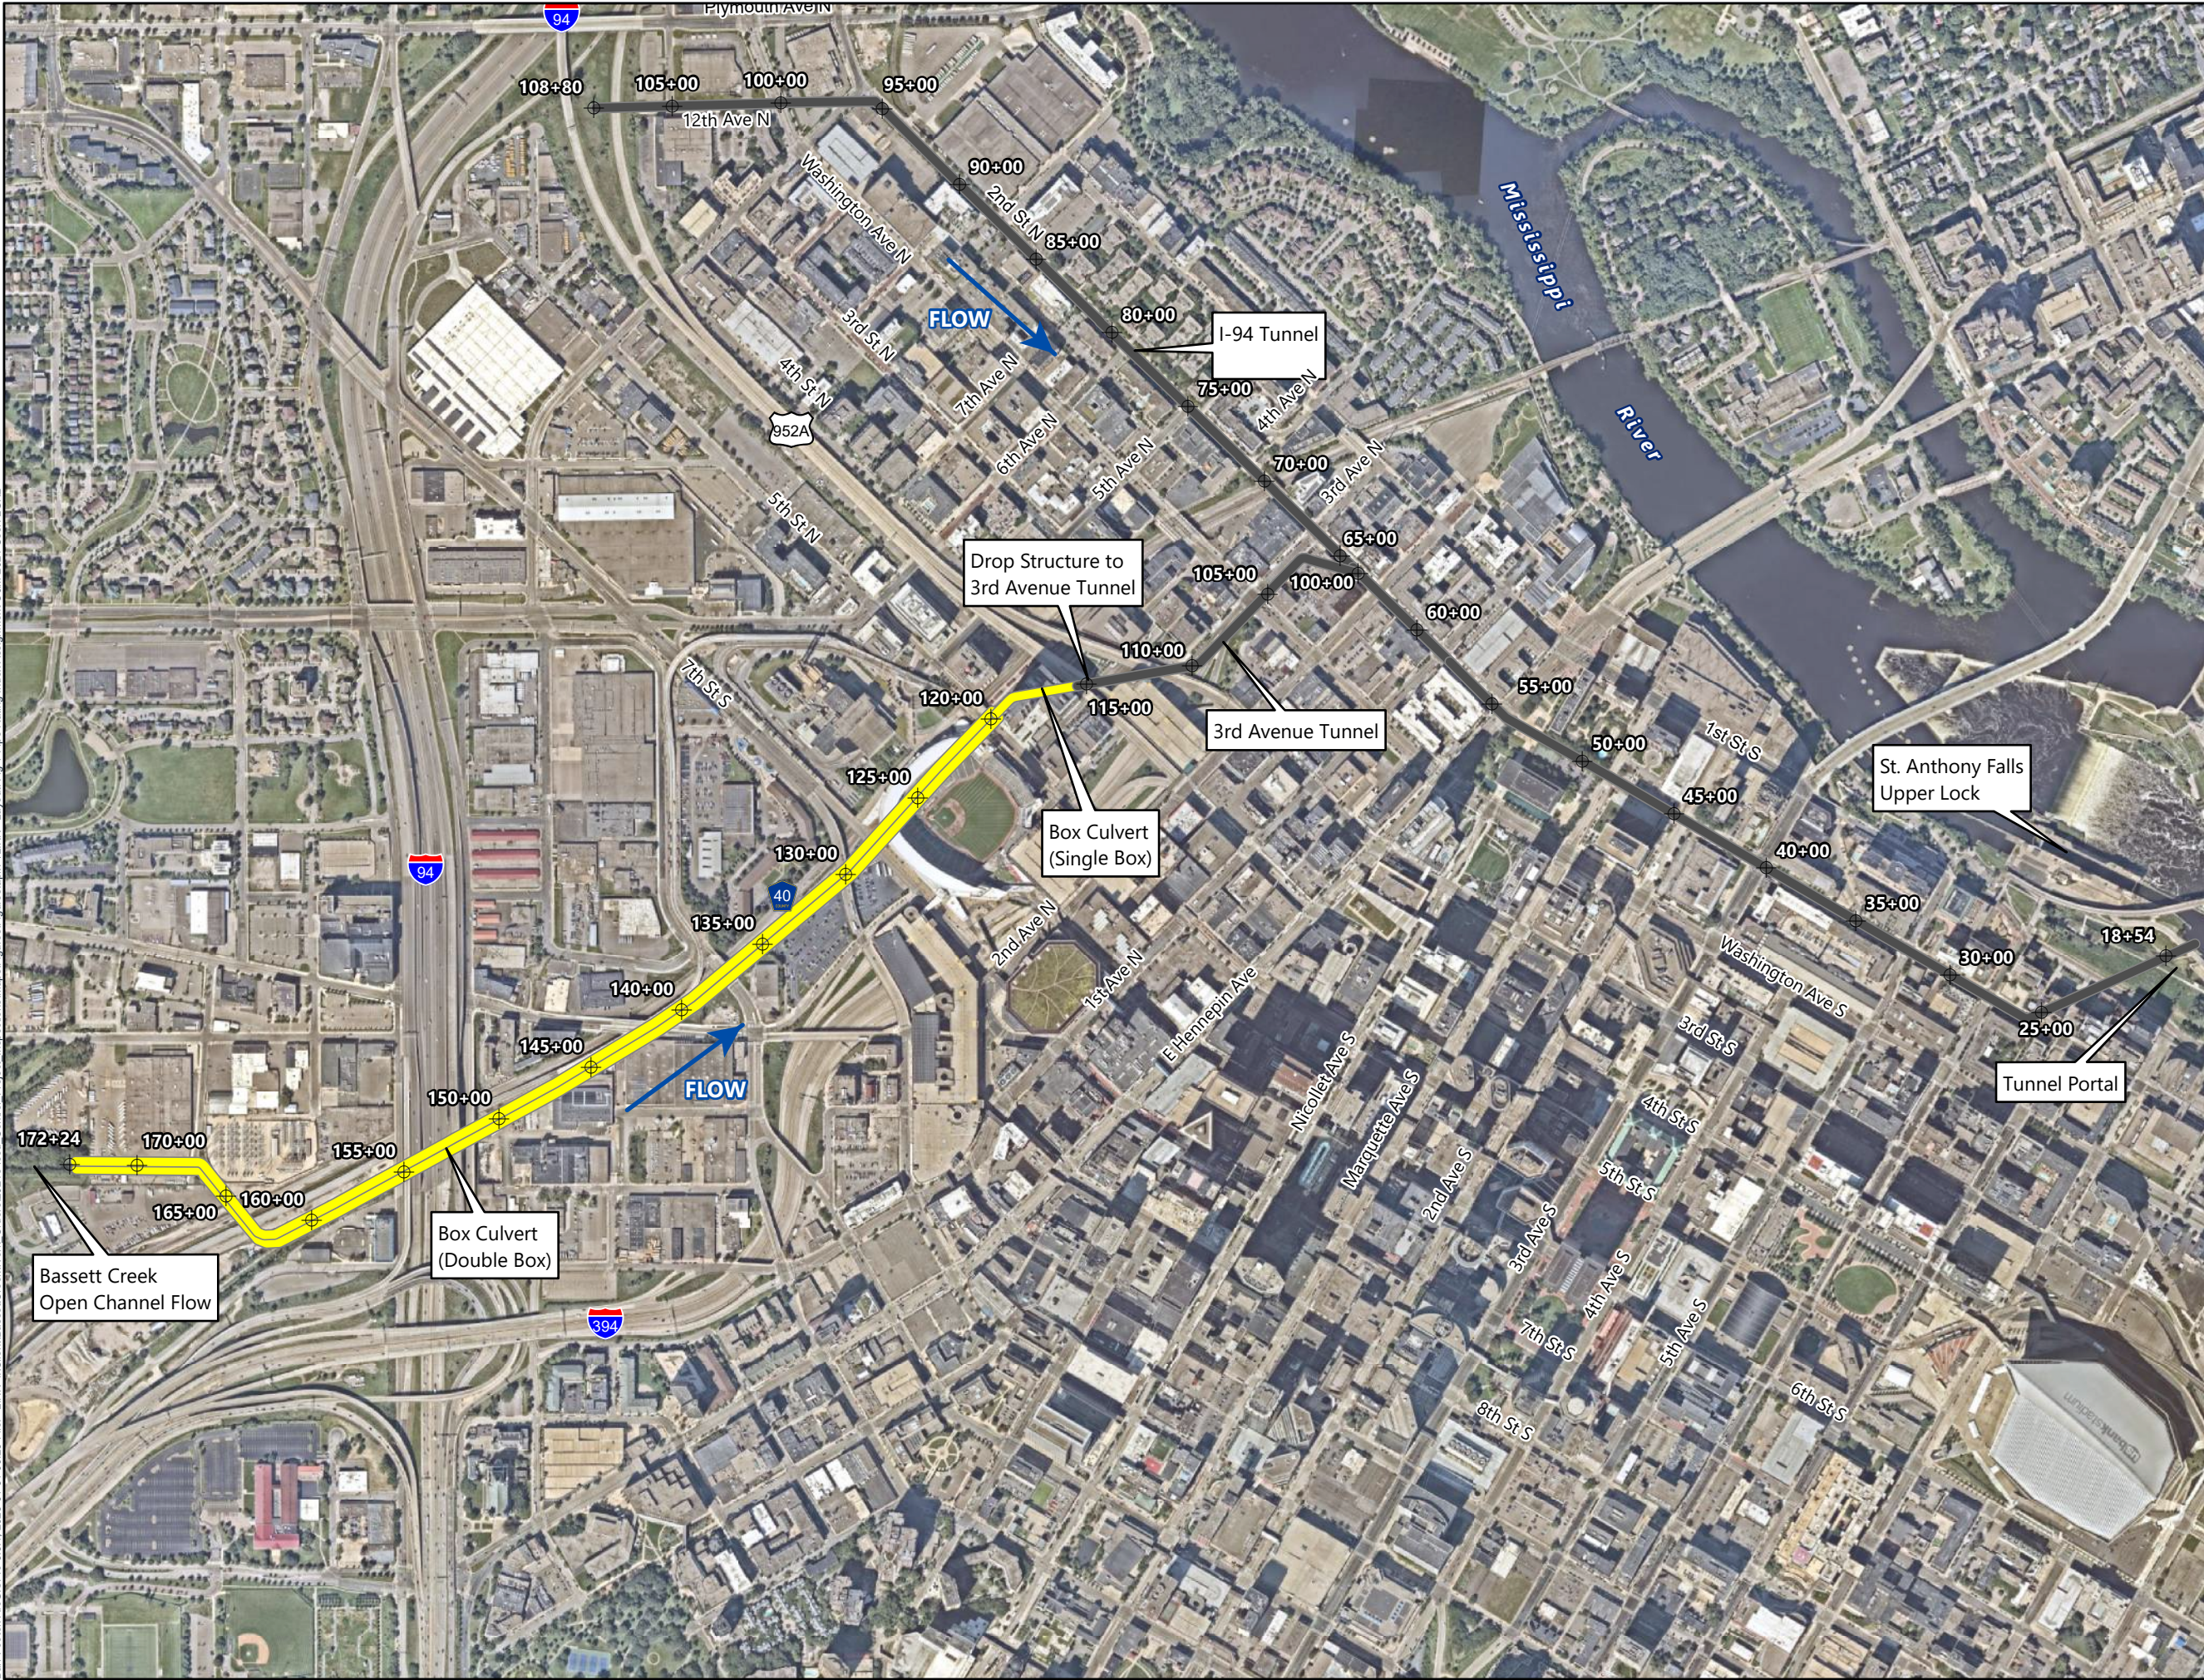
**PIPE RATING INDEX
 ASSIGNMENT OPERATIONS
 AND MAINTENANCE**
 2024 Bassett Creek
 Box Culvert Inspection
 Performed for the Bassett Creek
 Watershed Management Commission
FIGURE 1

Notes:
 1. Legend represents tunnel conditions from an operations and maintenance standpoint.
