Double Box Culvert Repair Project (FCP-1) Feasibility Report

Minneapolis, Minnesota

Prepared for
Bassett Creek Watershed Management Commission

June 2025

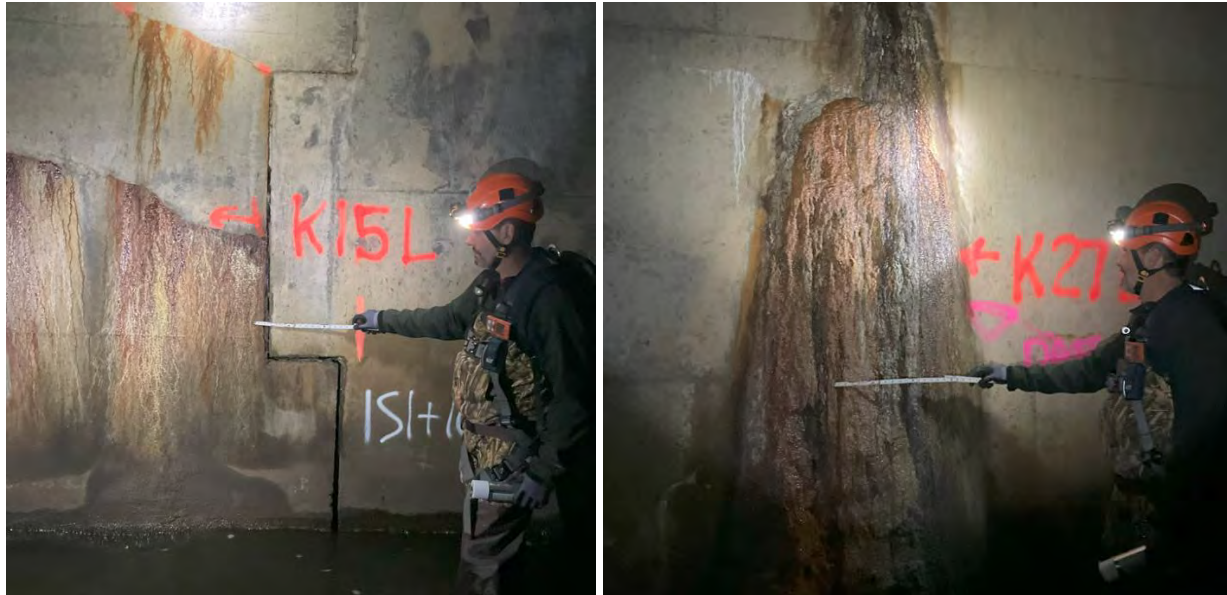
Figure 2 Typical Shear Keys Recommended for Repair

The Double Box Culvert was constructed with shear key joints at 35 locations along the Double Box Culvert alignment. The purpose of the shear keys is to transfer load between culvert segments and minimize differential settlement. During the 2019 and 2024 inspections (2) (3), the Commission Engineer observed infiltration, deposits, and concrete deterioration at many of the shear key joints. In addition, approximately 70% of the shear keys had missing or deteriorated bitumastic material within the 1- to 1.5-inch-wide joints. These defects and observations indicate some level of differential settlement has occurred at the shear keys since construction. In addition, water and soil intrusion through these joints could lead to void spaces developing outside of the box culvert walls, which can lead to settlement or sinkholes at the ground surface above the box culvert.

The primary objective of this repair is to replace deteriorated joint filler material to minimize potential migration of water and soil particles into the tunnel. Shear keys that are experiencing concrete deterioration will be repaired under “concrete surface repair,” “crack repair,” or “fracture repair” as noted in the subsections below. The approach to repair the shear key joints includes installing oakum, soaked in a hydrophilic chemical grout, to seal the joints and fractures. This would minimize water and soil intrusion and reduce the risk of void spaces developing outside of the box culvert. Photos showing typical shear key joints recommended for repair are included in Figure 2.

1. Shear keys repairs: consider one of several options to seal open joints and minimize the migration of water and soil particles into the tunnel, such as (1) full depth repairs with flexible chemical grout, (2) near surface repair consisting of placing backing bar and flexible seal, or (3) placement of oakum soaked in hydrophilic chemical grout in open joints that expands and seals the joints to minimize migration of soil particles.
2. Damaged concrete in tunnel walls and at shear keys: consider repairing spalled and fractured concrete. Consider if a structural repair is required (i.e. epoxy injection, removal of unsound

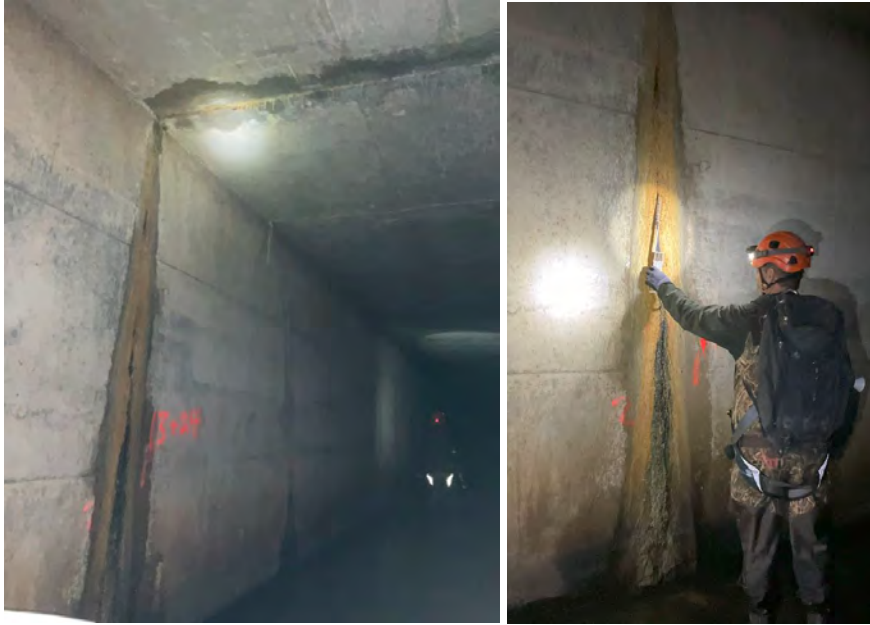
Figure 3 Typical Cracks Recommended for Repair

During the 2019 and 2024 inspections (2) (3), the Commission Engineer observed approximately 18,000 linear feet of cracks in the Double Box Culvert. A crack is defined as a break in a culvert or tunnel that is visible but not physically open. The majority of the cracks are fine “hairline” shrinkage and temperature cracks in the concrete that likely developed shortly after initial construction. However, some cracks are more prominent and are allowing water infiltration into the box culvert. Water infiltration through cracks can advance concrete and steel reinforcement deterioration and cause the formation of mineral encrustation within the tunnel. The Commission Engineer estimates that approximately 10% of the identified cracks warrant repairs as part of the project. To repair these cracks, a contractor would remove mineral deposits, drill holes that intercept the cracks and inject chemical grout to seal the cracks. Photos showing typical cracks recommended for repair are included in Figure 3. Note, some cracks recommended for repair occur along construction joints.

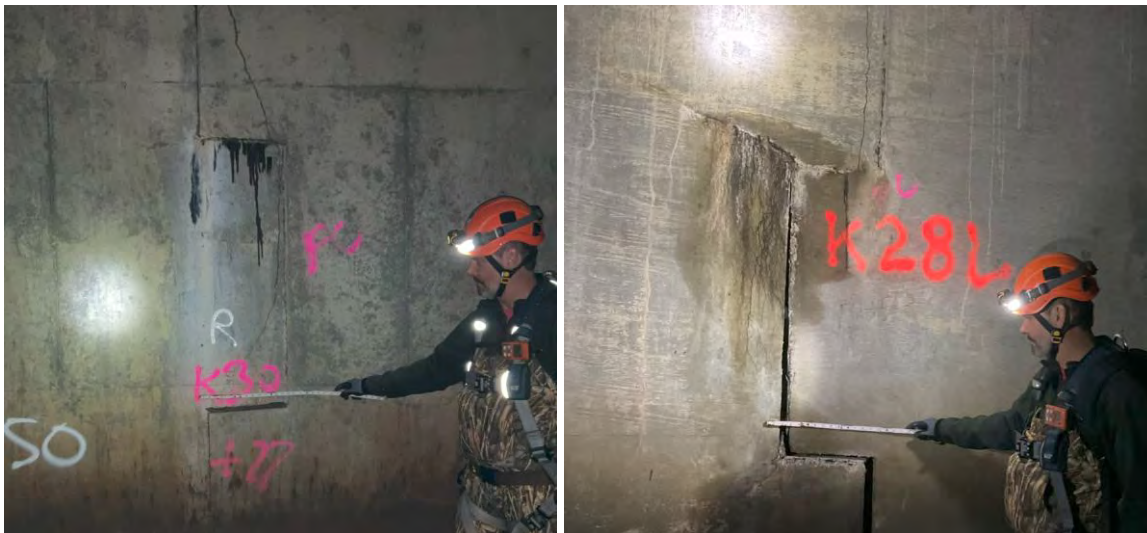
Figure 4 Typical Fractures Recommended for Repair

During the 2019 and 2024 inspections (2) (3), the Commission Engineer observed a total of approximately 100 linear feet fractures within the double box culvert that warrant repairs, most commonly at the shear key locations as a result of potential differential settlement occurring at that joint. A fracture is a crack that has become visibly open, and a gap can be seen. A fracture allows more groundwater infiltration/exfiltration than a crack. Similar to crack repairs, to repair fractures, a contractor would remove mineral deposits (if present), drill holes that intercept the fracture and inject epoxy into the fracture to complete the structural repair. Photos showing typical fractures recommended for repair are included in Figure 4.

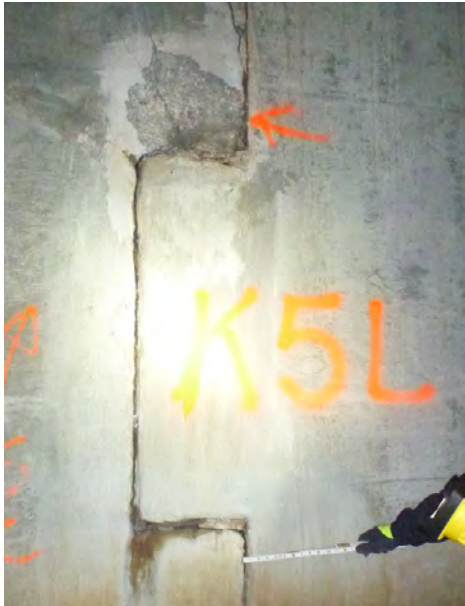
Figure 5 Typical Concrete Areas Recommended for Repair

During the 2019 and 2024 inspections (2) (3), the Commission Engineer observed approximately 34 locations of concrete surface defects and concrete spalling that warrant repair in the double box culvert. A contractor would perform concrete surface repairs by saw cutting a perimeter around the proposed repair, removing loose concrete, installing corrosion inhibitor on any exposed reinforcement, placing new reinforcement and anchorages as necessary, and placing repair mortar material to repair the defects. Photos showing typical concrete areas recommended for repair are included in Figure 5.

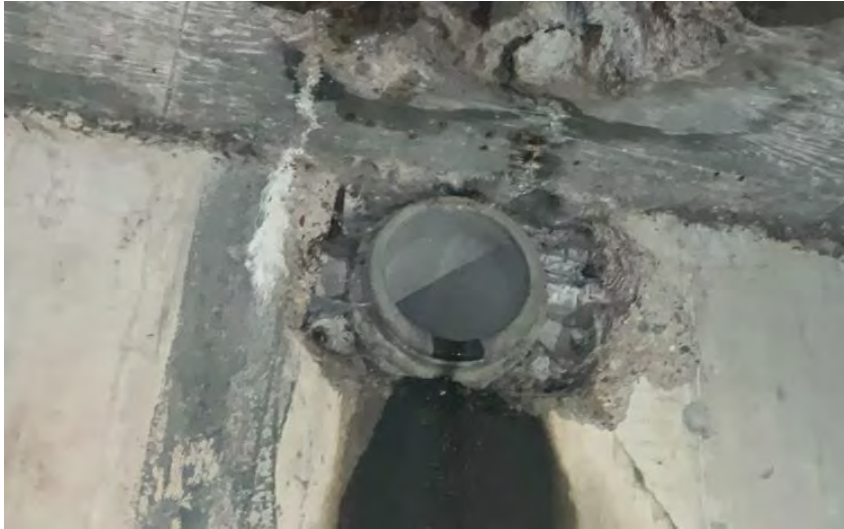
Figure 6 Tap Recommended for Repair

During the 2019 and 2024 inspections (2) (3), the Commission Engineer observed one tap location with a defective connection with the double box culvert. The defective connection is a source for infiltration and concrete degradation. The repair will include removing unsound material, repairing exposed reinforcement, and installing new repair mortar around the tap. A photo showing the tap recommended for repair is included in Figure 6.

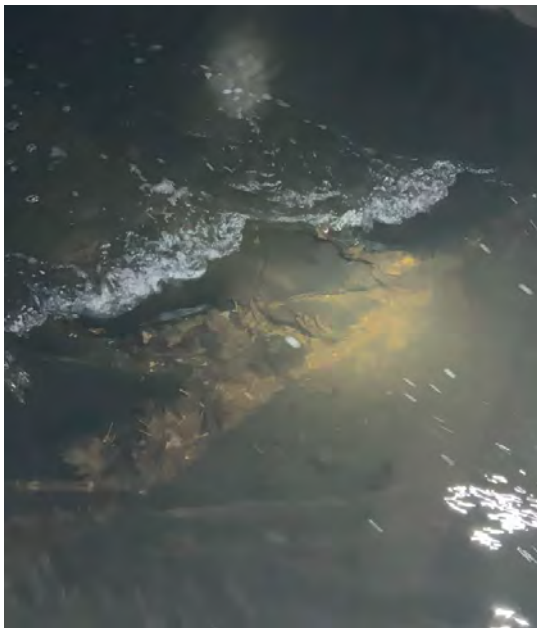
Figure 7 Invert Area Recommended for Repair

During the 2024 inspections (2) (3), the Commission Engineer observed three locations in the invert where the concrete appeared to be buckling and spalling. It is anticipated that additional invert deficiencies may be identified during construction when the tunnel is dewatered. The identified invert deficiencies were located at an existing invert joint. The invert repair work will include saw cutting and removing the deficient concrete, drilling and anchoring reinforcement and placing new concrete. A photo showing an invert area recommended for repair is included in Figure 7.

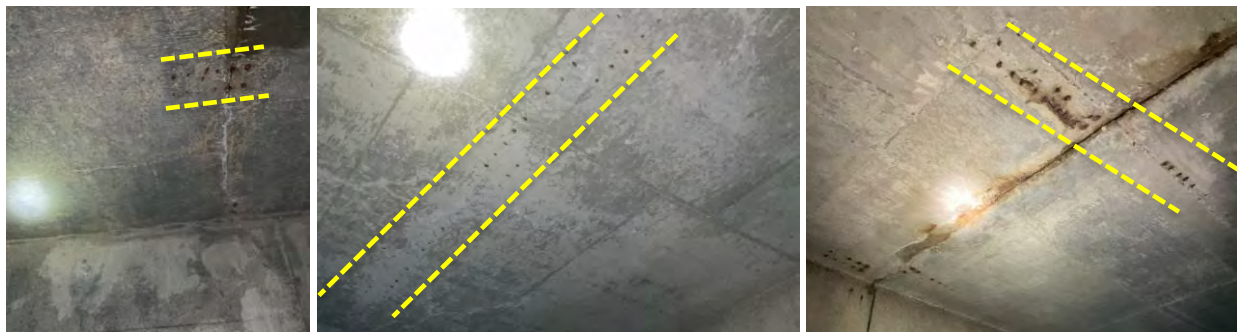
Figure 8 Typical Reinforcement Spacers Recommended for Repair

As part of the original Double Box Culvert construction, the structural reinforcement was placed on steel spacers to provide the specified concrete cover between the formwork and reinforcement. During the 2024 inspections (2) (3), the Commission Engineer observed that at various locations within the right box culvert, the reinforcement spacers along the ceiling of the tunnel were visible and corroding. The corrosion pattern was generally linear and often visible at multiple locations along the ceiling of the tunnel within select segments. For example, the pattern may be visible along the ceiling near the left wall, in the middle, and near the right wall within the same reach of the tunnel. In total, the Commission Engineer quantified approximately 1,200 feet of visible corrosion of the reinforcement spacers. This corrosion can contribute to concrete degradation over time; therefore, the Commission Engineer recommends repairs for the full extent of the visible corrosion. Anticipated repairs include removing the corrosion, installing a corrosion inhibitor over the exposed steel, and placing a skim coat of repair mortar over the affected area. Photos showing typical reinforcement spacer repair areas are included in Figure 8.

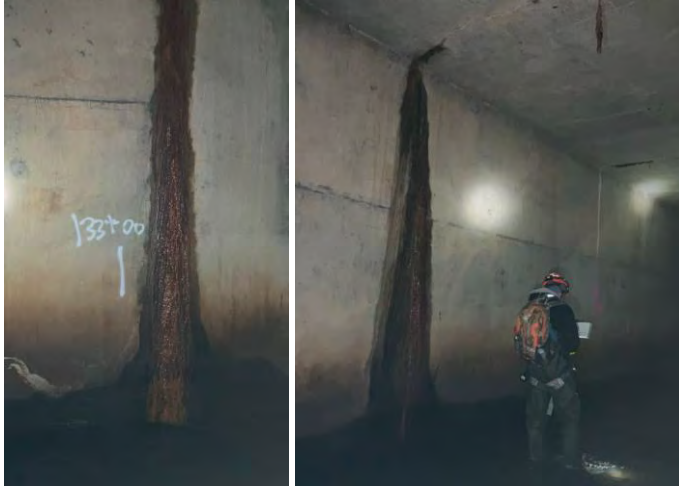
Figure 9 Typical Attached Deposits Recommended for Removal

During the 2024 inspections (2) (3), the Commission Engineer observed 34 locations of attached, encrusted deposits. Attached encrustations consist of mineral deposits left by the partial evaporation of infiltrating groundwater containing dissolved salts. These deposits will normally be concentrated alongside weeping or dripping joints or fractures. If left unchecked, attached deposits can hide other defects and eventually build up and reduce the cross-section area and capacity of the Double Box Culvert. Deposits are typically removed by a contractor using water blasting, chipping hammers and grinding wheels. Photos showing typical attached deposits recommended for removal are included in Figure 9.

4. Attached deposits: although not excessive, remove attached deposits as necessary to inspect and repair (if necessary) underlying concrete.
5. Invert repairs: One invert repair area was identified during the 2024 inspection and two additional invert repair areas were identified during the April 17, 2025 site meeting (3 total). It is anticipated additional invert repairs will be found during construction after box culverts are dewatered.
