PLYMOUTH CREEK STUDY REACH 1
 Plymouth Creek Feasibility Study
 Bassett Creek Watershed
 Management Commission

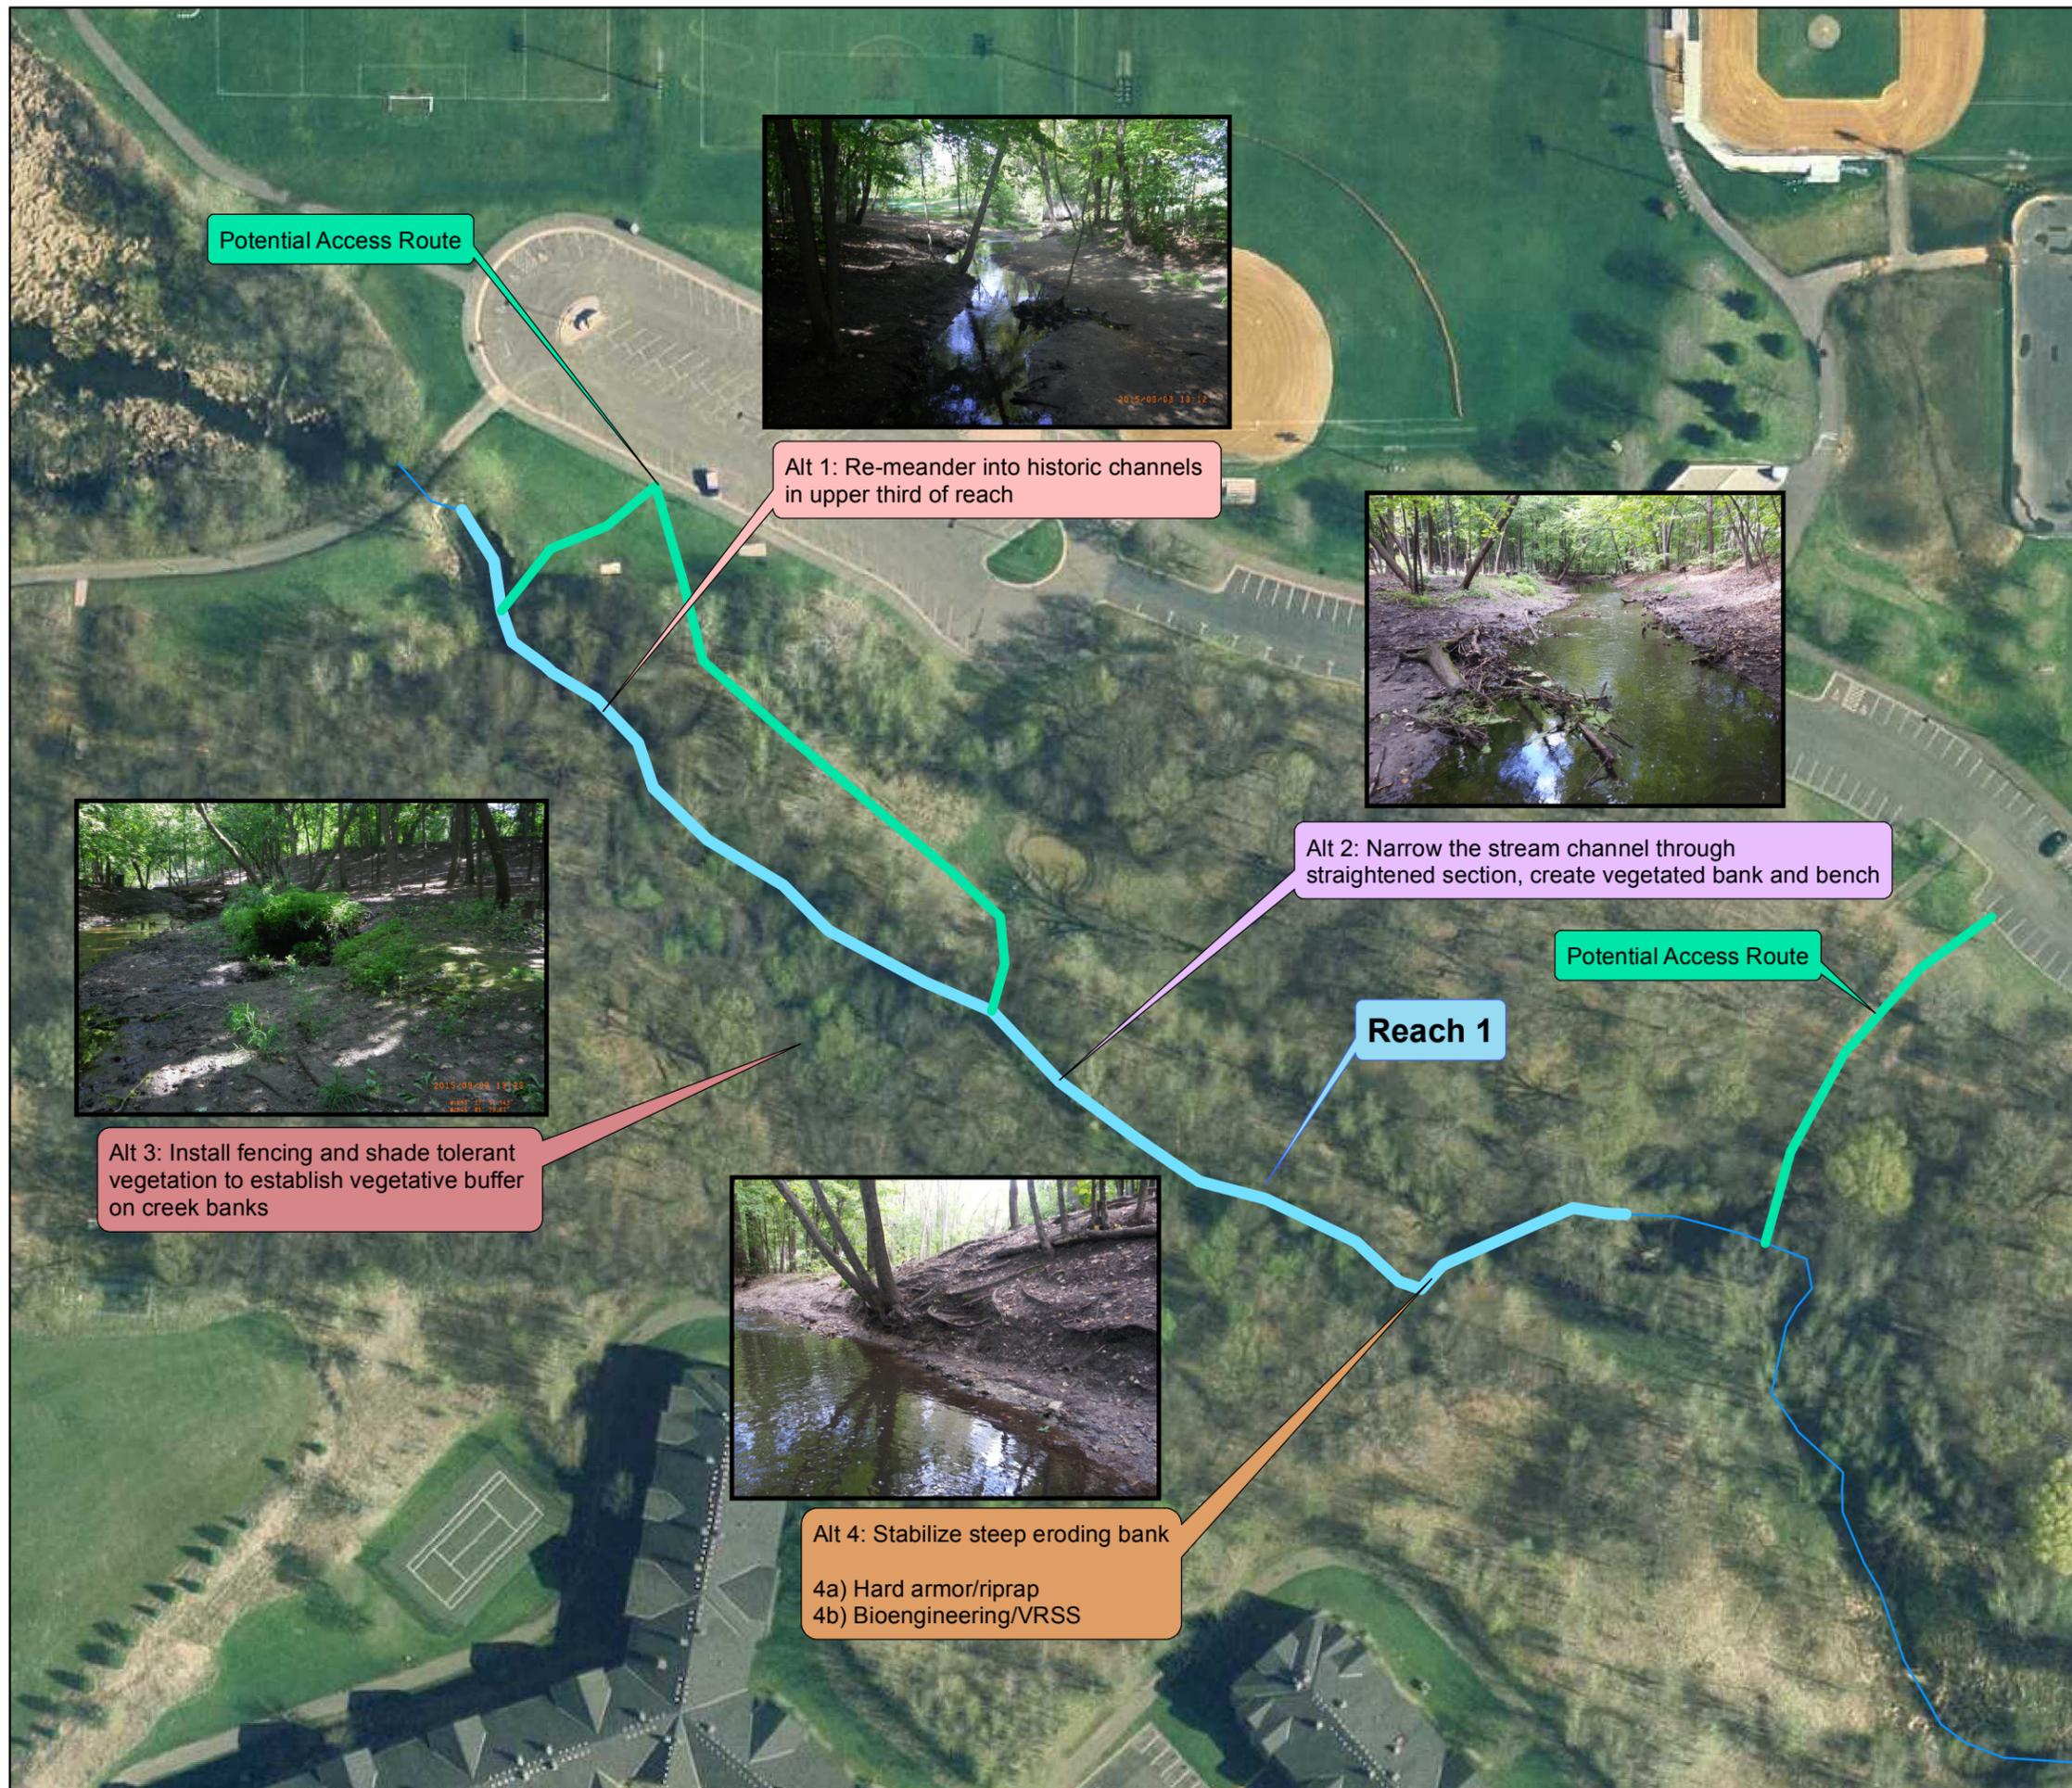
Figure 1

Reach 1

Issues: Appears to be historically straightened; channel is overwide with bare banks. Significant bare overbank areas due to disc golf usage. High clay content of soils helps reduce bank movement.

Constraints: Restoration must be compatible with disc golf course; need for bridge crossings. Narrow valley and low slope limit meandering potential. Deep shade limits vegetation options.
