Appendix G Plymouth Creek Restoration Project DRAFT Feasibility Study

G. Detailed alternatives for stabilization

PLYMOUTH CREEK POTENTIAL STABILIZATION SITES Plymouth Creek Feasibility Study Bassett Creek Watershed Management Commission

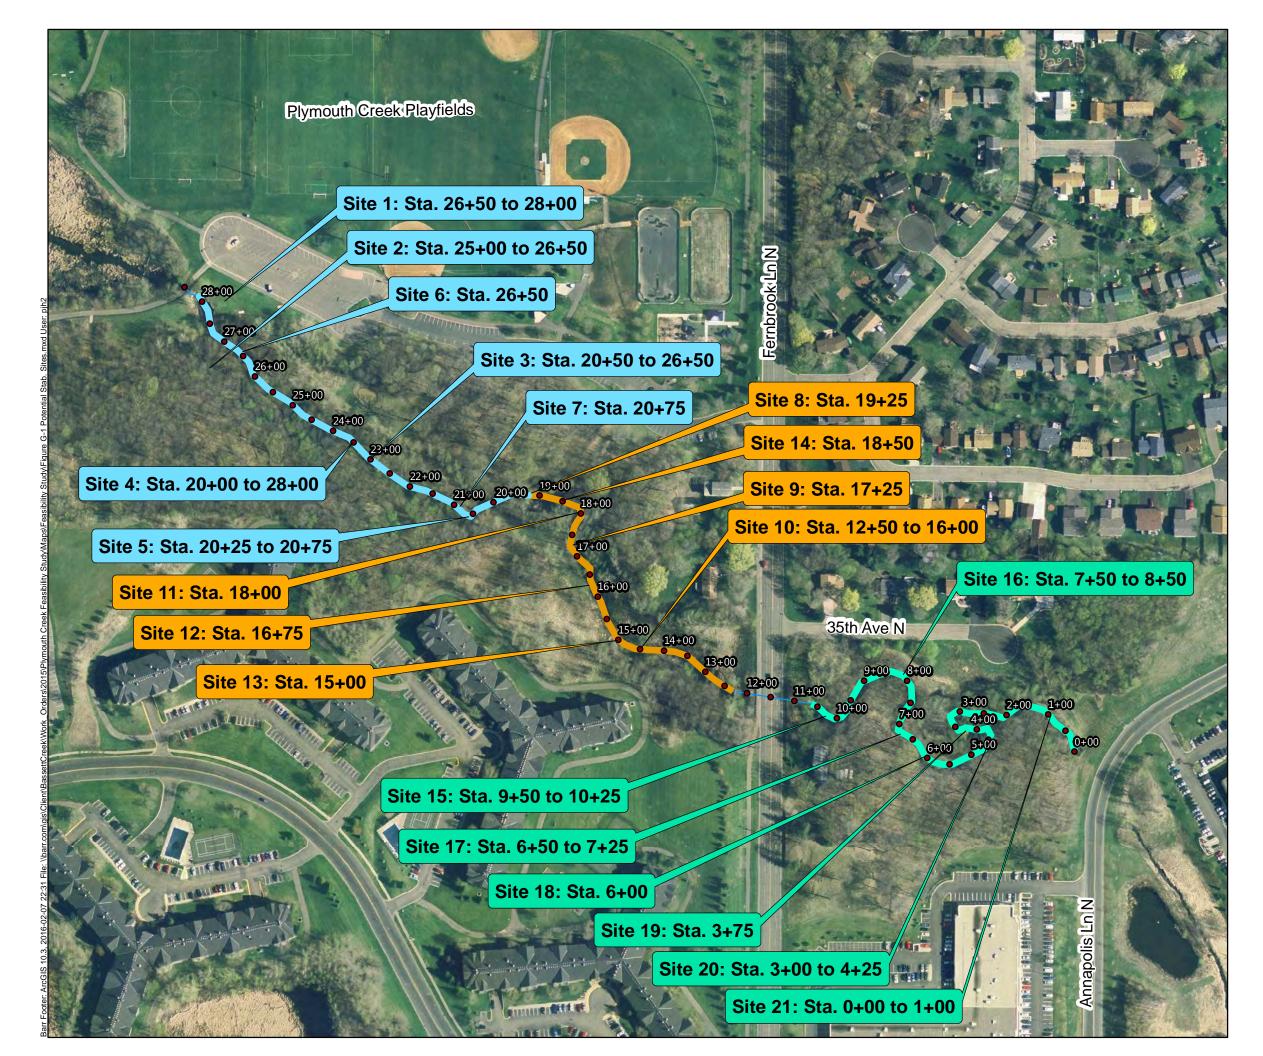
Figure G-1

The following discussion is organized by location within each reach, referred to as "stabilization sites." The stabilization sites for the entire project area are shown in Figure G-1. Potential stabilization alternatives for each reach are summarized in Figure G-2 through Figure G-4 and in Table G-1. Stabilization sites within each reach with similar characteristics and stabilization alternatives are discussed together.

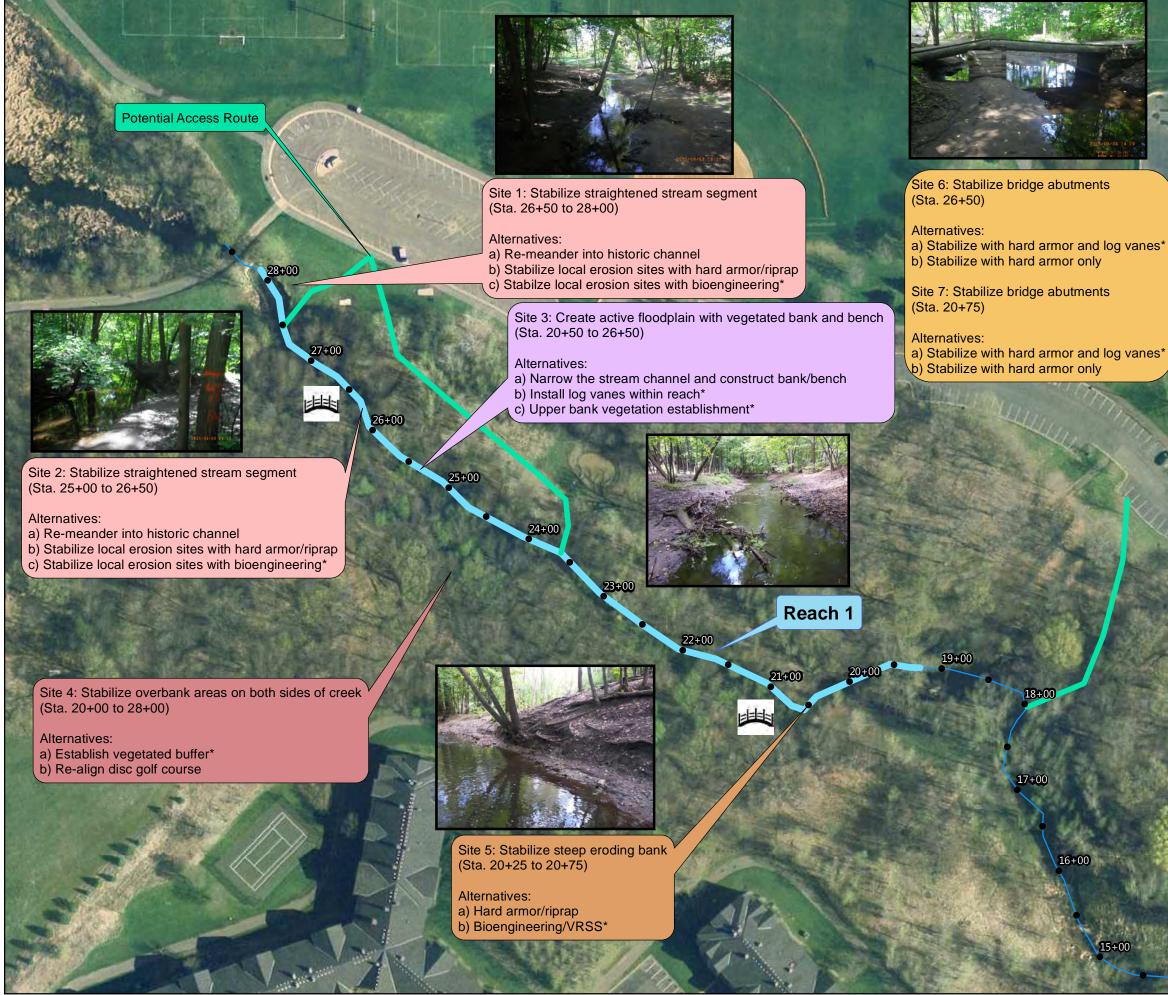
Reach 1

Issues: Appears to be historically straightened; channel is overwide with bare banks. Significant bare overbank areas due to disc golf usage. High clay content of soils helps reduce bank movement.

Constraints: Restoration must be compatible with disc golf course; need for bridge crossings. Narrow valley and low slope limit meandering potential. Deep shade limits vegetation options.

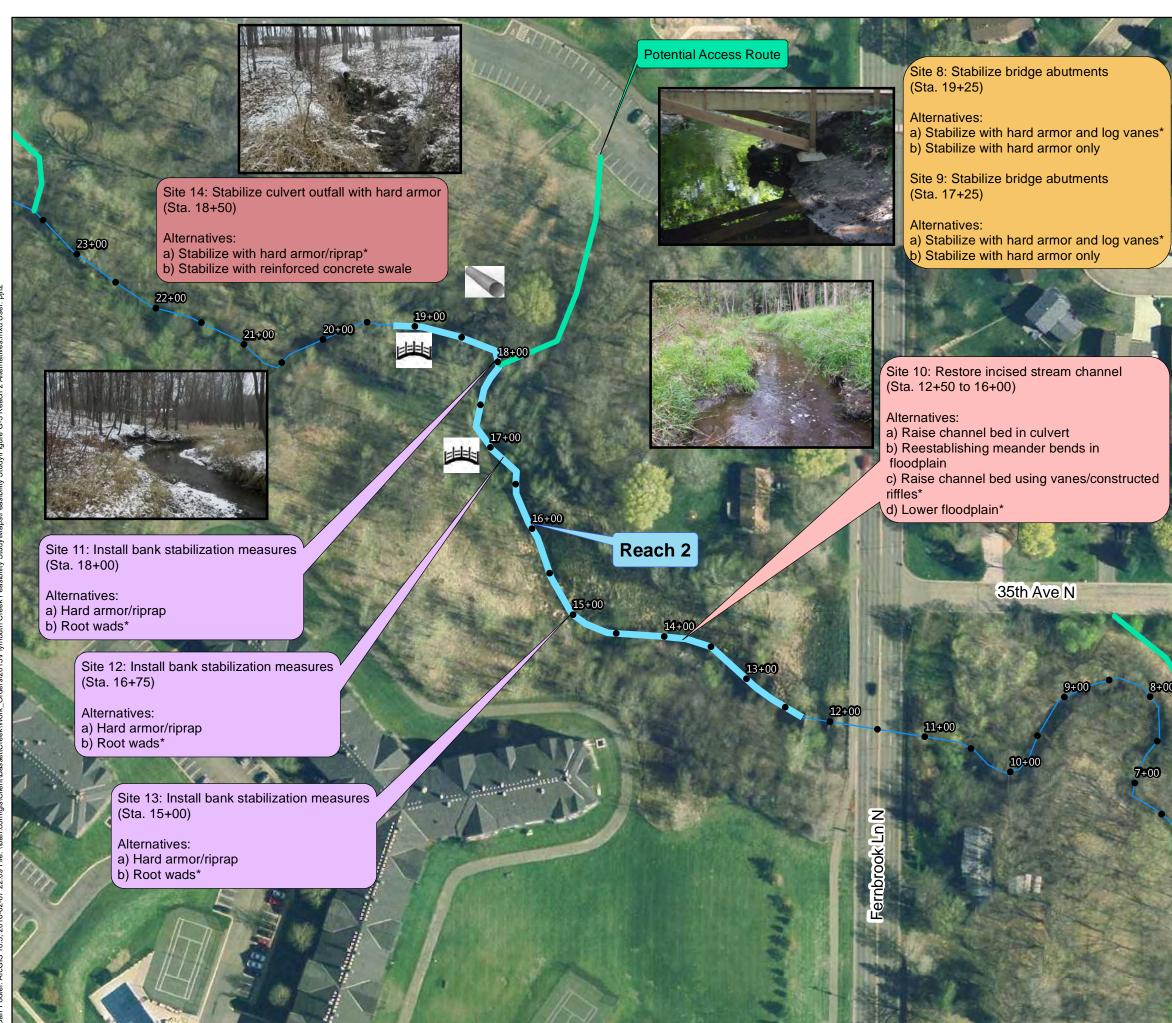
Reach 2

Issues: Erosion of the stream bed (incision) has resulted in limited access to floodplain. Incision perhaps due to culvert grade on downstream end of reach. Pockets of granular soils prone to bank erosion.

Constraints: Culvert limits flow in floods. Nearby home impacted if flood levels increase. Low slope. Sanitary sewer manholes should be avoided and access to these manholes should be maintained.

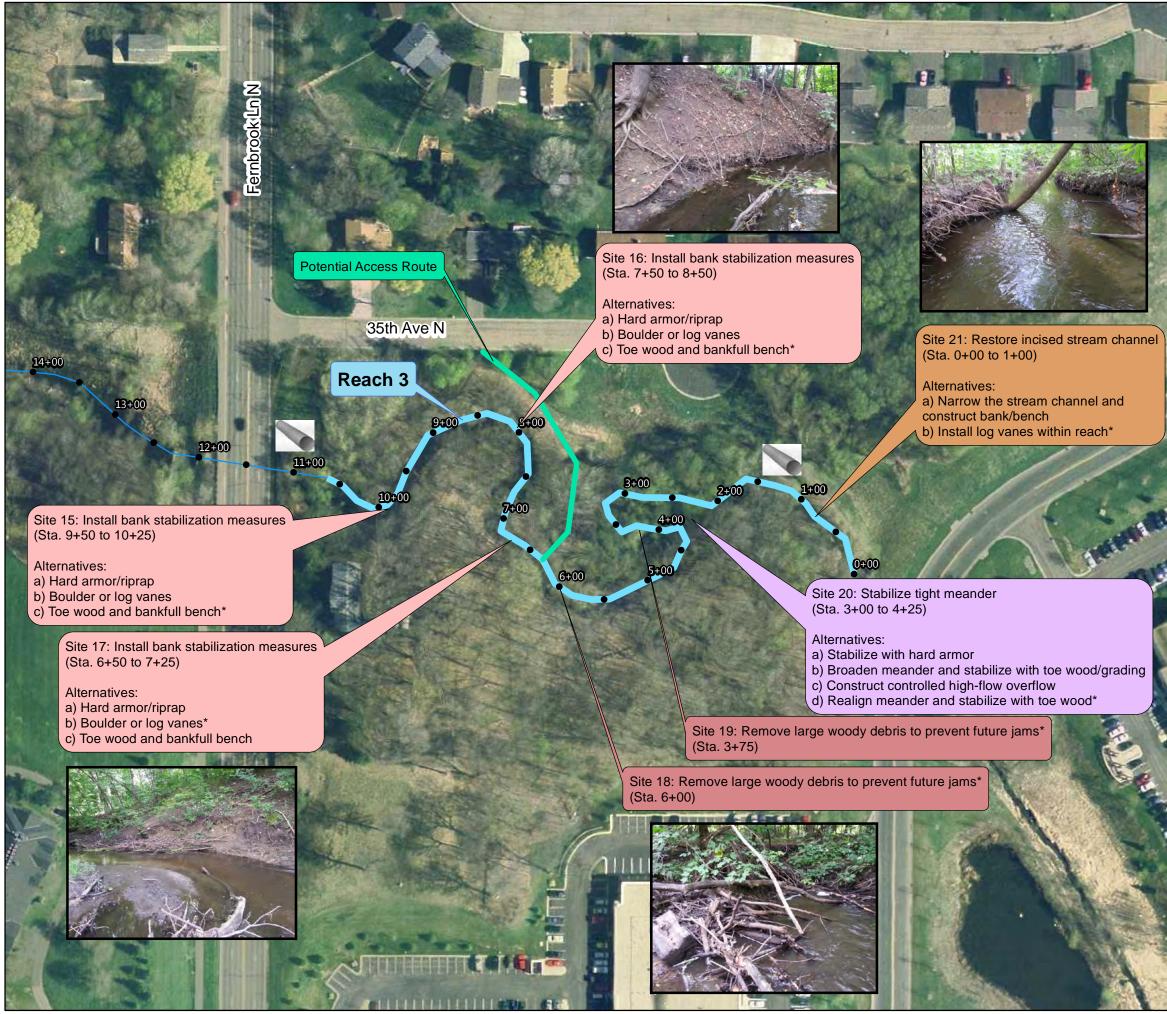
Reach 3

Issues: Several large eroding outer banks. Significant woody debris causing jams that redirect flow at banks. Unstable tight meander in downstream third in the process of being cut off.
