***Feasibility Report for
Bassett Creek Restoration Project***

Golden Valley and Crystal, Minnesota

***Prepared for
Bassett Creek Watershed Management Commission***

August 2009

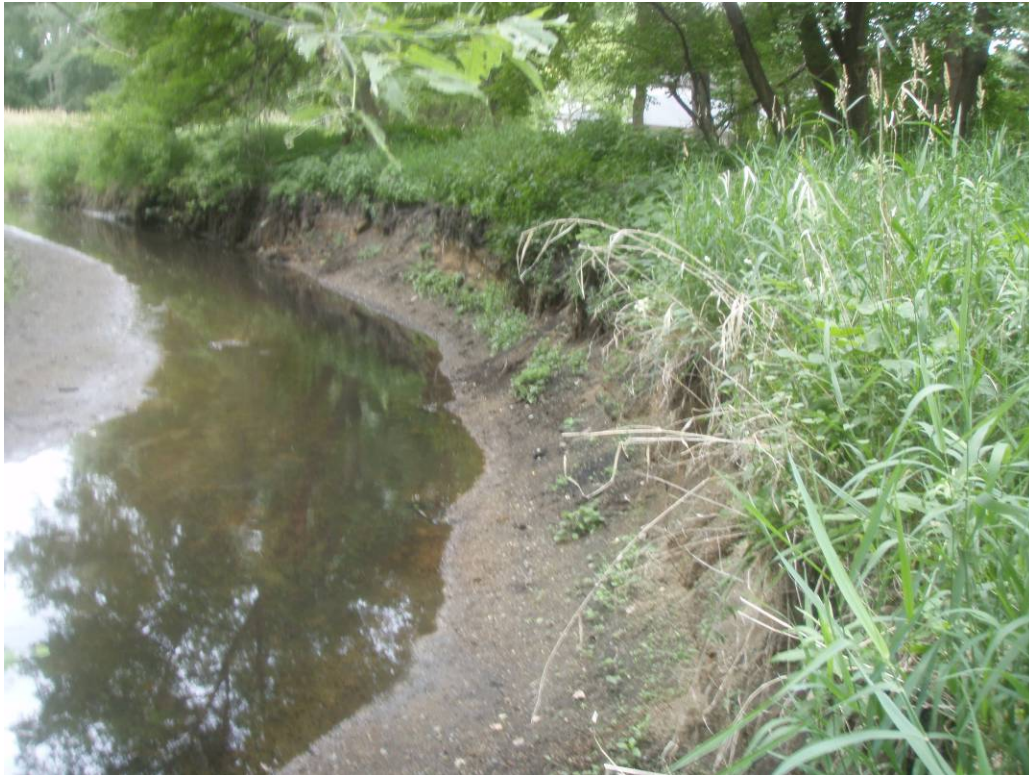
Photo 1. *Site 1.* Moderate to severe erosion on an outside bank of a meander

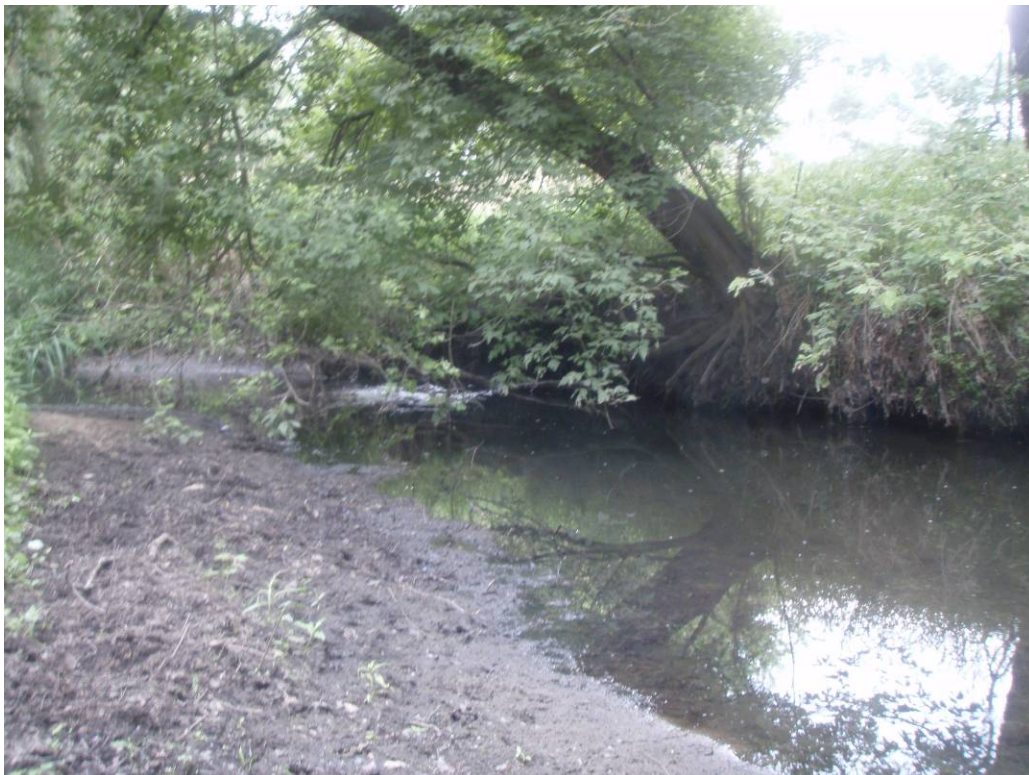
Photo 2. *Site 2.* Minor erosion and undercut bank.

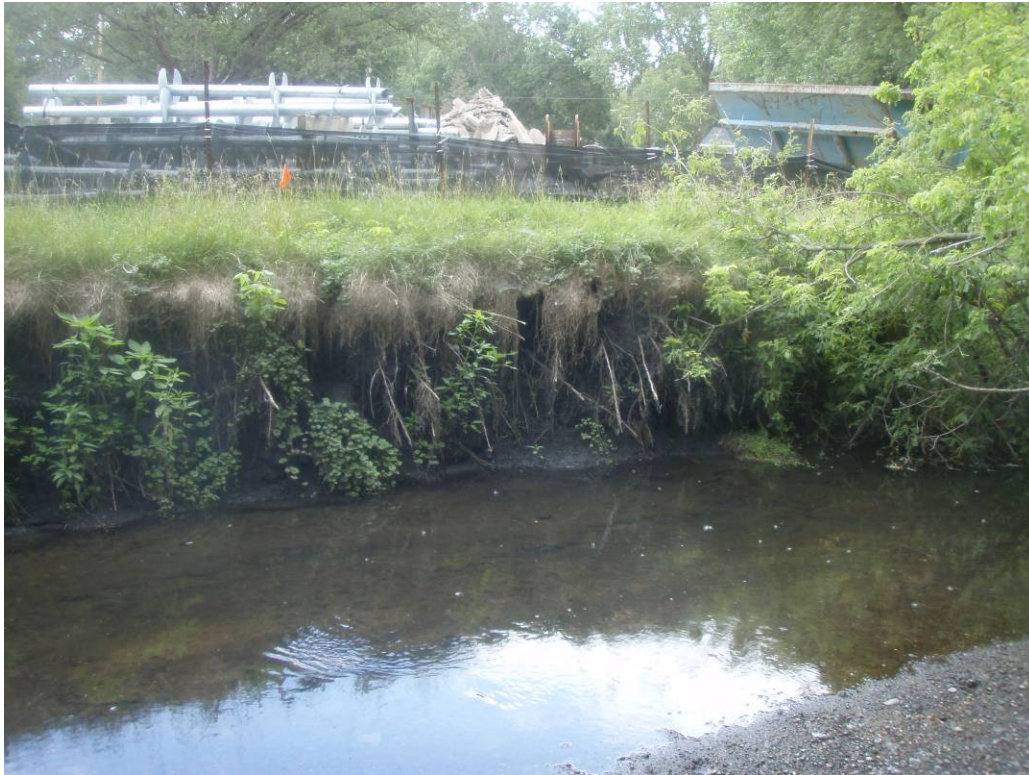
Photo 3. *Site 3.* Moderately eroding bank.

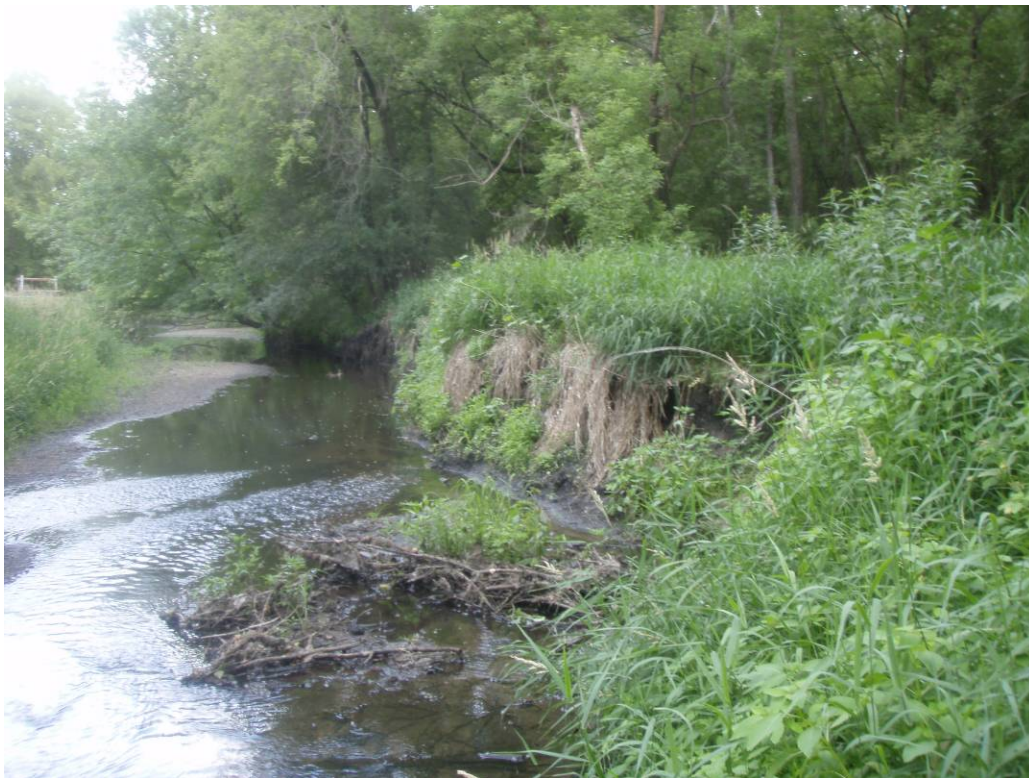
Photo 4. *Site 4.* Moderately eroding bank

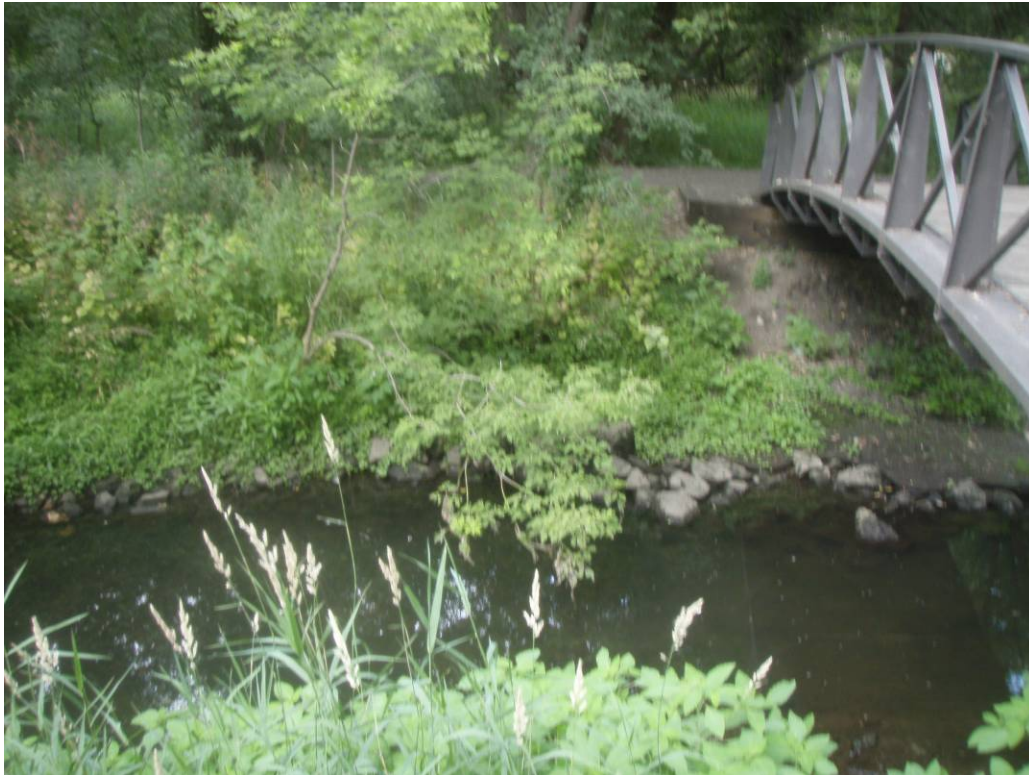
Photo 5. *Site 5.* Bank at pedestrian bridge on outside bank of a meander.

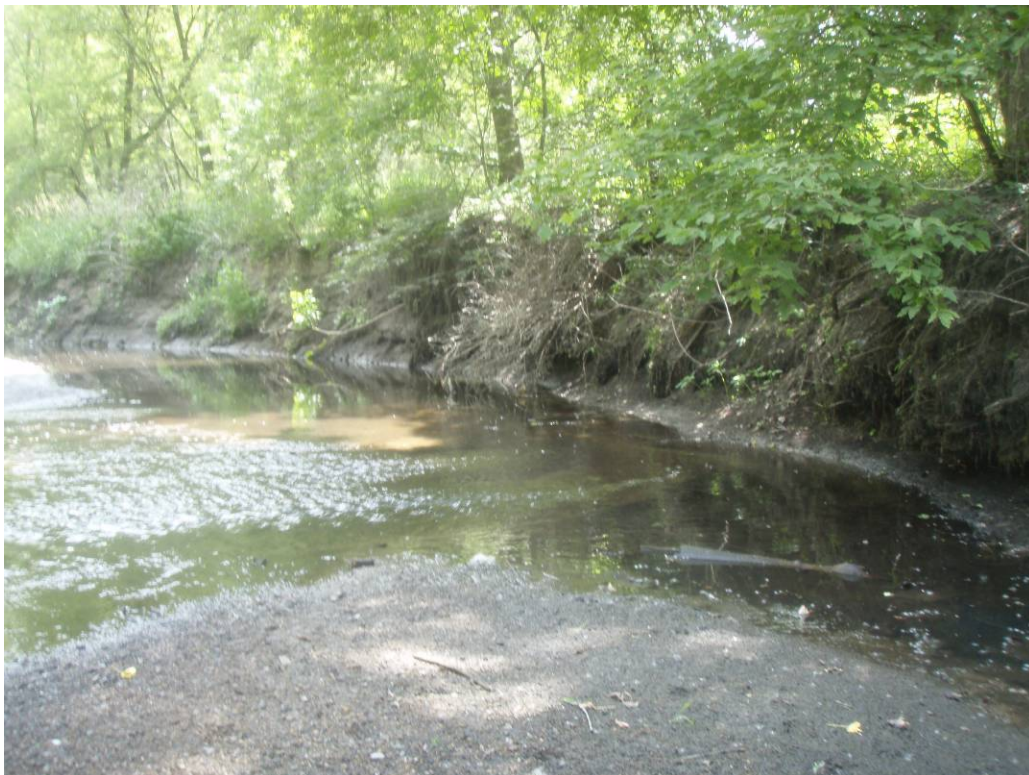
Photo 6. *Site 6.* Severe erosion on outside bank of a meander.

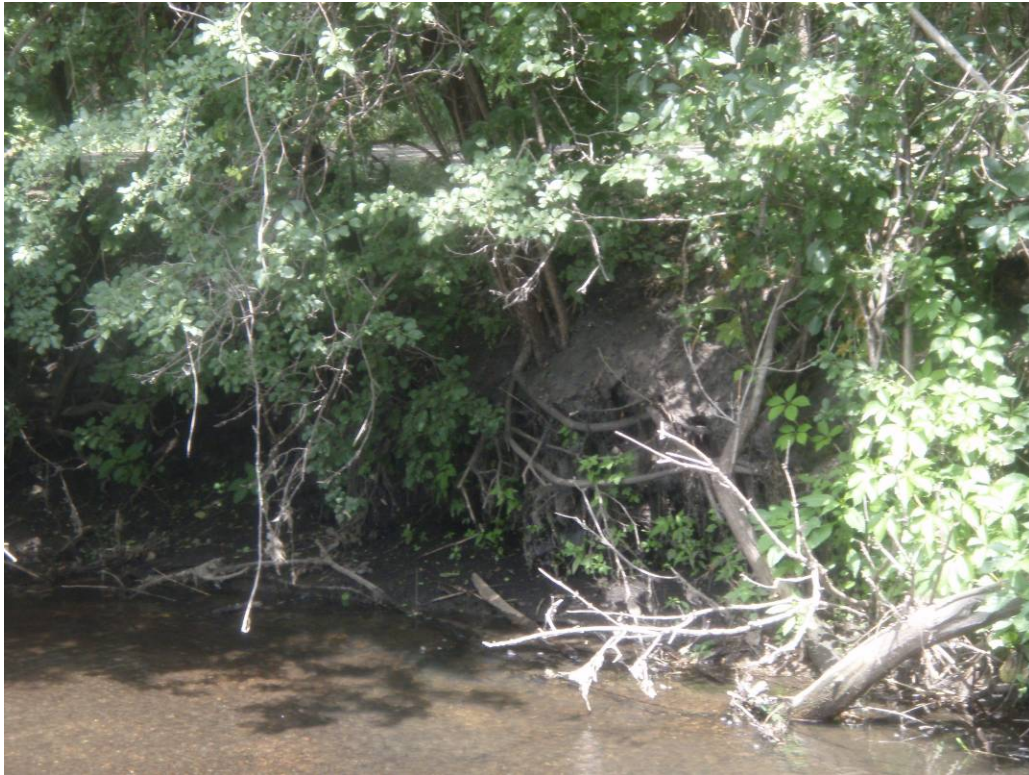
Photo 7. *Site 7.* Erosion threatening walking trail.

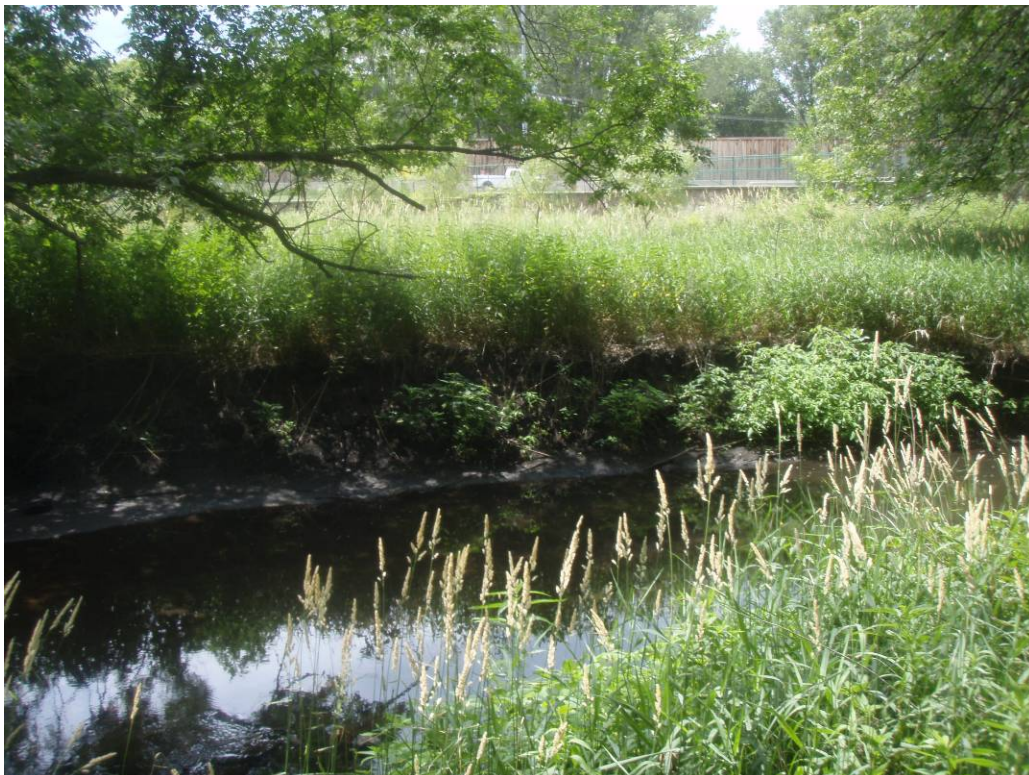
Photo 8. *Site 8.* Moderate erosion.

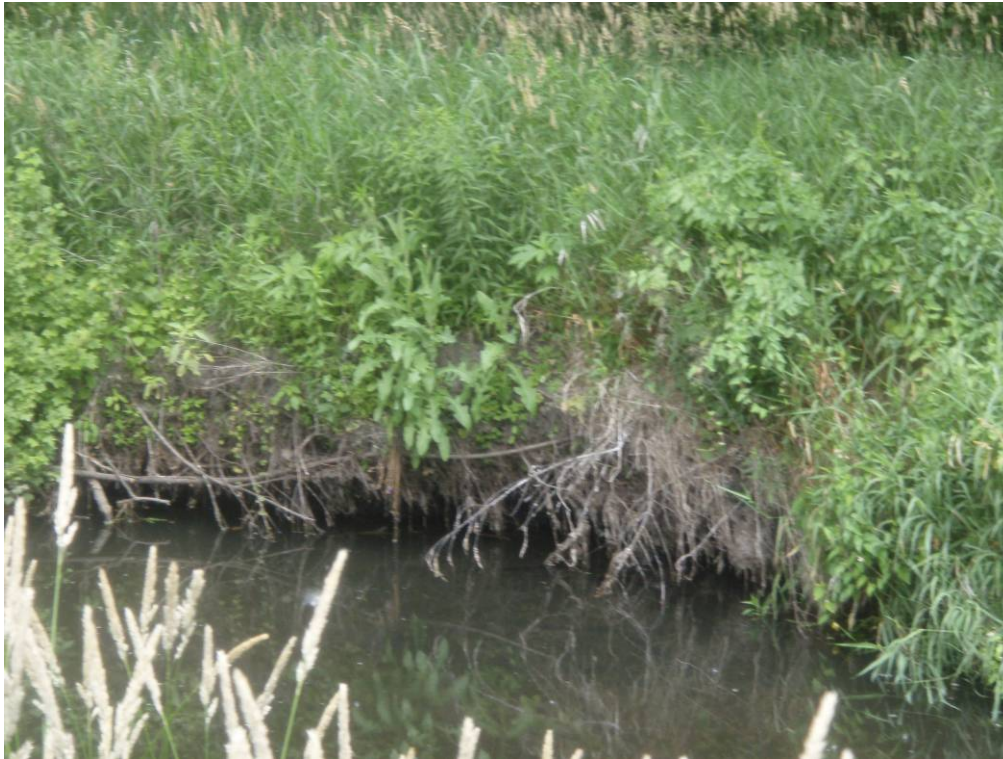
Photo 9. *Site 9.* Bank is being undercut and will likely fall into stream in the future

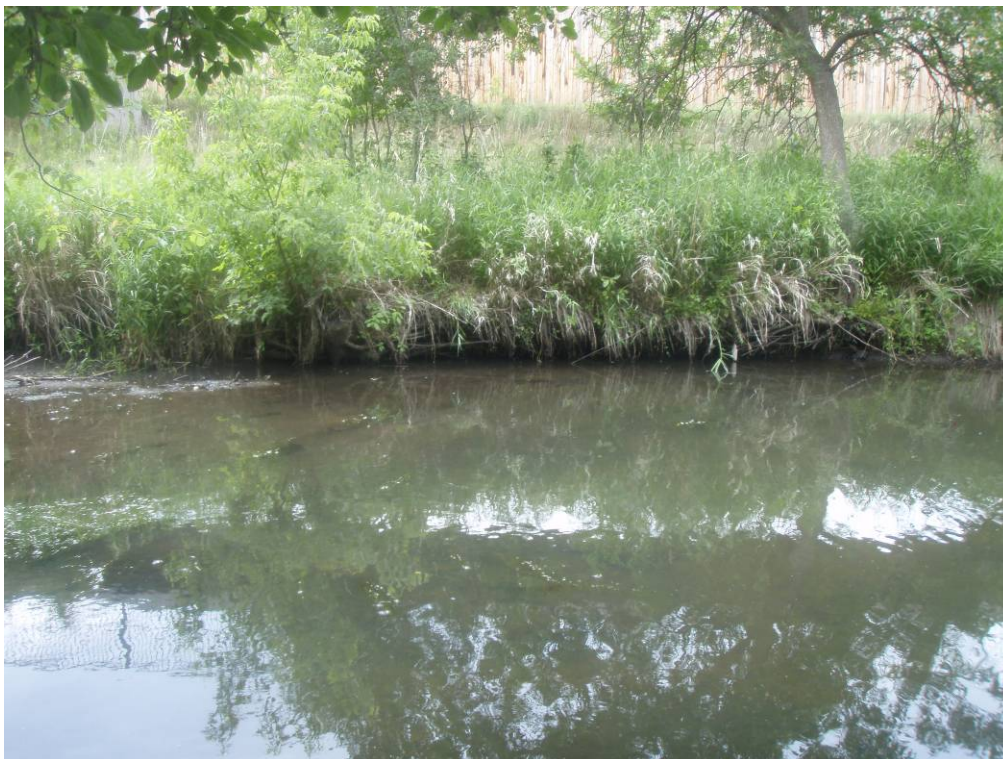
Photo 10. *Site 10.* Minor bank undercutting that could lead to future erosion.

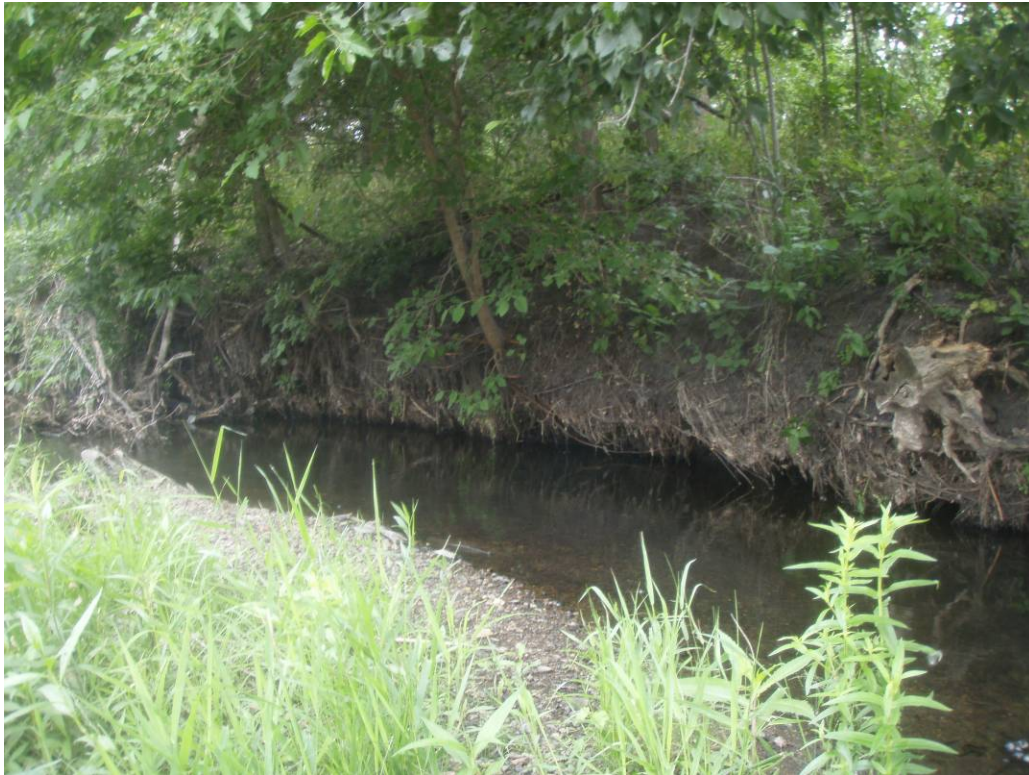
Photo 11. *Site 11.* Bank erosion near culvert under Highway 100.

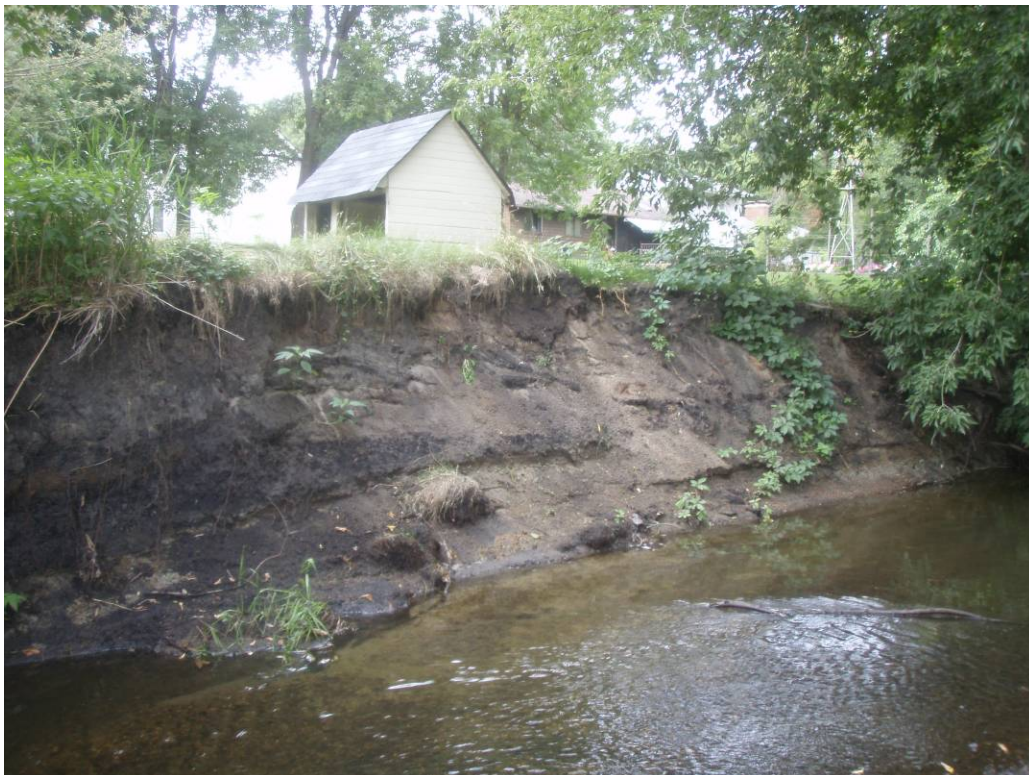
Photo 12. *Site 12.* Severe bank erosion on private property.

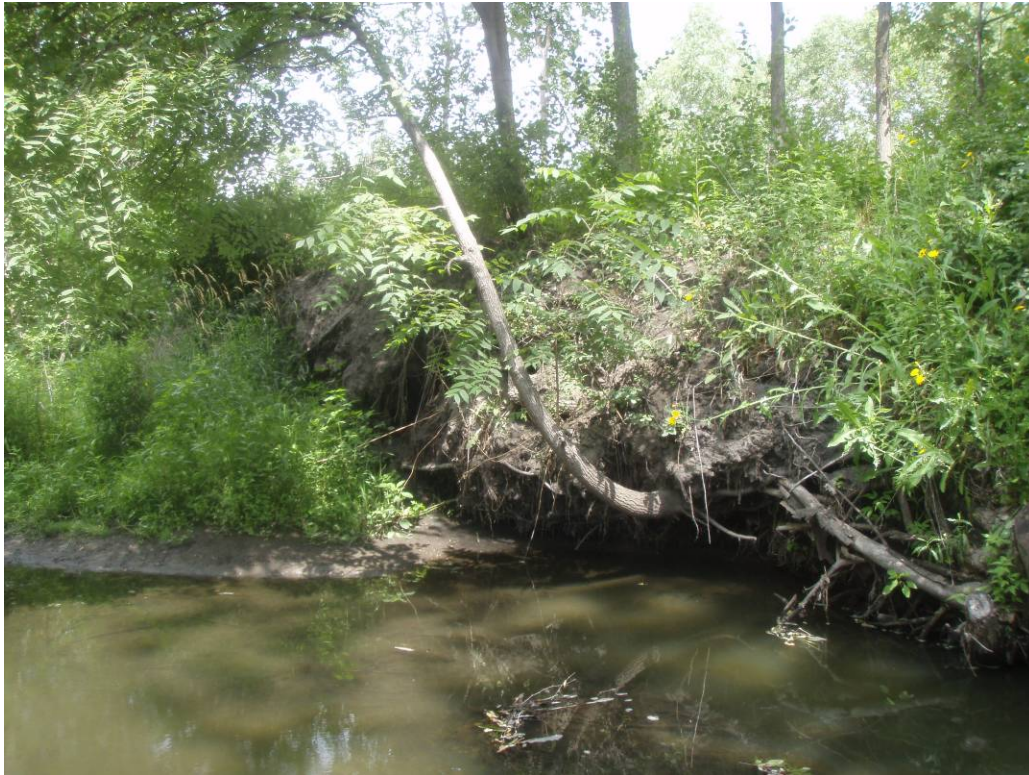
Photo 13. *Site 13.* Moderate bank erosion.

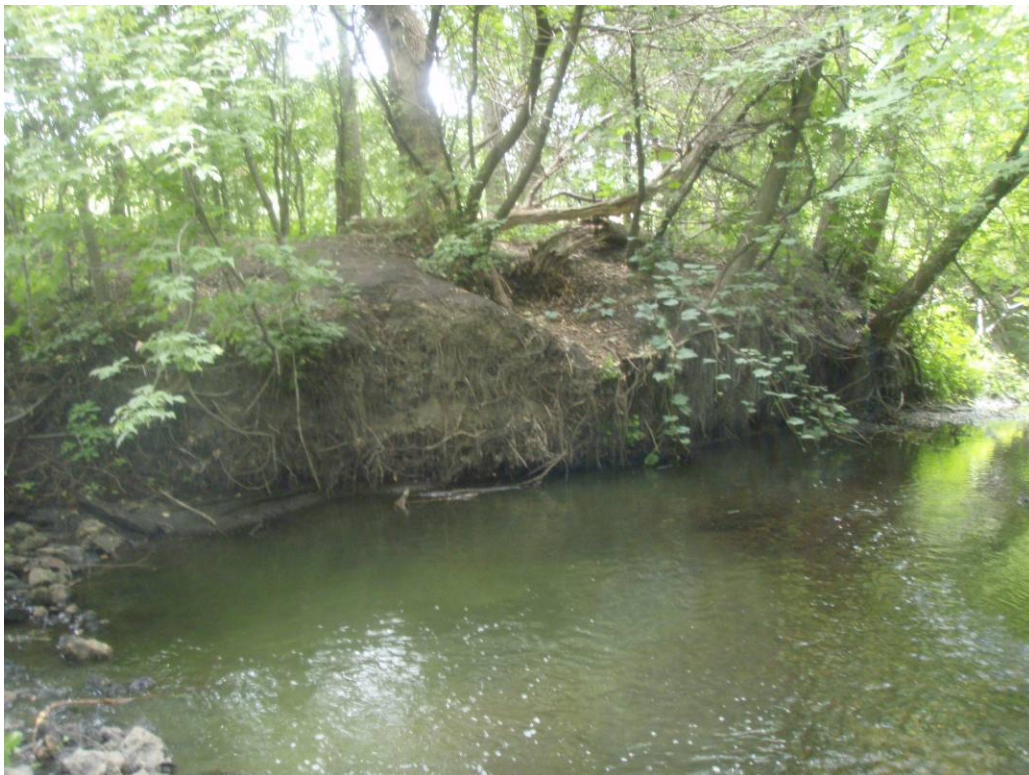
Photo 14. *Site 14.* Moderate bank erosion.

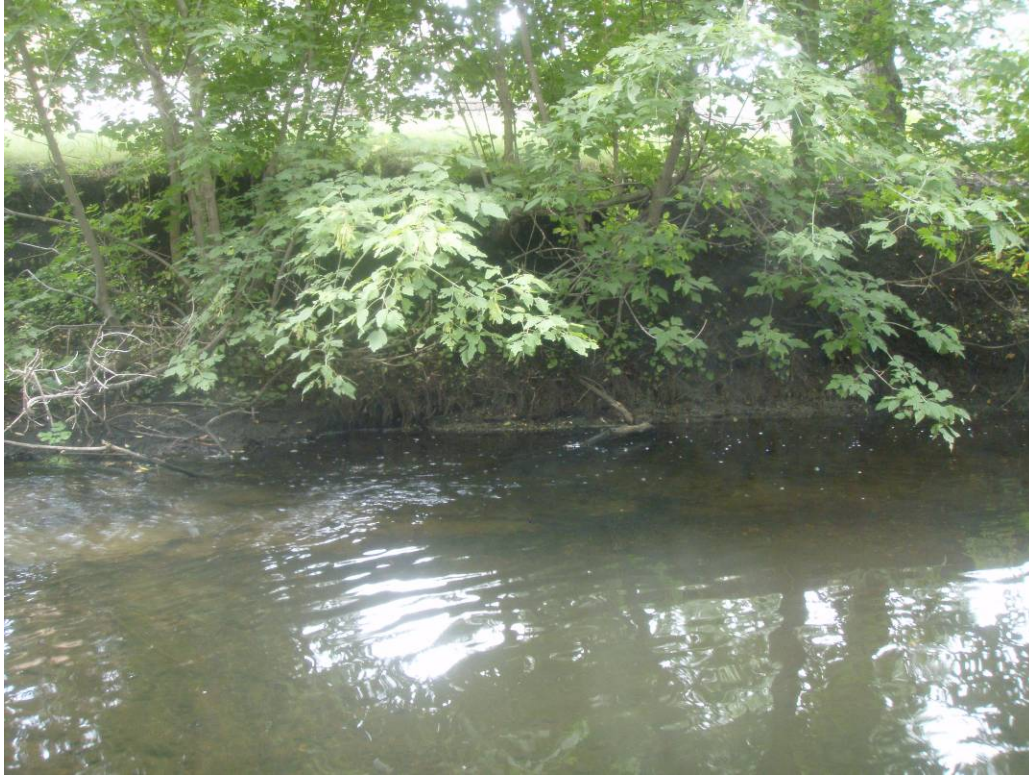
Photo 15. *Site 15.* Minor bank erosion.
