RE: Winnetka pond sediment removal project - update

Re: Request for additional funding from the Bassett Creek Watershed Management Commission Winnetka Pond Dredging Project - City of Crystal Project 2018-04

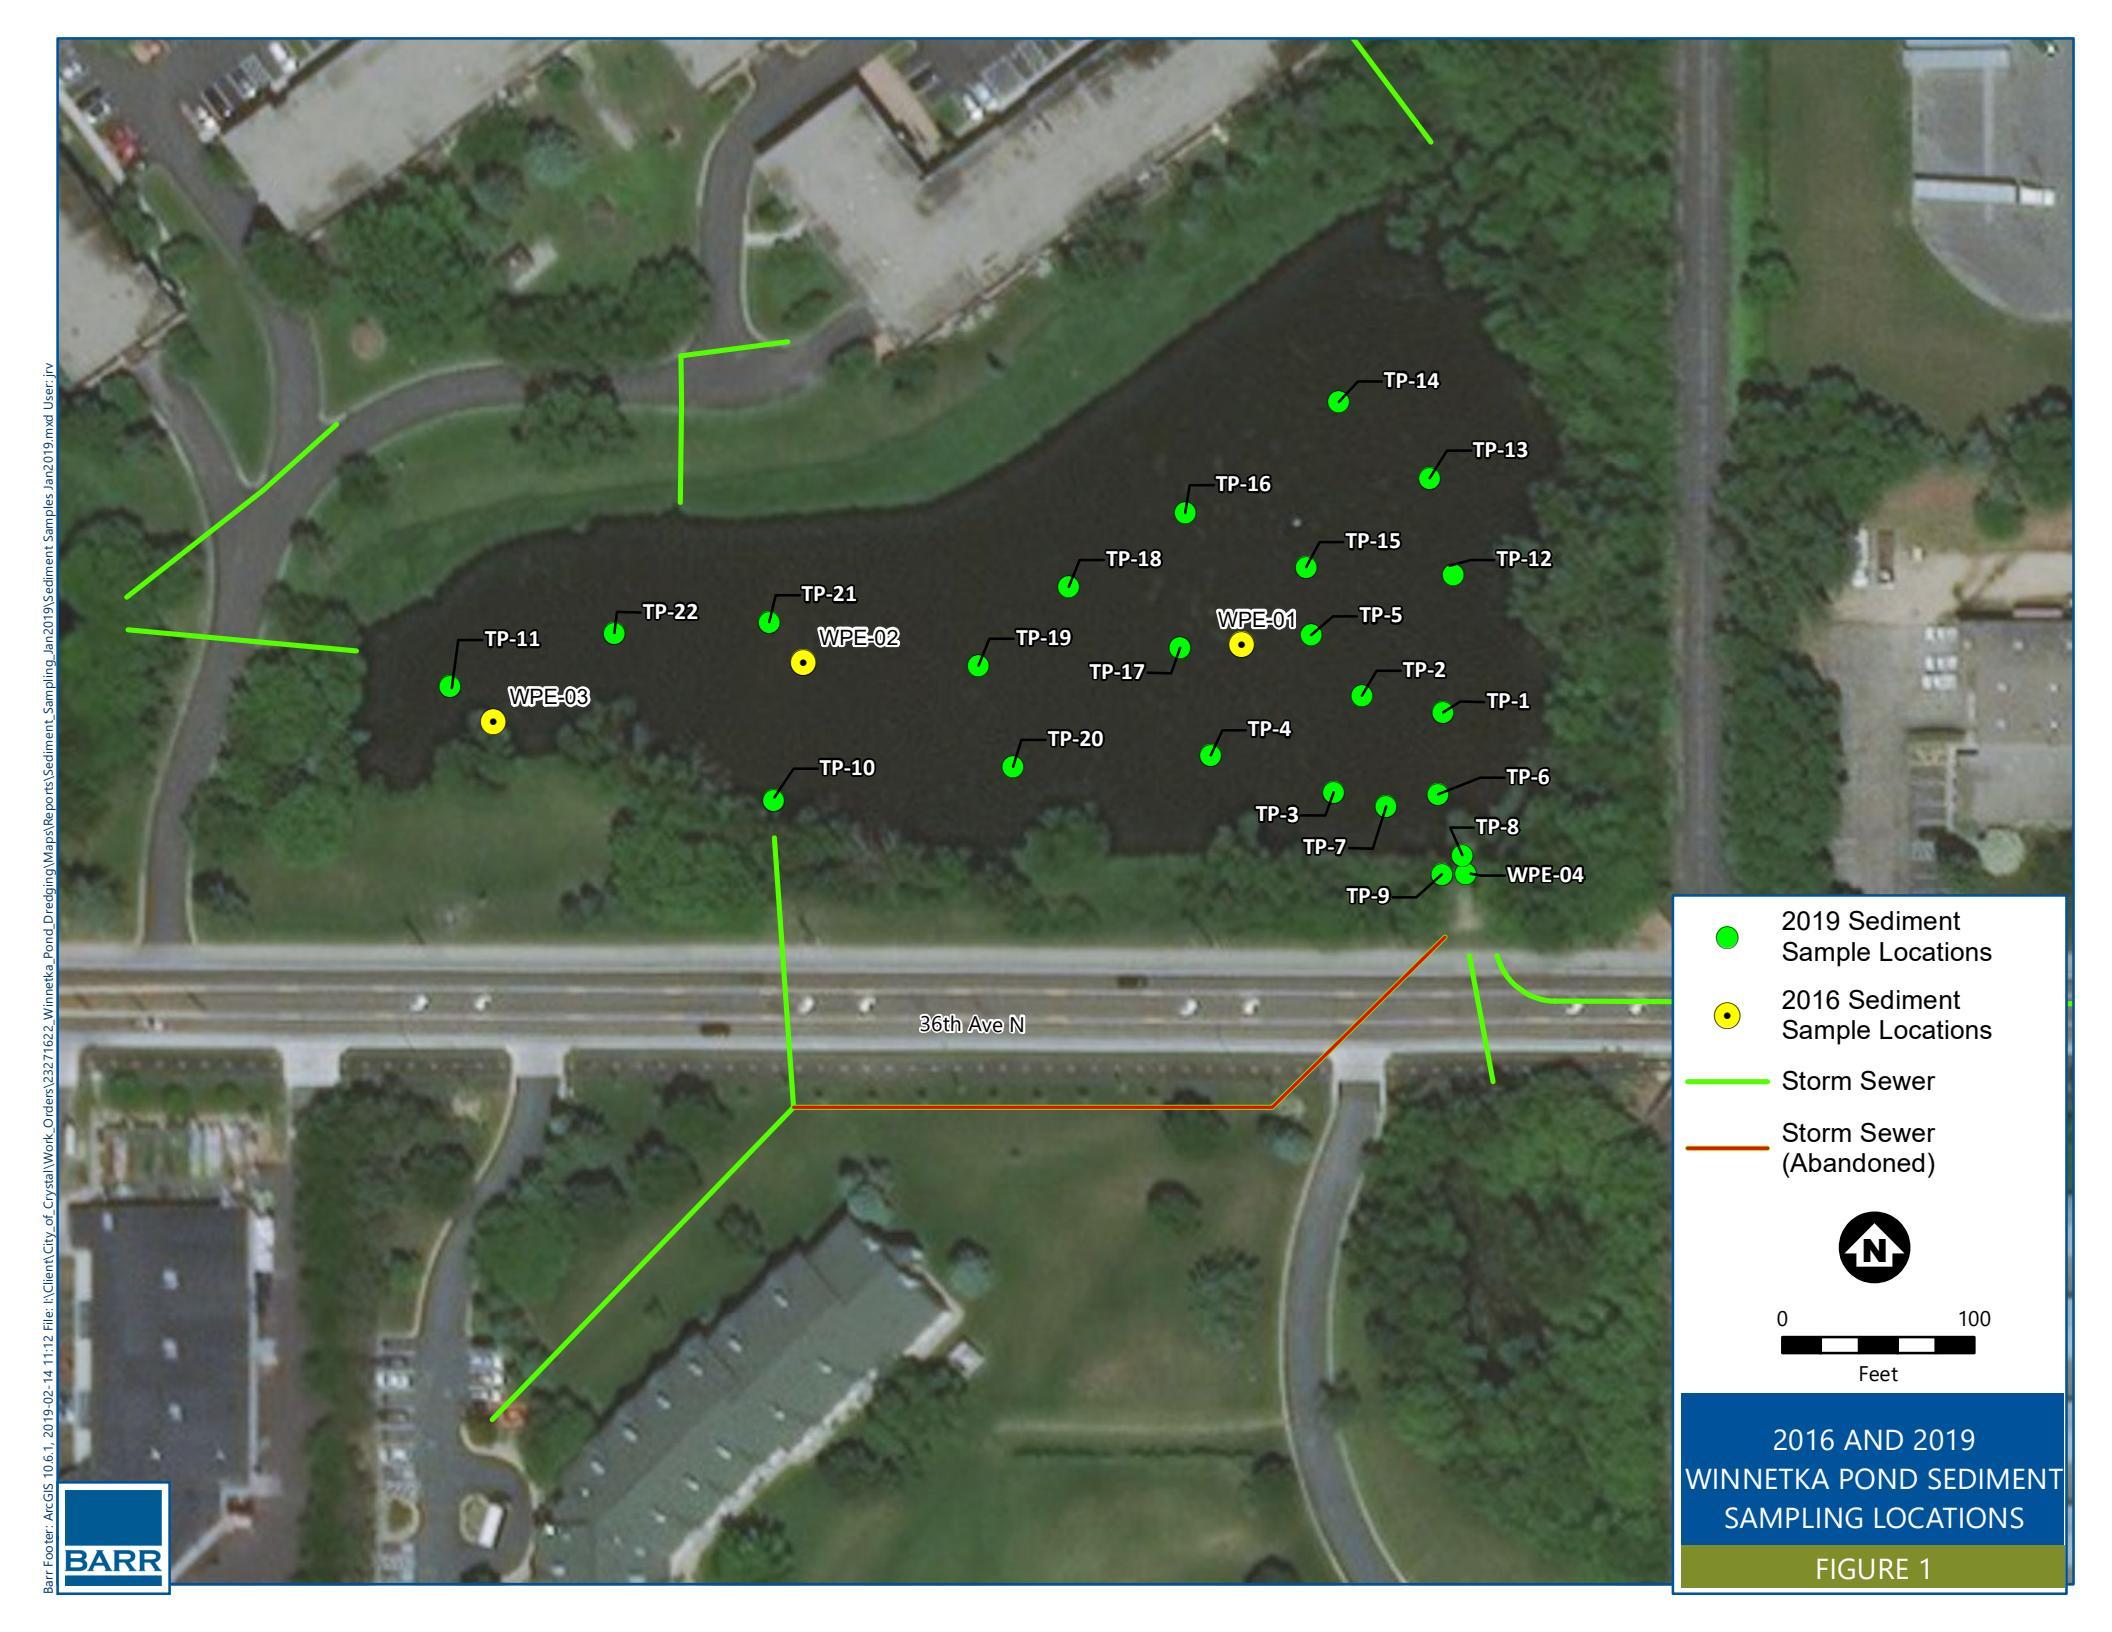
In September 2016, Winnetka Pond sediments were sampled as part of the BCWMC feasibility study for the CIP project. The sampling was performed in accordance with MPCA Best Management Practice (BMP) Guidance for Managing Stormwater Sediments (MPCA, 2015). Based on the size of the pond, the MPCA guidance recommended collecting and analyzing 3 samples of accumulated stormwater pond sediments (i.e., not native pond sediment) for PAHs, arsenic, and copper, as well as other contaminants that may have accumulated in the sediments based on the potential for a release from commercial or industrial operations near the pond. Field screening for evidence of contamination was completed during the sampling and no odors, oily sheen, or discoloration were observed. The field screening results indicated no analysis of Diesel Range Organics (DRO) or Gasoline Range Organics (GRO) or other chemicals was warranted. The laboratory results and field observations during the 2016 sediment sampling indicated the sediments met MPCA Unregulated Fill criteria, and could be managed as such and reused at offsite properties, as noted in the BCWMC feasibility study. Figure 1 shows the 2016 sampling locations (WPE-01, WPE-02 and WPE-03).

The original source of the contamination is unknown, but the contamination in the pond sediments near the outlet structure appears to have emanated from a layer of gravel pipe bedding in the abandoned and existing stormwater pipe trench in the southeast corner of the pond (see Figure 1). A pathway for the petroleum impacts to have migrated from documented release sites present around the area to the storm sewer trench has not been identified. Other unknowns include when the release occurred, the chemical that was spilled, how far it extends through the sewer line south of the pond, and whether it was deliberate dumping (e.g., into an open excavation) or from a known release from offsite. As noted above, the contamination is characteristic of an "aged petroleum product" which suggests the spill may have occurred many years/decades ago.

In addition to the initial sample collected near the outlet on January 22, 2019 (WPE-04), additional test pits were excavated on January 24, February 1, and February 6, 2019 to assess the extent of the impacts in the pond sediments (see Figure 1). Sample analysis was completed at multiple intervals of increasing radial distance from the outlet structure to determine the extent of the contaminated soil. After multiple rounds of analysis with DRO concentrations above the limit for Unregulated Fill, it appeared that DRO contamination could be present throughout the pond. A final round of sampling and analysis was completed on a pond-wide scale, which allowed for the delineation of two areas of contamination— 1) at the stormwater outlet structure where the petroleum impacts were first discovered and extending up to 150 feet north/northwest from the outlet; and 2) near the southern pond inlet where there was a DRO concentration of 153 mg/kg. PAHs were detected in the samples analyzed, but at concentrations below MPCA criteria for Unregulated Fill. In addition to identifying the extent horizontally, test results also

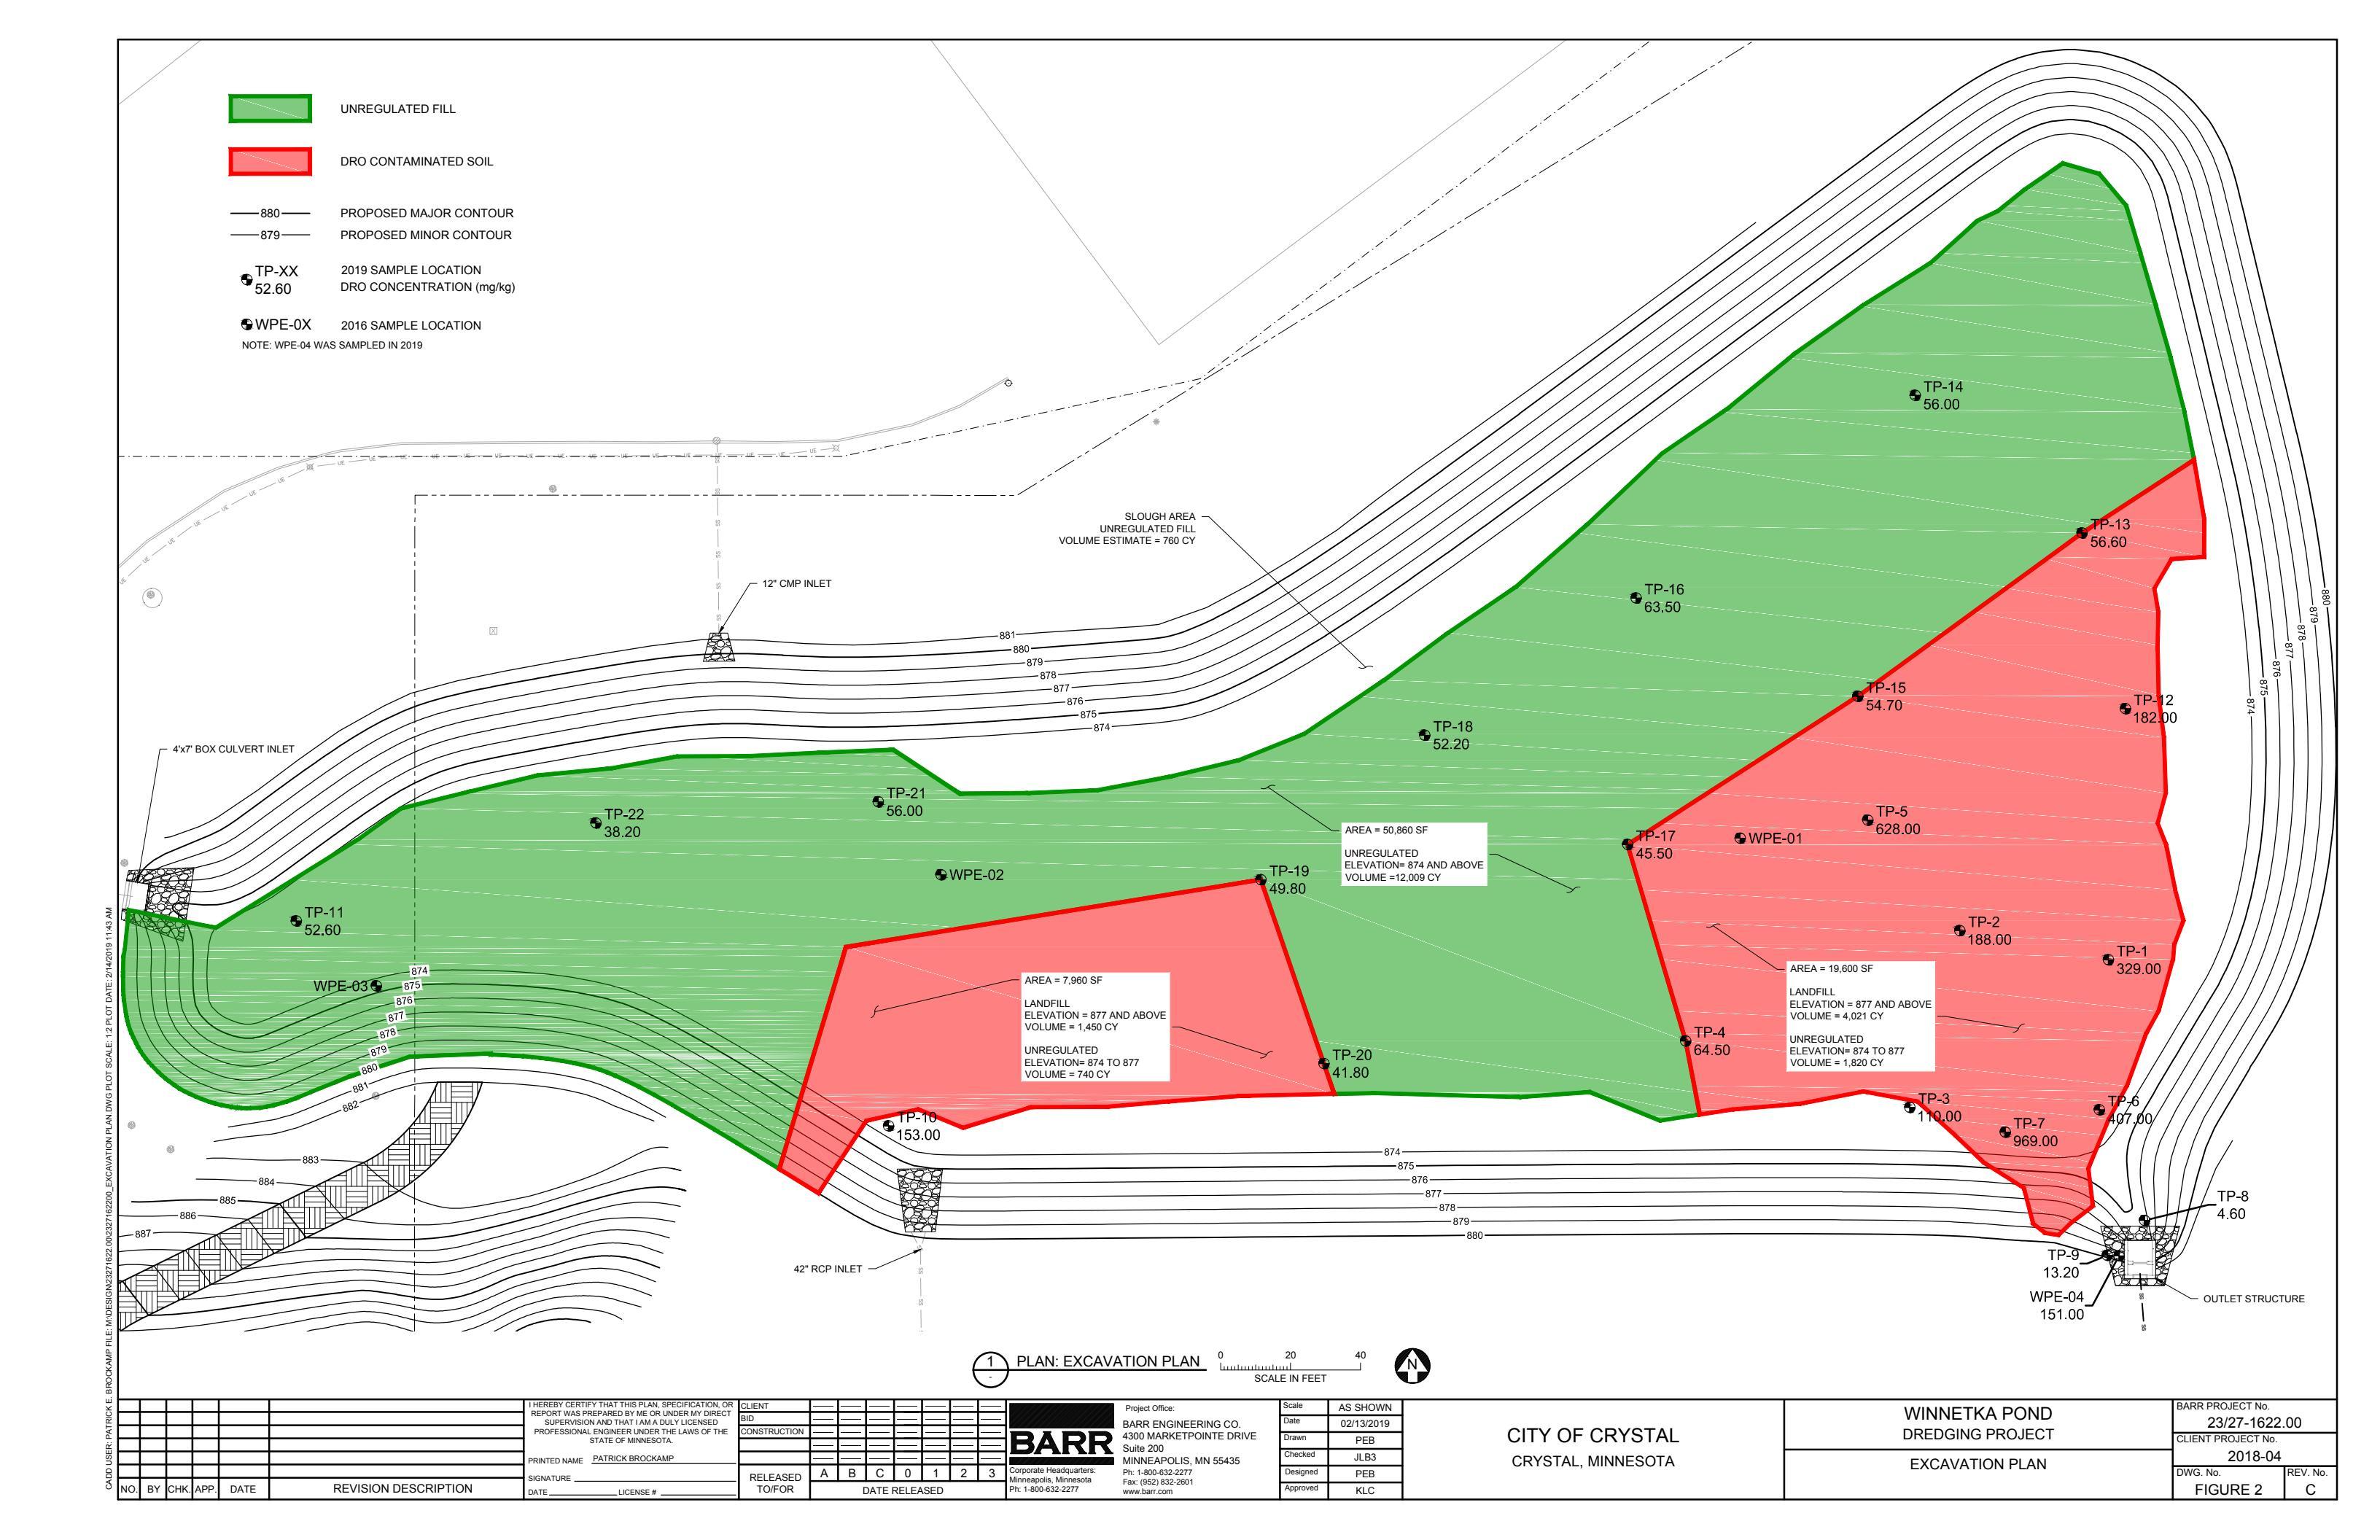
supported that the DRO contamination was only present in the top 2 feet of pond sediments. Figure 2 shows the test results and the areas where excavated accumulated sediment (top 2 feet) must be landfilled and where excavated material is Unregulated Fill.
