Double Box Culvert Repair Project (FCP-1) Feasibility Report

Prepared for Bassett Creek Watershed Management Commission

June 2025

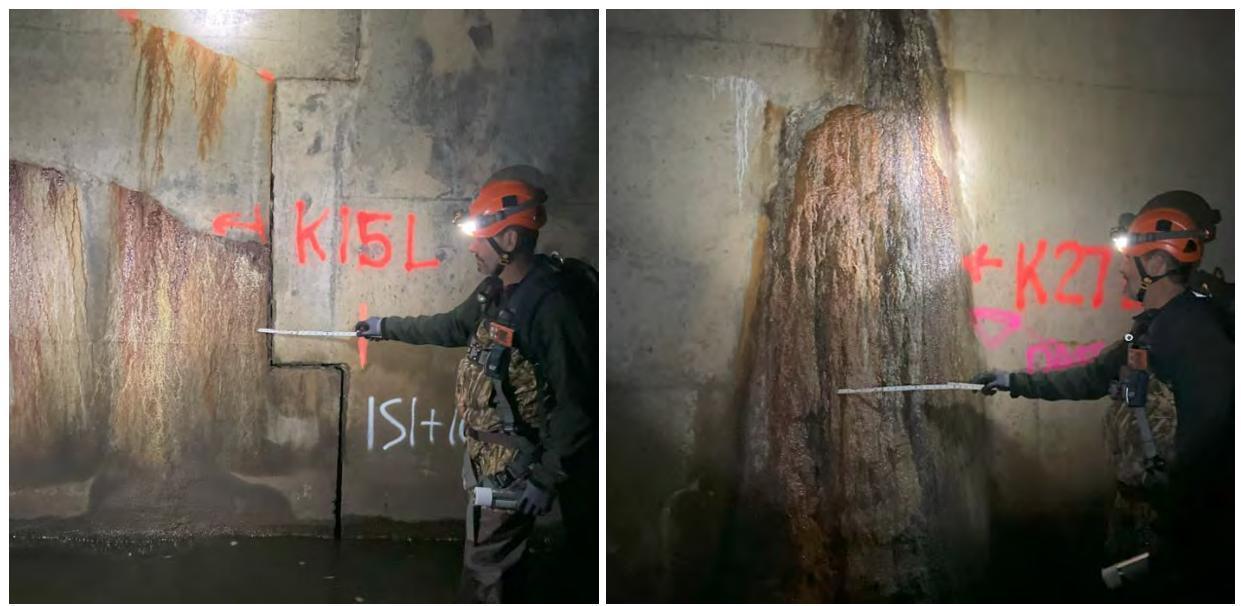
Figure 2 Typical Shear Keys Recommended for Repair

The Double Box Culvert was constructed with shear key joints at 35 locations along the Double Box Culvert alignment. The purpose of the shear keys is to transfer load between culvert segments and minimize differential settlement. During the 2019 and 2024 inspections (2) (3), the Commission Engineer observed infiltration, deposits, and concrete deterioration at many of the shear key joints. In addition, approximately 70% of the shear keys had missing or deteriorated bitumastic material within the 1- to 1.5-inch-wide joints. These defects and observations indicate some level of differential settlement has occurred at the shear keys since construction. In addition, water and soil intrusion through these joints could lead to void spaces developing outside of the box culvert walls, which can lead to settlement or sinkholes at the ground surface above the box culvert.

The primary objective of this repair is to replace deteriorated joint filler material to minimize potential migration of water and soil particles into the tunnel. Shear keys that are experiencing concrete deterioration will be repaired under "concrete surface repair," "crack repair," or "fracture repair" as noted in the subsections below. The approach to repair the shear key joints includes installing oakum, soaked in a hydrophilic chemical grout, to seal the joints and fractures. This would minimize water and soil intrusion and reduce the risk of void spaces developing outside of the box culvert. Photos showing typical shear key joints recommended for repair are included in Figure 2.

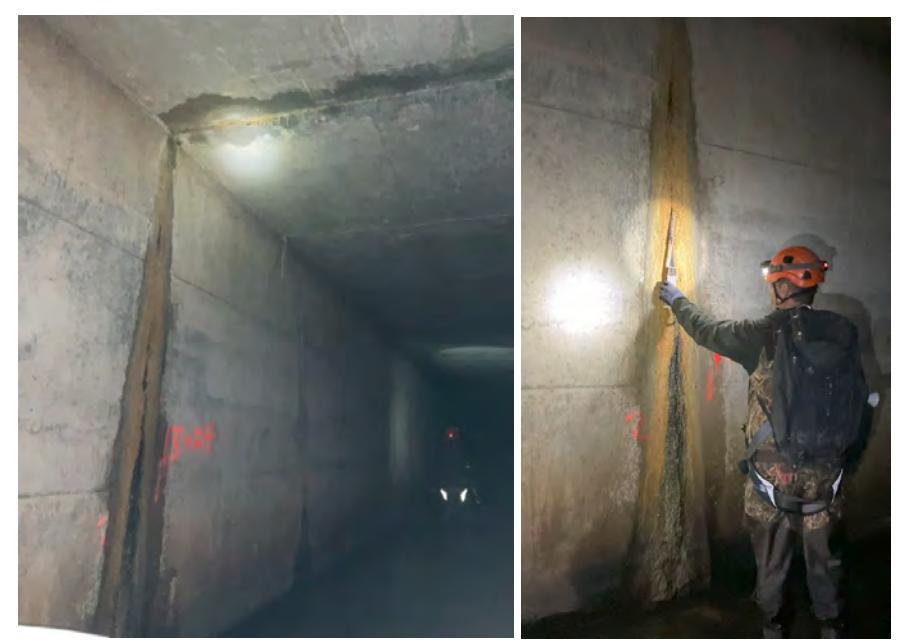
Figure 3 Typical Cracks Recommended for Repair

During the 2019 and 2024 inspections (2) (3), the Commission Engineer observed approximately 18,000 linear feet of cracks in the Double Box Culvert. A crack is a defined as a break in a culvert or tunnel that is visible but not physically open. The majority of the cracks are fine "hairline" shrinkage and temperature cracks in the concrete that likely developed shortly after initial construction. However, some cracks are more prominent and are allowing water infiltration into the box culvert. Water infiltration through cracks can advance concrete and steel reinforcement deterioration and cause the formation of mineral encrustation within the tunnel. The Commission Engineer estimates that approximately 10% of the identified cracks warrant repairs as part of the project. To repair these cracks, a contractor would remove mineral deposits, drill holes that intercept the cracks and inject chemical grout to seal the cracks. Photos showing typical cracks recommended for repair are included in Figure 3. Note, some cracks recommended for repair occur along construction joints.

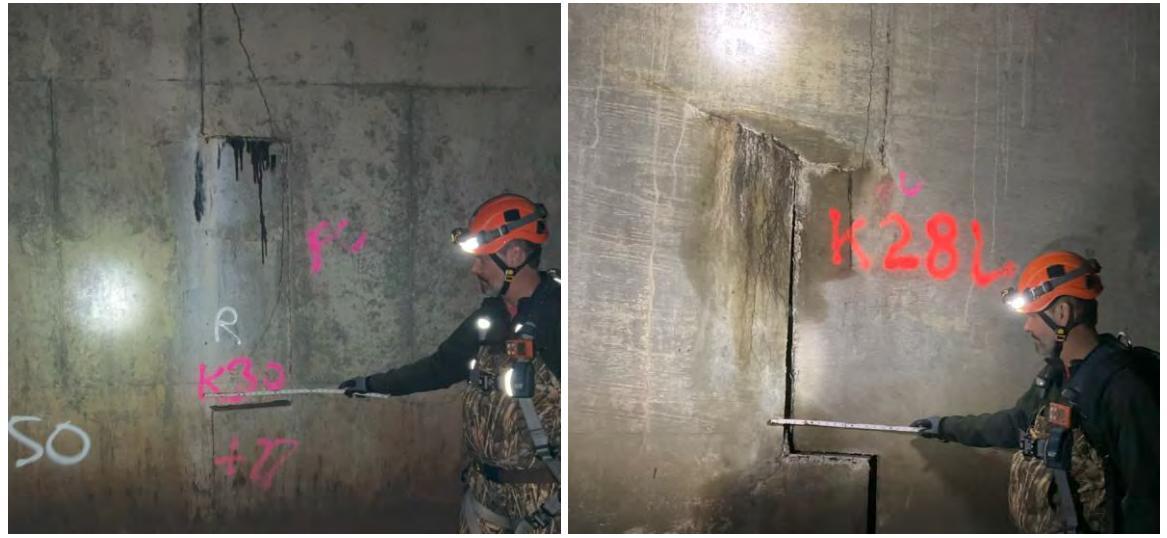
Figure 4

During the 2019 and 2024 inspections (2) (3), the Commission Engineer observed a total of approximately 100 linear feet fractures within the double box culvert that warrant repairs, most commonly at the shear key locations as a result of potential differential settlement occurring at that joint. A fracture is a crack that has become visibly open, and a gap can be seen. A fracture allows more groundwater infiltration/exfiltration than a crack. Similar to crack repairs, to repair fractures, a contractor would remove mineral deposits (if present), drill holes that intercept the fracture and inject epoxy into the fracture to complete the structural repair. Photos showing typical fractures recommended for repair are included in Figure 4.

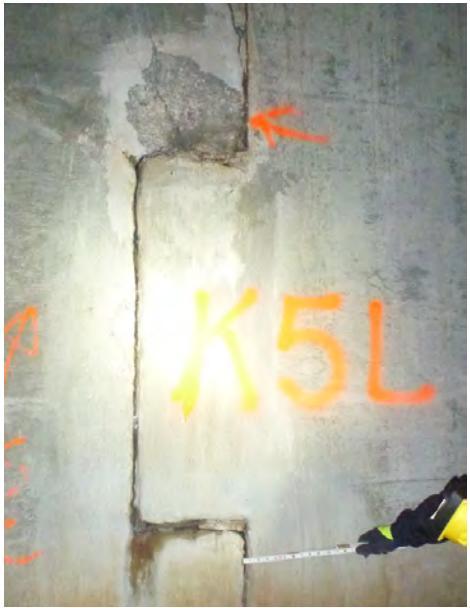
Figure 5 Typical Concrete Areas Recommended for Repair

During the 2019 and 2024 inspections (2) (3), the Commission Engineer observed approximately 34 locations of concrete surface defects and concrete spalling that warrant repair in the double box culvert. A contractor would perform concrete surface repairs by saw cutting a perimeter around the proposed repair, removing loose concrete, installing corrosion inhibitor on any exposed reinforcement, placing new reinforcement and anchorages as necessary, and placing repair mortar material to repair the defects. Photos showing typical concrete areas recommended for repair are included in Figure 5.

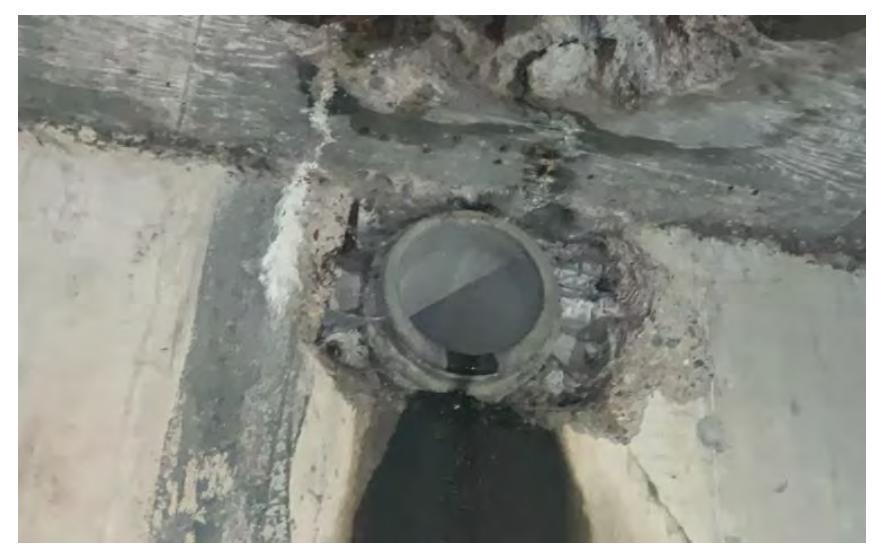
Figure 6 Tap Recommended for Repair

During the 2019 and 2024 inspections (2) (3), the Commission Engineer observed one tap location with a defective connection with the double box culvert. The defective connection is a source for infiltration and concrete degradation. The repair will include removing unsound material, repairing exposed reinforcement, and installing new repair mortar around the tap. A photo showing the tap recommended for repair is included in Figure 6.

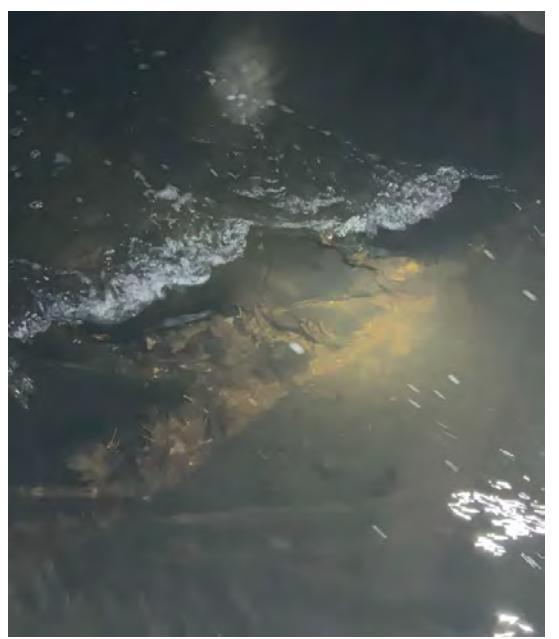
Figure 7 Invert Area Recommended for Repair

During the 2024 inspections (2) (3), the Commission Engineer observed three locations in the invert where the concrete appeared to be buckling and spalling. It is anticipated that additional invert deficiencies may be identified during construction when the tunnel is dewatered. The identified invert deficiencies were located at an existing invert joint. The invert repair work will include saw cutting and removing the deficient concrete, drilling and anchoring reinforcement and placing new concrete. A photo showing an invert area recommended for repair is included in Figure 7.

SAW CUT THE PERIMETER OF THE DEFECT. 2. PREPARE EXISTING CONCRETE SURFACE.

3. IF REINFORCEMENT IS ENCOUNTERED IN REPAIR AREA, DEMO CONCRETE BEHIND REINFORCEMENT TO PROVIDE 1" MIN CLEAR COVER (ALL SIDES).

4. REMOVE CORROSION FROM REINFORCEMENT (IF PRESENT) AND INSTALL CORROSION INHIBITOR.

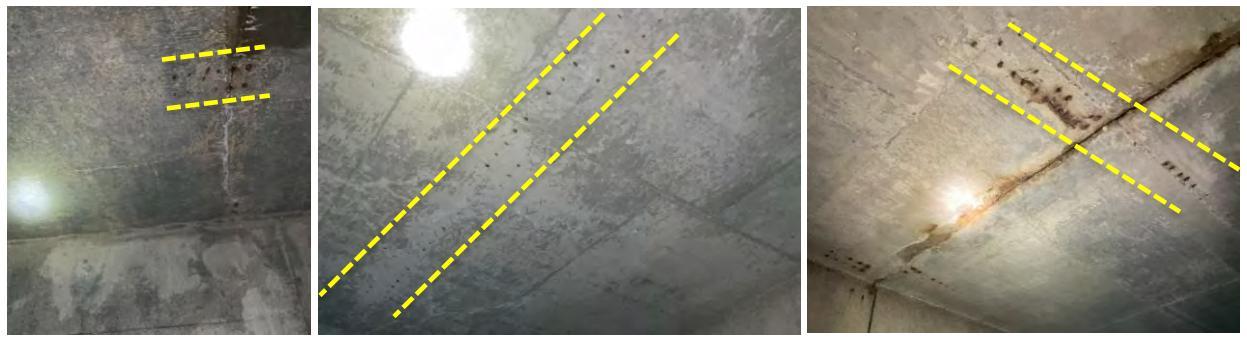
Figure 8 Typical Reinforcement Spacers Recommended for Repair

As part of the original Double Box Culvert construction, the structural reinforcement was placed on steel spacers to provide the specified concrete cover between the formwork and reinforcement. During the 2024 inspections (2) (3), the Commission Engineer observed that at various locations within the right box culvert, the reinforcement spacers along the ceiling of the tunnel were visible and corroding. The corrosion pattern was generally linear and often visible at multiple locations along the ceiling of the tunnel within select segments. For example, the pattern may be visible along the ceiling near the left wall, in the middle, and near the right wall within the same reach of the tunnel. In total, the Commission Engineer quantified approximately 1,200 feet of visible corrosion of the reinforcement spacers. This corrosion can contribute to concrete degradation over time; therefore, the Commission Engineer recommends repairs for the full extent of the visible corrosion. Anticipated repairs include removing the corrosion, installing a corrosion inhibitor over the exposed steel, and placing a skim coat of repair mortar over the affected area. Photos showing typical reinforcement spacer repair areas are included in Figure 8.

1. REMOVE CORROSION FROM REINFORCEMENT SPACERS. 2. INSTALL CORROSION INHIBITOR. 3. INSTALL SKIM COAT OF REPAIR MORTAR OVER REINFORCEMENT SPACERS.

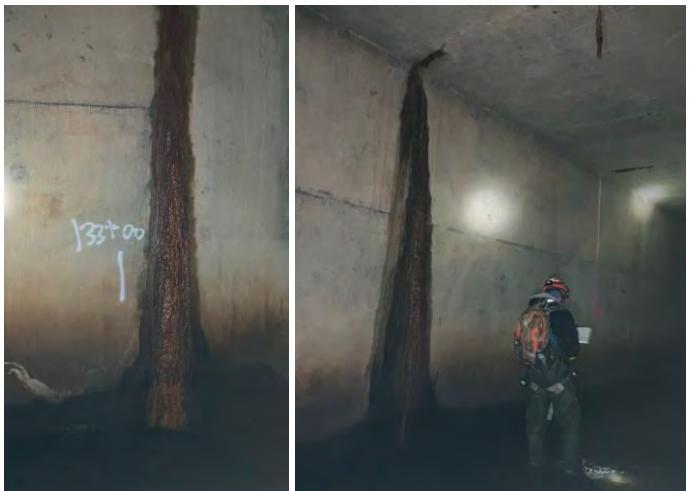
Figure 9 Typical Attached Deposits Recommended for Removal

During the 2024 inspections (2) (3), the Commission Engineer observed 34 locations of attached, encrusted deposits. Attached encrustations consist of mineral deposits left by the partial evaporation of infiltrating groundwater containing dissolved salts. These deposits will normally be concentrated alongside weeping or dripping joints or fractures. If left unchecked, attached deposits can hide other defects and eventually build up and reduce the cross-section area and capacity of the Double Box Culvert. Deposits are typically removed by a contractor using water blasting, chipping hammers and grinding wheels. Photos showing typical attached deposits recommended for removal are included in Figure 9.
