Wetland Delineation Report - DRAFT

Plymouth Creek Feasibility Study

Prepared for Bassett Creek Watershed Management Commission

January 2016

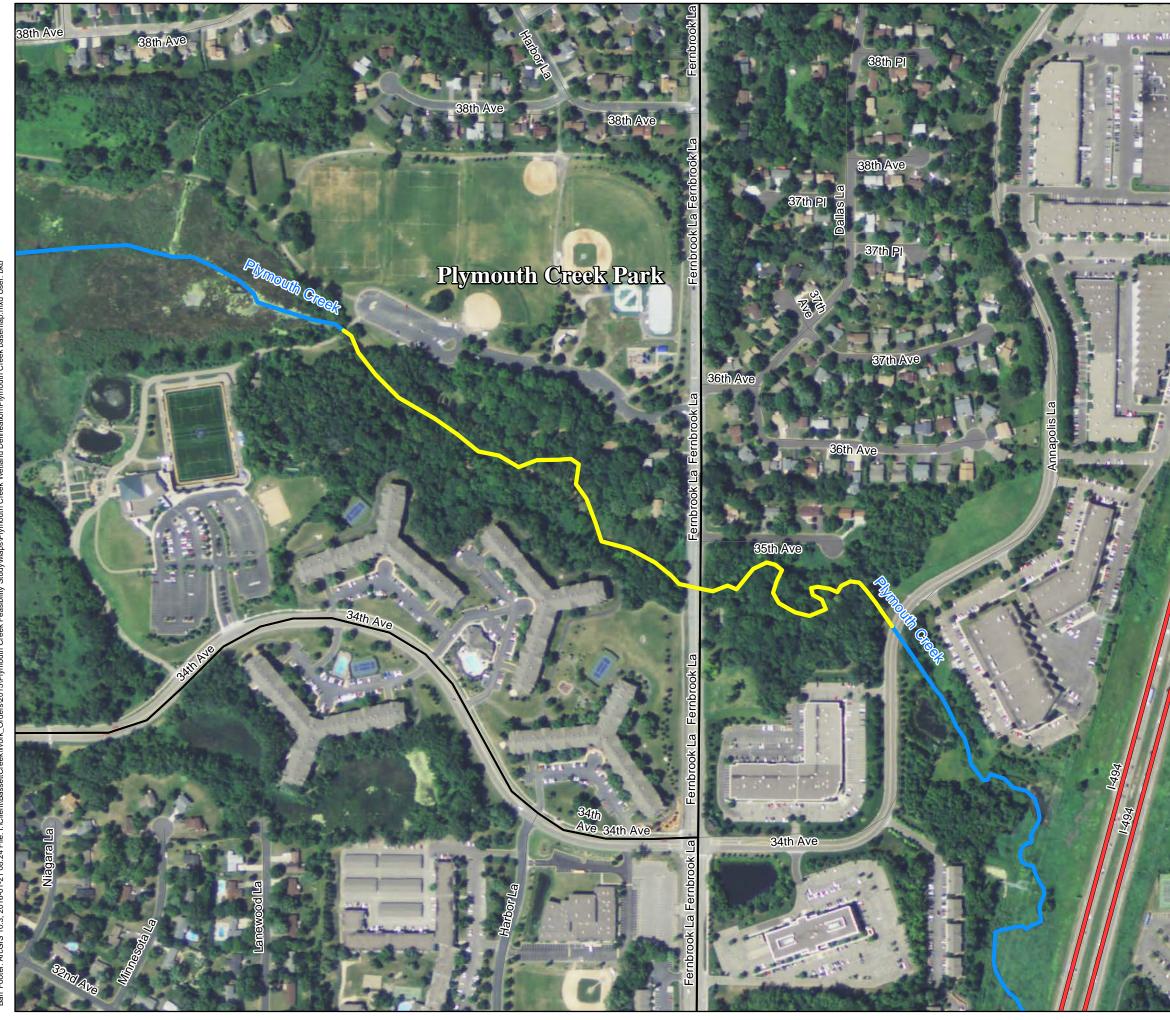
Basset Creek Watershed Management Commission (BCWMC) is submitting a Wetland Delineation Report as part of a study that examines the feasibility of restoring sites along Plymouth Creek reaches damaged by erosion or affected by sedimentation. The project area is located along several reaches of Plymouth Creek beginning at Plymouth Creek Park and continues between Fernbrook Lane North and Annapolis Lane North, Plymouth, Hennepin County, Minnesota. The project area is within Sections 16, 21 and 22 of Township 118 North, Range 21 West (**Figure 1**).

The proposed project area is located within City of Plymouth property. The project area west of Fernbrook Lane North is bordered by medium density apartment property to the south and Plymouth Creek Park to the north and west. The project area located east of Fernbrook Lane North has medium density housing to the North and office building space to the south. Lands surrounding the project area are forested with deciduous trees (**Figure 1**).

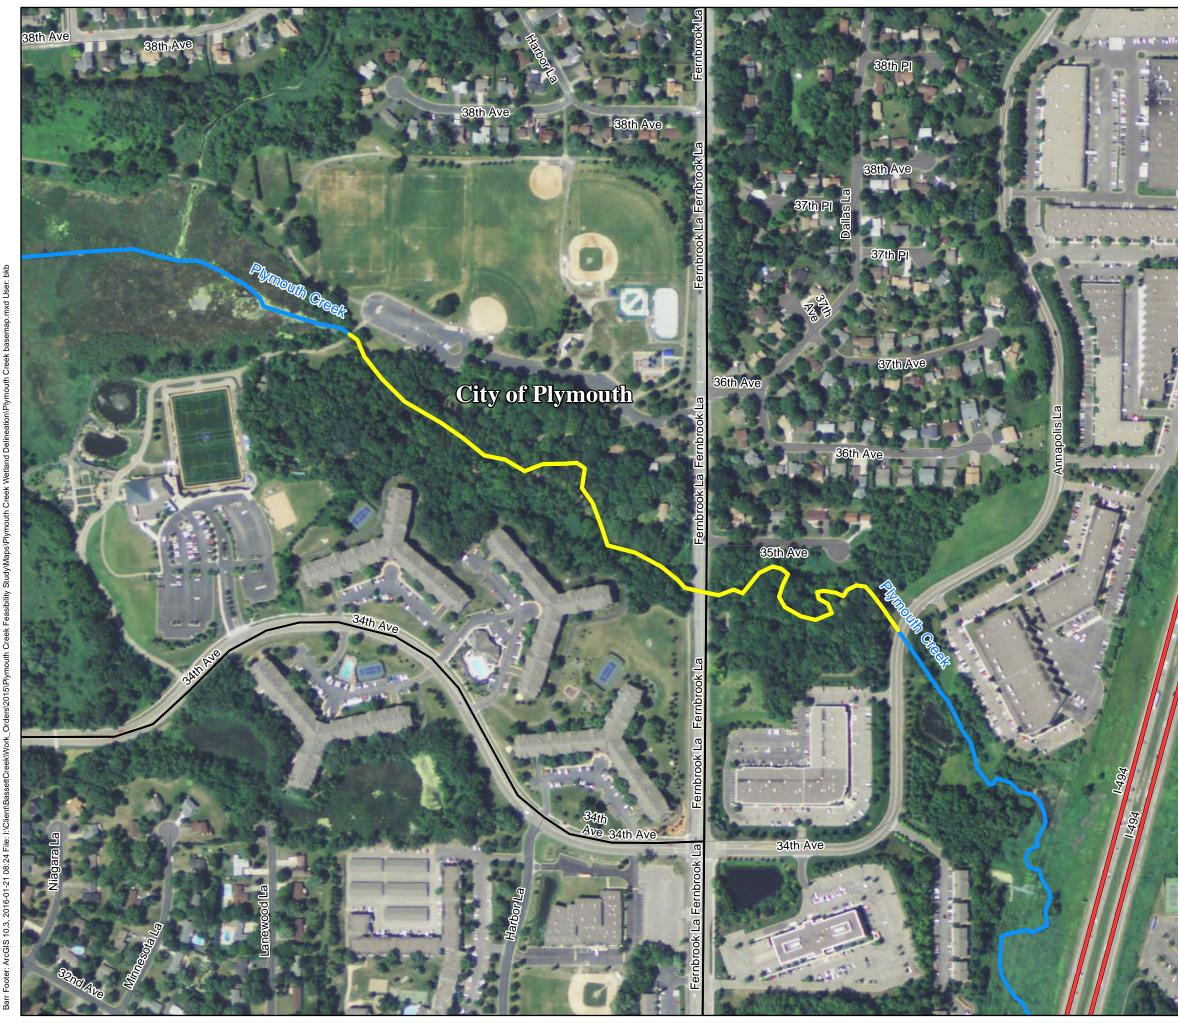
The project area has moderately undulating to flat topography throughout and in most areas along Plymouth creek there is an abrupt topographic break leading into the creek due to erosion. Topography surrounding the project area further away is relatively flat (**Figure 2**).

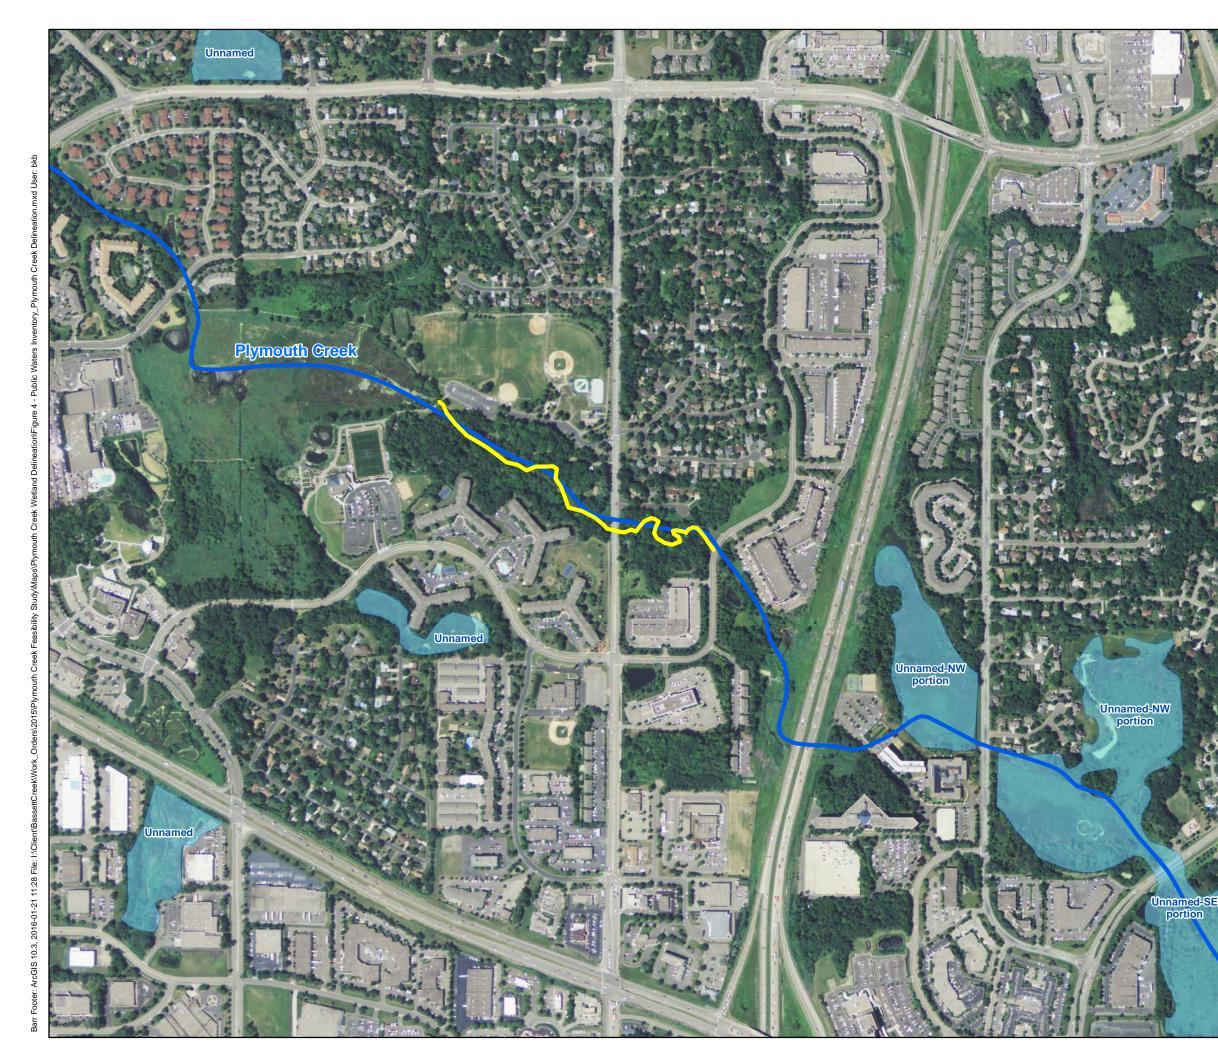
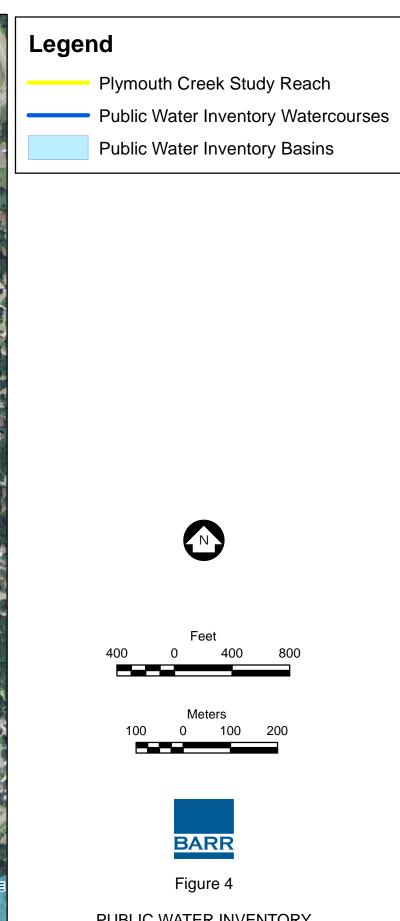
PUBLIC WATER INVENTORY Plymouth Creek Feasibility Study Wetland Delineation Bassett Creek Watershed Management Commission

The Minnesota Department of Natural Resources (MnDNR) Public Waters Inventory (PWI) has identified Plymouth Creek as a public water inventory watercourse (**Figure 4**). Reaches of Plymouth Creek located within the project area were delineated along with two wetland fringe areas. Plymouth Creek is not identified by the Minnesota Pollution Control Agency (MPCA) as an impaired water.

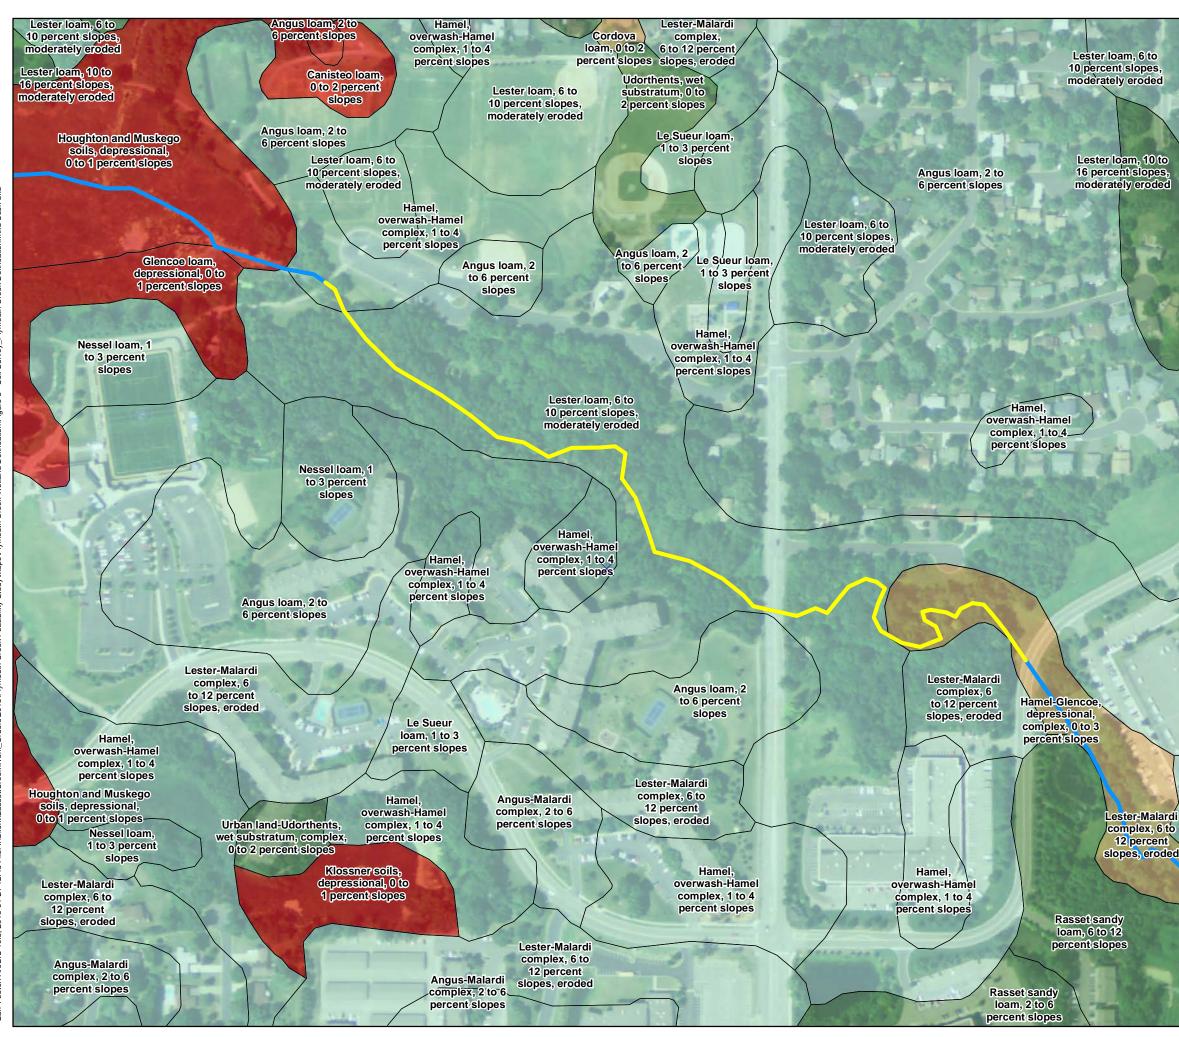
Soil information for the wetland evaluation area was obtained from the Soil Survey of Hennepin County, Minnesota (USDA, 1974). Three soil map units were identified within the project area along the Plymouth Creek reaches: Hamel overwash-Hamel complex, 1 to 4 percent slopes (L36A), Lester Ioam, 6 to 10 percent slopes, moderately eroded (L22C2) and Hamel-Glencoe depressional, complex, 0 to 3 percent slopes (L132A). The Hamel overwash-Hamel complex and Lester Ioam are mapped as predominately Non-Hydric. The Hamel-Glencoe depressional is mapped as predominately hydric (**Figure 5**).

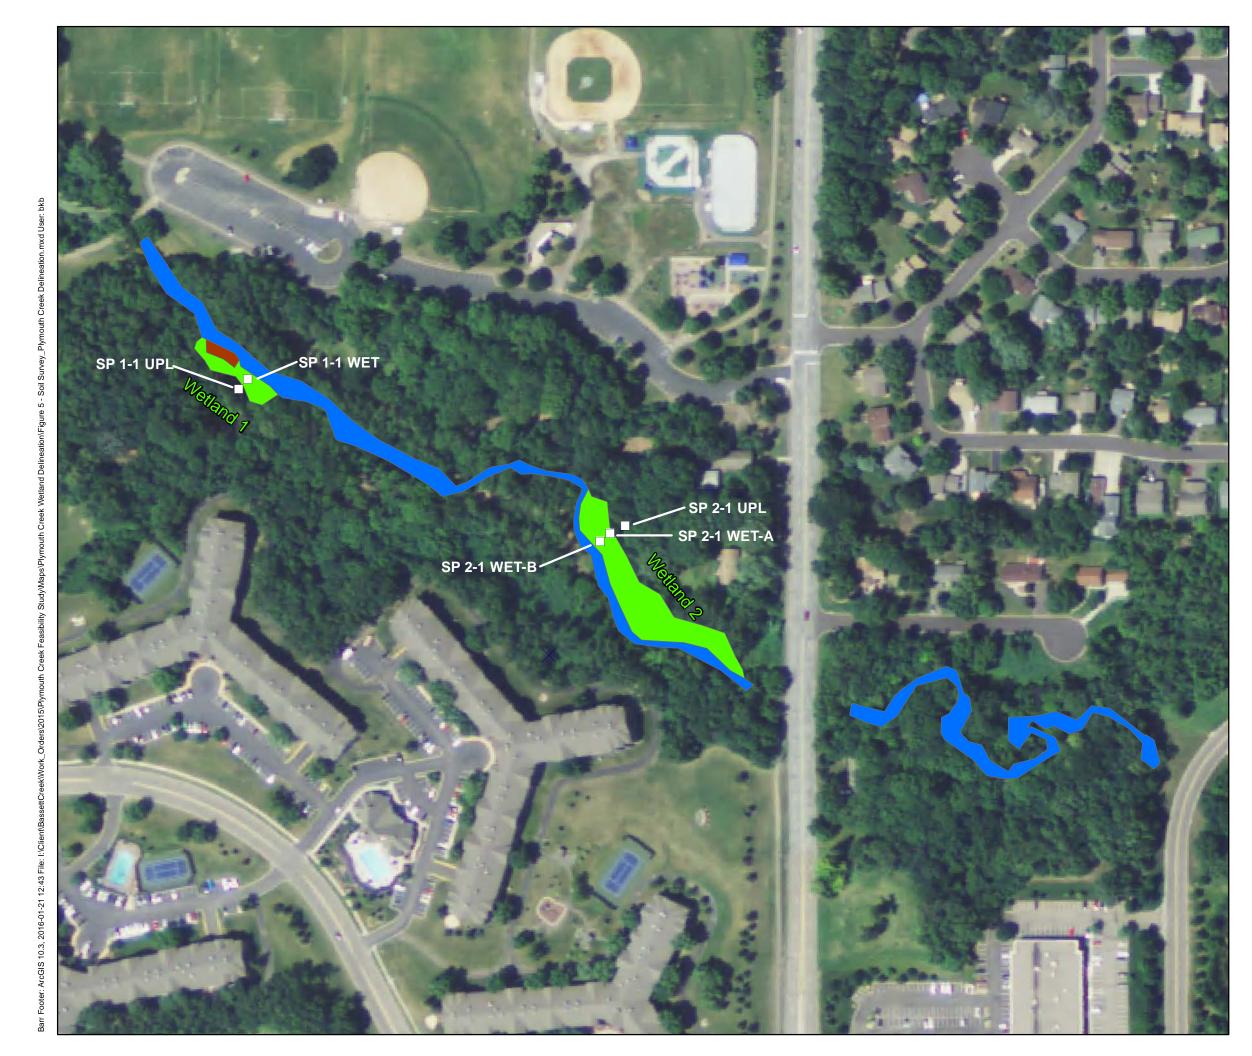
A field wetland delineation was conducted along the fringes of these stream reaches to include delineation of creek edges. Two wetland boundaries were delineated along the creek fringes and are depicted in **Figure 6**.

The delineated wetland boundaries and sample points were surveyed using a Global Positioning System (GPS) with sub-meter accuracy (**Figure 6**).

Wetland 1 is a Type 1 (PEMA), seasonally flooded basin within floodplain located on the right bank of Plymouth Creek within Plymouth Creek Park (**Figure 6**). The surrounding area has steep and abrupt slopes leading into Wetland 1. There is an upland island between Wetland 1 and Plymouth creek approximately 8 feet higher in elevation than the surface of the wetland. Flood waters may periodically enter the north end of Wetland 1 between the upland island and the adjacent forested uplands to the south, which flow through and back to Plymouth Creek further downstream.
