Feasibility Report for Plymouth Creek Restoration Project

Plymouth, Minnesota

Prepared for
Bassett Creek Watershed Management Commission

March 2016

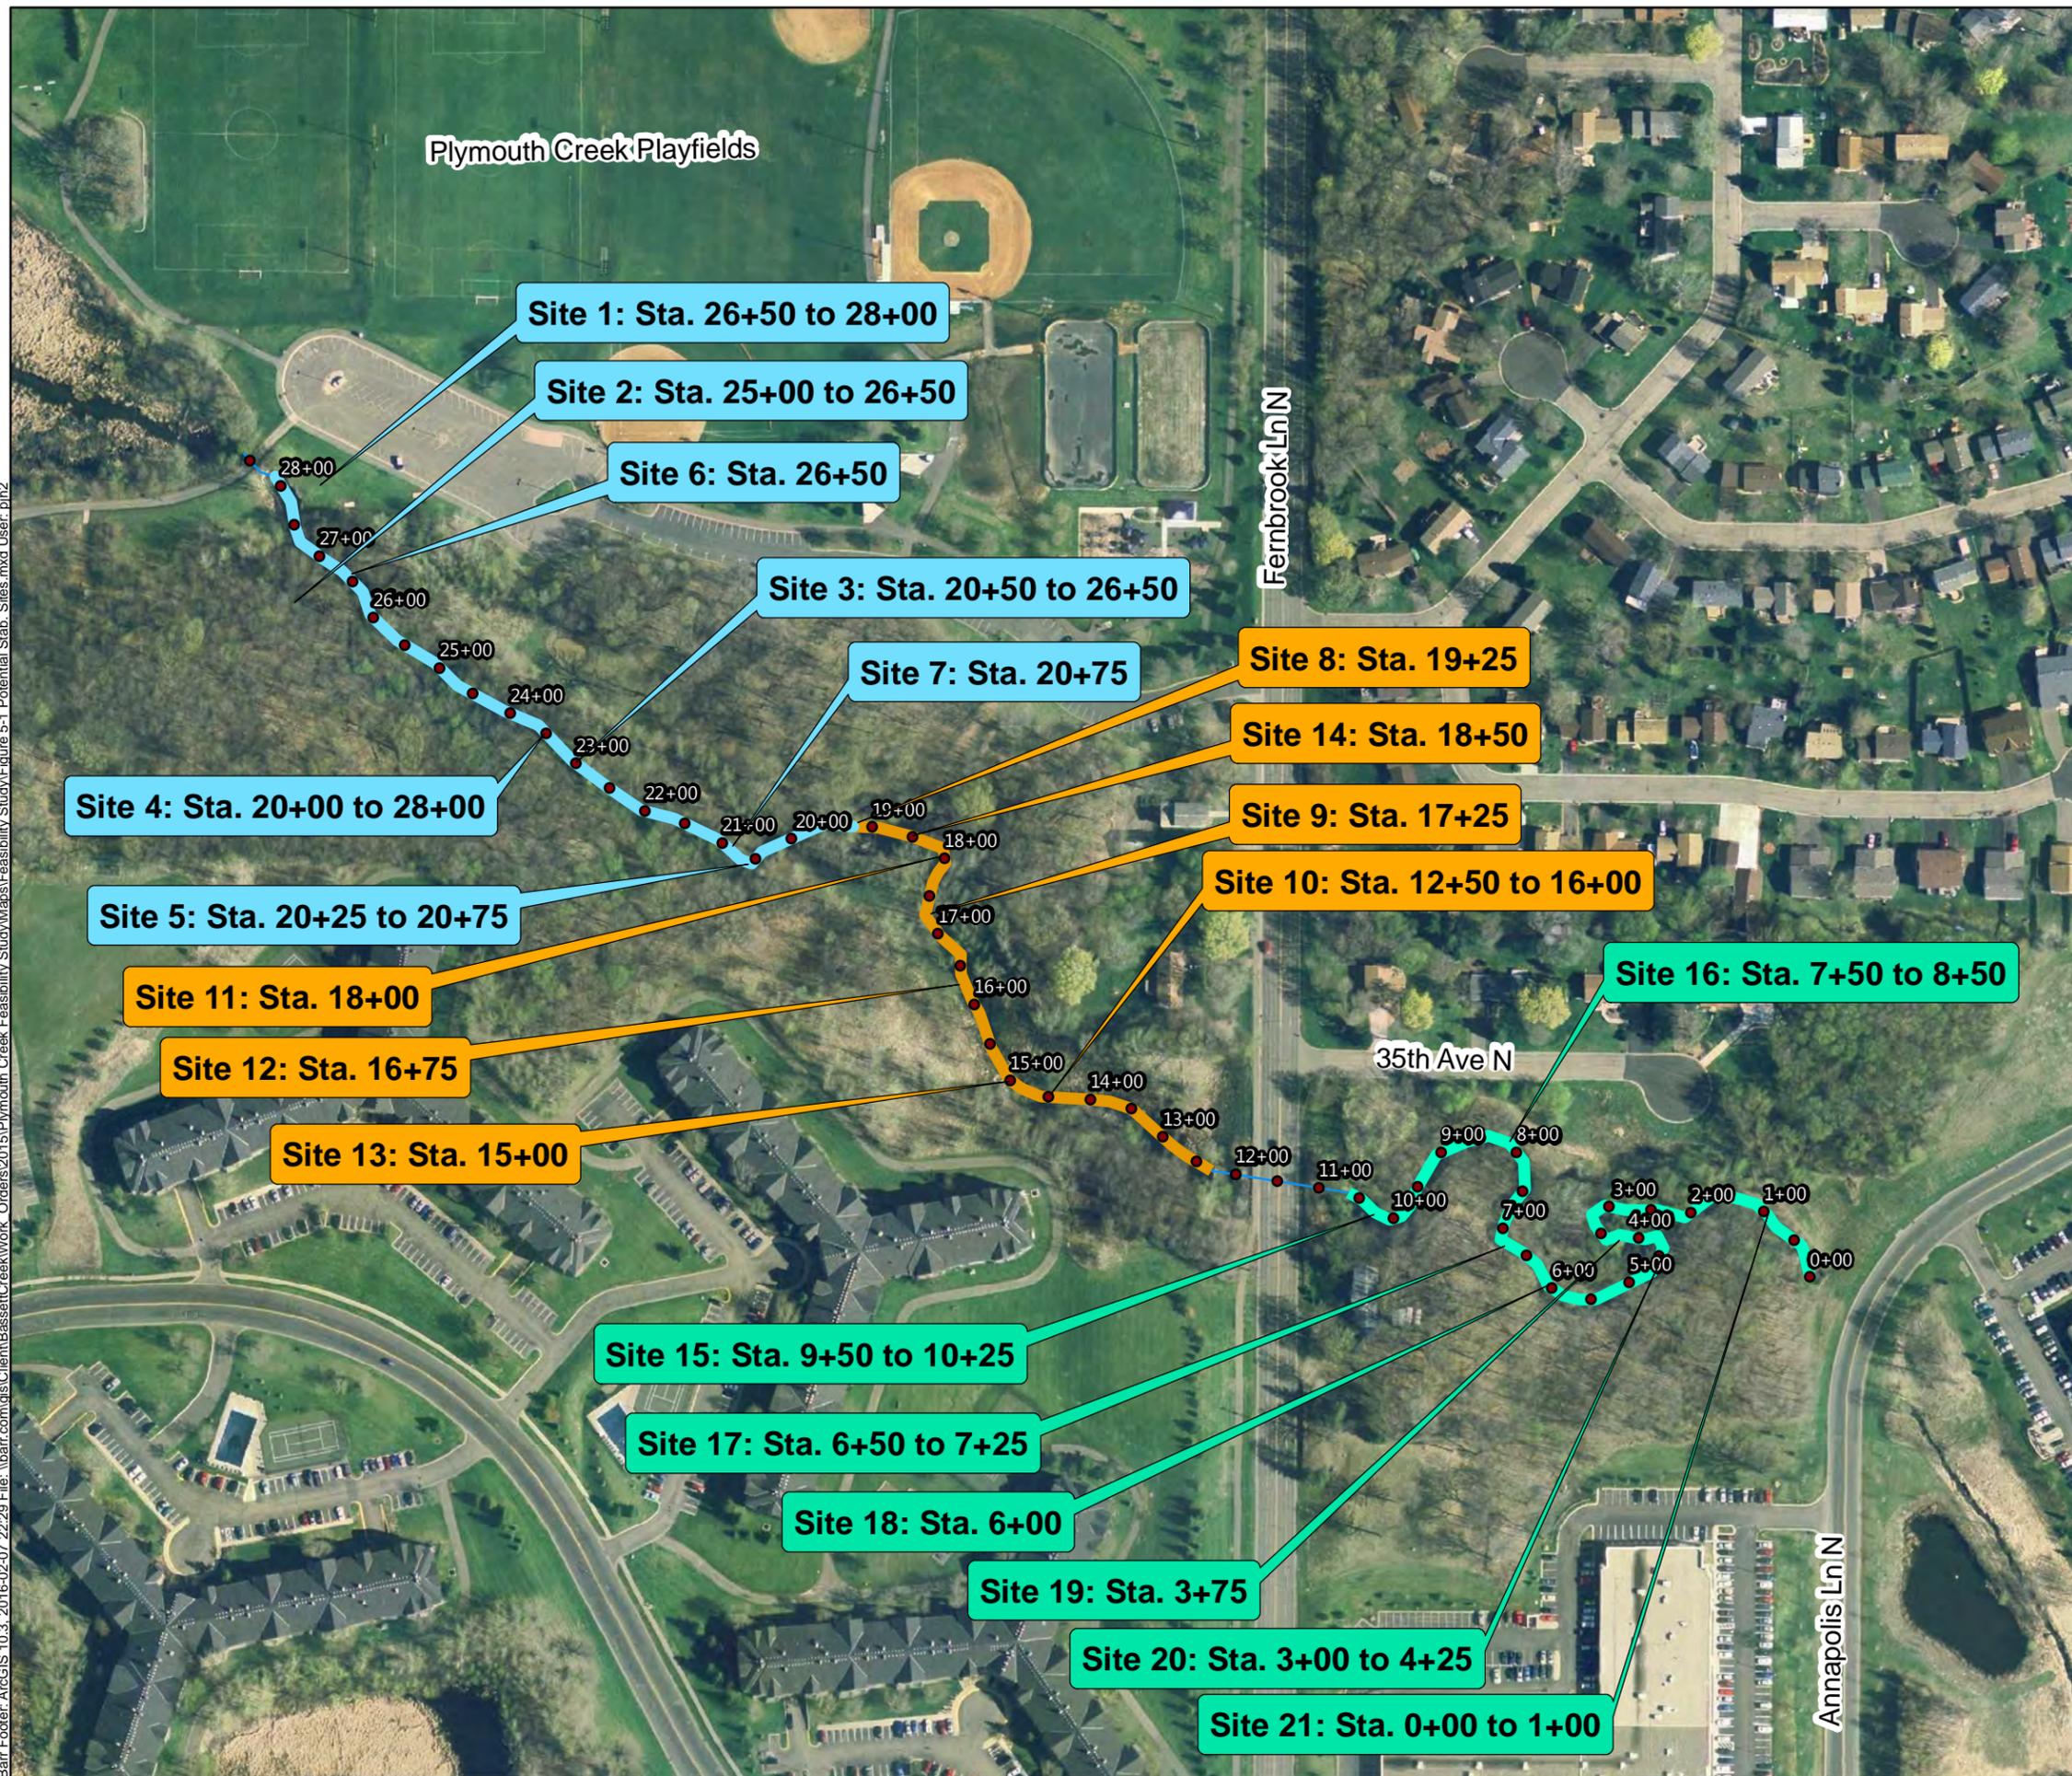
The following discussion is organized by location within each reach, referred to as “stabilization sites.” The stabilization sites for the entire project area are shown in Figure 5-1. Stabilization sites within each reach with similar characteristics and stabilization alternatives are discussed together in the following sections. Recommended stabilization alternatives for each reach are shown in Figure 5-2 (Reach 1), Figure 5-3 (Reach 2), and Figure 5-4 (Reach 3). Complete discussion of the stabilization alternatives considered for each site is included in Appendix G.

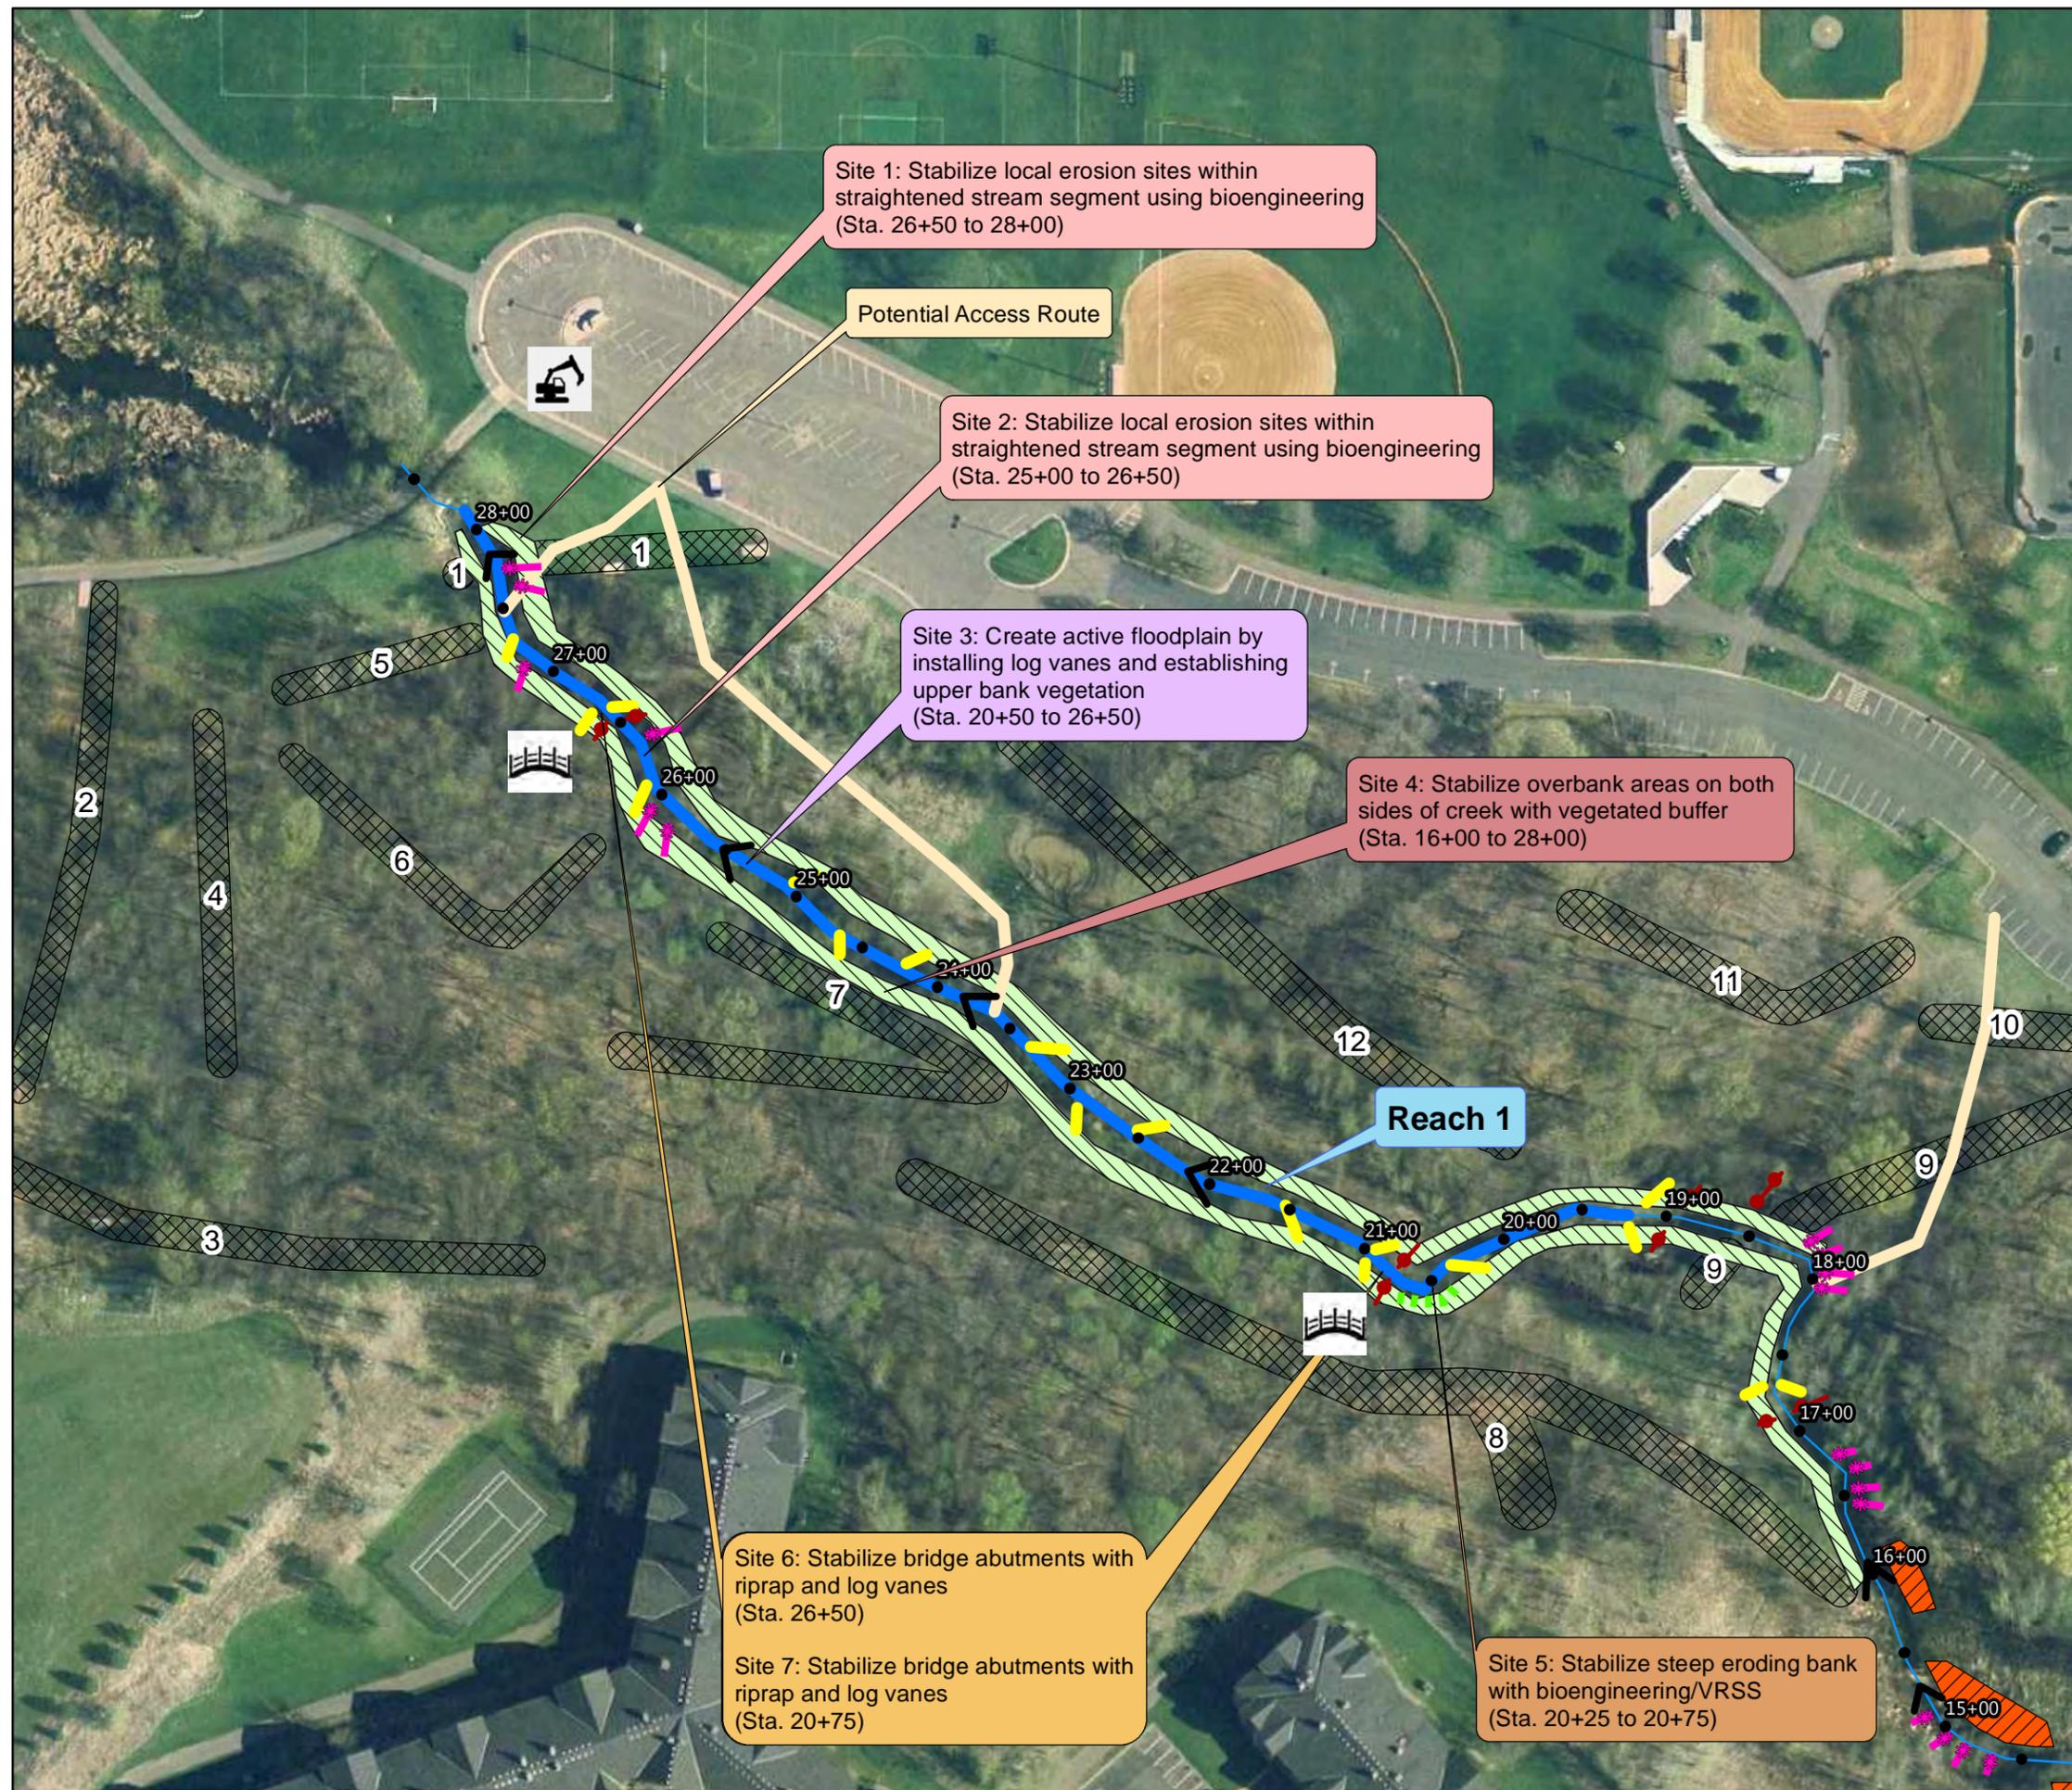
Figure 5-2
 PLYMOUTH CREEK REACH 1
 RECOMMENDED ALTERNATIVES
 Plymouth Creek Feasibility Study
 Bassett Creek Watershed
 Management Commission

Recommended alternative summary (Alternatives 1C and 2C): Install root wads and log vanes to stabilize eroding areas. Use log vanes to reshape the channel bottom and narrow the low-flow channel while maintaining the overall channel cross section. Establish vegetation on bare banks.

Recommended alternative summary (Alternatives 3B and 3C): Install log vanes and reshape the channel bottom to narrow the low-flow channel while maintaining the overall channel cross section. Use one or more log cross vanes to provide grade control and prevent downcutting. Vegetate existing bare upper banks above the bankfull flow elevation with shade-tolerant trees, shrubs, and seed mixes. This alternative will benefit from a project-wide plan to establish vegetation while managing foot traffic from the disc golf course.

The recommended stabilization measures include a combination of bioengineering and hard armoring techniques and are discussed in Section 5.2 and shown in Figure 5-2, Figure 5-3, and Figure 5-4.

Site 3 consists of an over-widened stream channel with a small active floodplain. It extends from Station 20+50 to 26+50, as shown on Figure 5-2. There are many areas where sediment is being deposited near the banks and the channel is beginning to narrow. Due to the wide channel bottom, water depth is very low during low-flow conditions, resulting in poor aquatic habitat. The channel banks are bare and the dense tree canopy overhead creates consistent shade along the stream channel.

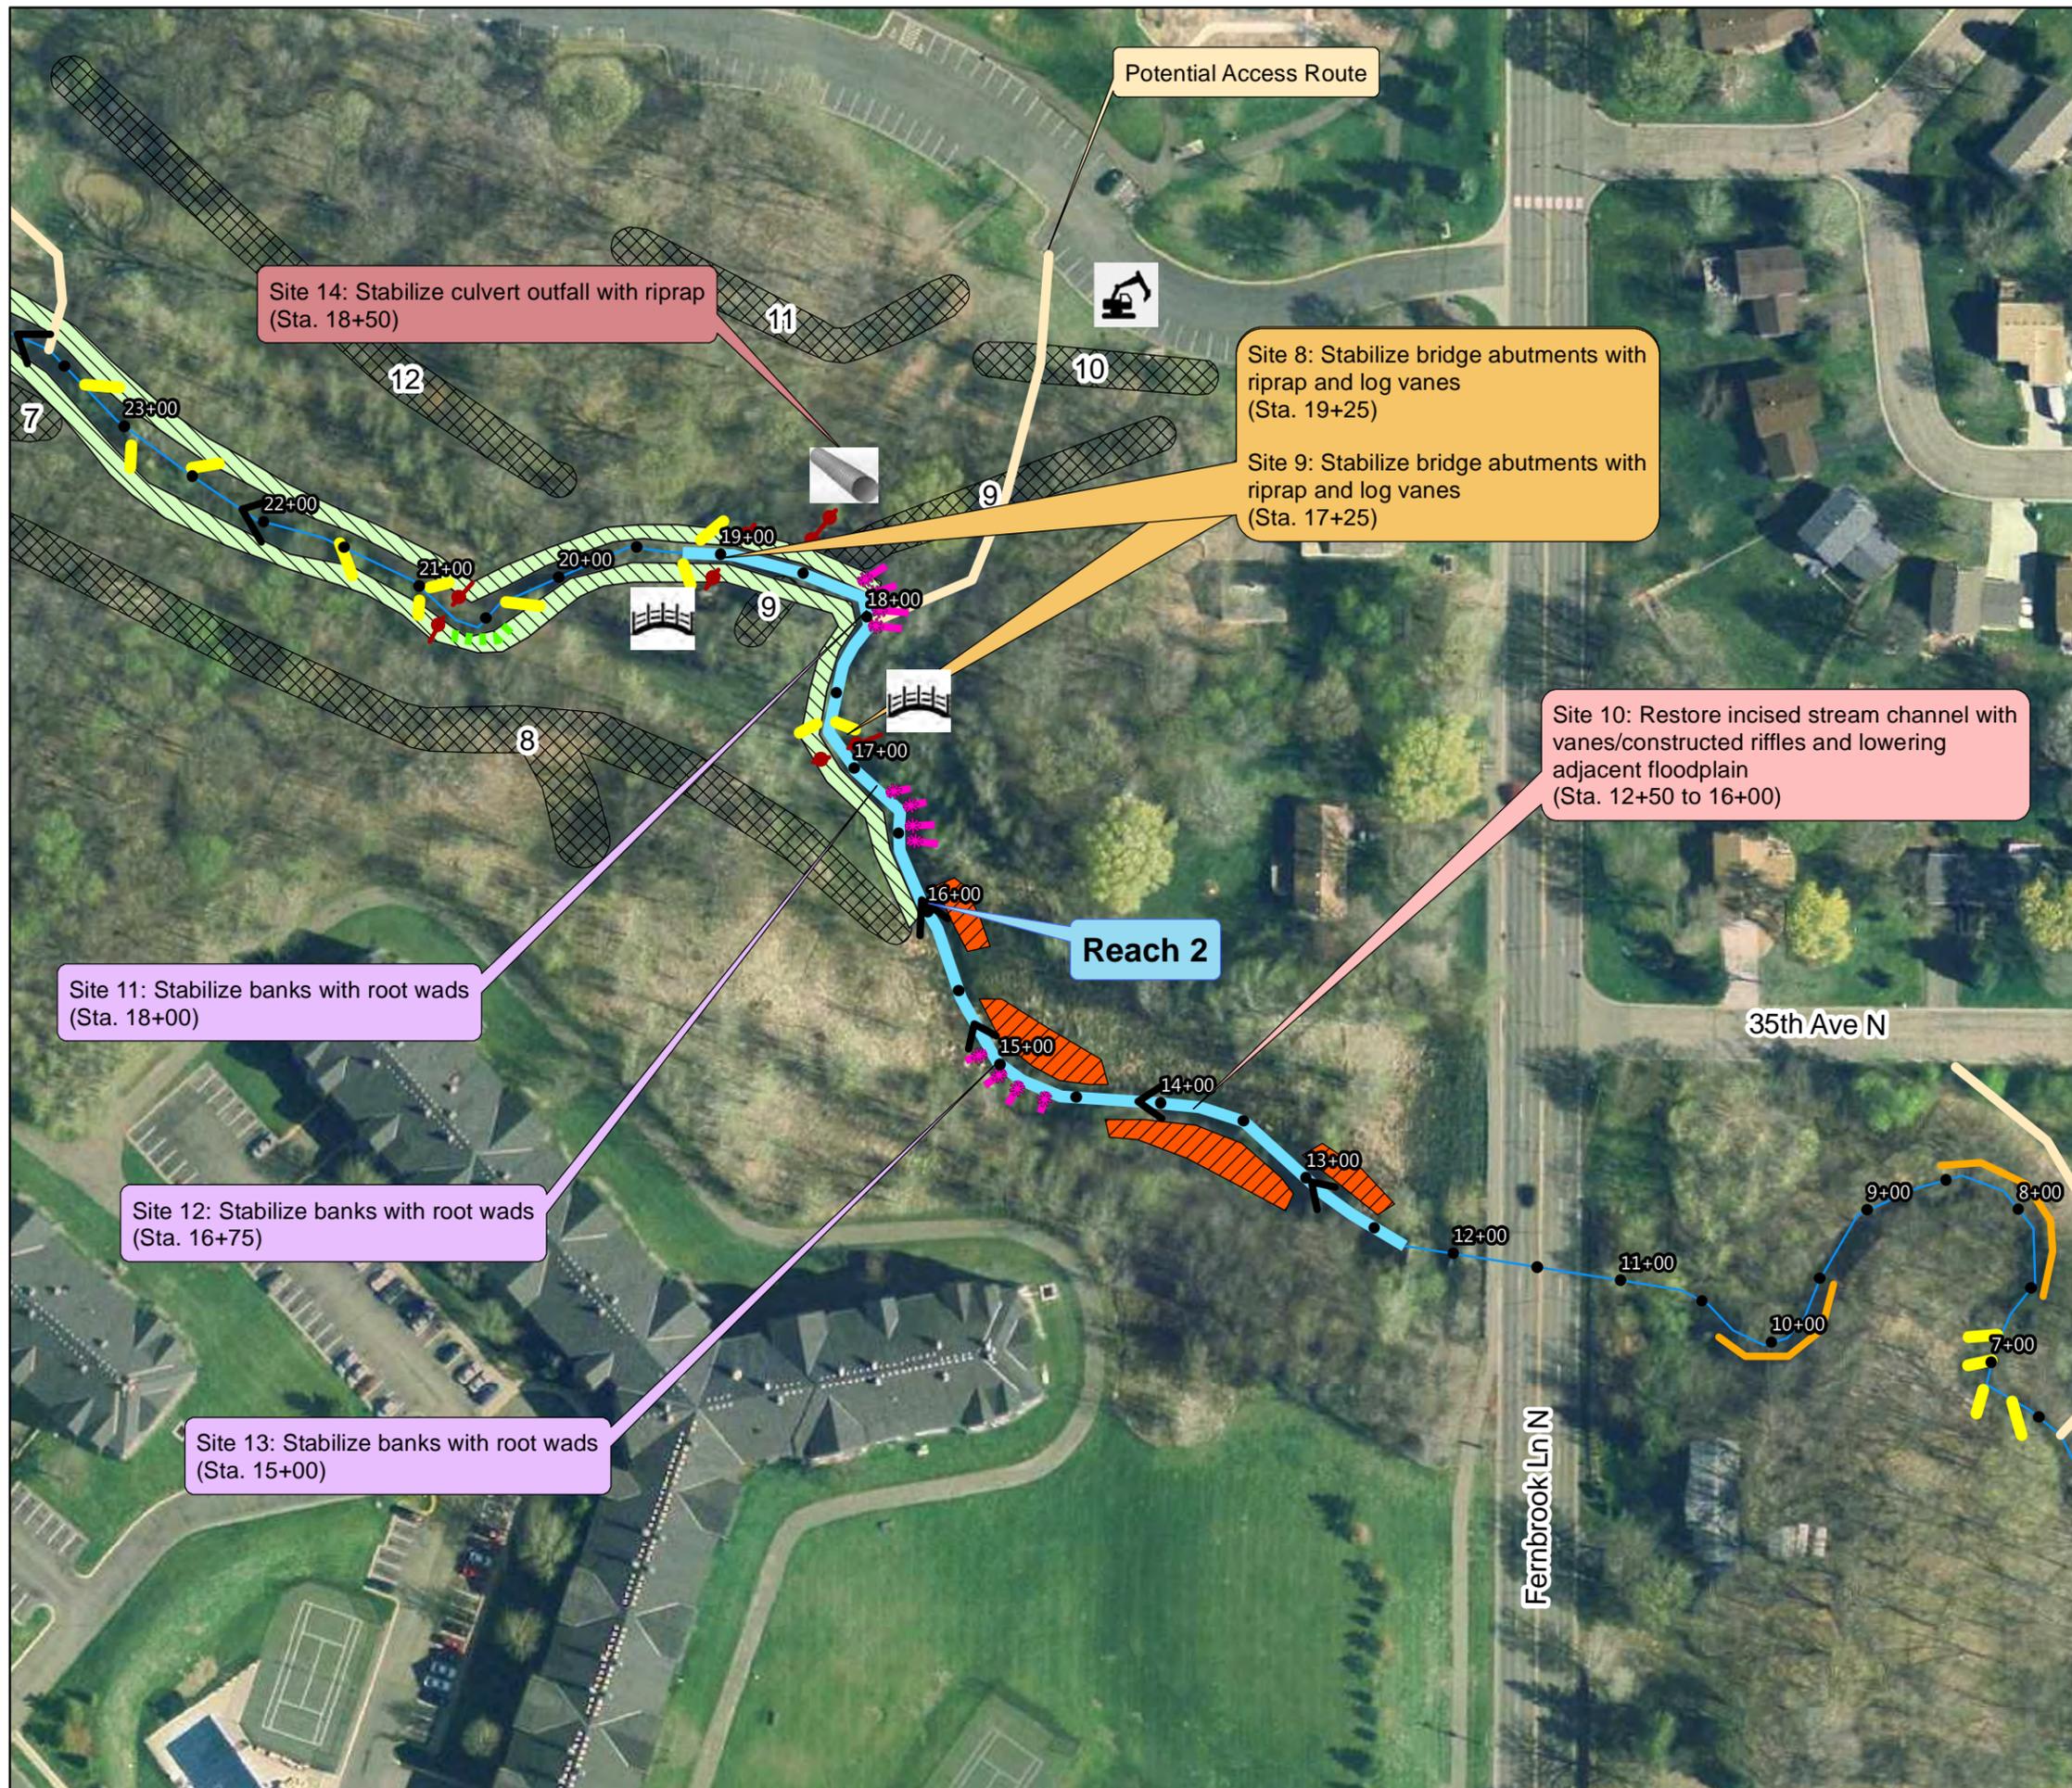
Figure 5-3

Recommended alternative summary (Alternatives 10C and 10D): Raise the channel bed elevation with boulder cross vanes or constructed riffles to act as localized grade control and improve connectivity of flood flows with the floodplain. Lower portions of the floodplain adjacent to the stream channel as needed to improve connectivity of flood flows with the floodplain and maintain the existing flood profile.

PLYMOUTH CREEK REACH 2
 RECOMMENDED ALTERNATIVES
 Plymouth Creek Feasibility Study
 Bassett Creek Watershed
 Management Commission

Site 10 includes much of the stream channel located in the downstream half of Reach 2 (see Figure 5-3). The stream bed in this section appears to be mildly incised, resulting in limited access to the floodplain. Incised streams often have greater-than-average erosion; unlike streams that are well-connected to the floodplain, they do not effectively transfer flood energy. The excess energy causes bank erosion, suggesting the erosion at this site may continue to worsen. If the channel incision migrates upstream, additional banks and lengths of stream may be more prone to erosion.

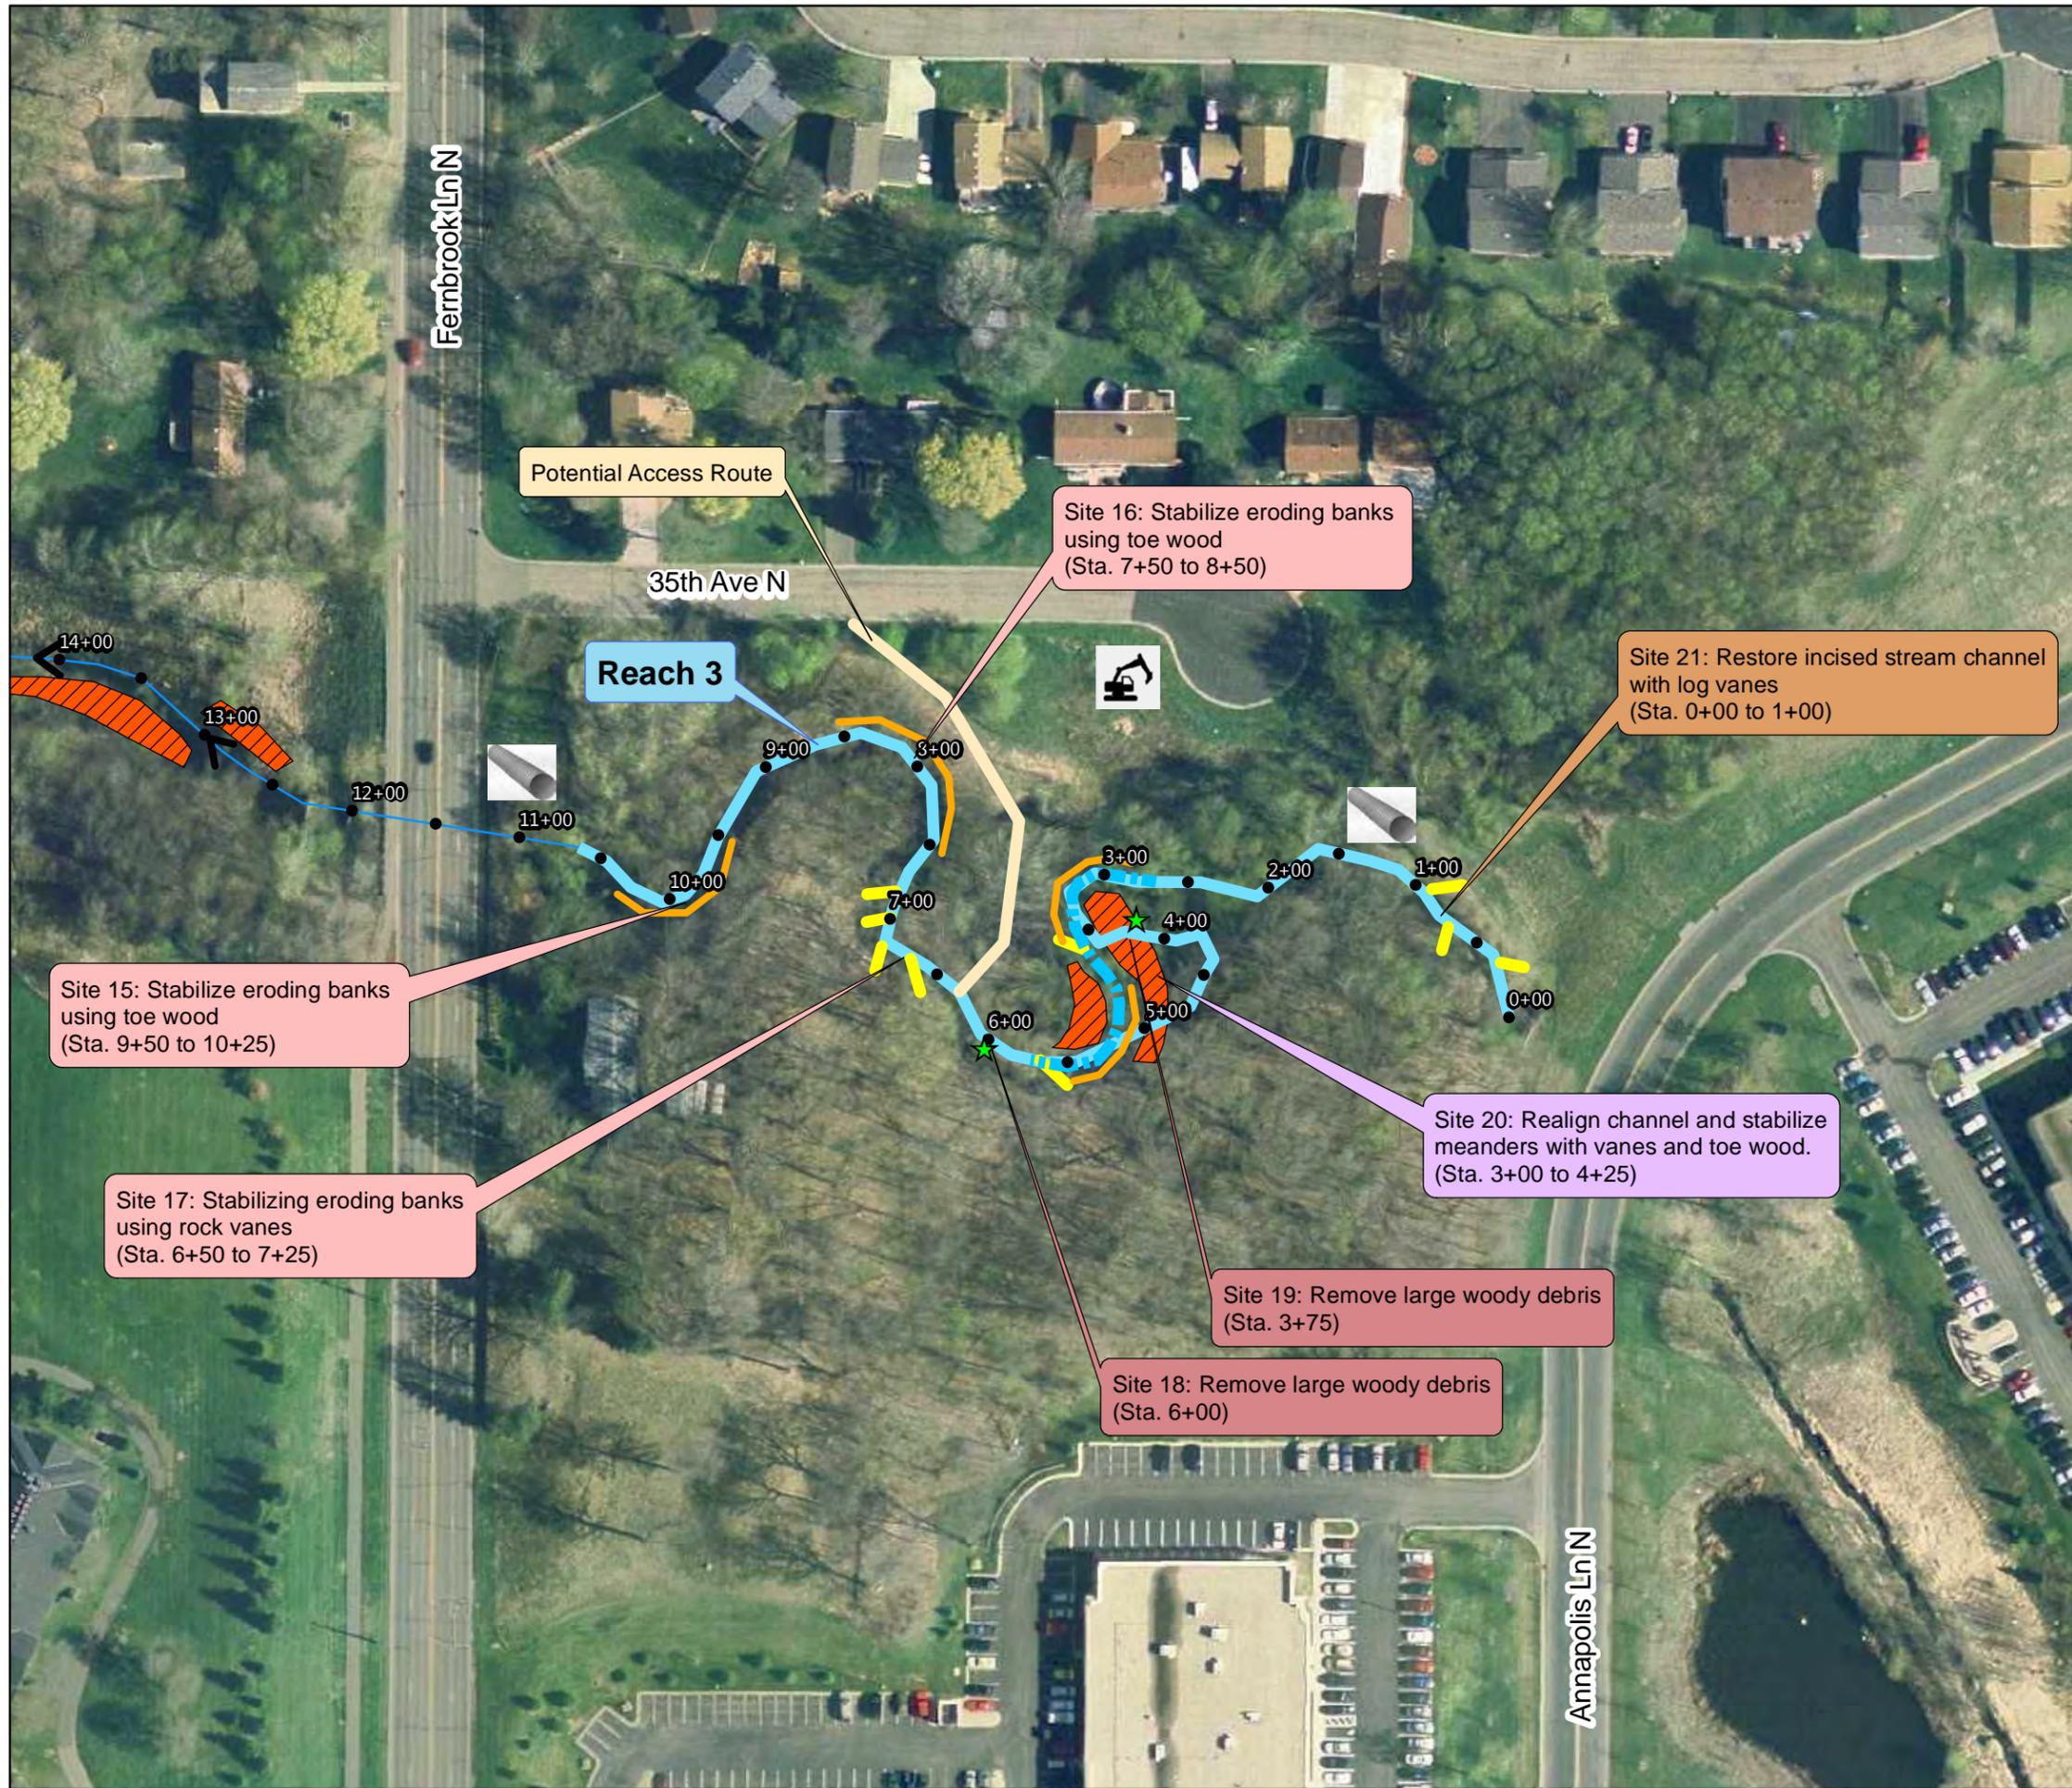
Figure 5-4
PLYMOUTH CREEK REACH 3
RECOMMENDED ALTERNATIVES
 Plymouth Creek Feasibility Study
 Bassett Creek Watershed
 Management Commission

Recommended alternative summary (Alternatives 15C, 16C, and 17B): Install toe wood (root wads and large woody debris) around the first two eroding bends (Sites 15 and 16) to increase roughness of the lower banks and establish a vegetated bench at the toe of the high, eroding banks. Install boulder or log vanes around the third eroding bend (Site 17) to direct flow to the center of the stream.

Recommended alternative summary (Alternatives 18A and 19A): Remove existing large woody debris from the stream.

Recommended alternative summary (Alternative 20D): Change the stream channel alignment upstream of the cutoff and the tight meanders (from approximately Station 3+00 to 6+25) to create meanders with stable curvature. Install toe wood (root wads and large woody debris) around the eroding bends (Station 3+00 to 3+50 and 4+00 to 4+50) and boulder or log vanes to increase roughness of the lower banks and establish a vegetated bench at the toe of the high, eroding banks.

Recommended alternative summary (Alternative 21B): Install log vanes and reshape the channel bottom to narrow the low-flow channel while maintaining the overall channel cross section.

Steep eroding banks are present in three locations within Reach 3, as shown on Figure 5-4. In these locations, the bend radius is not overly tight, but the stream channel is cutting into high valley walls, causing bank failures, and undercutting trees.

Large woody debris is present in two primary locations within the stream (see Figure 5-4). The debris causes jams within the stream—redirecting flow towards the banks, which causes bank erosion.

Similar to Site 3 in Reach 1, Site 21 consists of an over-widened stream channel without an active floodplain (see Figure 5-4).
