***Feasibility Report for
Plymouth Creek Restoration Project***

Plymouth, Minnesota

***Prepared for
Bassett Creek Watershed Management Commission***

July 2009

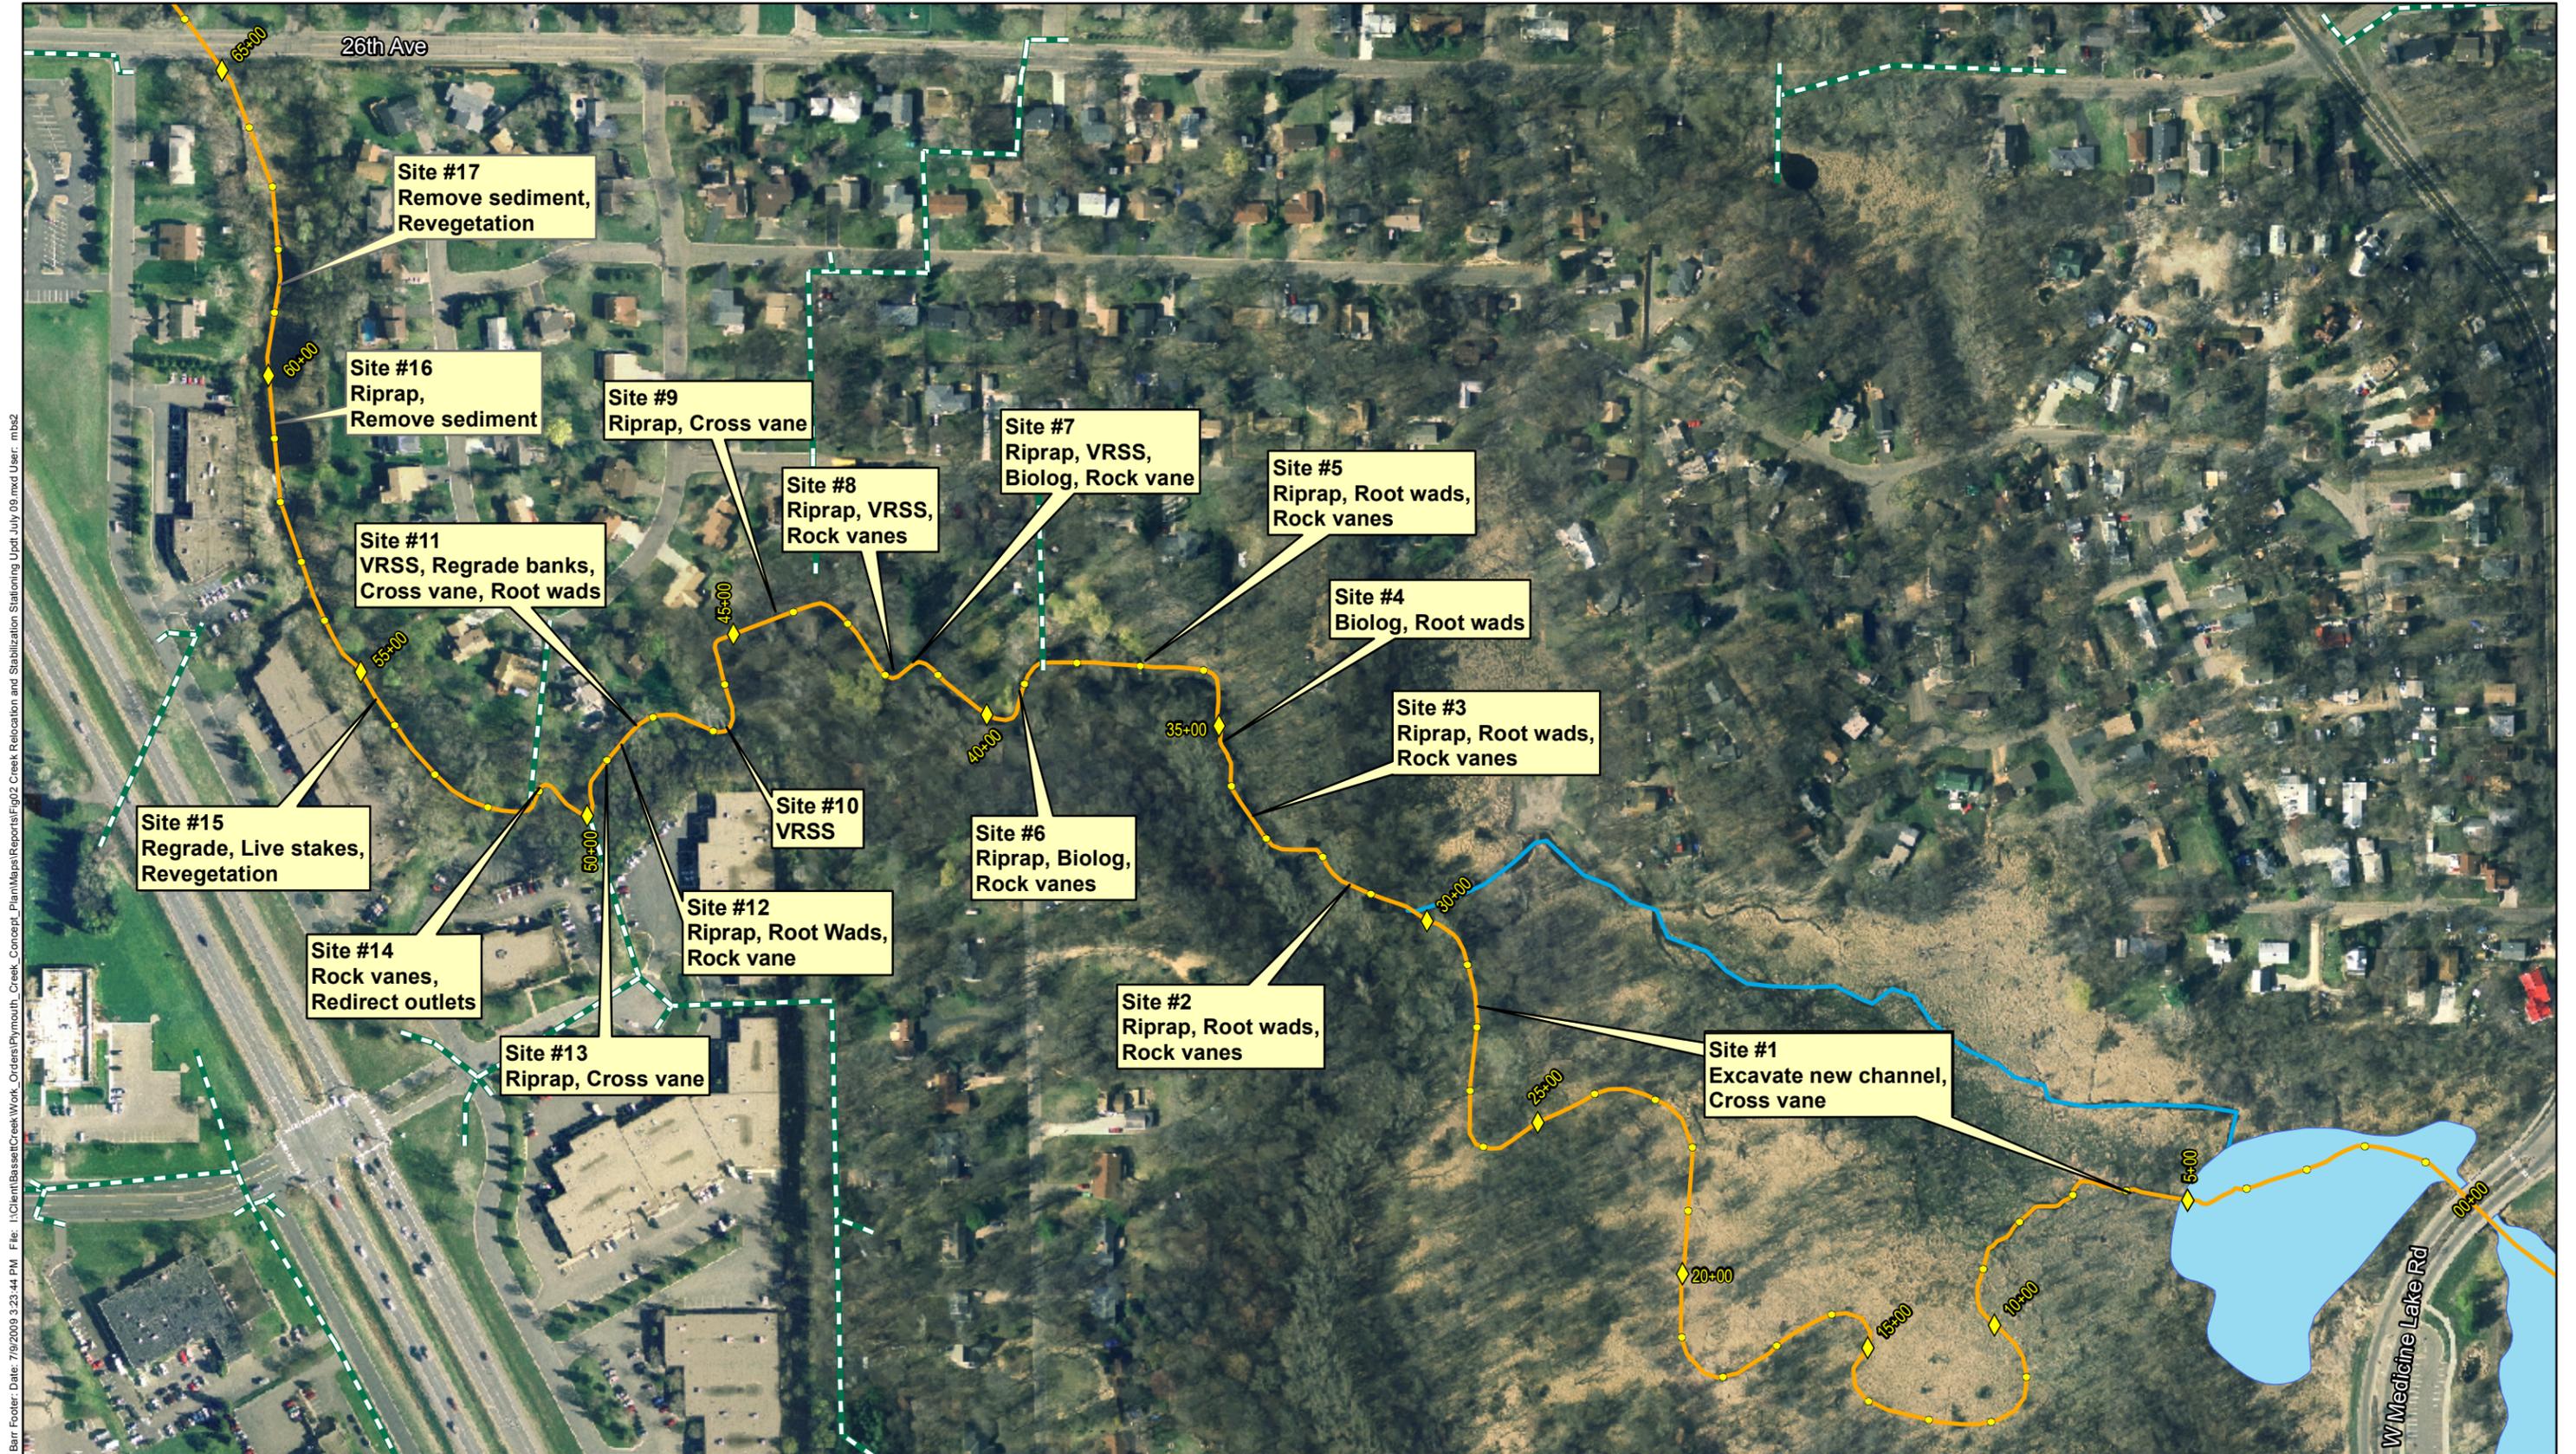
- Station
- Storm Sewer
- Extent of Channel to be Restored and Relocated
- Existing Creek Alignment
- Proposed Pond Extent

The estimated construction cost for the Plymouth Creek Restoration Project is \$845,200. Assuming an additional \$120,000 for construction easements brings the total estimated project cost to \$965,200. This cost assumes wetland mitigation is not necessary; however, if wetland mitigation is required under WCA for the stream channel realignment, up to 1.7 acres of wetland mitigation may be needed (assuming 1:1 replacement). The mitigation costs for 1.7 acres of wetland are estimated at \$50,000 per acre of new wetland totaling \$75,000 – \$100,000 in additional project construction and related costs. A feasibility-level cost estimate for the project construction is included in **Table 3**. **Figure 2** shows the corresponding site numbers and stationing referenced in **Table 3**.

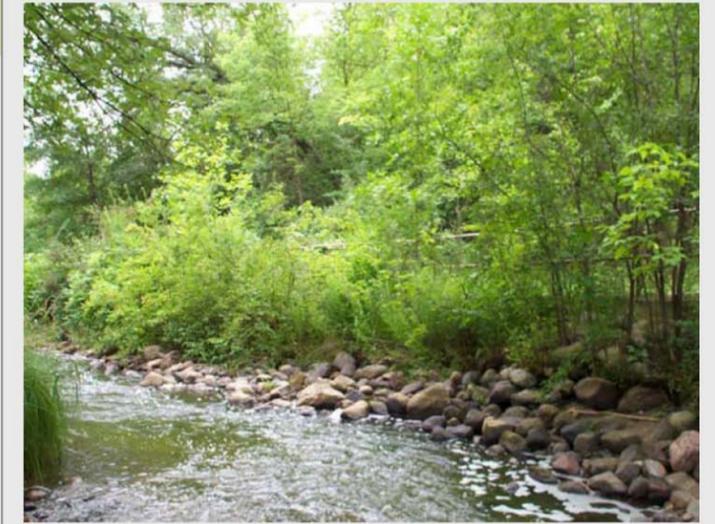
Stone toe protection has been used extensively in Nine Mile Creek's Lower Valley, in conjunction with deflector dikes, grade control measures and stabilization of large bank failures. Following the 1987 "super storm," the proposed design allowed the stream to continue its course while taking measures to protect areas where water flow was eroding valley walls. The resulting measures have stabilized the stream channel and valley walls while blending seamlessly with the natural environment.

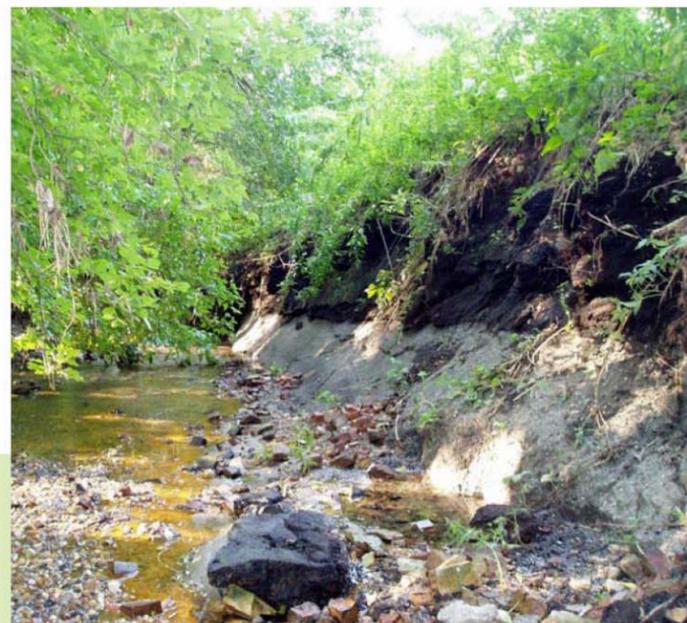
Fluvial bank erosion is caused by water in the stream moving past the streambanks. The shear stress caused by the flow entrains soil particles into the flow, causing the stream bank to erode away. This is the most common type of erosion that occurs in streams. Virtually all streams experience this type of erosion as their flow path evolves over time. However, the rate of fluvial bank erosion can increase when the stream is out of equilibrium with its watershed. Increased flow from a watershed will increase the rate of fluvial bank erosion. In many cases, it appears to be a part of the natural process of stream evolution. In places where the channel is confined by the valley walls, however, fluvial bank erosion can lead to failure of the high banks. It can also undermine storm sewer inlets.

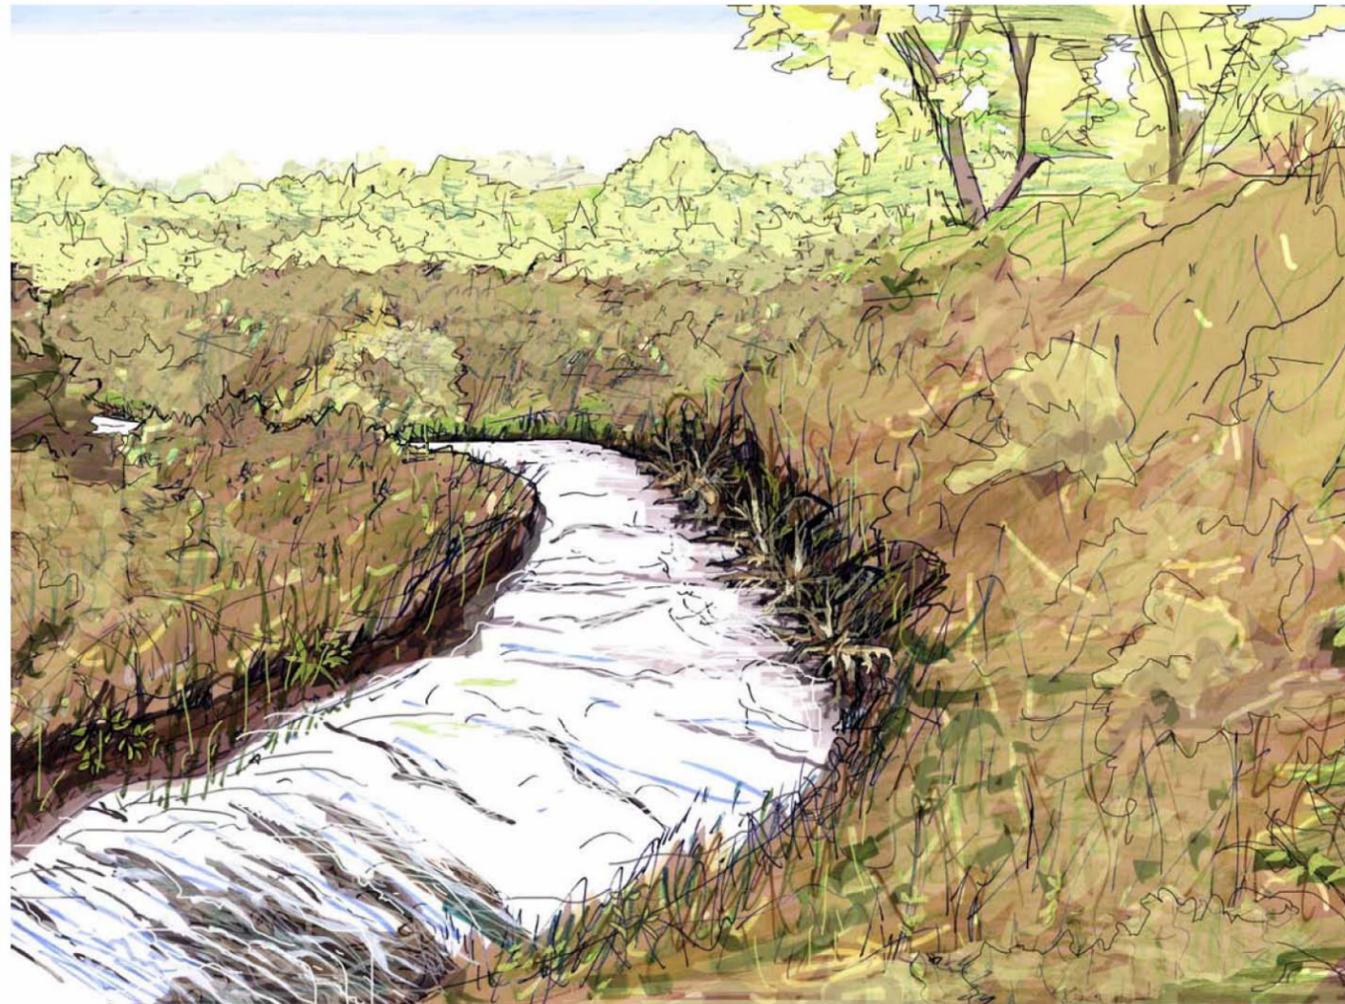
Figure 3

Riprap is used along the creek edge to protect the toe of the stream bank. In stream systems, riprap typically consists of cobble-sized rock (six inches to 12 inches in diameter). The riprap is keyed in to the streambed and extends up the bank to approximately the bankfull level. The bankfull level is the elevation of the water in the channel during a 1.5-year event. In some areas, this level may be below the top of the stream bank. Also called stone toe protection, riprap is typically used in conjunction with revegetation of the upper banks to provide full bank protection. Riprap is especially effective in heavily shaded areas, where it is difficult to establish vegetation. **Figure 3** illustrates this practice.

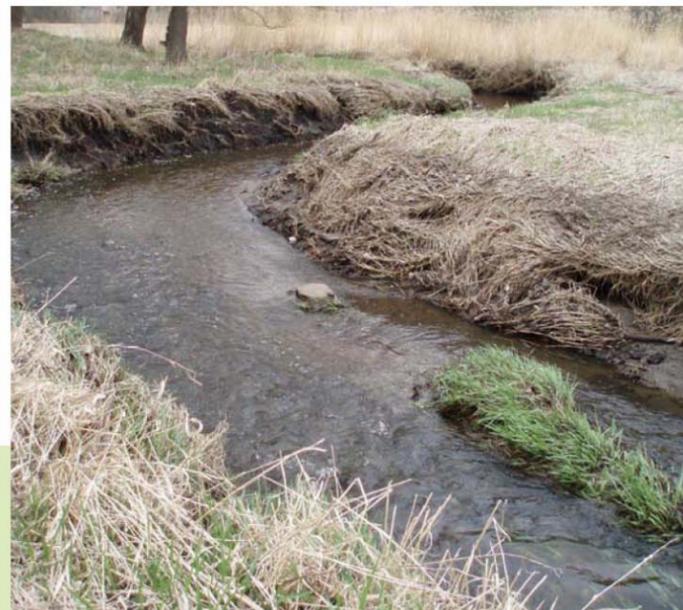
Fluvial bank erosion is caused by water in the stream moving past the streambanks. The shear stress caused by the flow entrains soil particles into the flow, causing the stream bank to erode away. This is the most common type of erosion that occurs in streams. Virtually all streams experience this type of erosion as their flow path evolves over time. However, the rate of fluvial bank erosion can increase when the stream is out of equilibrium with its watershed. Increased flow from a watershed will increase the rate of fluvial bank erosion. In many cases, it appears to be a part of the natural process of stream evolution. In places where the channel is confined by the valley walls, however, fluvial bank erosion can lead to failure of the high banks. It can also undermine storm sewer inlets.

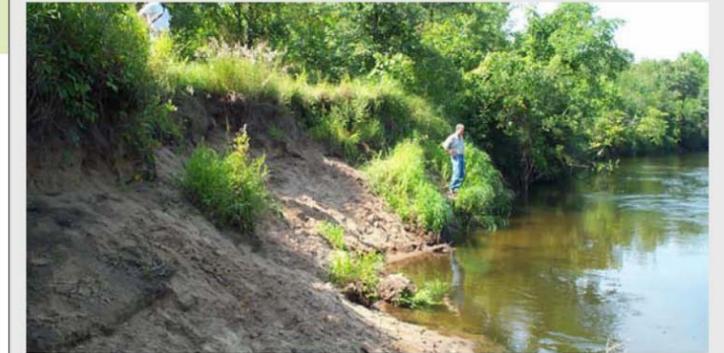
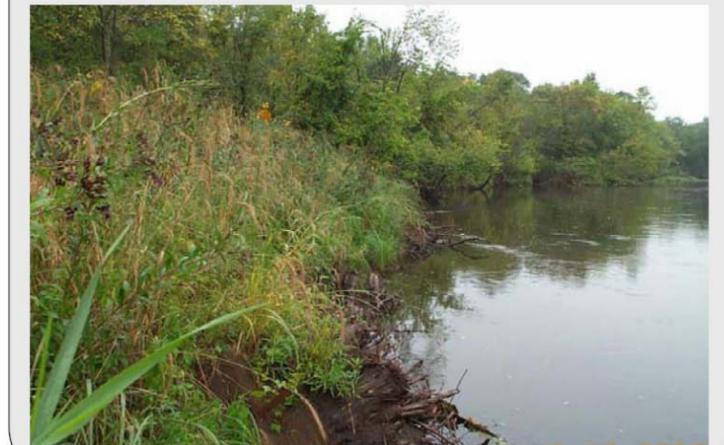
Root wads were used to stabilize two sites on the Rum River in Anoka, Minnesota, where severe bank erosion threatened to destroy adjacent trails. Approximately six root wads were placed at each site under difficult, high-water conditions. The banks were then graded, topsoil was added, and native vegetation was planted. Despite the difficult placement, the root wads have protected the lower bank, allowing the vegetation to become well established.

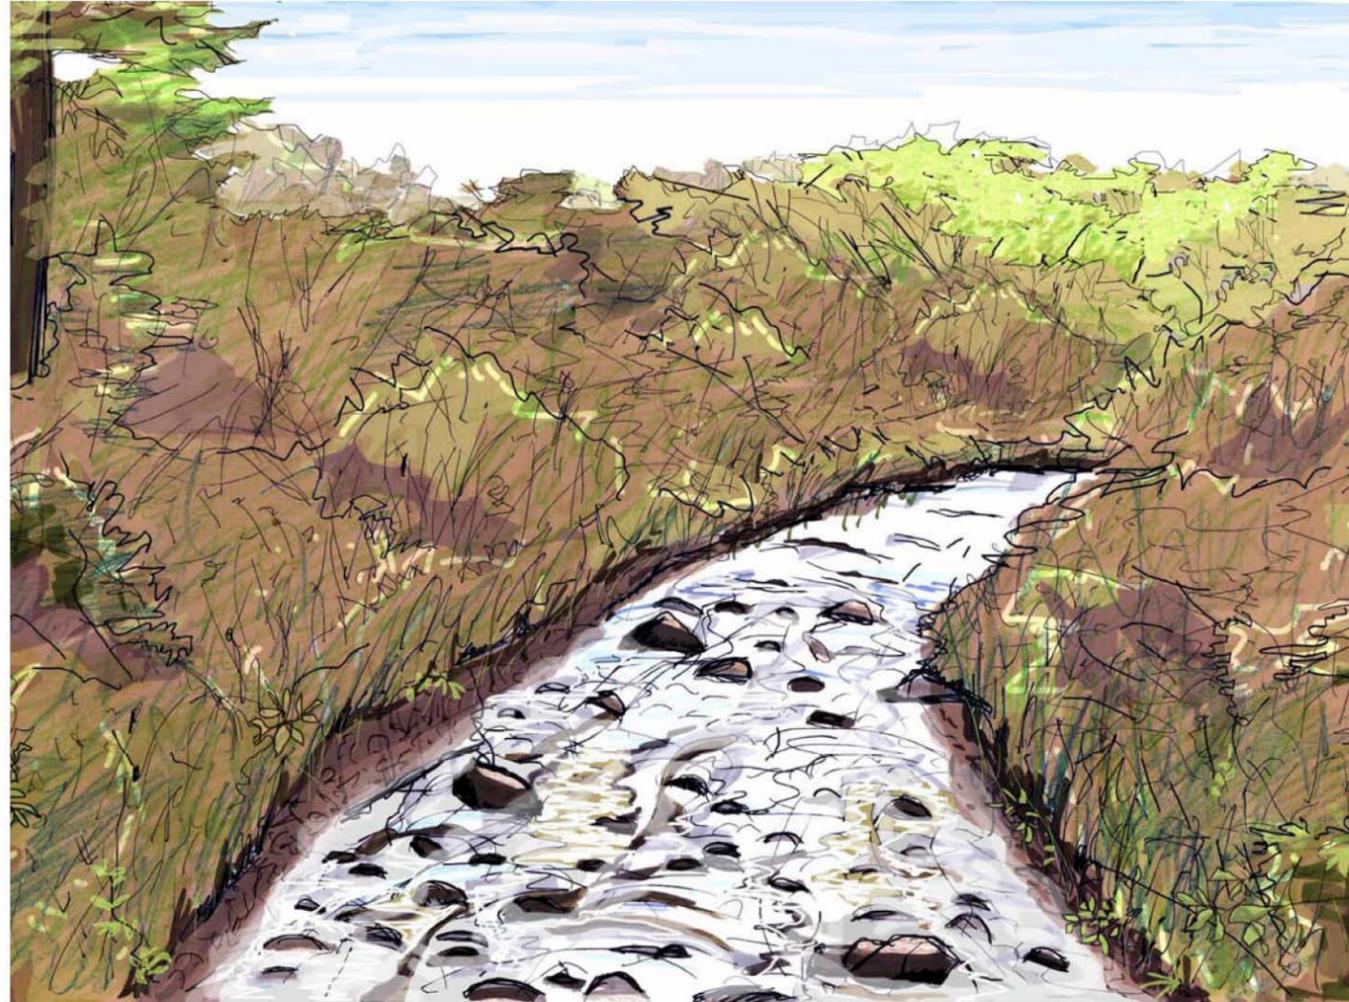
Figure 5
Biologs Bank Protection
Plymouth Creek Restoration Project
Bassett Creek Watershed Management Commission

the stream bank slope above the biolog will be performed to achieve a more stable slope (2:1 to 3:1). **Figure 5** illustrates this practice.

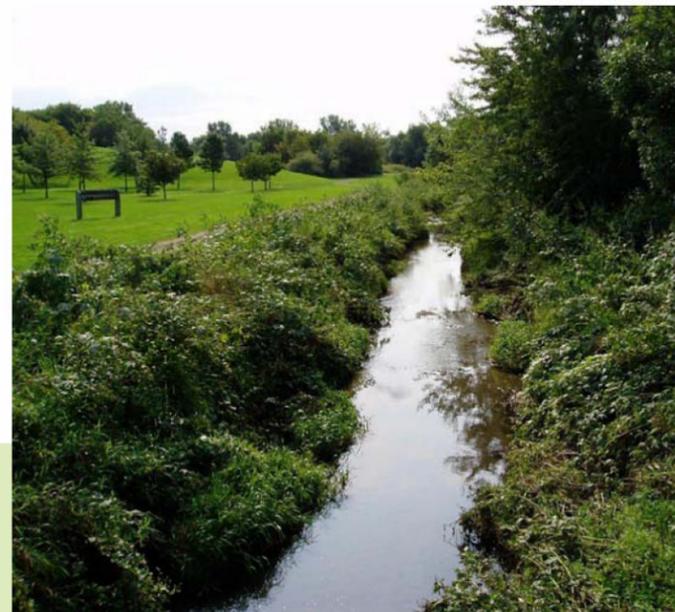
Channel incision occurs when there is an imbalance between the sediment supply and the sediment carrying capacity of the stream. Erosion will occur when the sediment carrying capacity of a stream exceeds the sediment supply. In streams with cohesive banks and steep channel slope, the erosion will first occur primarily on the channel bottom because that is where the erosive forces are the strongest. As the channel deepens, the stream will gradually become wider as the banks eventually fail. The stream will gradually return to equilibrium; however, the process can take many years and significant amounts of erosion will occur during the process.

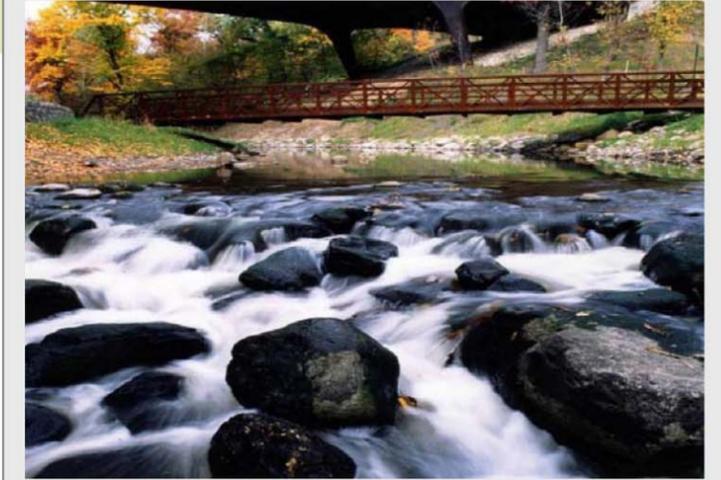
Following the 1987 "super storm," a rapids was constructed on Nine Mile Creek downstream of the 106th Street Bridge. The rapids was one of several grade-control structures that were installed on a three-mile stretch of creek in the lower valley. The proposal allowed the stream to continue its course while taking measures to protect areas where water flow was eroding valley walls. Protection measures included applying porous deflector dikes, burying sheetpile walls parallel to the creek to prevent undercutting of slopes, installing weirs (rock or capped sheetpile) to limit stream-bed degradation, and improving storm-sewer outlets.

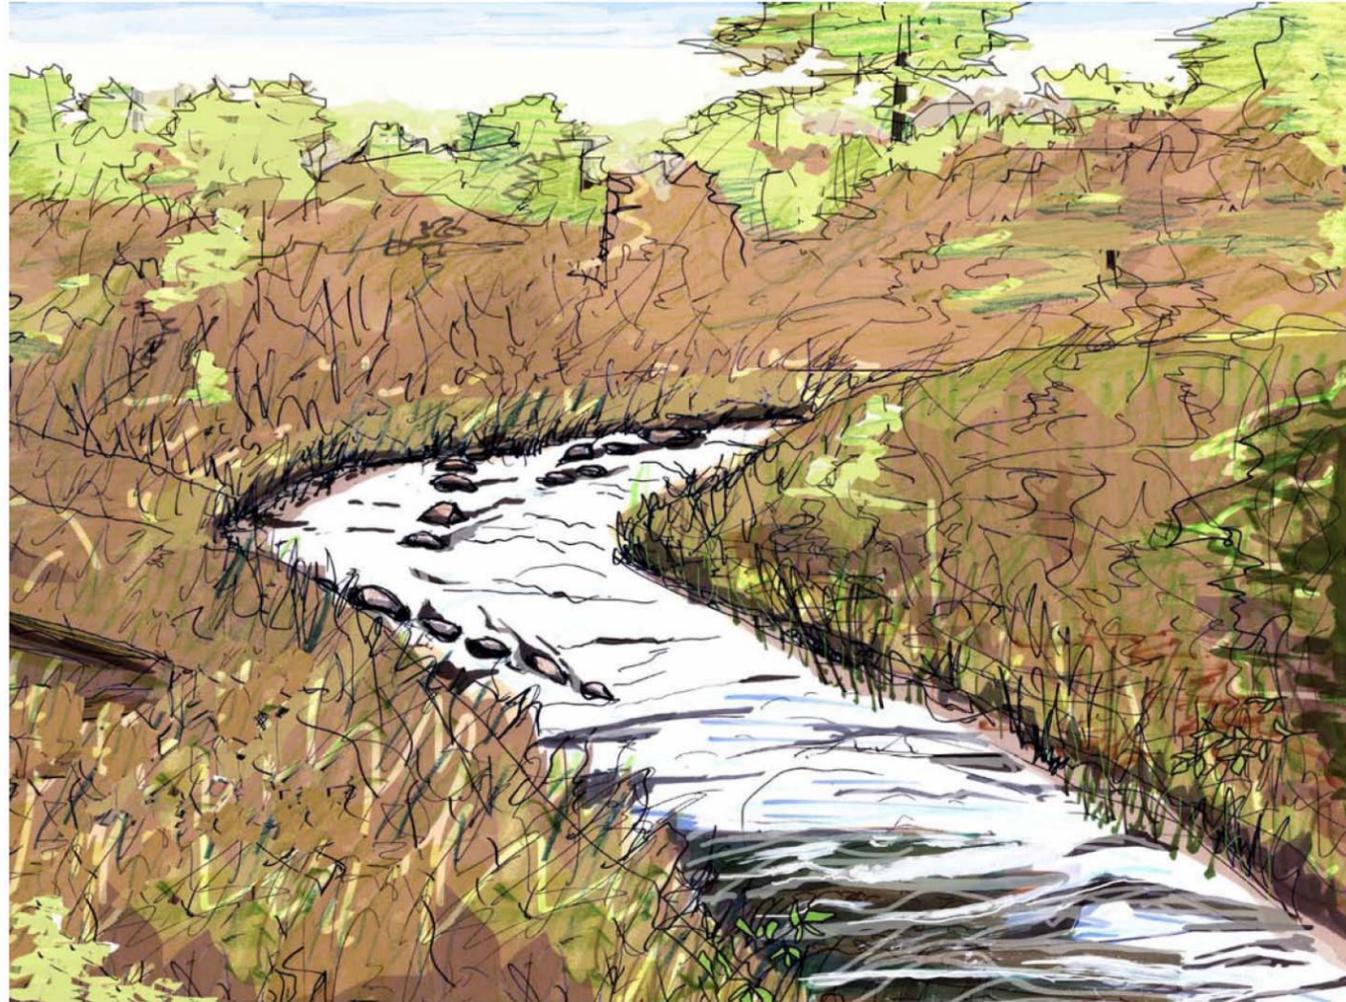
Figure 6

Cross vanes are drop structures, which are typically constructed of boulders and rocks to flatten the slope of the channel and reduce the velocity of the flow in the channel. Cross vanes, also called constructed riffles, extend across the creek bottom, and are embedded in each bank. Cross vanes direct the main flow to the center of the stream to reduce bank erosion. **Figure 6** illustrates this practice.

Materials will consist of various gradations of rock, ranging from large, 3-foot boulders to coarse gravel.

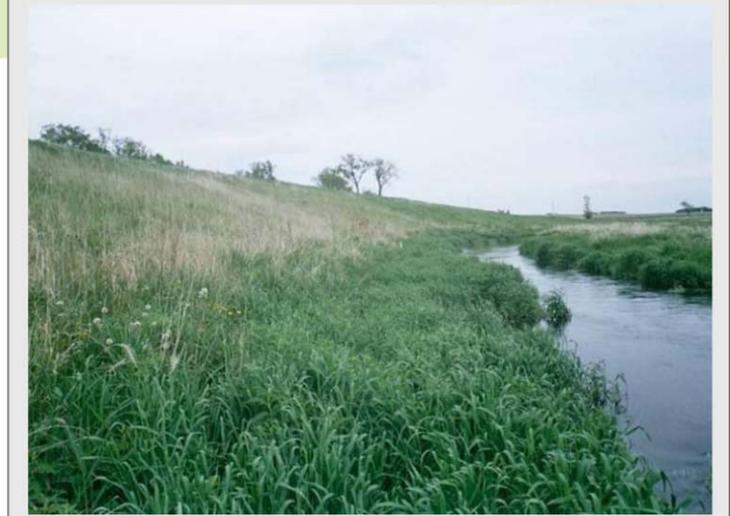
Here is an example of a stabilization project designed for a 1,000-foot long, 20-foot high streambank that was severely eroded. The channel was directed away from the bank toe by installing six rock vanes. The bank was planted with native vegetation and protected with erosion control blanket, while the terrace above the bank was graded to redirect surface runoff to a less vulnerable area. The restored streambank withstood significant flooding during 2001, and has become nicely vegetated (see picture above).

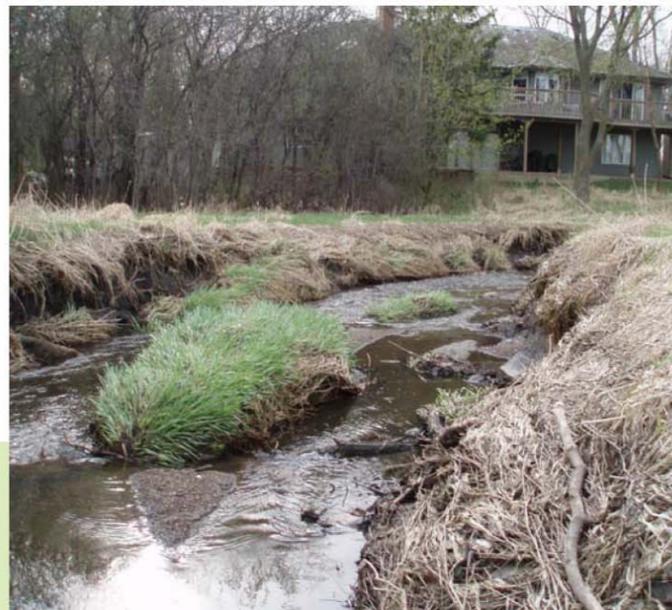
Fluvial bank erosion is caused by water in the stream moving past the streambanks. The shear stress caused by the flow entrains soil particles into the flow, causing the stream bank to erode away. This is the most common type of erosion that occurs in streams. Virtually all streams experience this type of erosion as their flow path evolves over time. However, the rate of fluvial bank erosion can increase when the stream is out of equilibrium with its watershed. Increased flow from a watershed will increase the rate of fluvial bank erosion. In places where the channel is confined by the valley walls, however, fluvial bank erosion can lead to failure of the high banks. It can also undermine storm sewer inlets.

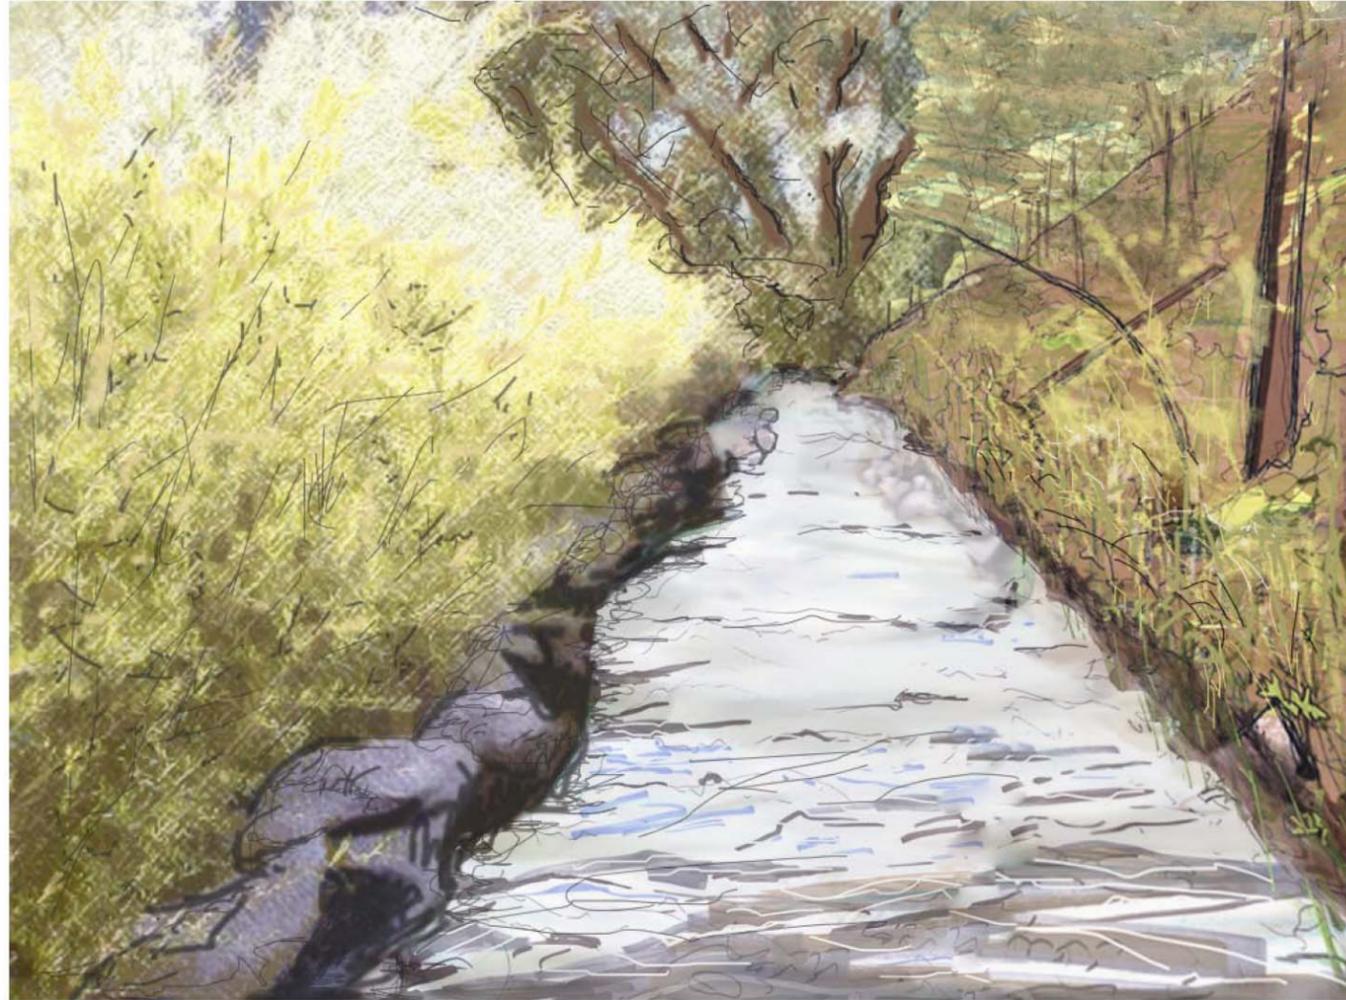
Figure 7

J-vanes (also called rock vanes) are constructed of boulders placed on the creek bottom. The vanes are embedded in the stream bank and are oriented upstream to direct the flow away from that bank. J-vanes typically occupy no more than one-third of the channel width. **Figure 7** illustrates this practice.

Rock vanes are constructed from boulders on the creek bottom. They function by diverting channel flow toward the center and away from the bank. They are typically oriented in the upstream direction and occupy no more than one third of the channel width. Vanes are largely submerged and inconspicuous. The rocks are chosen such that they will be large enough to resist movement during flood flows or by vandalism, with additional smaller rock material to add stability. Rock vanes function in much the same way as root wads in that they push the stream thalweg (zone of highest velocity) away from the outside bend. They also promote sedimentation behind the vane, which adds to the toe protection.

Vanes can also be constructed from both banks, forming an upstream-pointing "V." In this configuration, the vane protects both banks and also provides grade control.

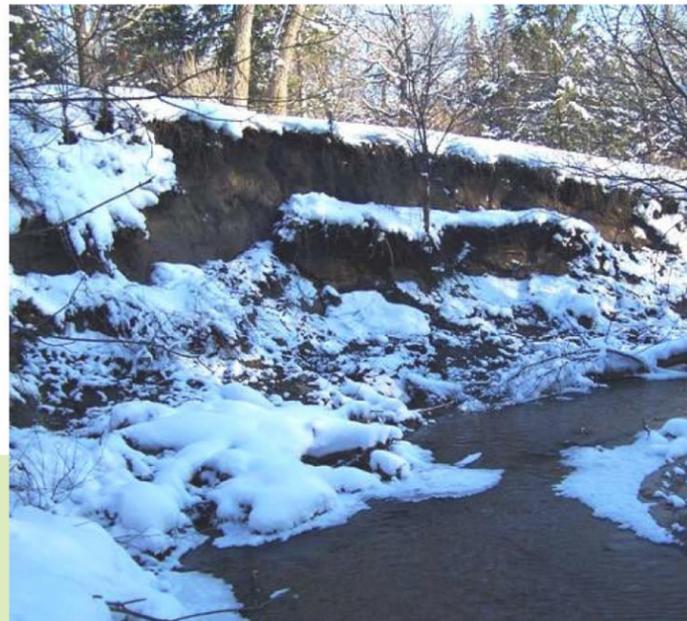
Fluvial bank erosion is caused by water in the stream moving past the streambanks. The shear stress caused by the flow entrains soil particles into the flow, causing the stream bank to erode away. This is the most common type of erosion that occurs in streams.

Virtually all streams experience this type of erosion as their flow path evolves over time. However, the rate of fluvial bank erosion can increase when the stream is out of equilibrium with its watershed. Increased flow from a watershed will increase the rate of fluvial bank erosion.

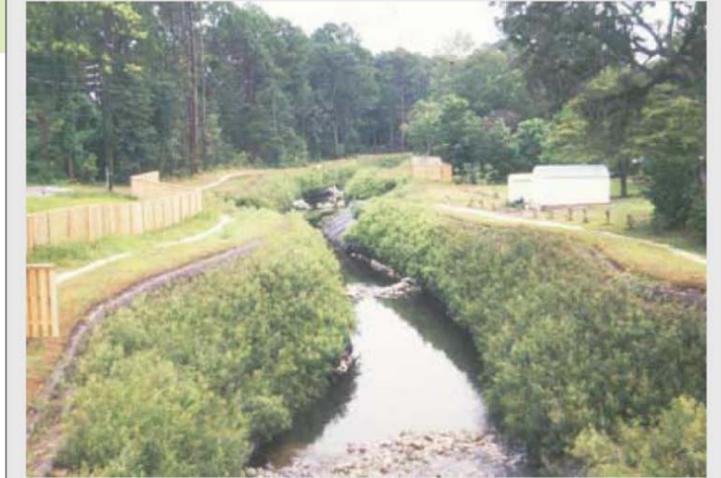
The Mill Creek Restoration Project utilized soil bioengineering design to stabilize 175 linear feet of severely eroding streambanks within the Caldwell Recreation Park in southeastern Ohio. The work included two 25-foot vegetated reinforced soil slope (VRSS) sections, two 50-foot fill bank sections protected with woven coir and direct woody plantings, and a 12.5-foot tie-in on the upstream and downstream end of streambank work area.

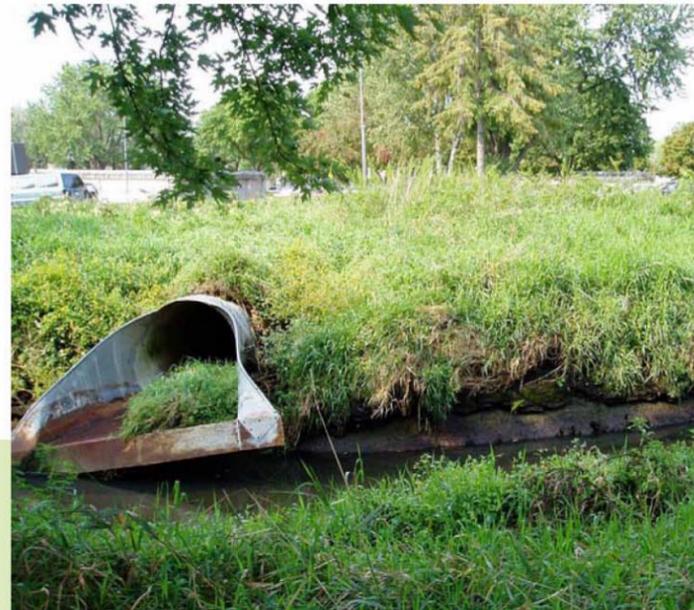
Erosion is frequently observed at culvert outlets for a variety of reasons, including insufficient erosion protection at the culvert outlet, streambank erosion, and channel downcutting, which leaves the culvert perched above the channel. Filter fabric is often used at culvert outlets to separate riprap protection from underlying soils, however the fabric provides a slippery surface for the riprap, which commonly slides into the channel.

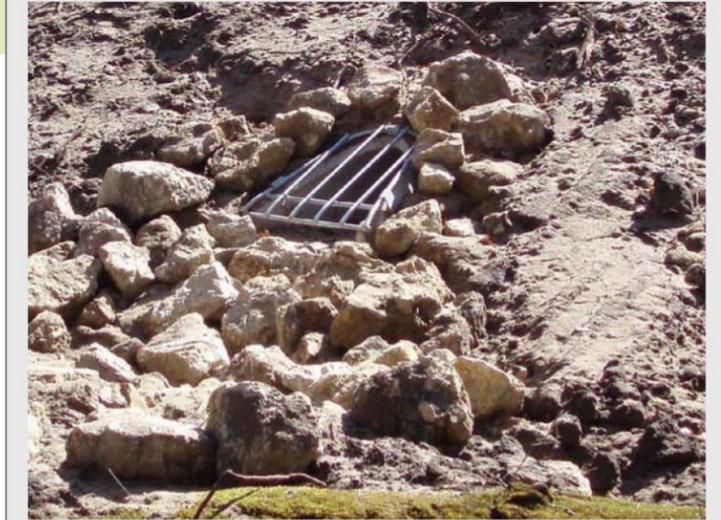
There are many culvert stabilization designs used on various streams and rivers. Because they are often small projects, the work is often performed by local municipalities or completed as part of a larger project.

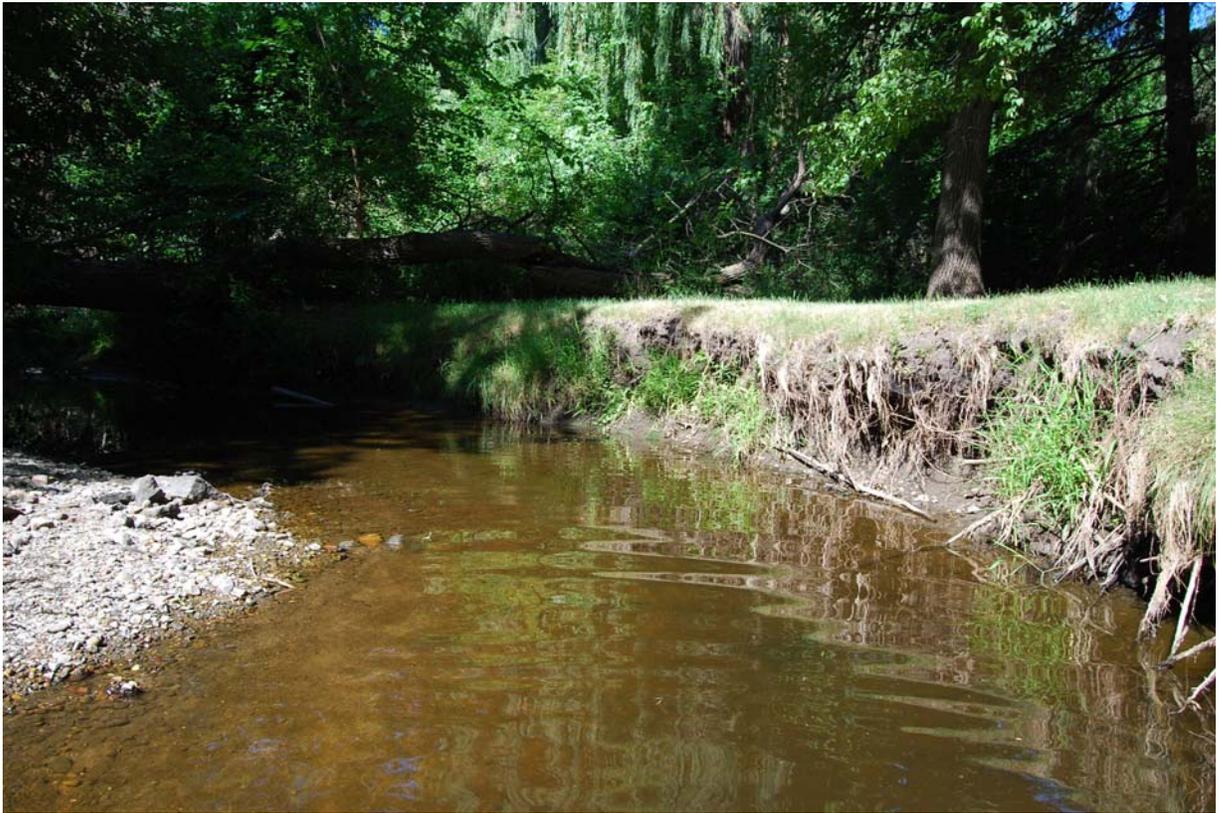
Stream bank erosion and existing vegetation at Site 5.

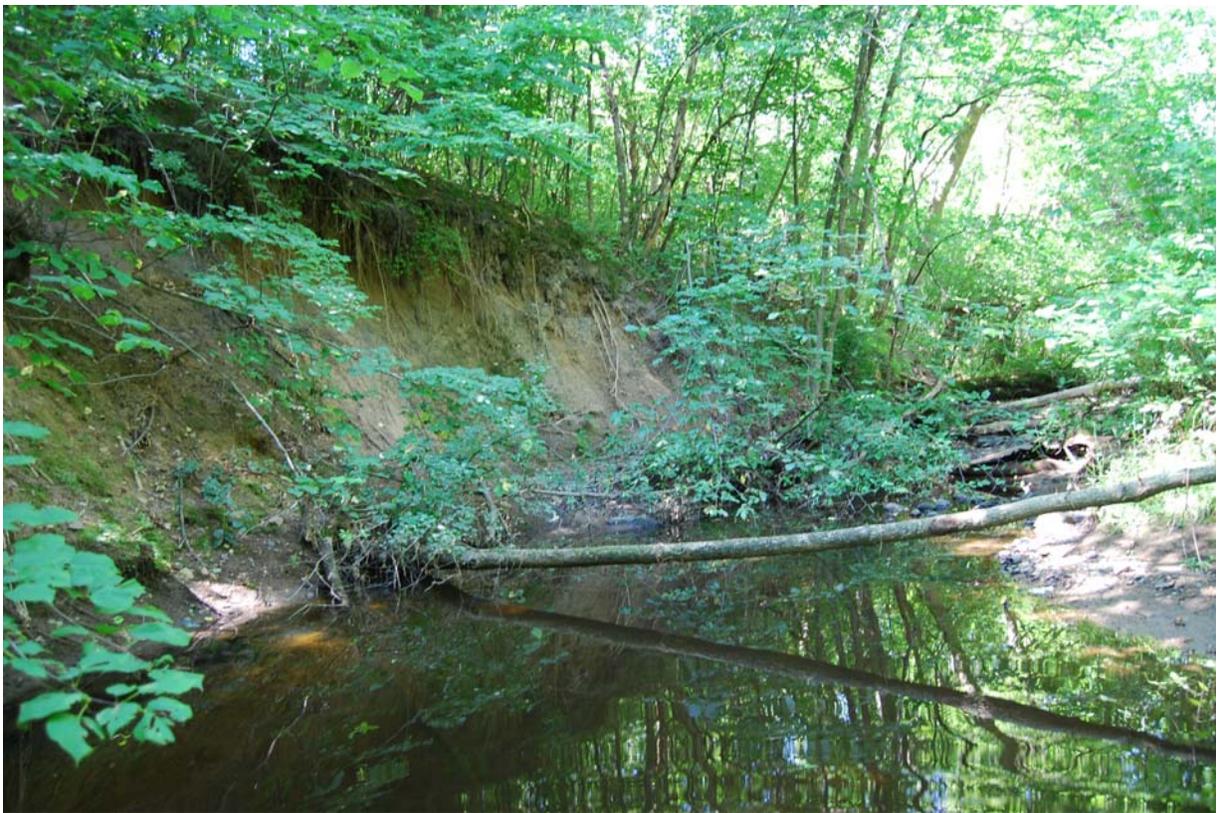
Stream bank erosion and existing vegetation at Site 8.

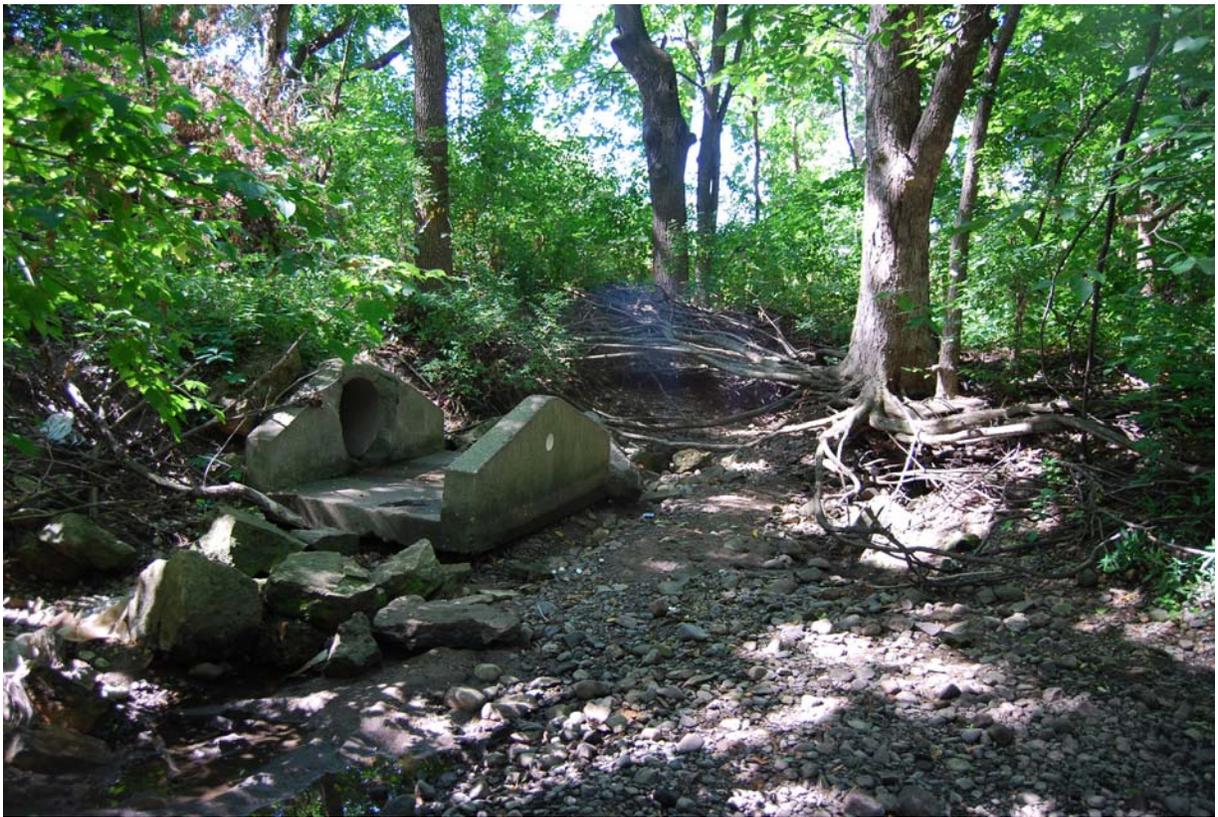
Stormsewer outlet and bank erosion at Site 14.

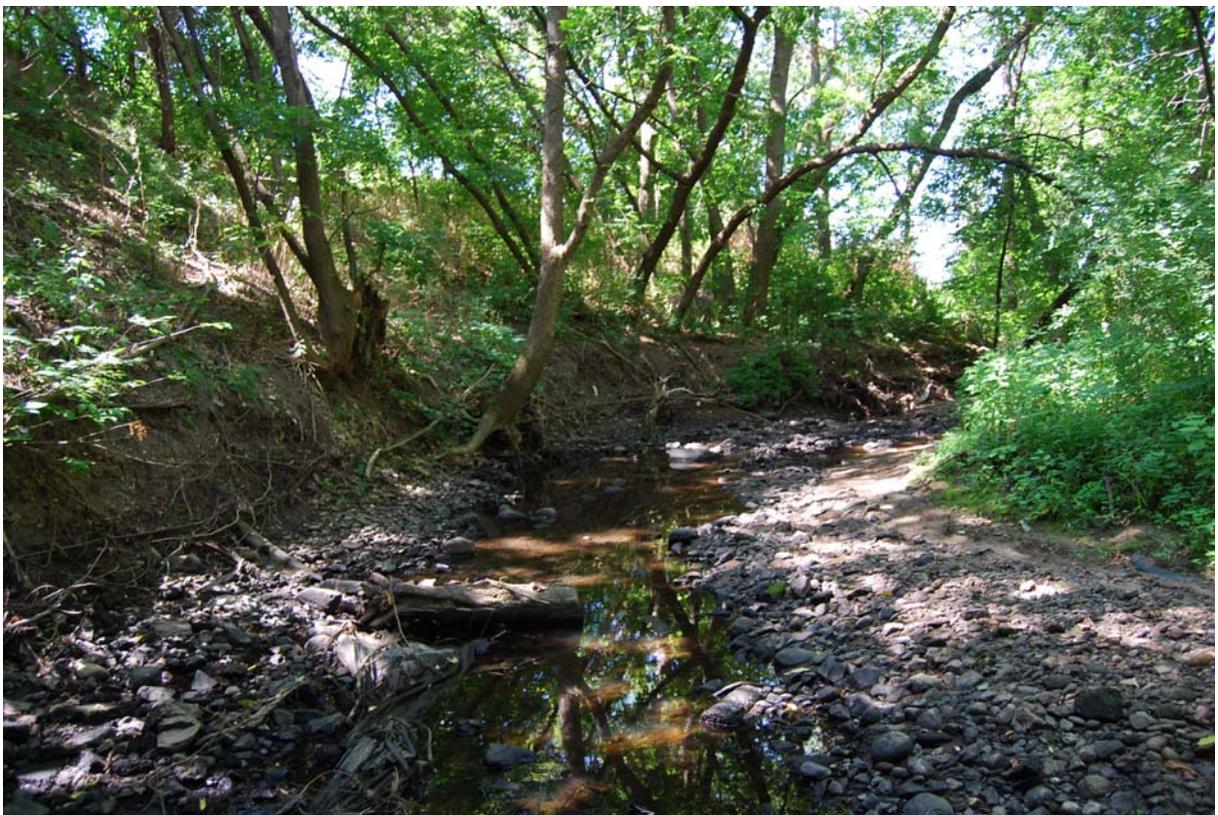
Stream bank erosion and existing vegetation at Site 15.
