Minnesota Wetland Conservation Act

Notice of Application

Applicant Name Derek Asche, City of Plymouth	Project Name Plymouth Creek Stream Restoration - 16007	Date of Application 3/7/17	Application Number NA
--	--	--------------------------------------	---------------------------------

Wetland Delineation Report

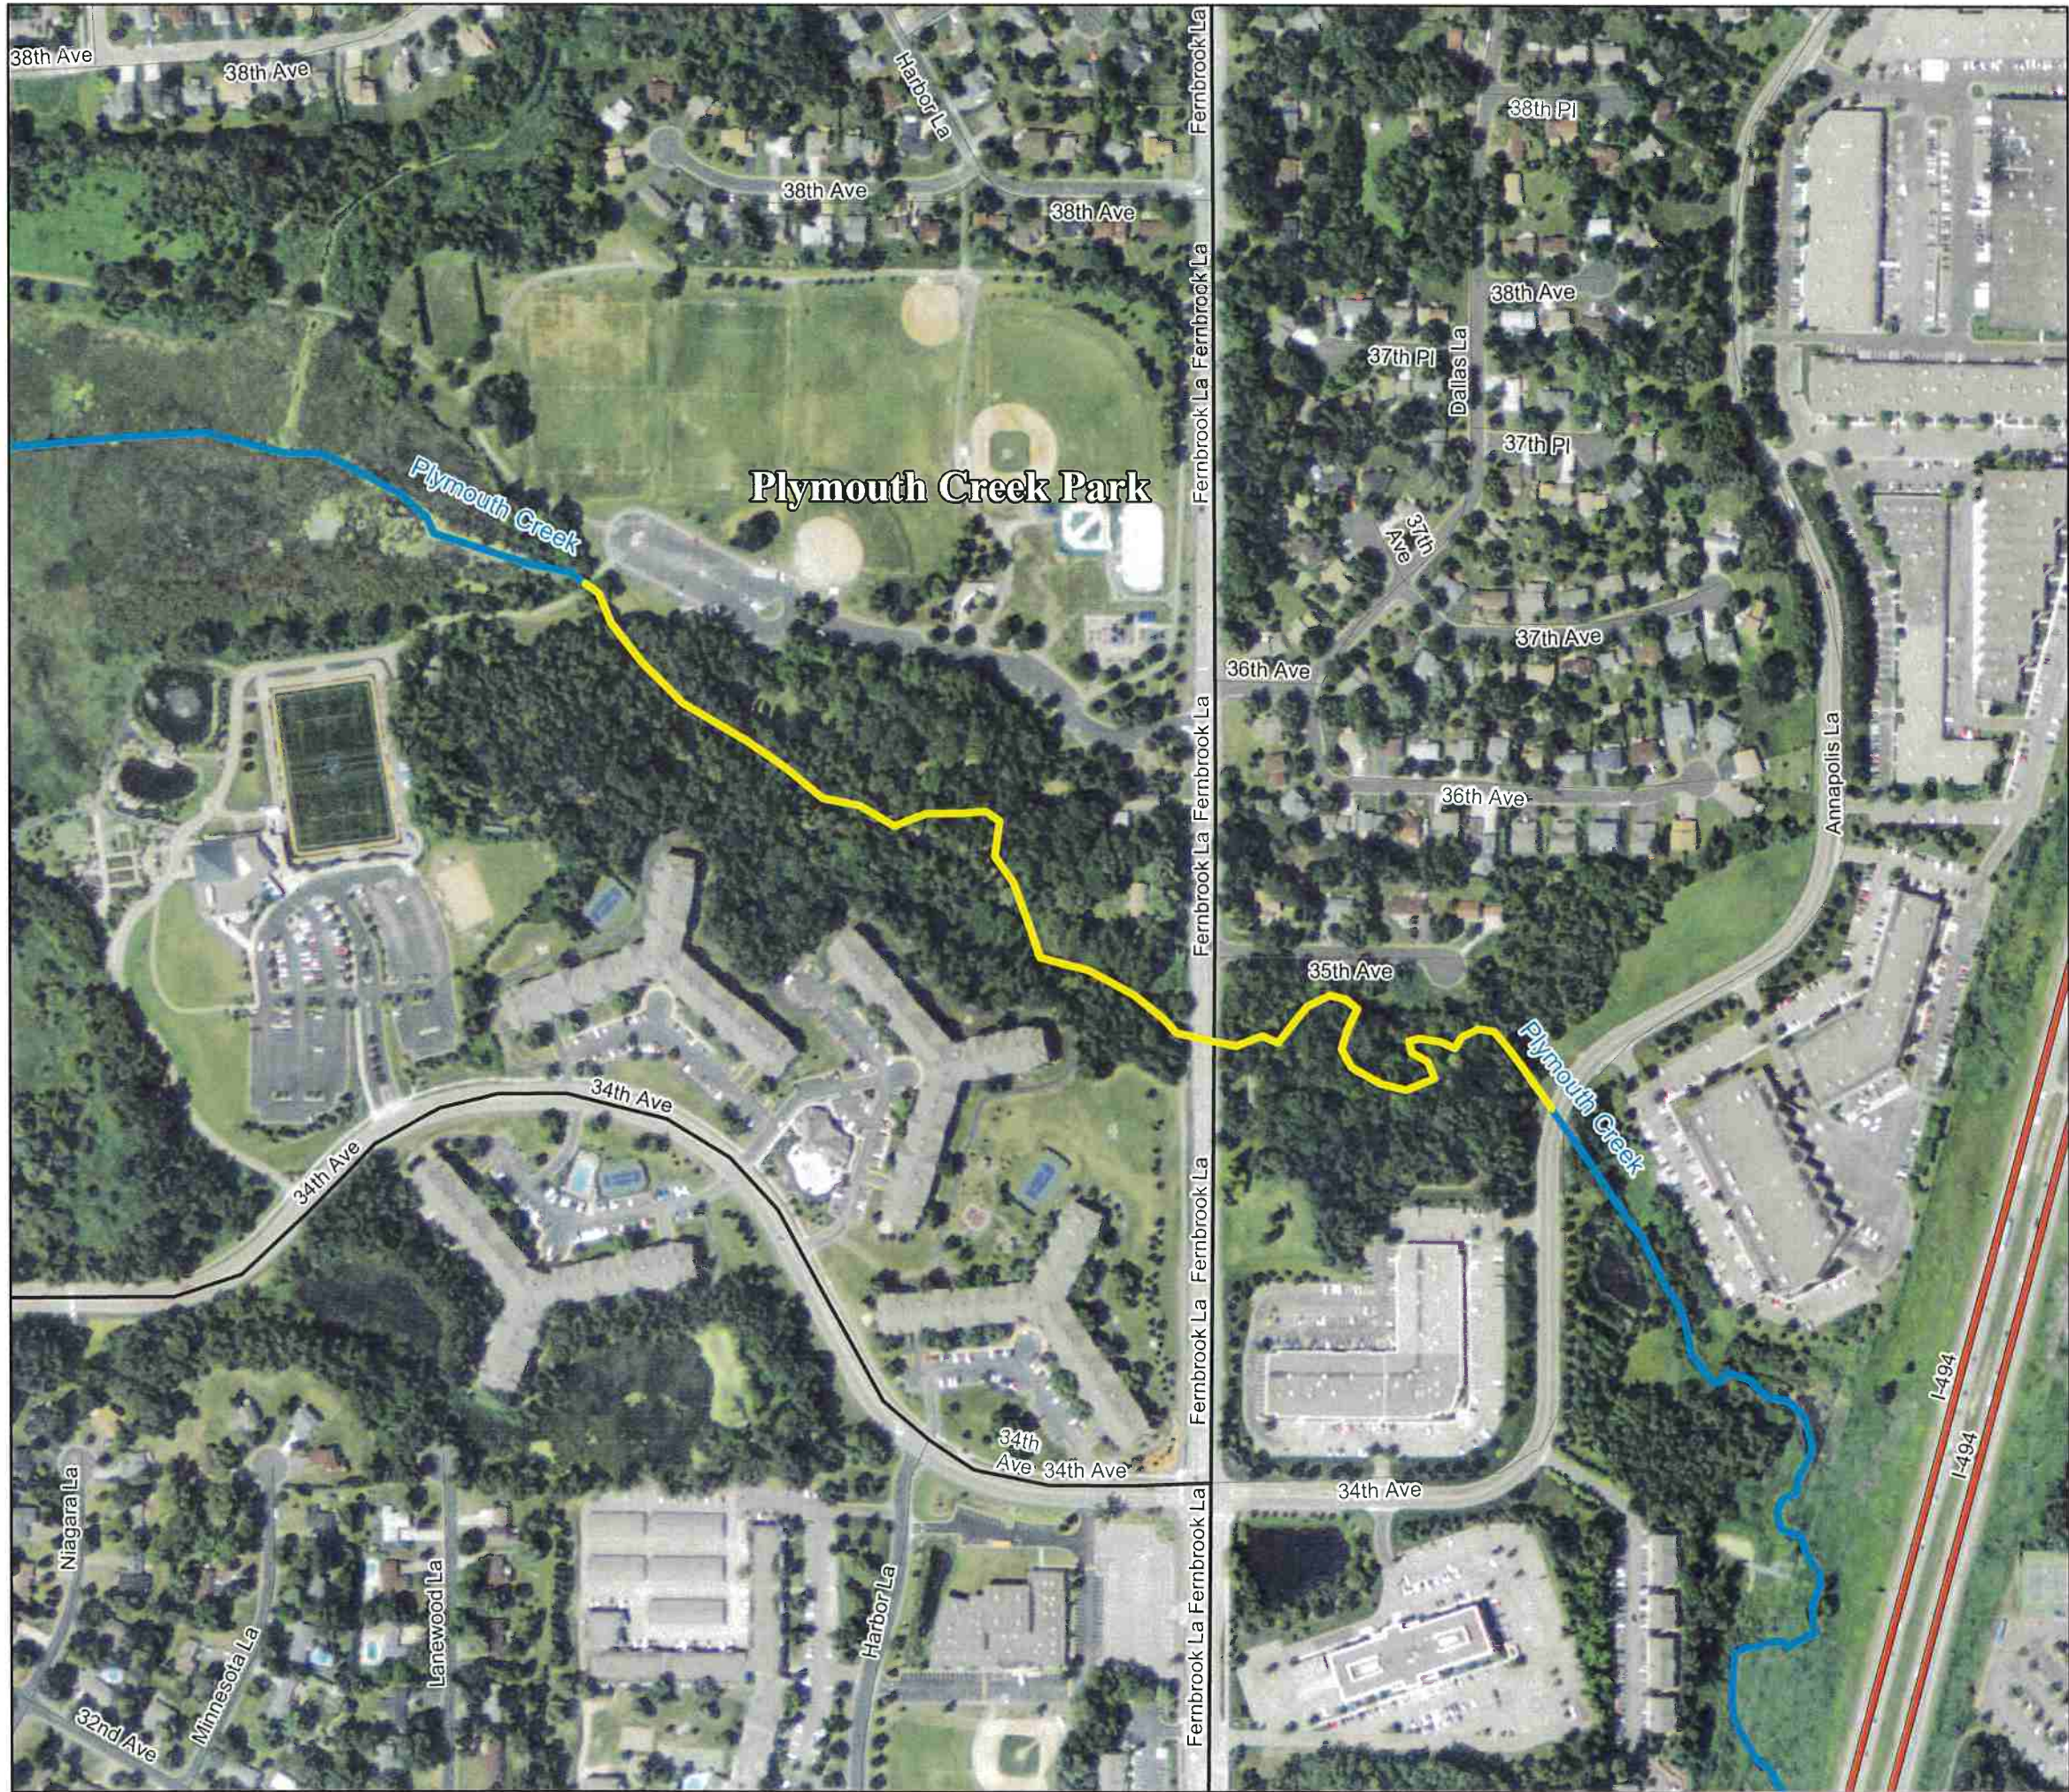
Figure 1

Bassett Creek Watershed Management Commission (BCWMC) is submitting a Wetland Delineation Report as part of a study that examines the feasibility of restoring sites along Plymouth Creek reaches damaged by erosion or affected by sedimentation. The project area is located along several reaches of Plymouth Creek beginning at Plymouth Creek Park and continues between Fernbrook Lane North and Annapolis Lane North, Plymouth, Hennepin County, Minnesota. The project area is within Sections 16, 21 and 22 of Township 118 North, Range 21 West (**Figure 1**).

PROJECT LOCATION MAP
Plymouth Creek Feasibility Study
Wetland Delineation
Bassett Creek Watershed
Management Commission

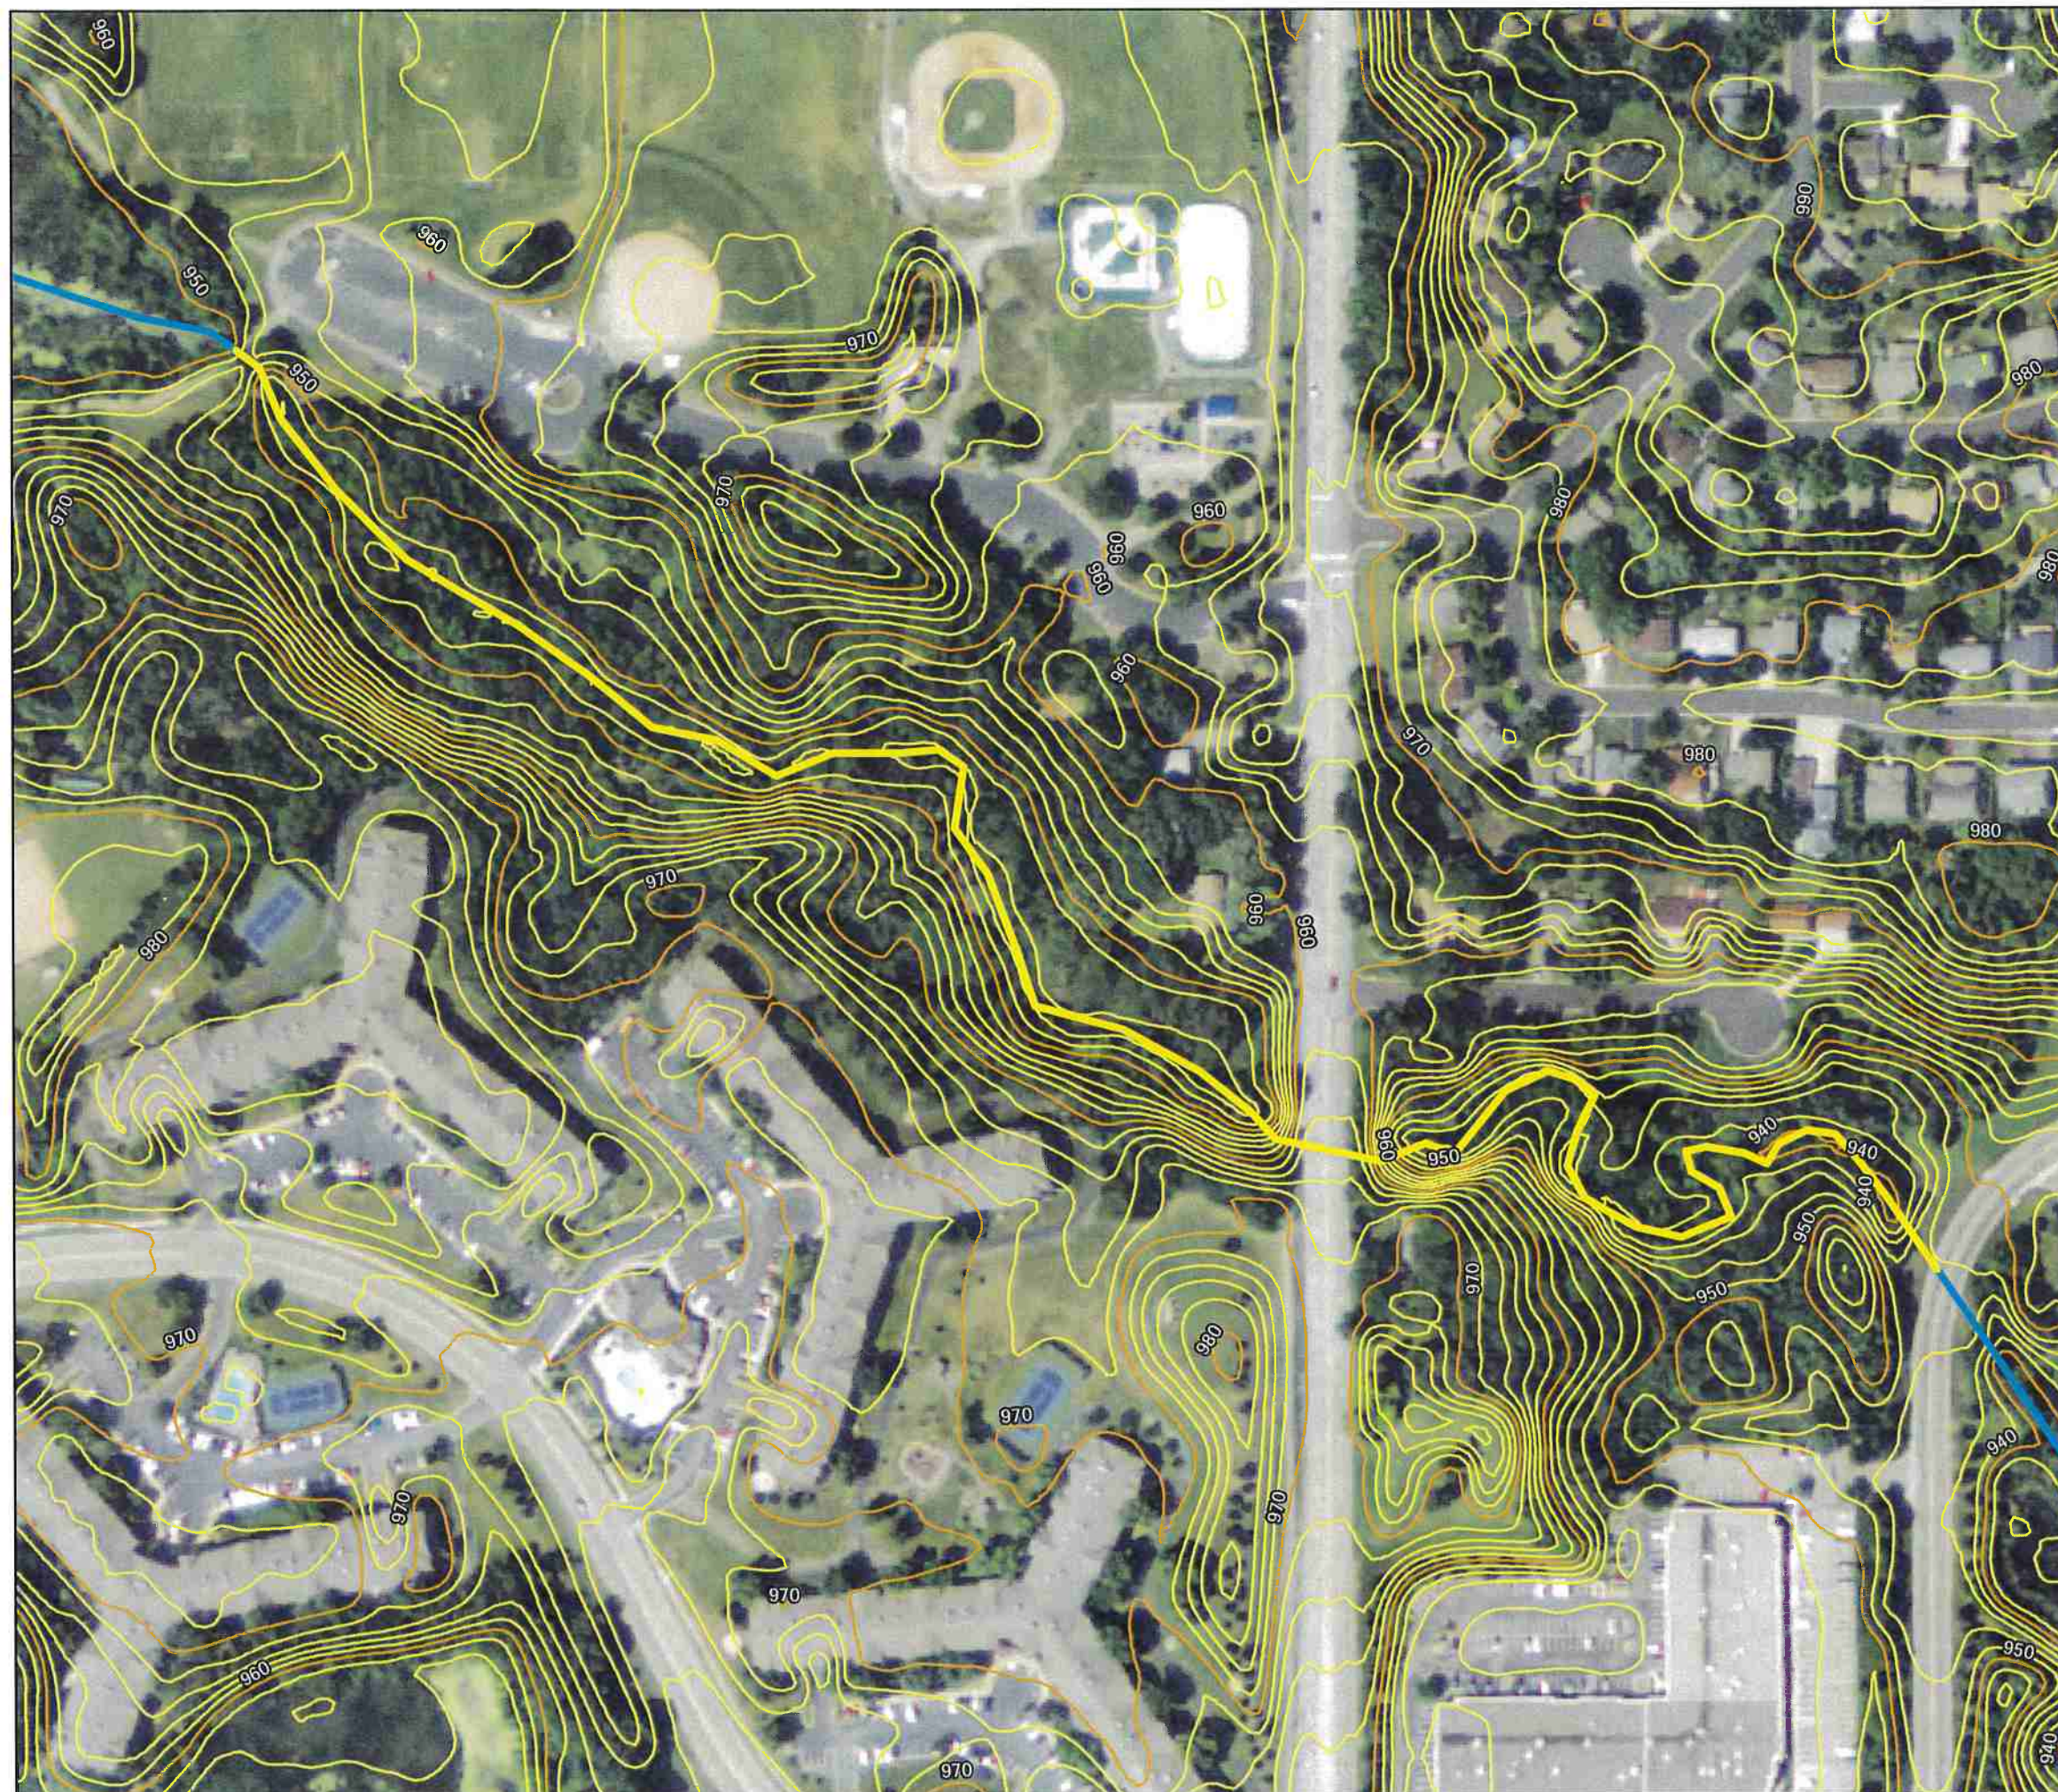
Figure 2

TOPOGRAPHY MAP
Plymouth Creek Feasibility Study
Wetland Delineation
Basset Creek Watershed
Management Commission

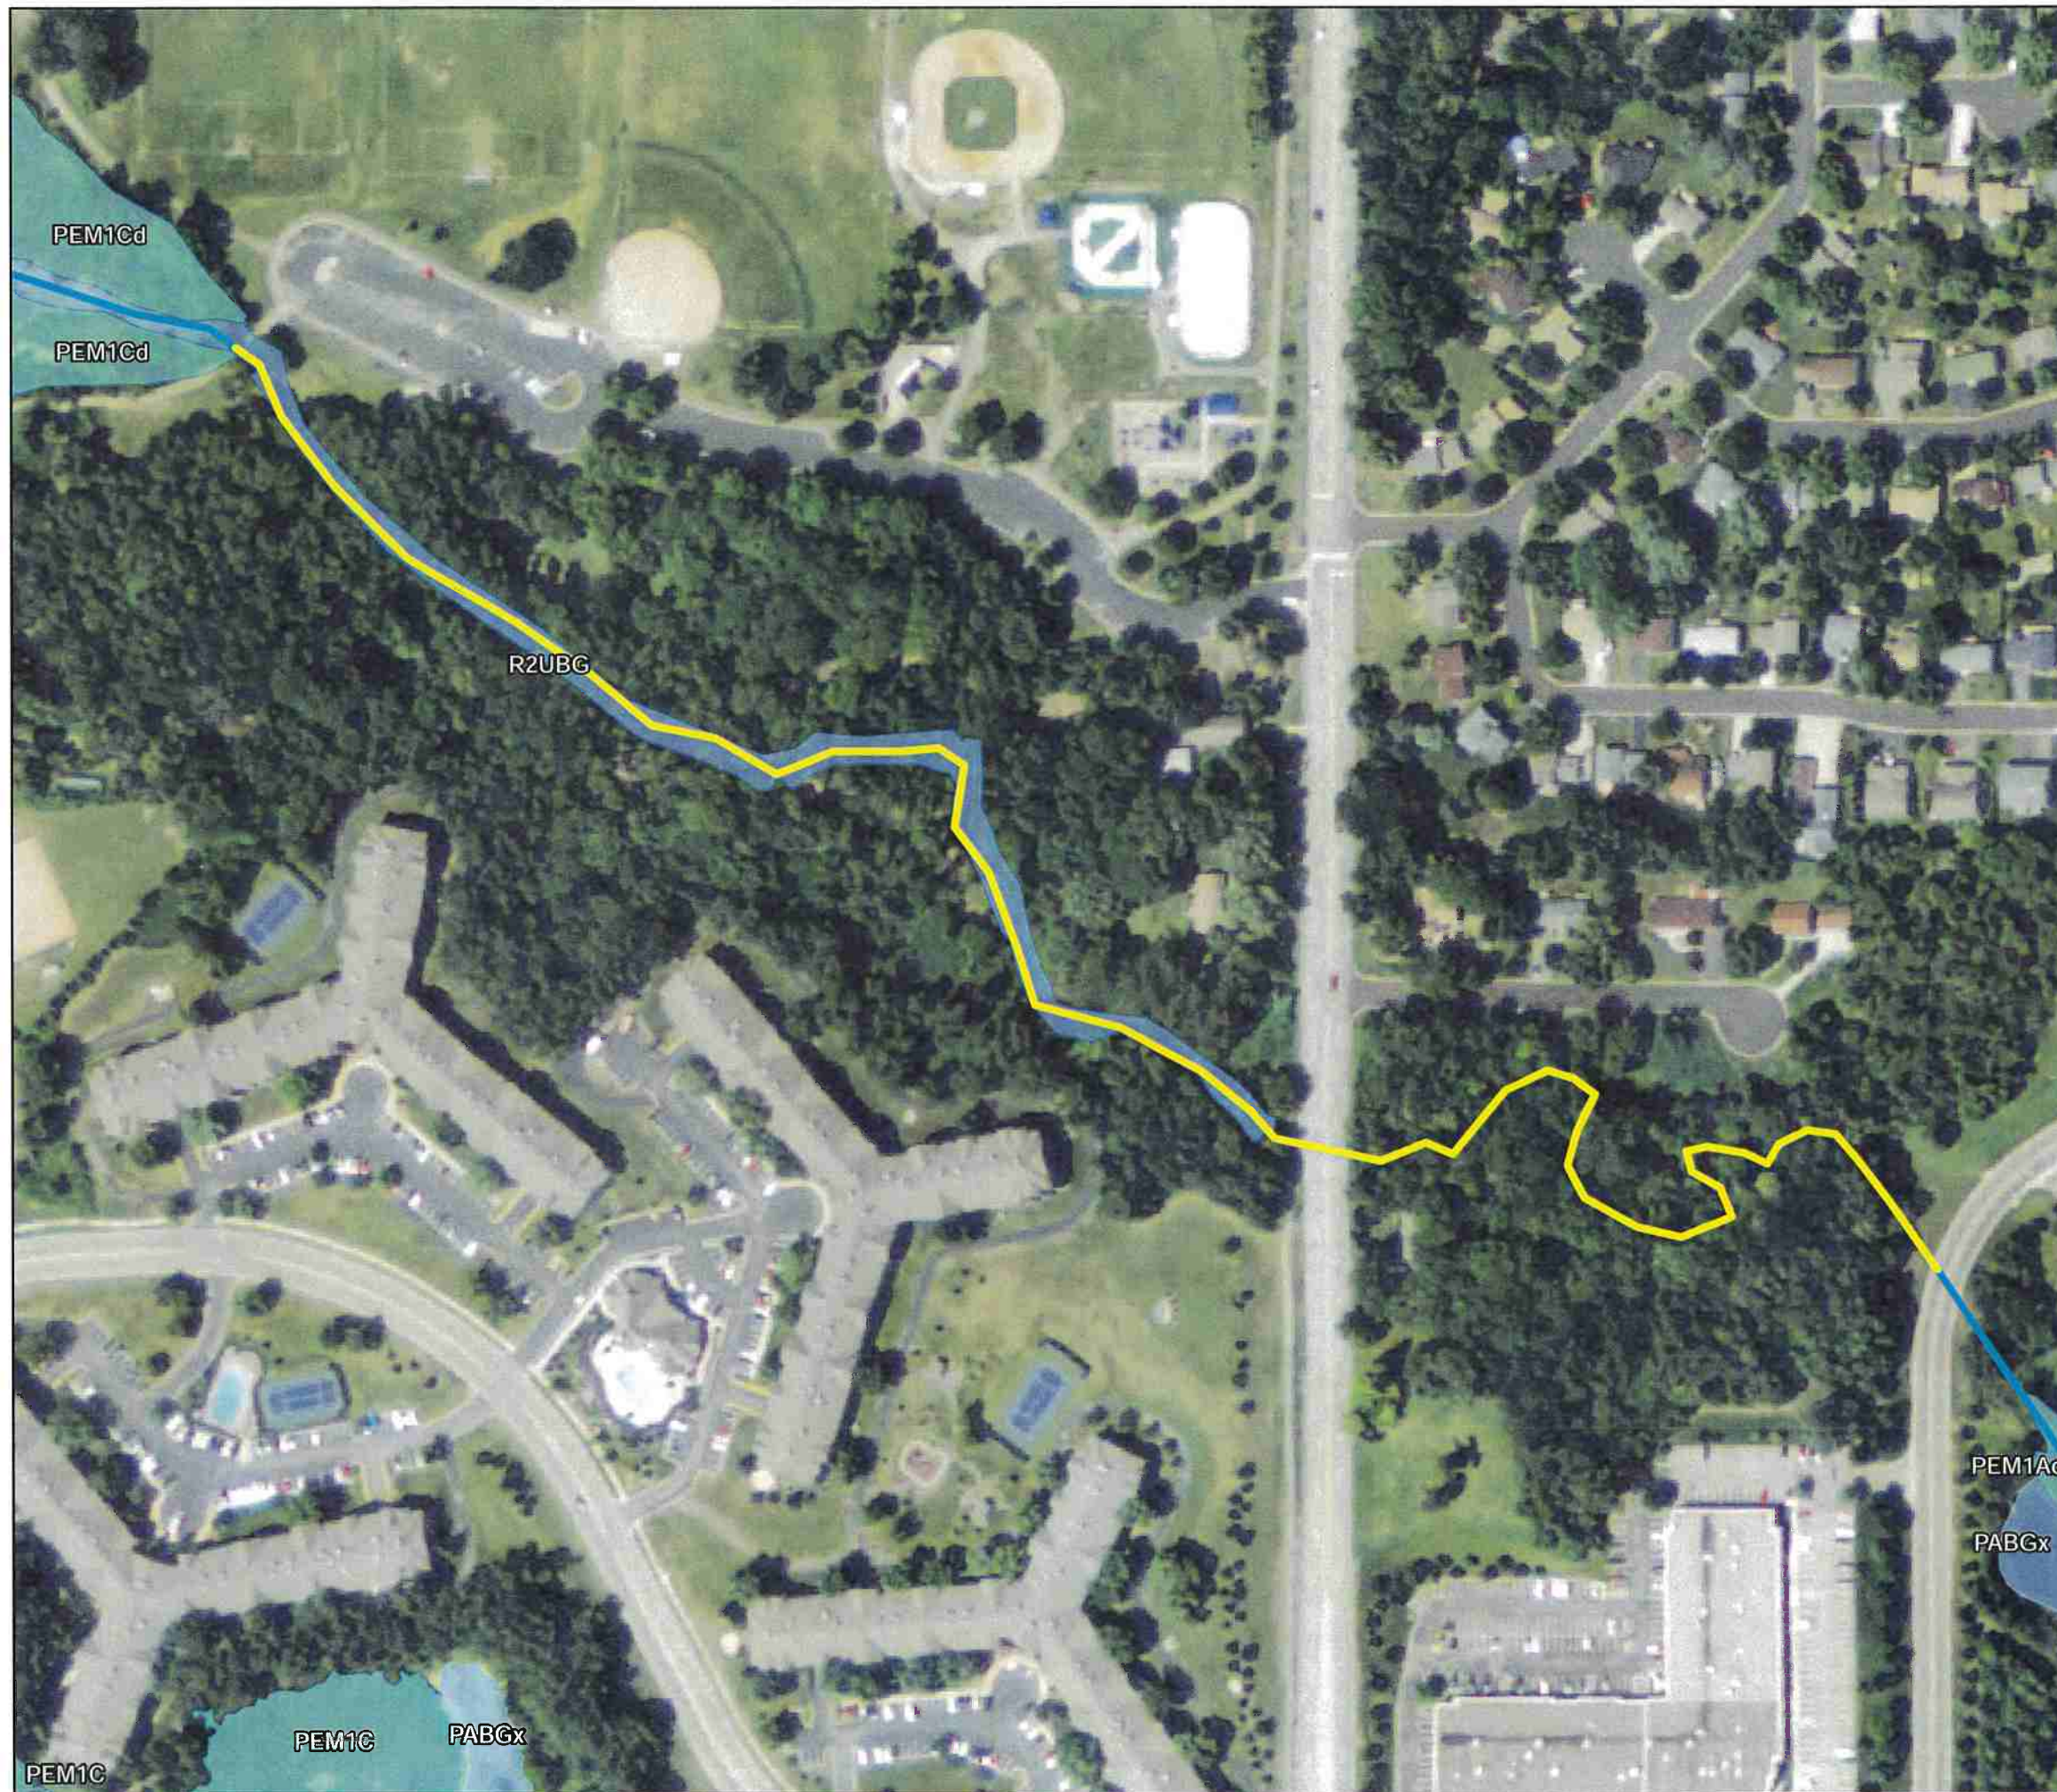
Figure 3

NATIONAL WETLAND INVENTORY
Plymouth Creek Feasibility Study
Wetland Delineation
Bassett Creek Watershed
Management Commission

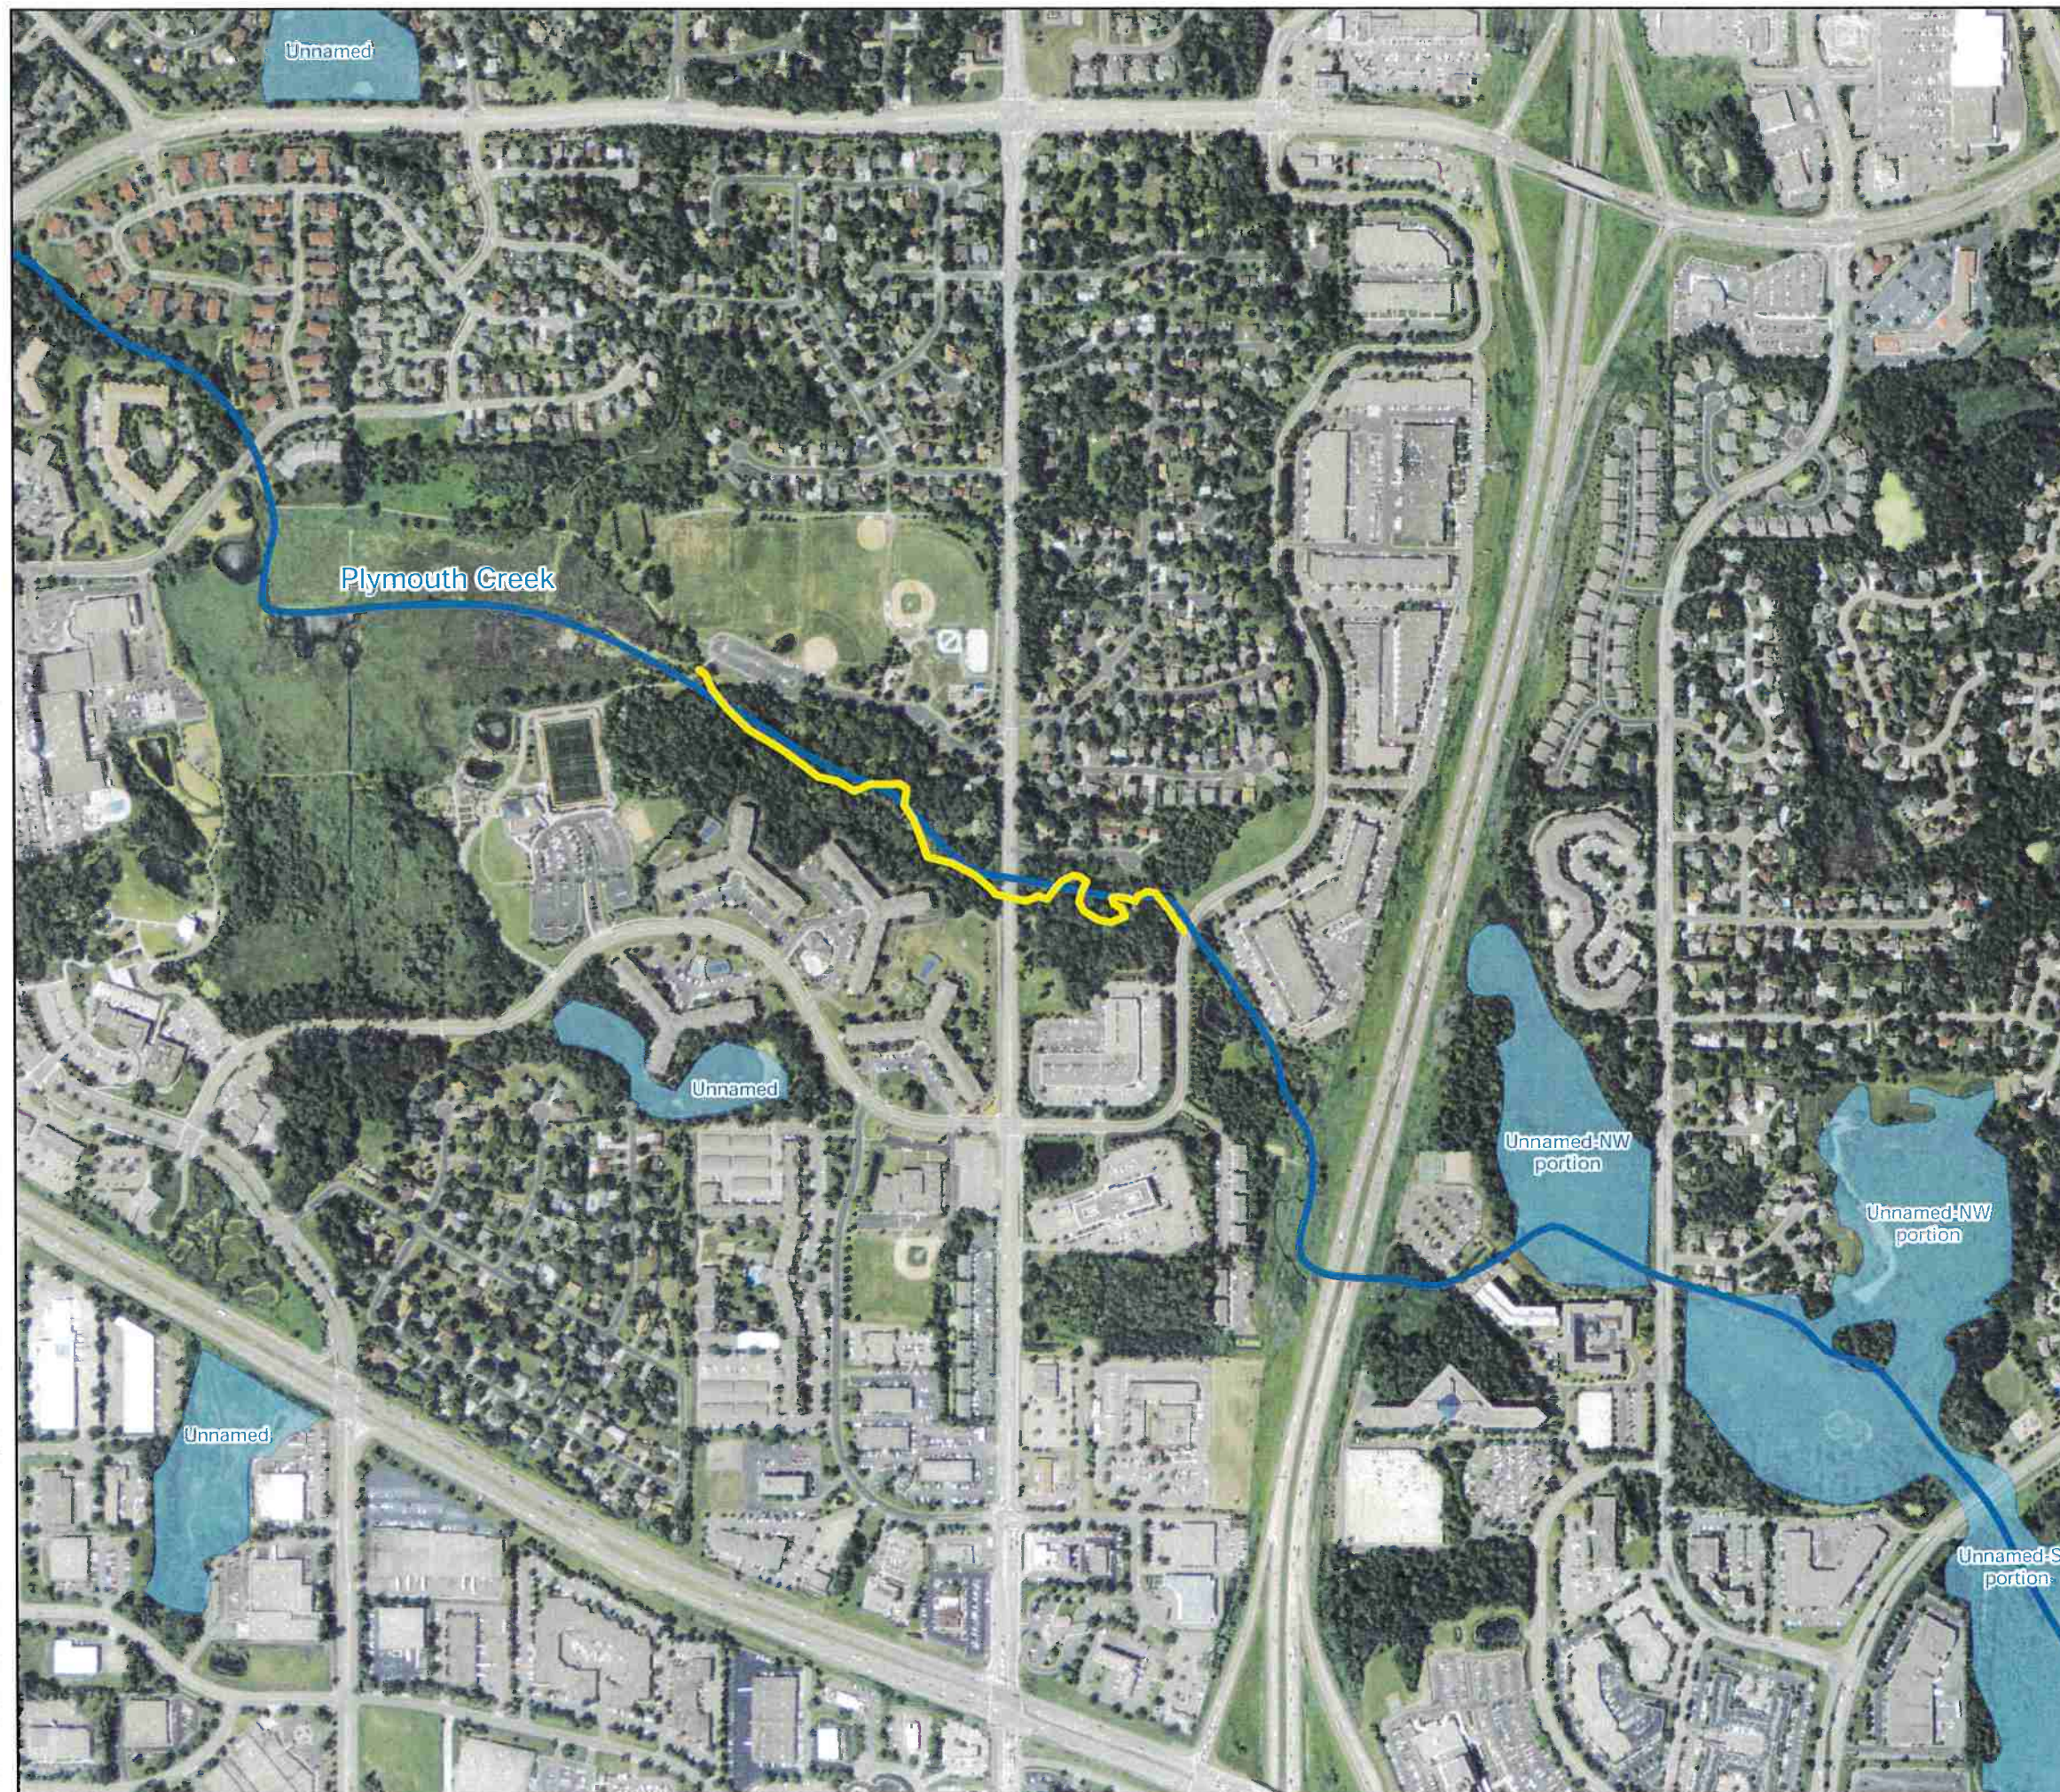
Figure 4

PUBLIC WATER INVENTORY
Plymouth Creek Feasibility Study
Wetland Delineation
Bassett Creek Watershed
Management Commission

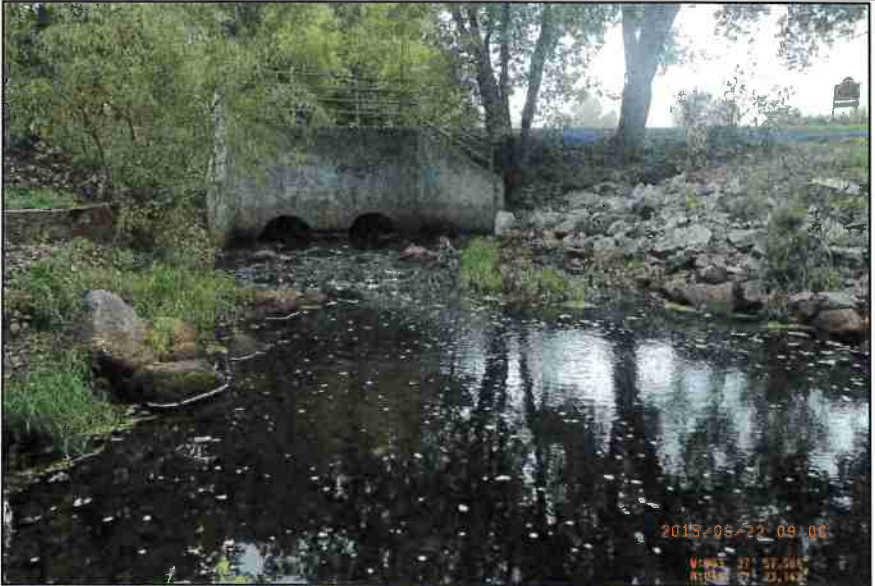
<p>Photo 1 – September 22, 2015</p> <p>Study Reach (West of Fernbrook Ln. N)</p> <p>Water-level-control structure at start of the survey within Plymouth Creek Park.</p>

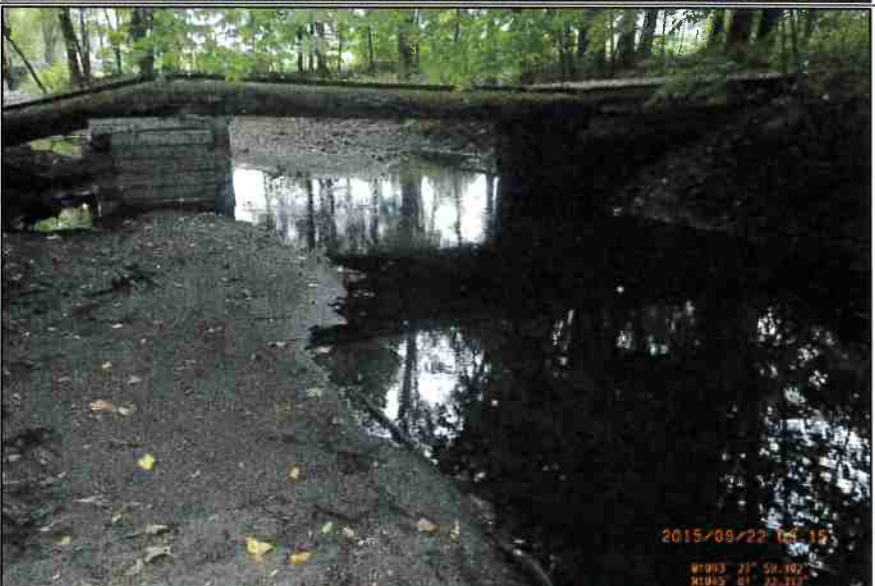
<p>2015/09/22 09:01 N: 43° 22' 57.50" W: 71° 23.162"</p>
<p>Photo 2 – September 22, 2015</p> <p>Study Reach (West of Fernbrook Ln. N)</p> <p>Bridge crossing and typical view of Plymouth Creek in this area.</p>

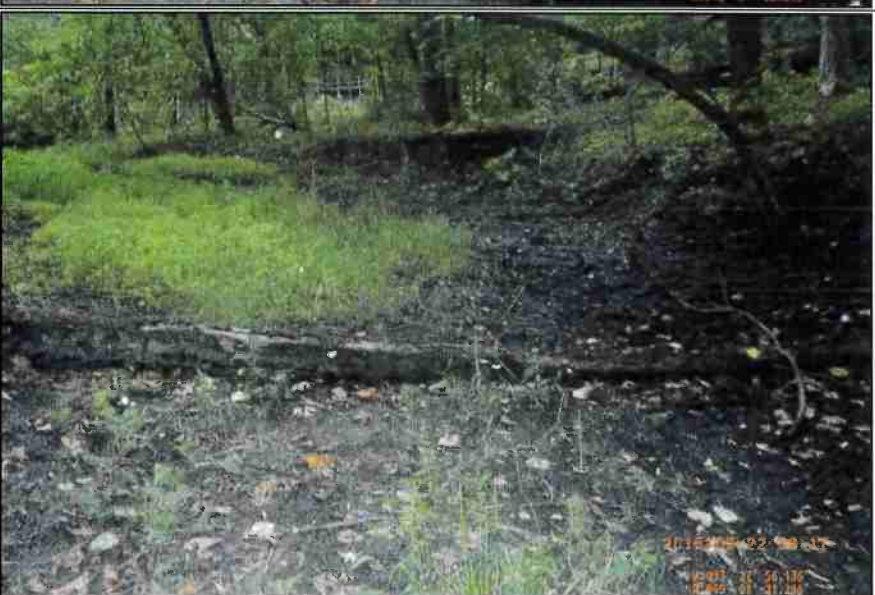
Primary indicators of hydrology that were observed were high water table (A2), and saturation (A3). Secondary indicators of hydrology present included geomorphic position (D2), and a positive FAC-Neutral test (D5).

<p>2015/09/22 09:15 N: 43° 21' 59.10" W: 71° 23.323"</p>
<p>Photo 3 – September 22, 2015</p> <p>Wetland 1</p> <p>Facing southeast. This photo shows the eroded edge of Wetland 1 and saturated soils.</p>

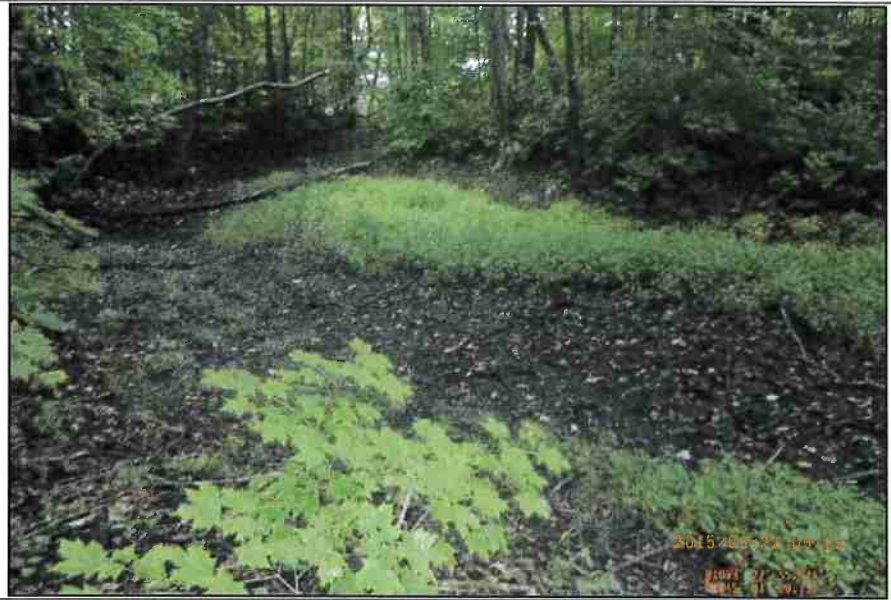
<p>Photo 4 – September 22, 2015</p> <p>Wetland 2</p> <p>Facing northwest. The upland island is located on the right side of the photo.</p>

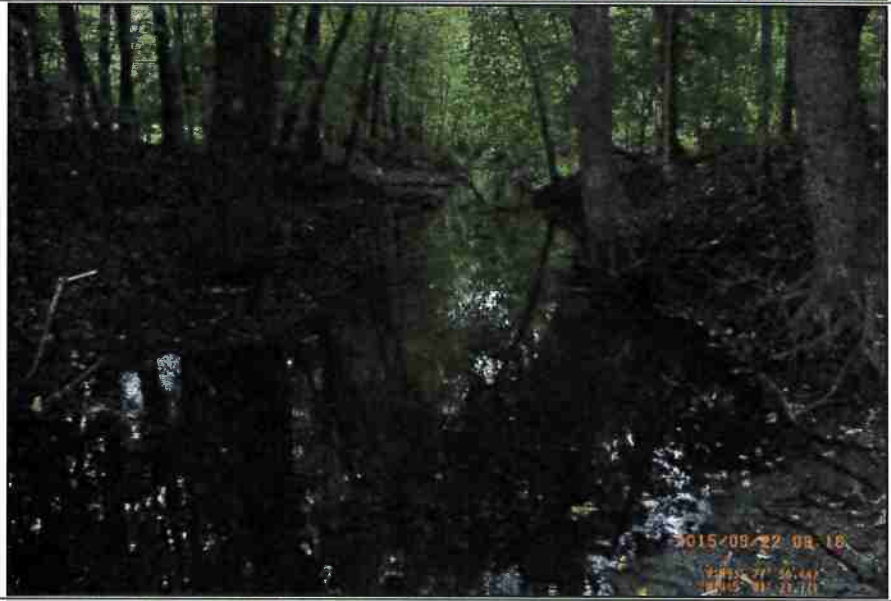
<p>Photo 5 – September 22, 2015</p> <p>Study Reach (West of Fernbrook Ln. N)</p> <p>Typical view of the stream reach between Wetlands 1 and 2.</p>

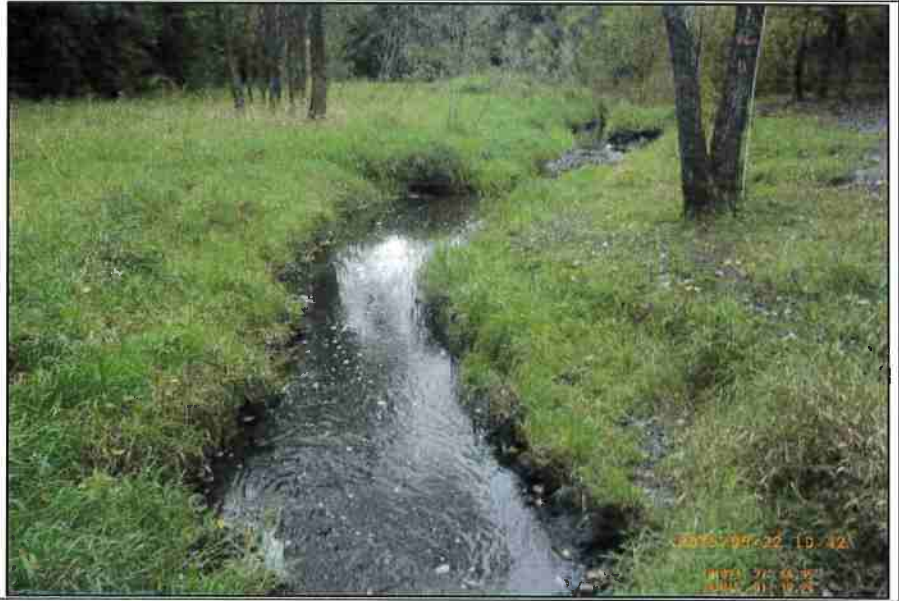
<p>Photo 6 – September 22, 2015</p> <p>Wetland 2</p> <p>Facing south at the north edge of Wetland 2. Wetland 2 is located on the left side of this photo.</p>

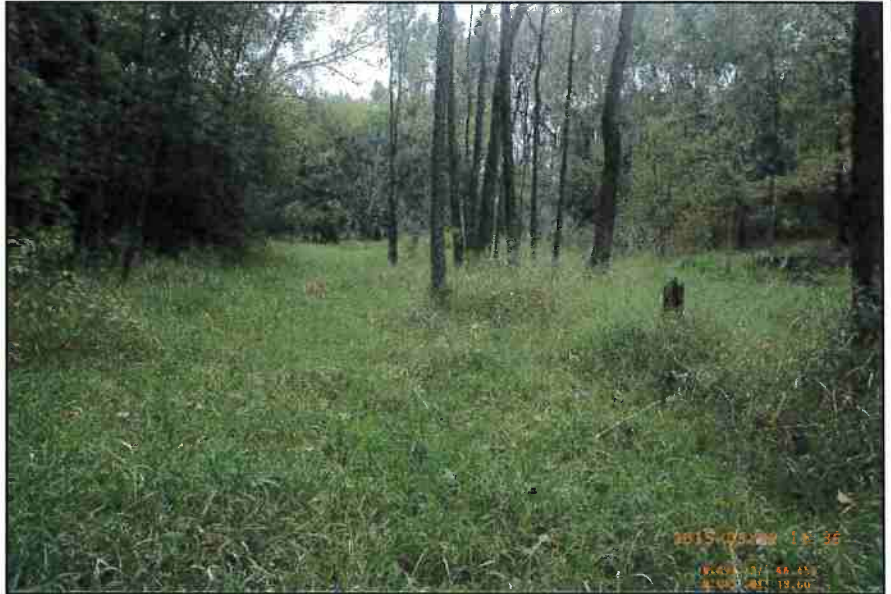
Photo 7 – September 22, 2015

Wetland 2

Another view of wetland 2 facing southeast. Wetland 2 is dominated by reed canary grass.

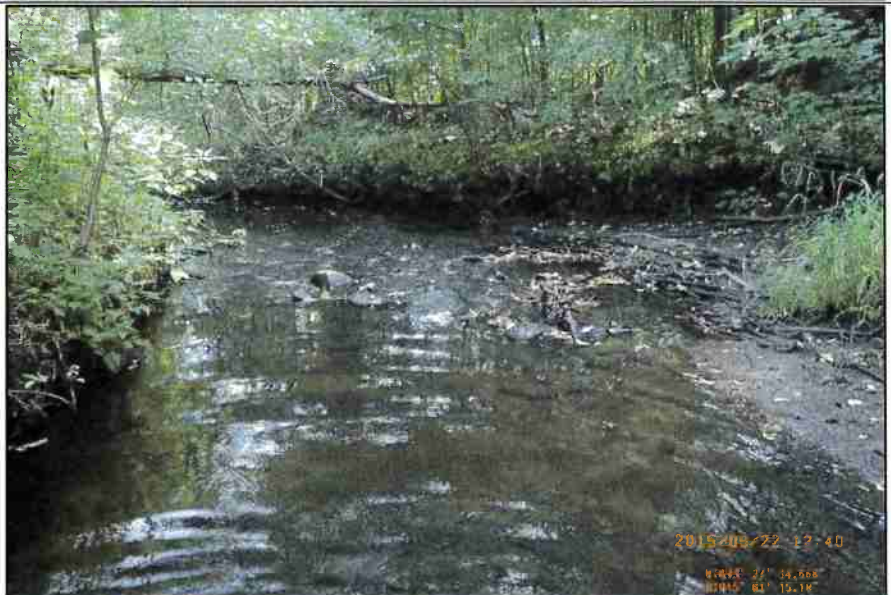
Photo 8 – September 22, 2015

Stream bank erosion is a natural process that occurs at some rate on all alluvial channels, and the natural erosion rate can be accelerated by local and regional changes in land use and hydrology. The bank erosion and bank failures throughout the project area appear to be caused by a combination of natural stream erosion processes, problems associated with changing watershed hydrology, and effects of riparian land use. Of the 5,600 feet of stream bank in the project area, approximately 2,850 feet (more than half) showed some degree of erosion.

**Study Reach
(East of Fernbrook Ln. N)**

This photo shows an undercut portion of stream channel, which is typical along many areas of Plymouth Creek.

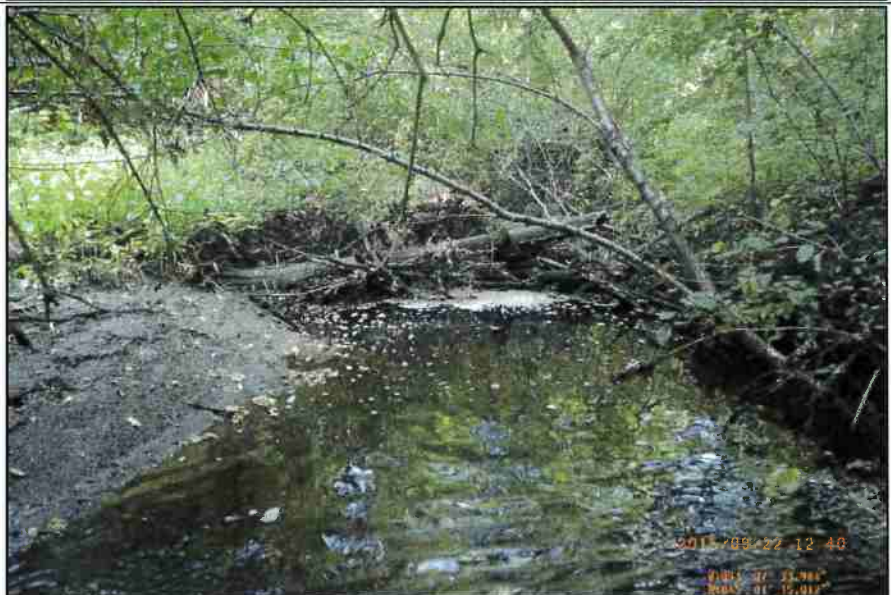
Photo 9 – September 22, 2015

Water flowage within the creek channel had a slow to medium velocity and substrate was sandy in most of the shallow areas and siltier in deeper areas. Downed trees and other debris obstructed several areas within the creek channel, particularly at points where the creek meanders sharply. No emergent, or aquatic plants were observed within the creek channel. Reed canary grass was dominant along creek edge points where the banks were low. Mixed hardwood trees and shrubs were dominant at higher elevations adjacent to the creek.

**Study Reach
(East of Fernbrook Ln. N)**

Many areas within the stream reach east of Fernbrook Lane have snags that obstruct water flow.
