Minneapolis Park and Recreation Board Preferred Master Plan Alternatives

BRYN MAWR PARK

For settlement analyses, the upper bound of consolidation coefficients and corresponding void ratio and preconsolidation pressures were matched to the clay layers of the generalized soil profile. For immediate settlement, the undrained modulus of elasticity was estimated from the overconsolidation ratio (OCR) and index properties of the clayey soils (Fang, 2007). The drained modulus of elasticity was estimated from correlations with SPT results (Fang, 2007).

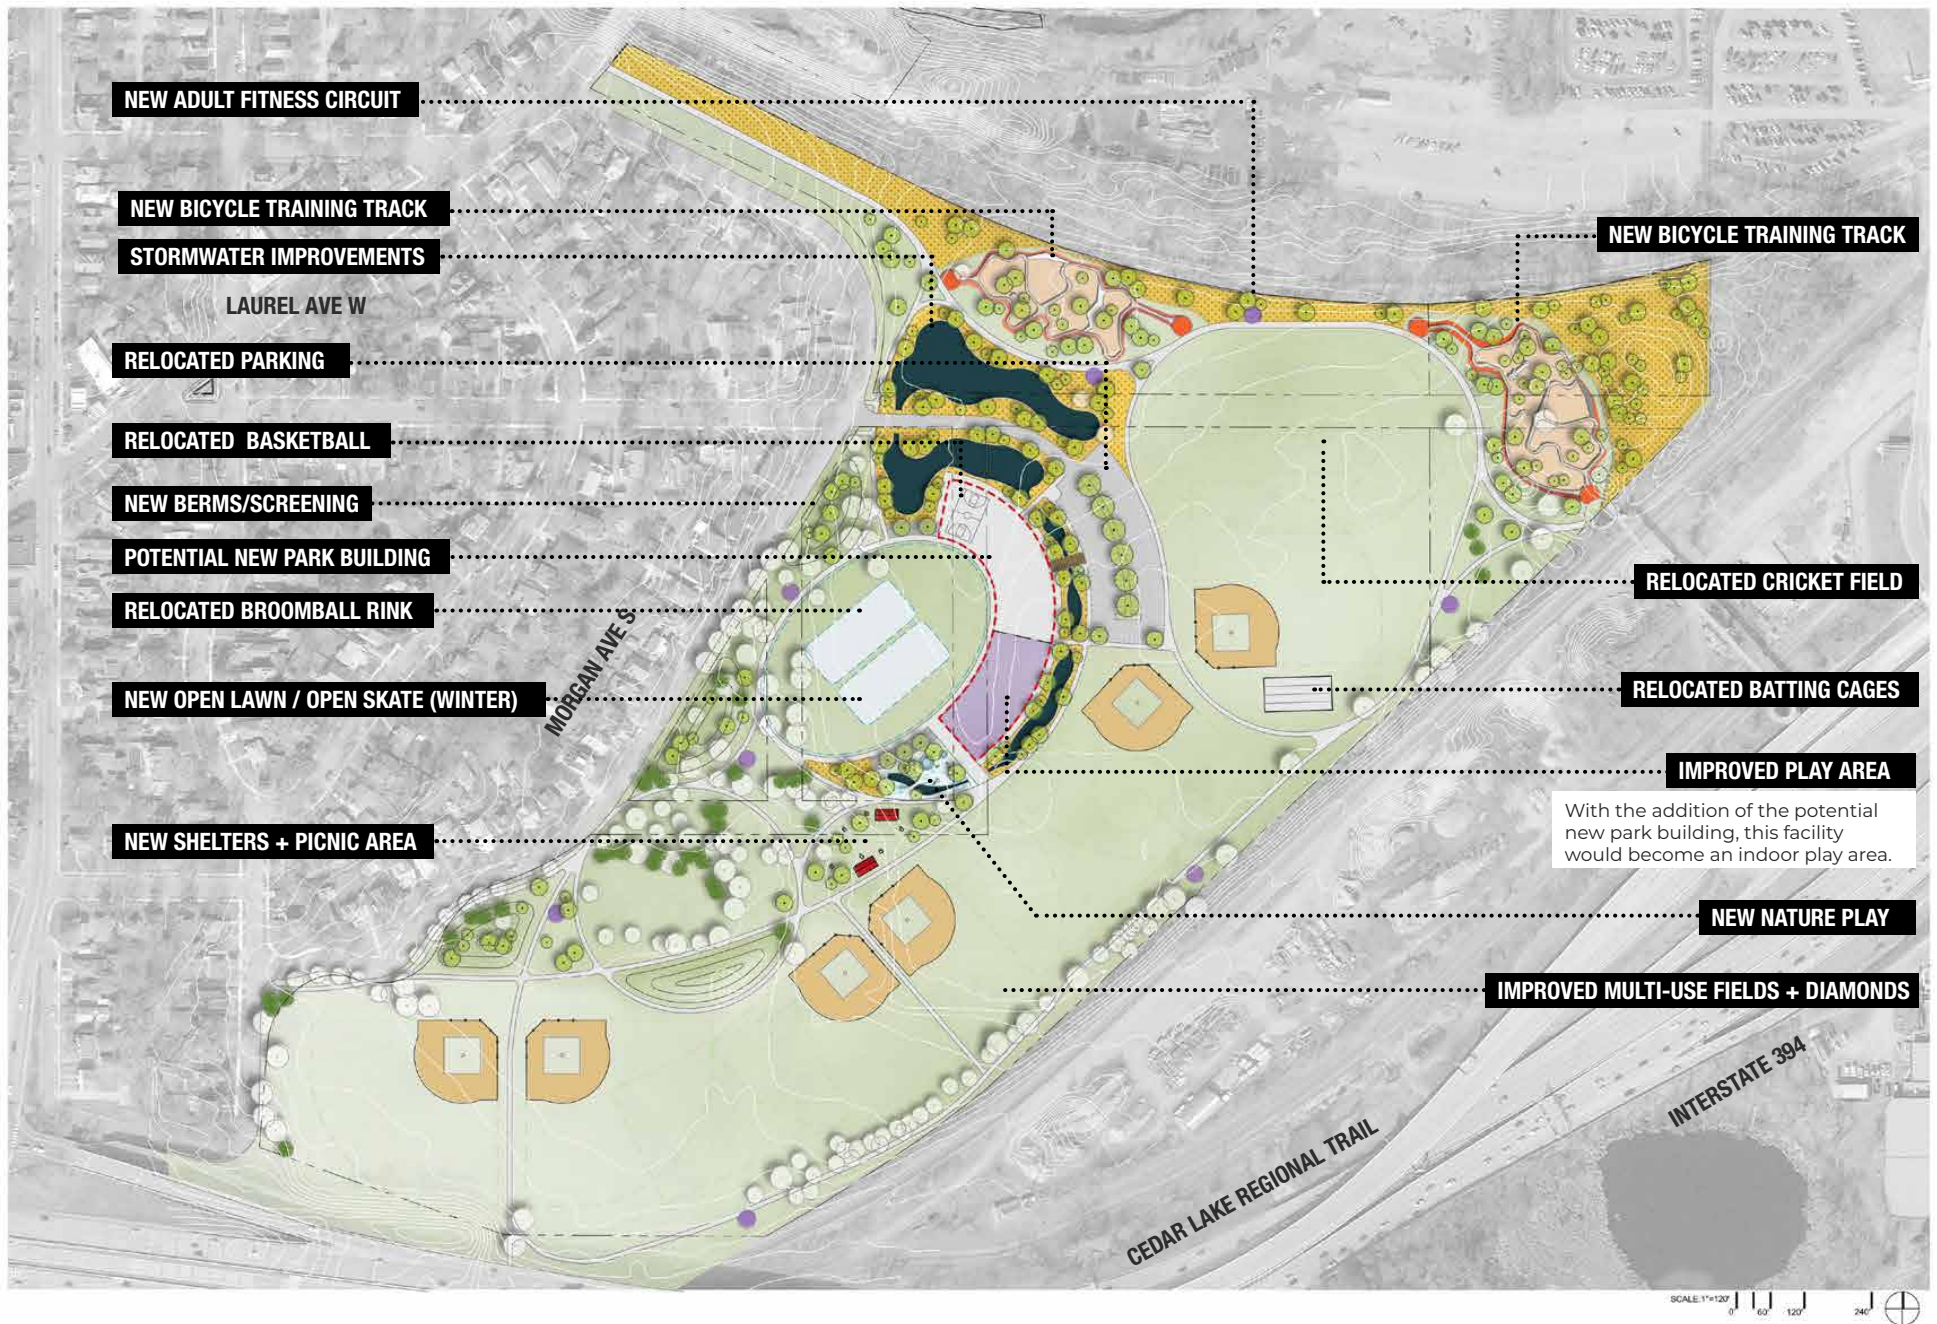
PROPOSED PLAN: BRYN MAWR PARK

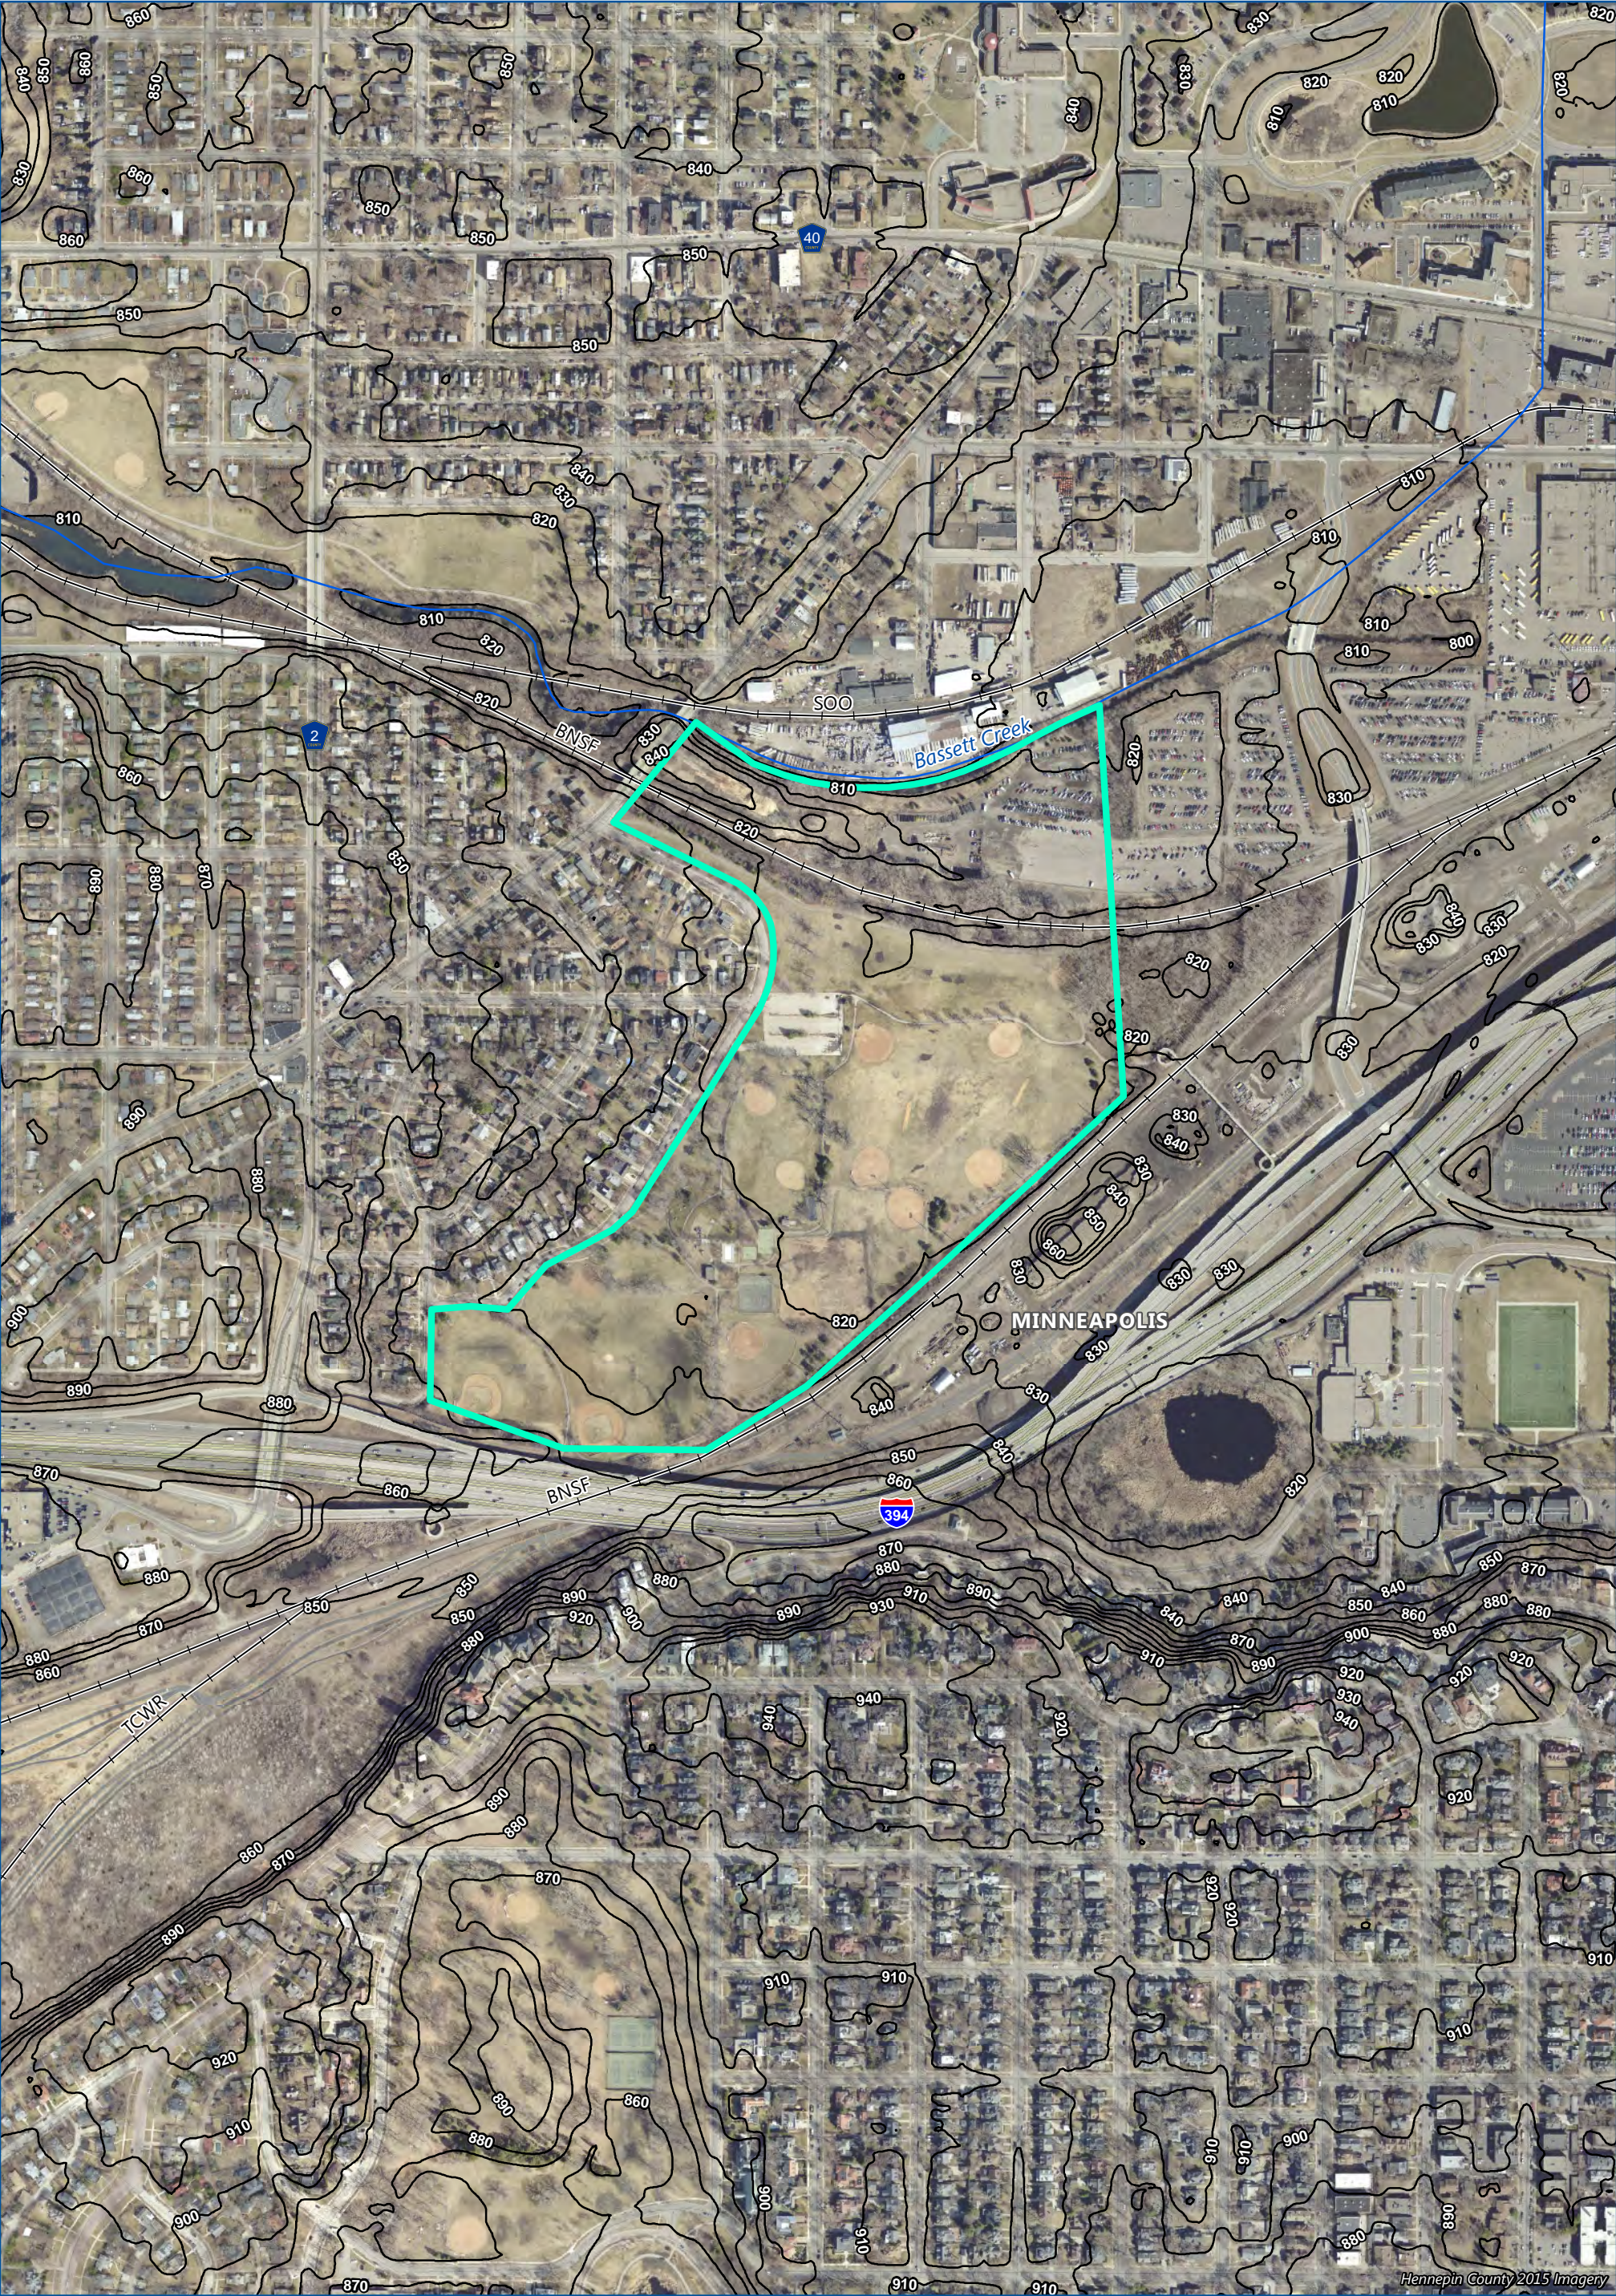
FIGURE 2

The majority of the feasibility study area maintains a flat topography in recreational and parking lot areas. Forested areas located in the central and northern regions of the feasibility study area have more moderate undulations with steeper slopes along ditches adjacent to Railroad bed and leading into Bassett Creek and wetland areas (**Figure 2**).

Feasibility Study for
Bryn Mawr Meadows
Water Quality Improvement Project
BCWMC

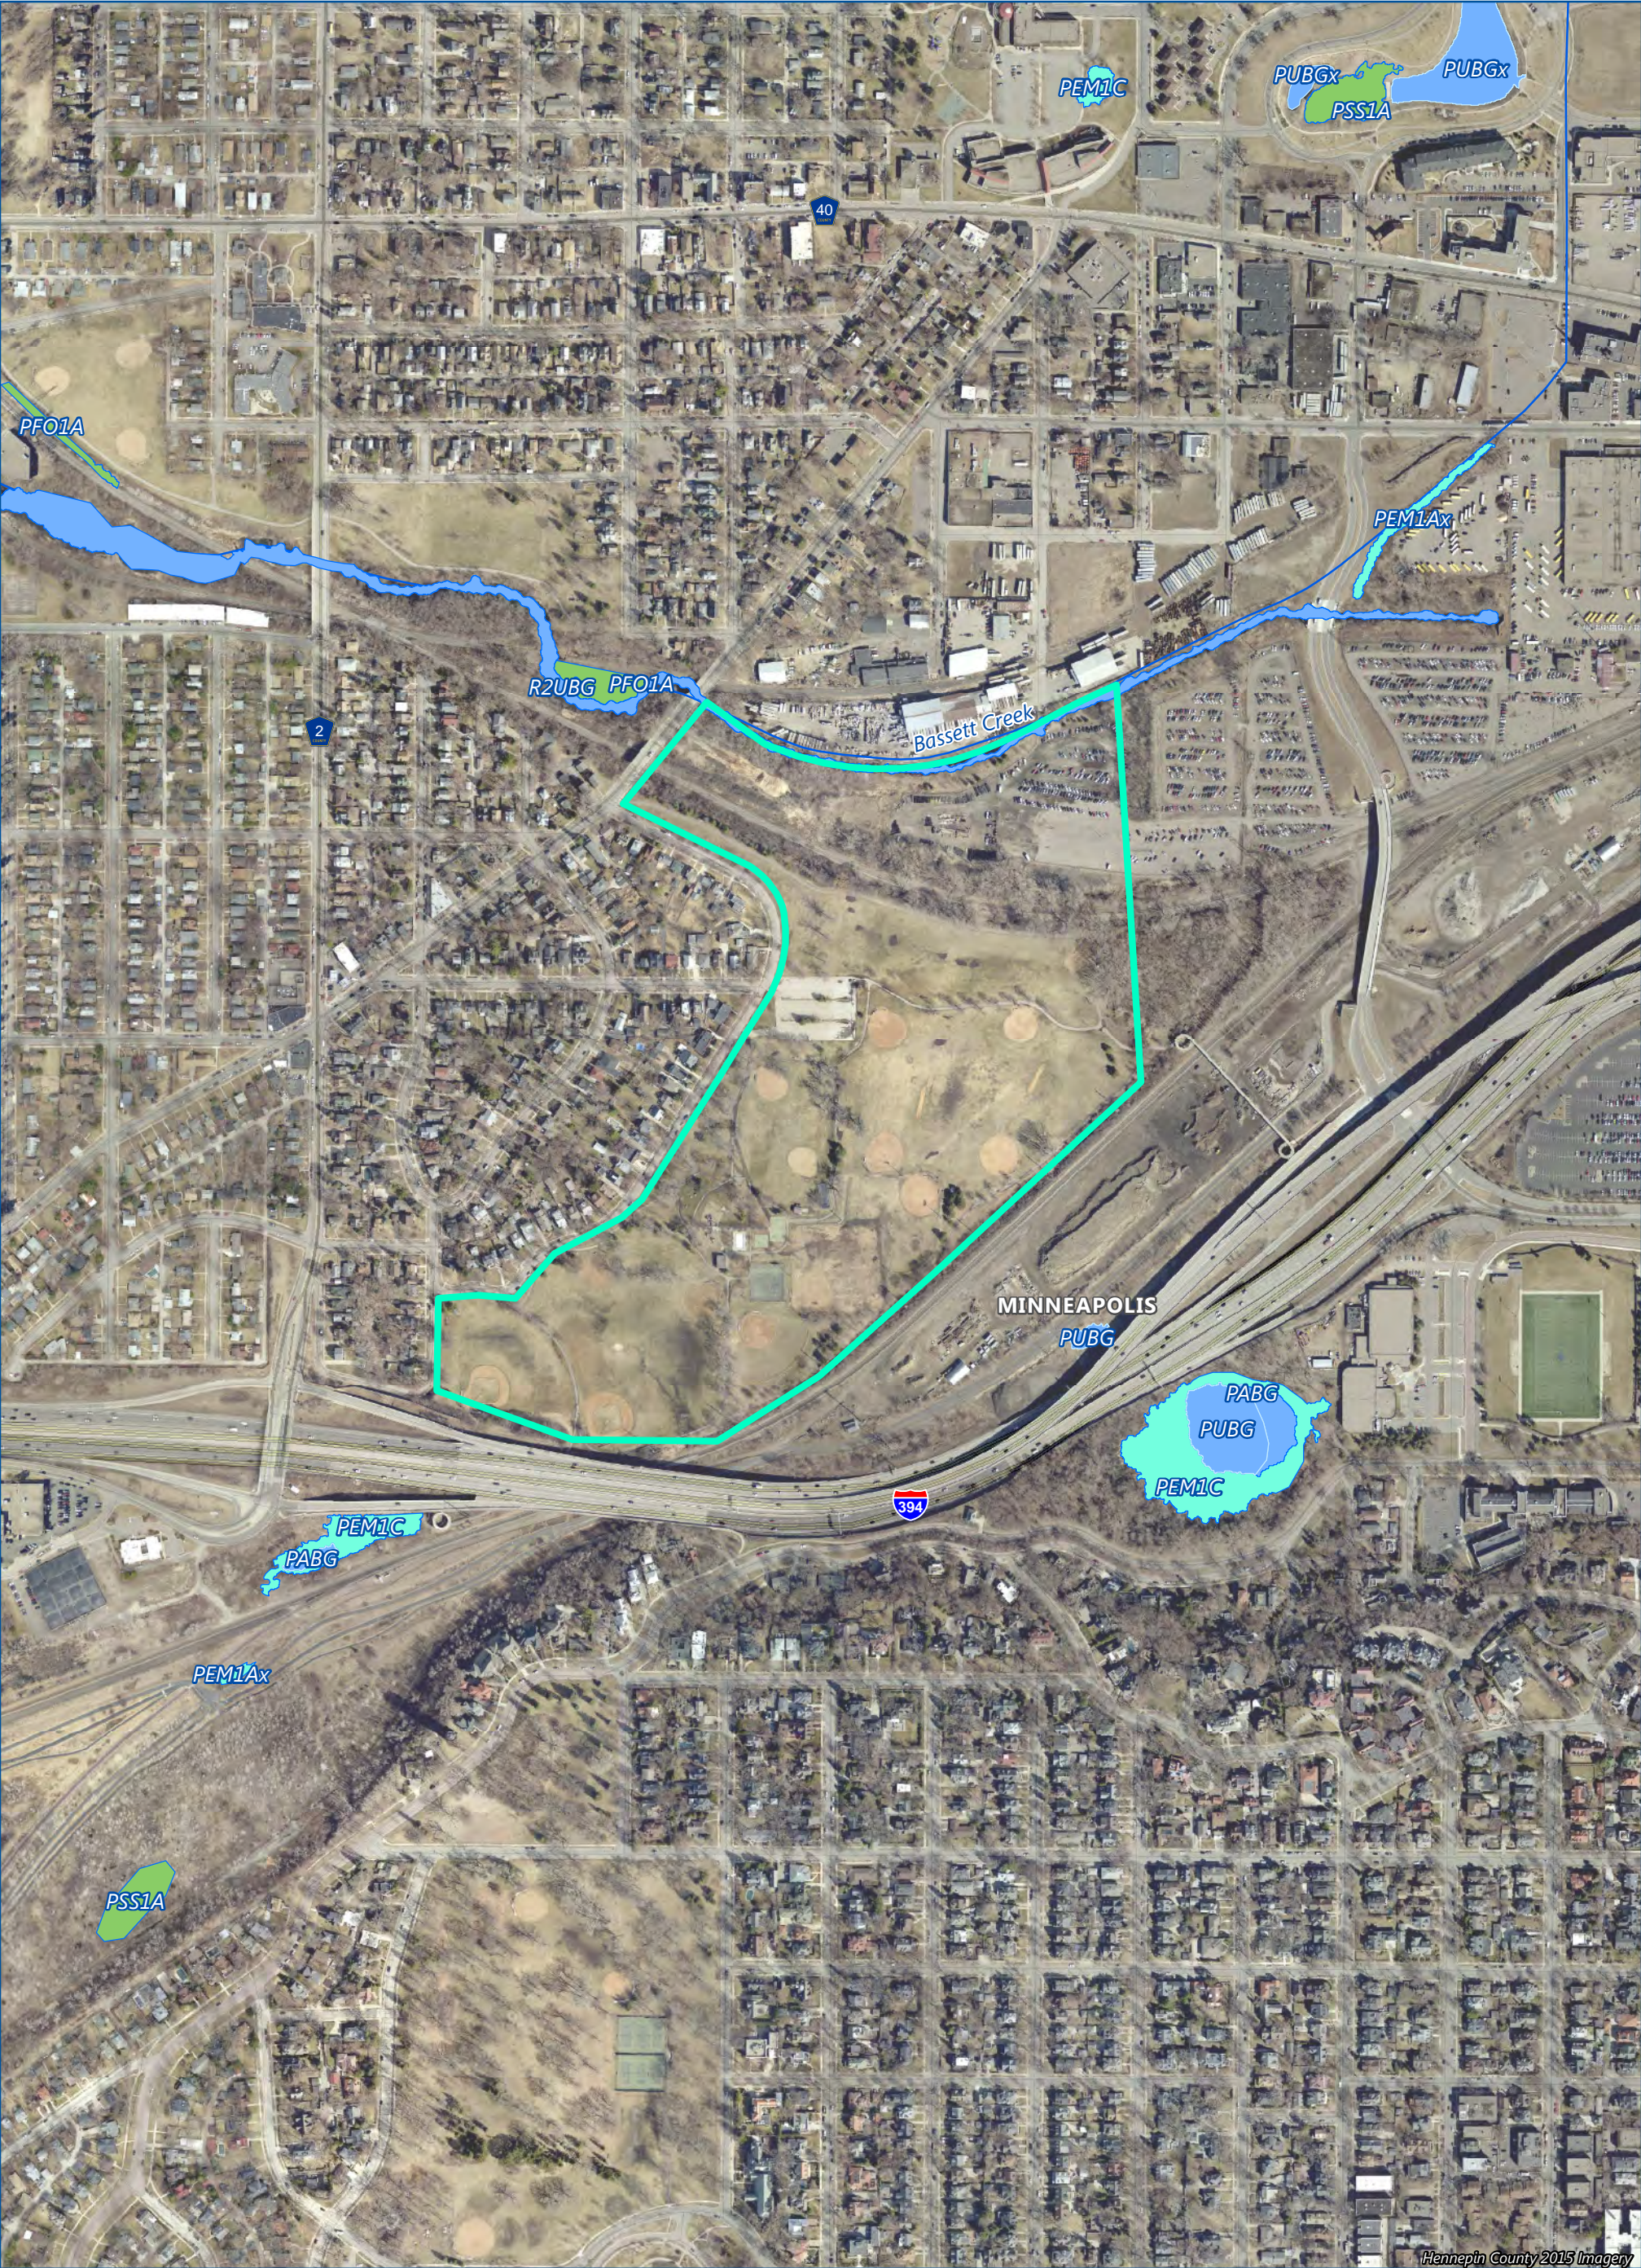
FIGURE 3

The National Wetland Inventory (NWI) has identified one riverine wetland (Bassett Creek) along the northern boundary of the feasibility study area (**Figure 3**). This portion of Bassett Creek within the feasibility study area was also delineated by Barr on November 25, 2015 (Barr, 2016).

NATIONAL WETLANDS INVENTORY
Feasibility Study for
Bryn Mawr Meadows
Water Quality Improvement Project
BCWMC

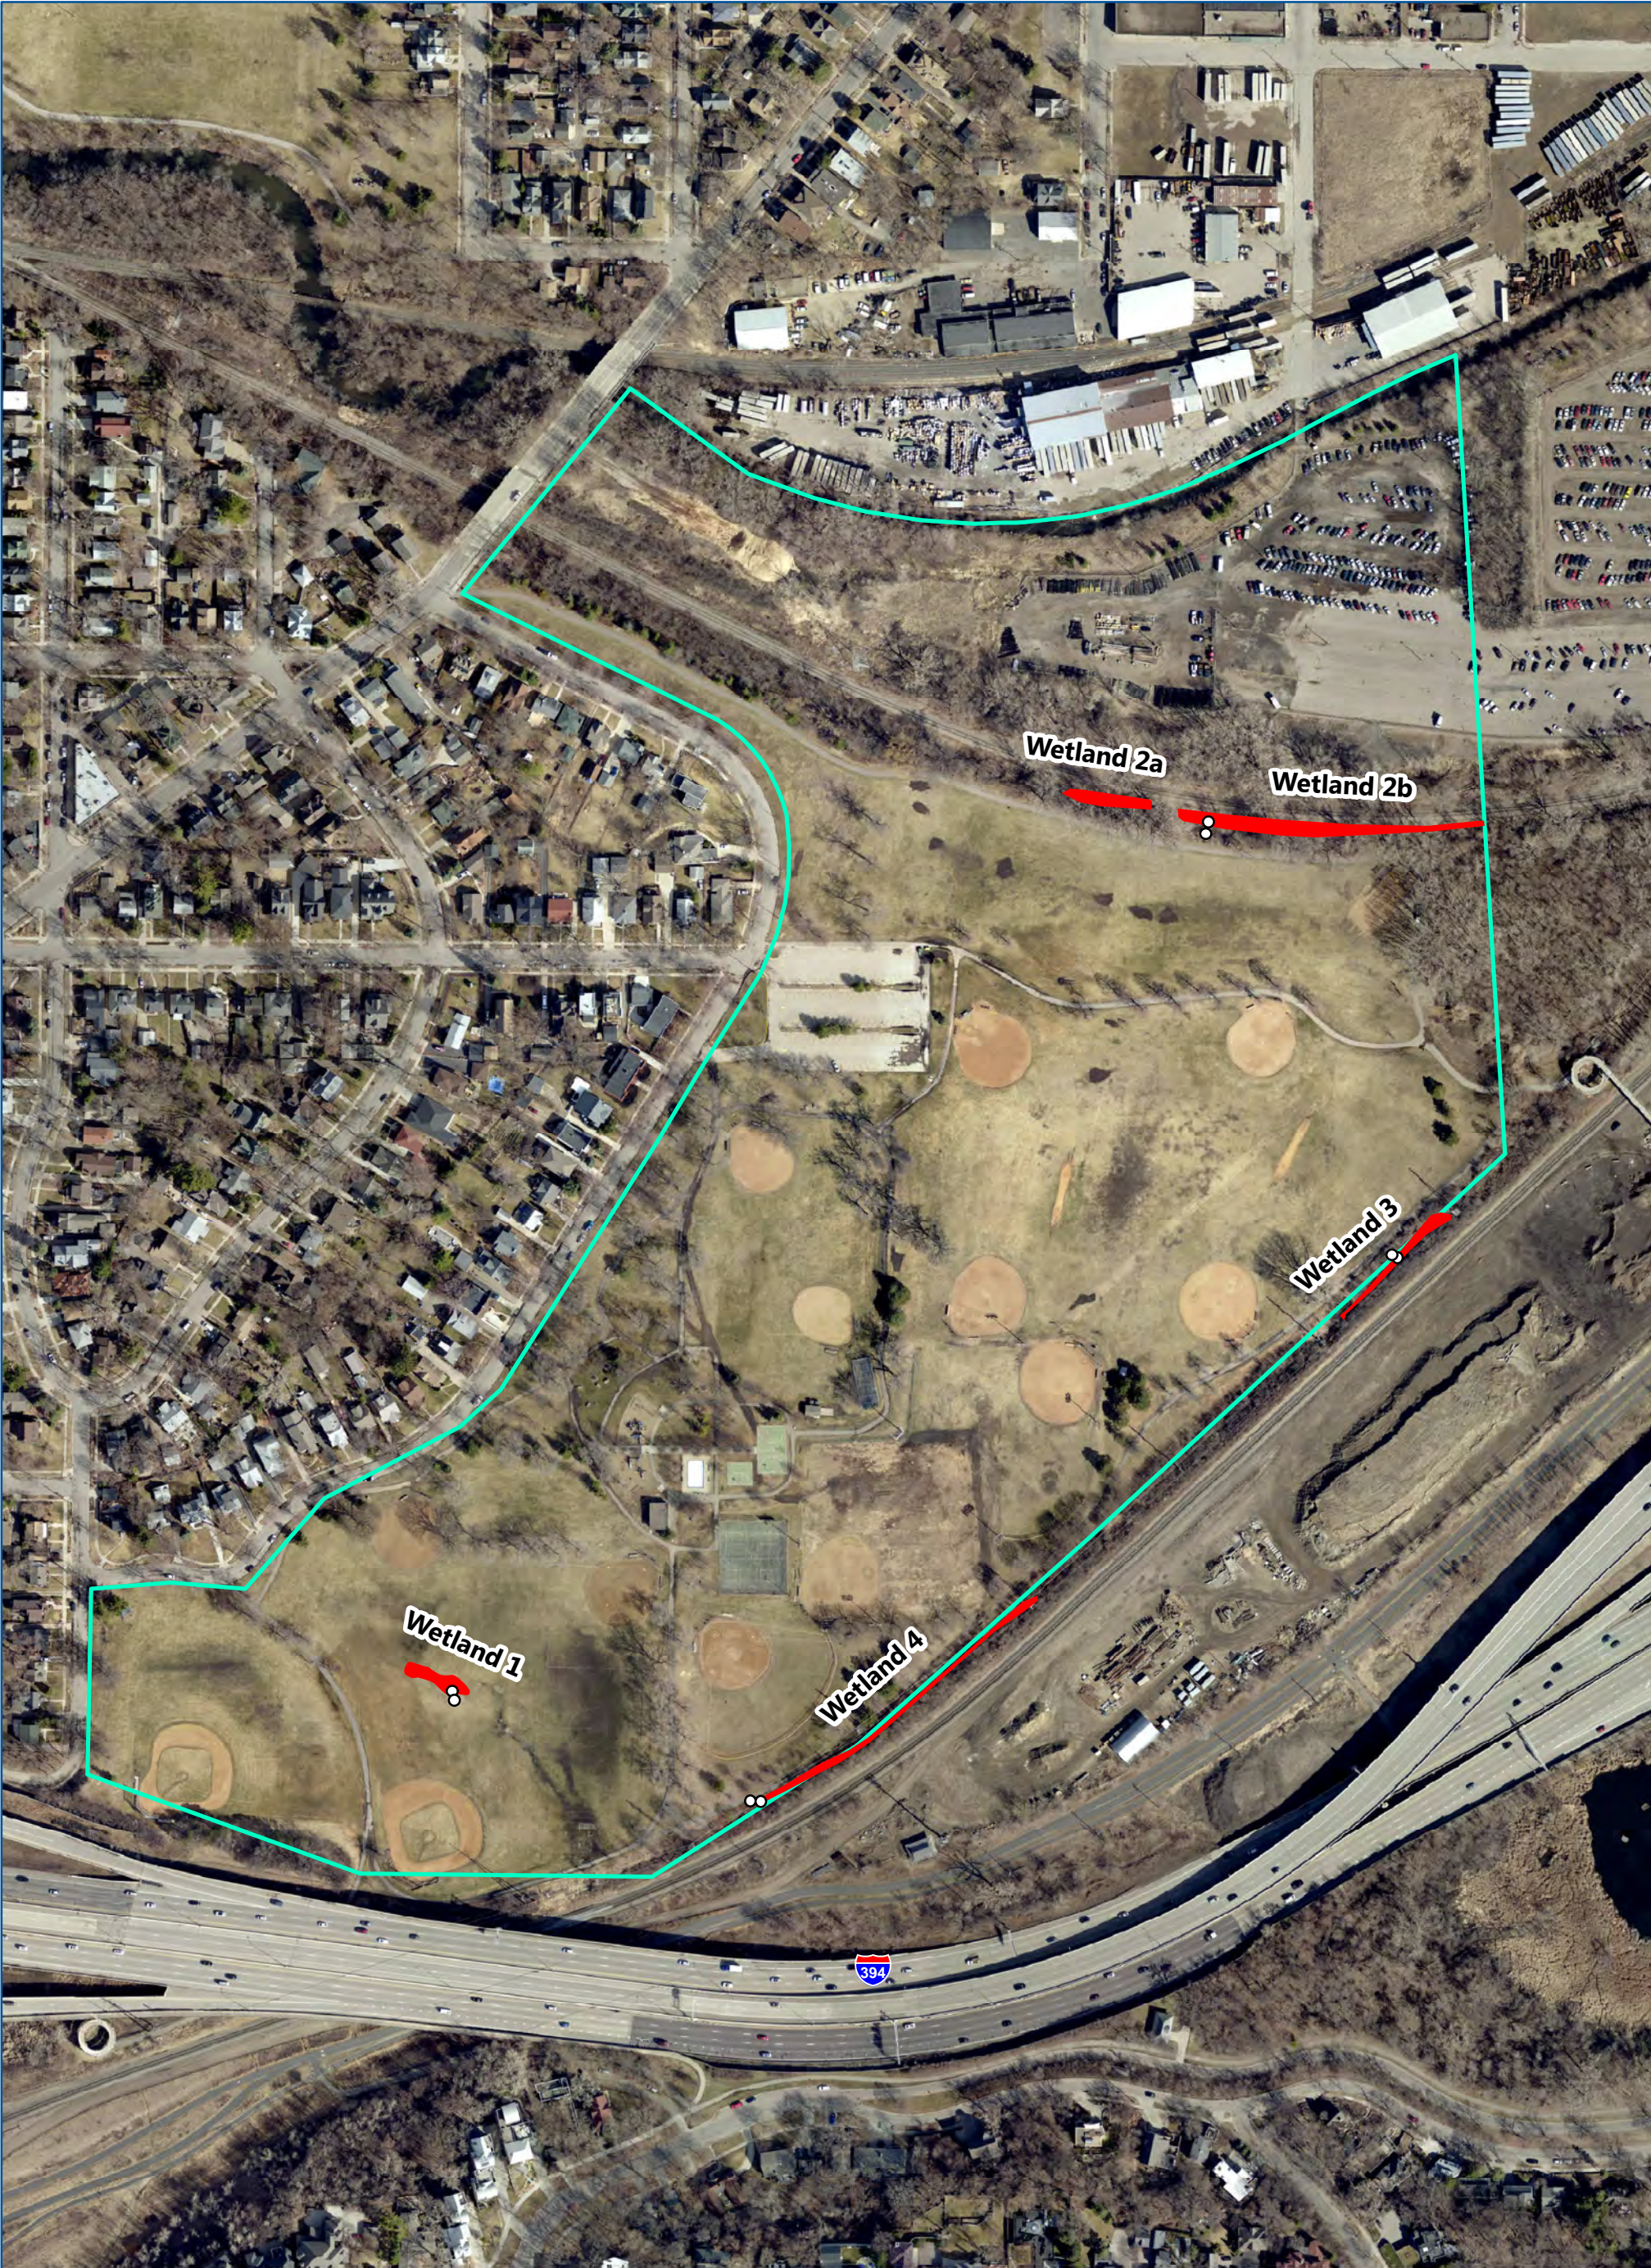
5.2.3.4 Settlement

The downdrag force is a function of design pile load and length which are unavailable at the time of this report. When the individual pile loads and lengths become finalized, the downdrag analysis should be completed.

Design of piles for uplift should be based on a combination of the skin friction and the weight of the pile. As is standard, skin friction should not be assumed to contribute to uplift resistance throughout the frost zone and the weight of the pile should be taken as the buoyant weight at depths below the water table. It is recommended that the skin friction contributing to uplift resistance should be taken as 75 percent of the skin friction used in compression (FHWA, 1999) applied to account for the potential loss of lateral earth pressure in uplift

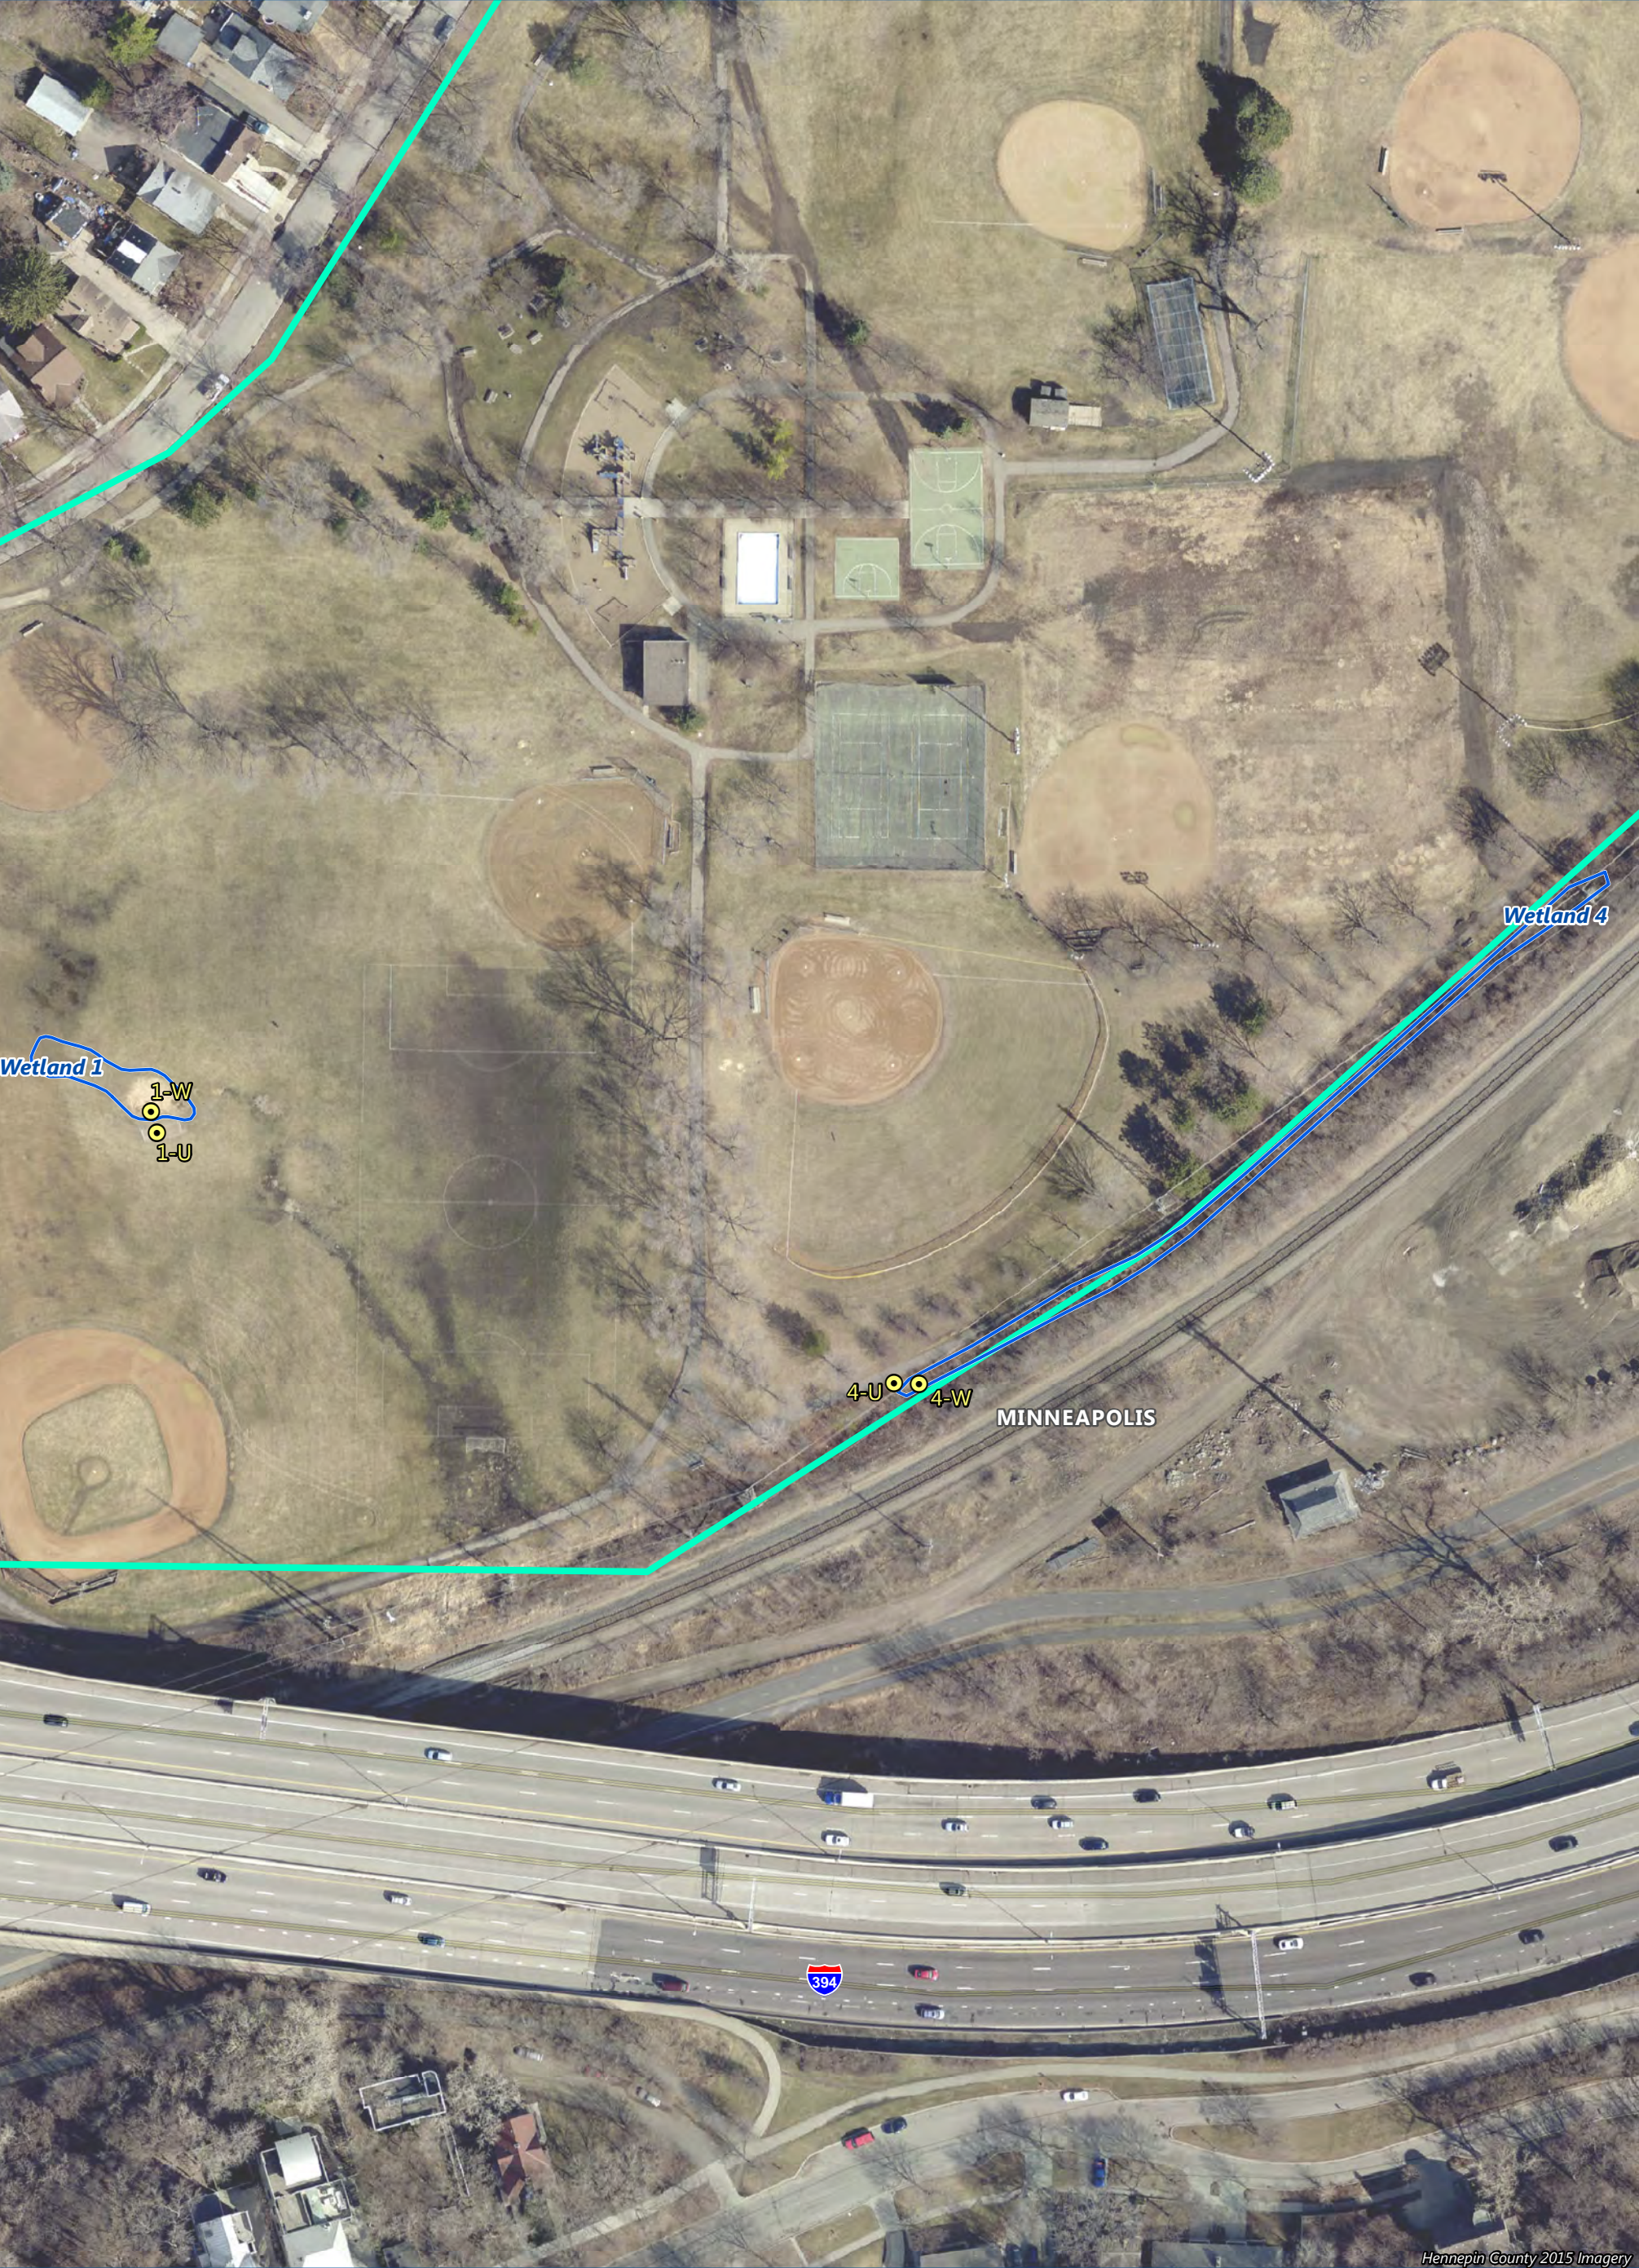
FIGURE 6

Five wetlands were delineated within the feasibility study area of the Park and along the Railroad. See **Figure 6** for an overview of the five delineated wetlands. Wetlands 1 and 4 are depicted in greater detail on **Figure 7**, and Wetlands 2a, 2b and 3 are depicted in greater detail on **Figure 8**. Areas within the feasibility study area located north of the Railroad were not investigated for wetlands during the site visit on October 20, 2017. Descriptions and assessments of each wetland are provided below, with representative photographs in **Appendix B**.

WETLAND DELINEATION
SITE OVERVIEW
Feasibility Study for
Bryn Mawr Meadows
Water Quality
Improvement Project
BCWMC

The delineated wetland boundaries and sample points were surveyed using a Global Positioning System (GPS) with sub-meter accuracy (**Figures 6, 7 & 8**).

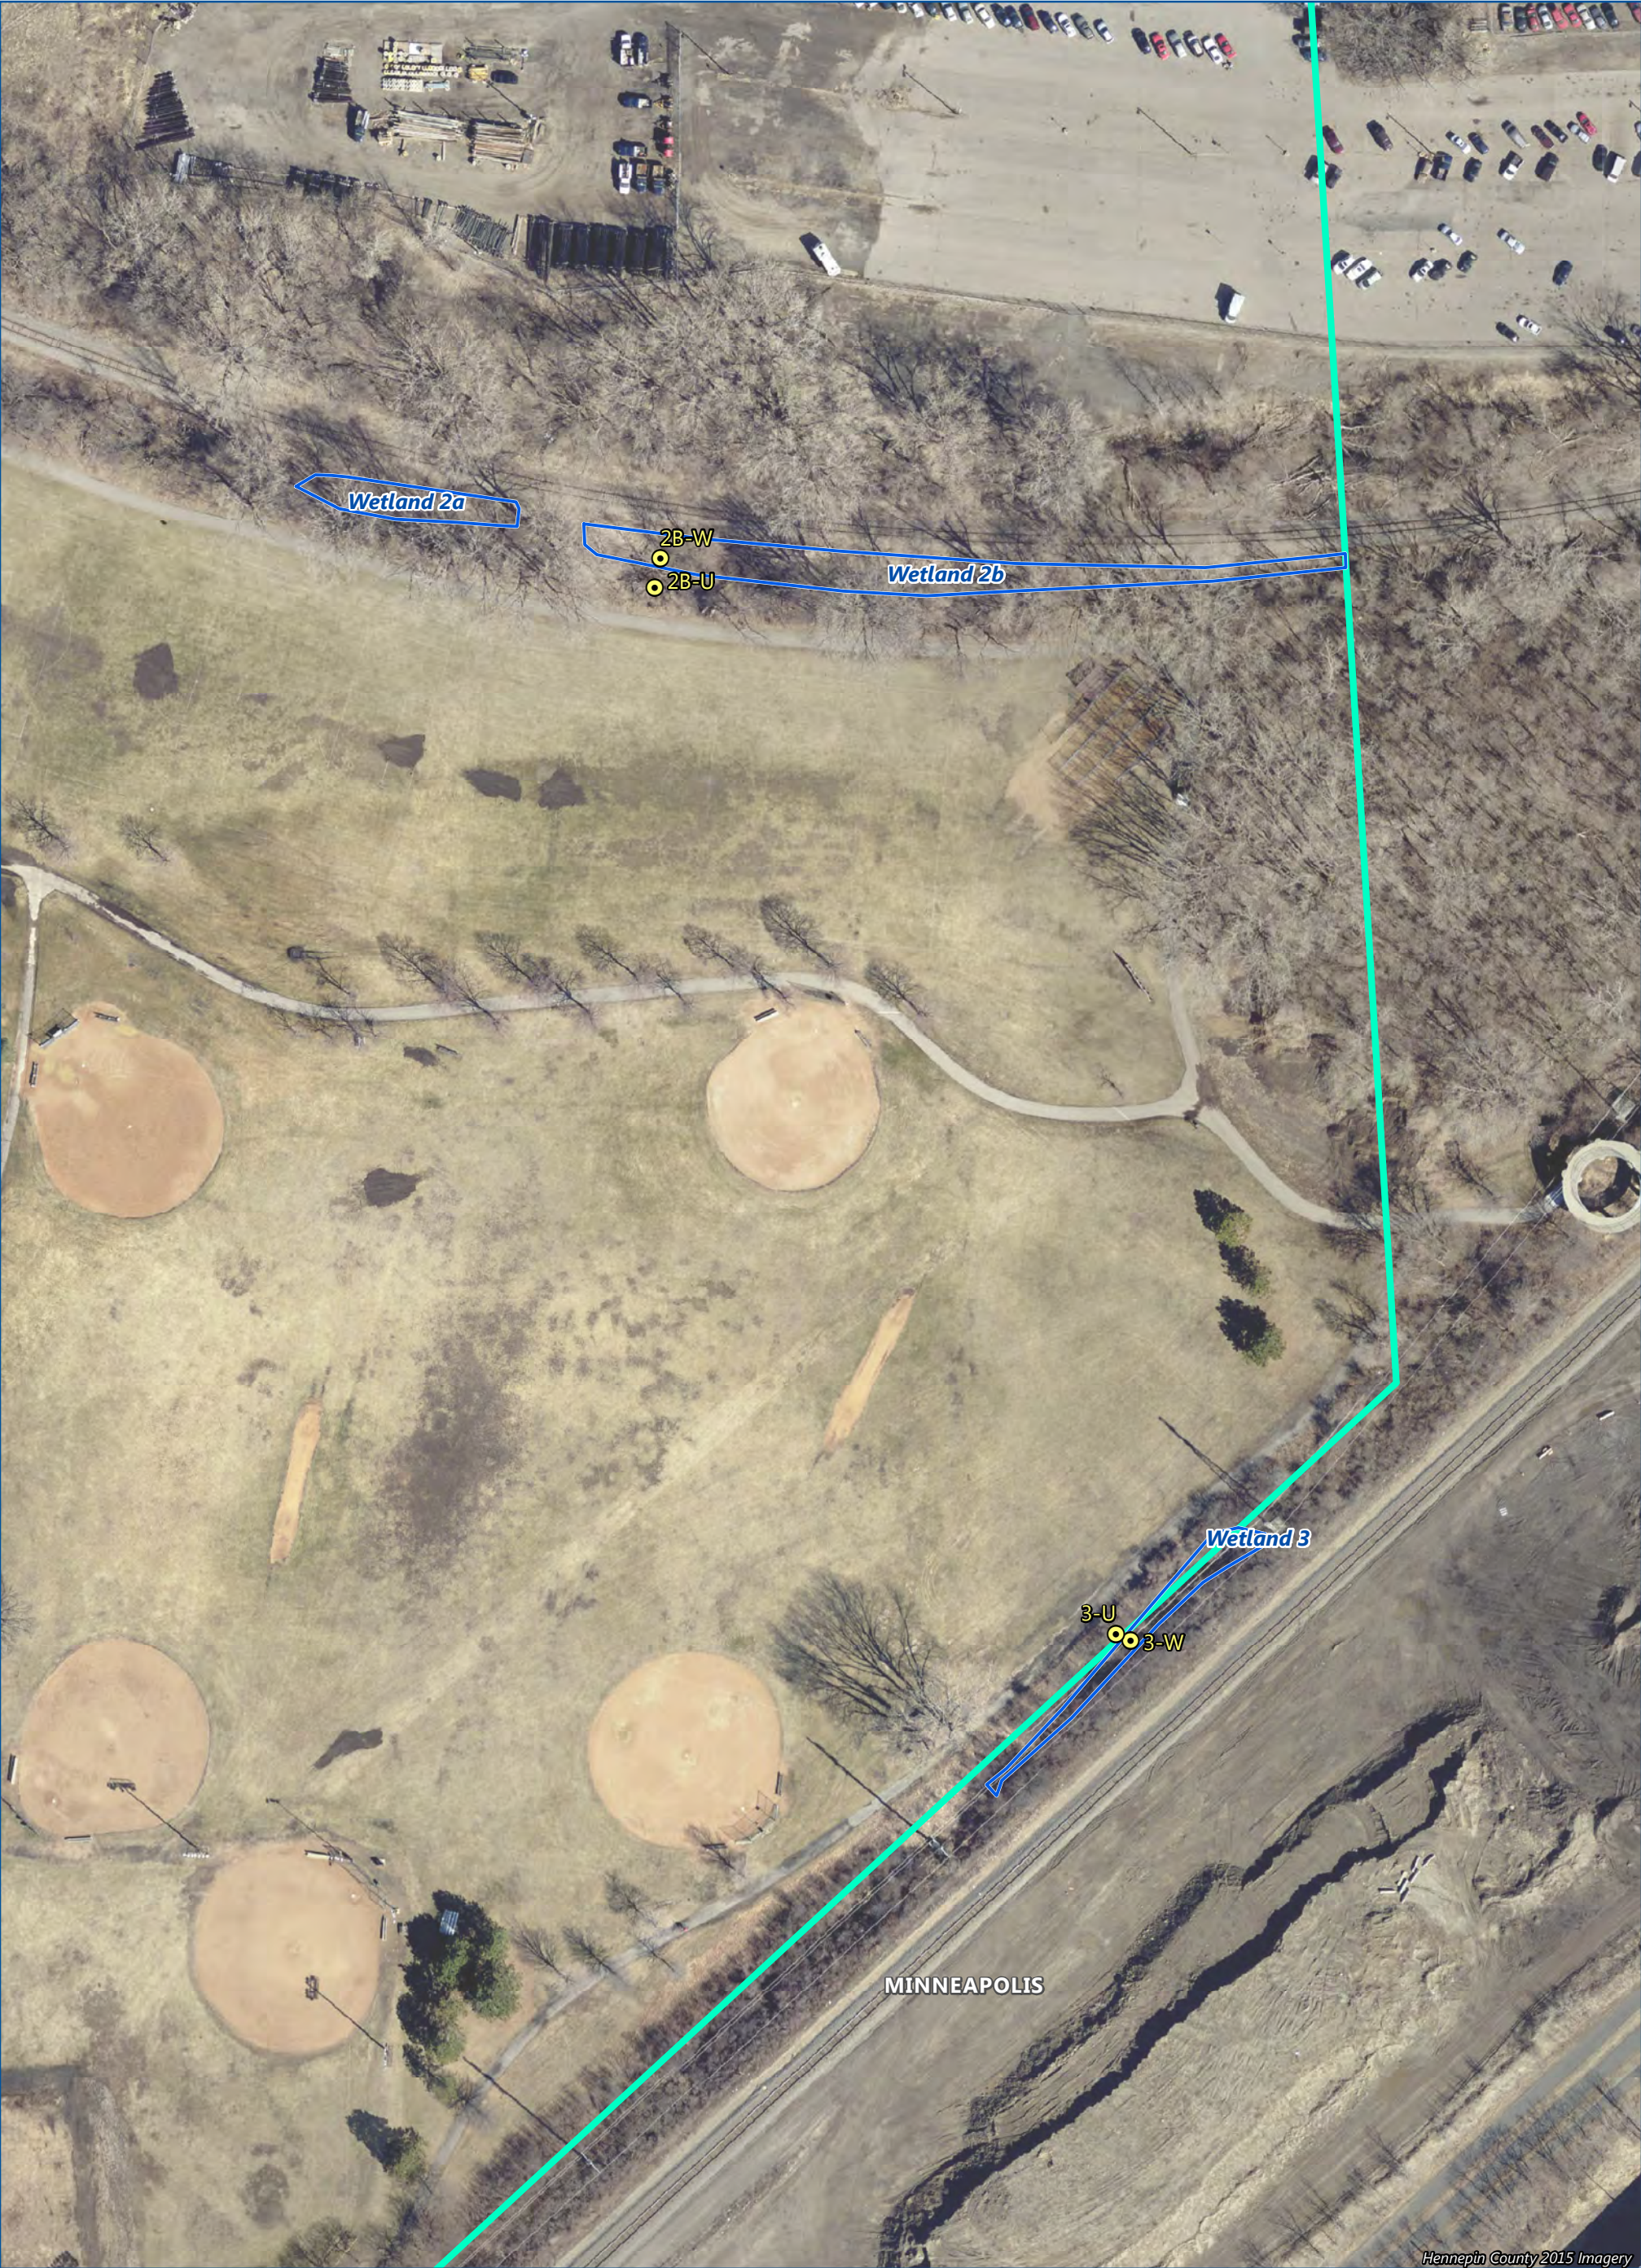
FIGURE 7

Wetland 1 is a 0.05 acre Type 2/3 (PEMB/C), wet meadow/shallow marsh located in the southwest section of the Park in a flat area utilized for sporting activities such as baseball and soccer (**Figure 7**). Wetland 1 is dominated by narrow-leaf cattail (*Typha angustifolia*), common duckweed (*Lemna minor*), Kentucky bluegrass (*Poa pratensis*), and blunt spikerush (*Eleocharis obtusa*). Hydrology within Wetland 1 ranges from surface saturation in the wet meadow community to 3 inches of inundation in the shallow marsh community. Surrounding uplands in this area and throughout the Park are dominated by Kentucky bluegrass.

WETLAND DELINEATION
WETLANDS 1 & 4
Feasibility Study for
Bryn Mawr Meadows
Water Quality Improvement Project
BCWMC

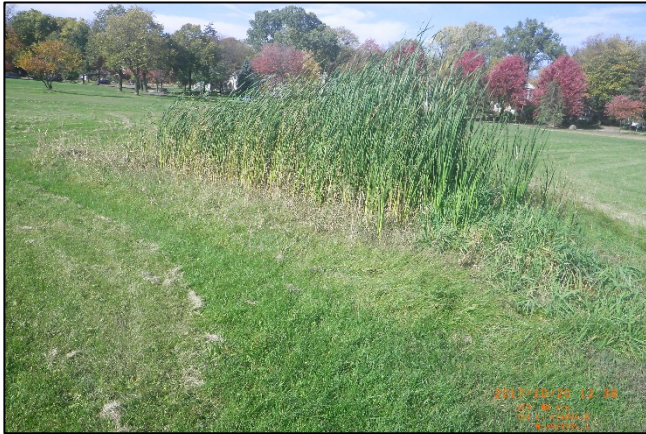
Photo 1: Wetland 1 facing northwest. Hydrology contributing to this wetland appears to be originating from an exposed pipe causing water to pool in this low area which is creating shallow marsh community.

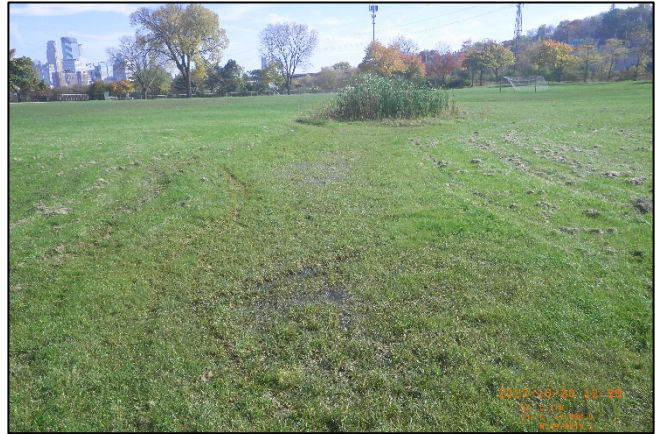
Photo 2: Wetland 1 facing east. Most of the wet meadow portion of Wetland 1 is saturated to the surface and dominated by mown Kentucky bluegrass.
