Minneapolis Park and Recreation Board Preferred Master Plan Alternatives

BRYN MAWR PARK

For settlement analyses, the upper bound of consolidation coefficients and corresponding void ratio and preconsolidation pressures were matched to the clay layers of the generalized soil profile. For immediate settlement, the undrained modulus of elasticity was estimated from the overconsolidation ratio (OCR) and index properties of the clayey soils (Fang, 2007). The drained modulus of elasticity was estimated from correlations with SPT results (Fang, 2007).

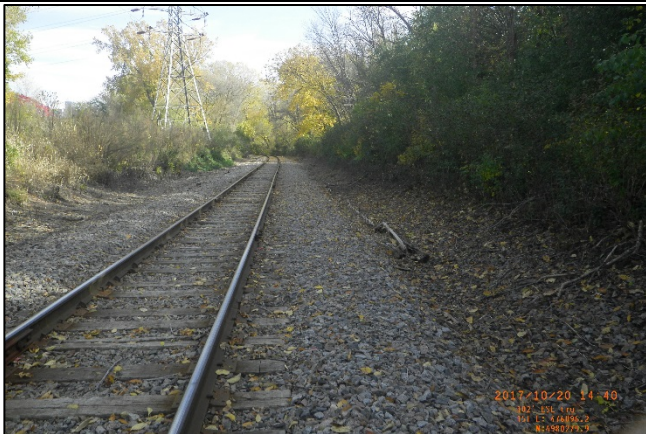
Photo 3: Non-vegetated upland ditch area adjacent to railroad bed. This area eventually leads into Wetland 2a located approximately 650 feet ESE from this point. This is a typical view of upland areas adjacent to the railroad bed.

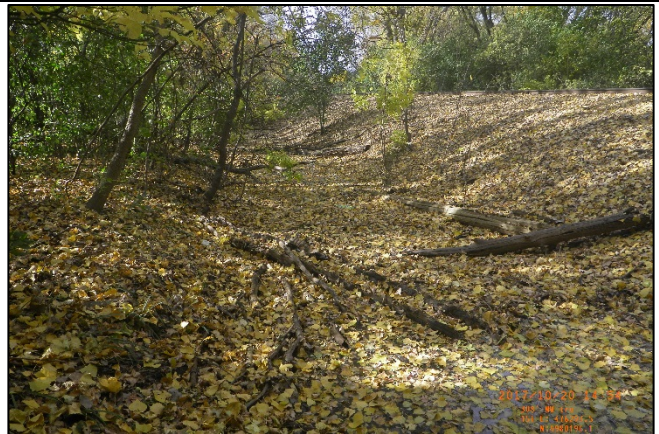
Photo 4: Wetland 2a facing west. Most of the 6-12 inches of surface water in Wetland 2a is covered by leaves, but dominant vegetation present at the time of the site visit was common duckweed. Wetlands 2a & 2b are ditch wetlands separated by a culvert.

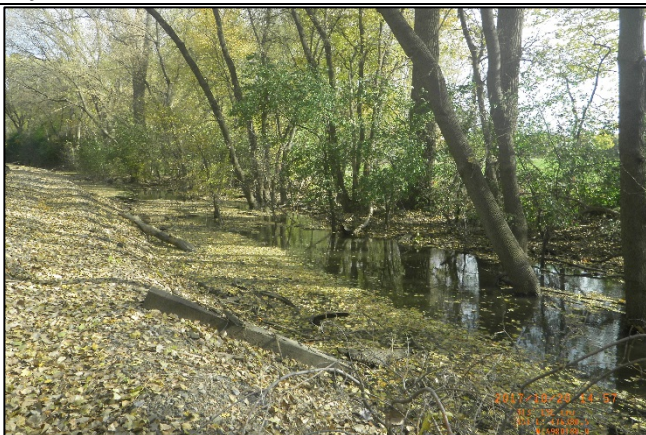
Photo 5: Wetland 2b facing east-southeast. Dominant vegetation present at the time of the site visit was common duckweed. Wetland 2b was inundated between 6 and 24 inches. Wetlands 2a & 2b are ditch wetlands separated by a culvert.

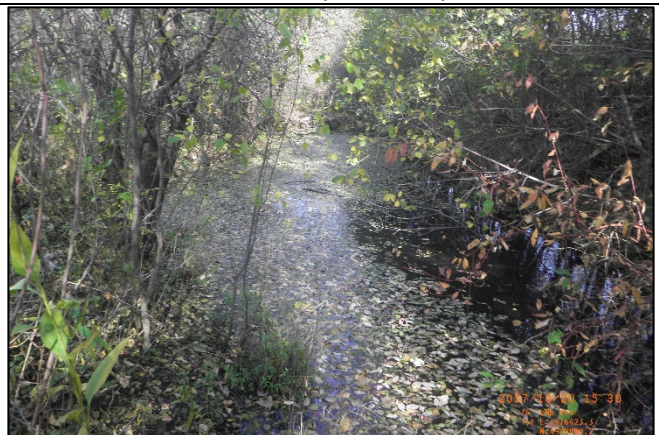
Photo 6: Wetland 3 facing southwest. Wetland 3 is a narrow ditch wetland (between 5-10 feet wide) dominated by common duckweed, and reed canary grass. Wetlands 3 and 4 are low spots within the same ditch.

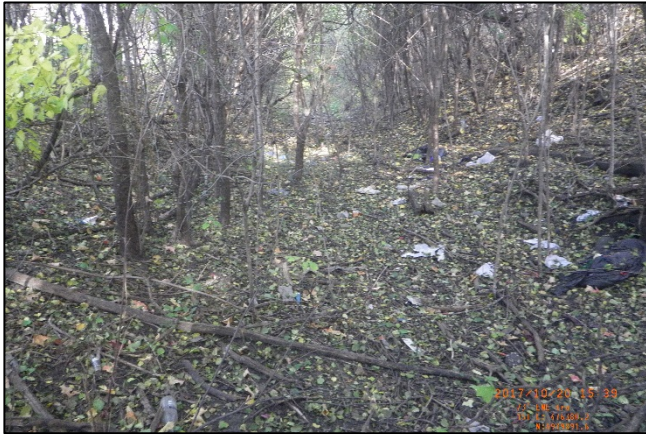
Photo 7: Typical view of upland ditch located between Wetland 3 and Wetland 4. Area is mostly not vegetated but does harbor European buckthorn in the herbaceous and shrub layers in some areas.

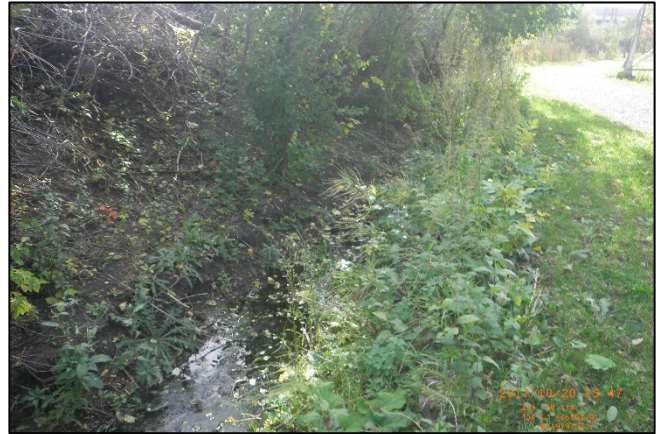
Photo 8: Wetland 4 facing southeast at the narrowest point (approximately 12 inches wide). Common duckweed is dominant in this location and is inundated approximately 2 inches. Wetlands 3 and 4 are low spots within the same ditch.

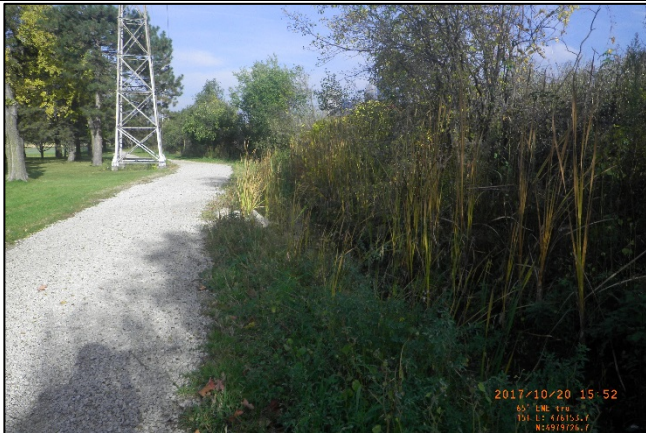
Photo 9: Wetland 4 facing northeast at the widest point (approximately 4 feet wide). Duckweed, lakebank sedge, reed canary grass, and cattail are all dominant at this location and is inundated approximately 12 inches.

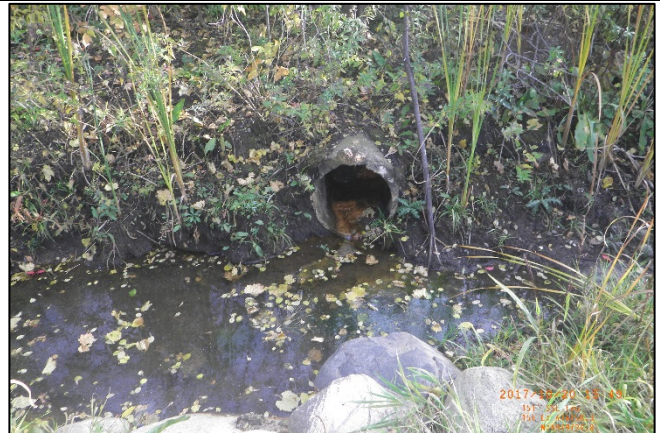
Photo 10: Wetland 4 facing southeast. Culvert reveals one potential source of hydrology for Wetland 4.

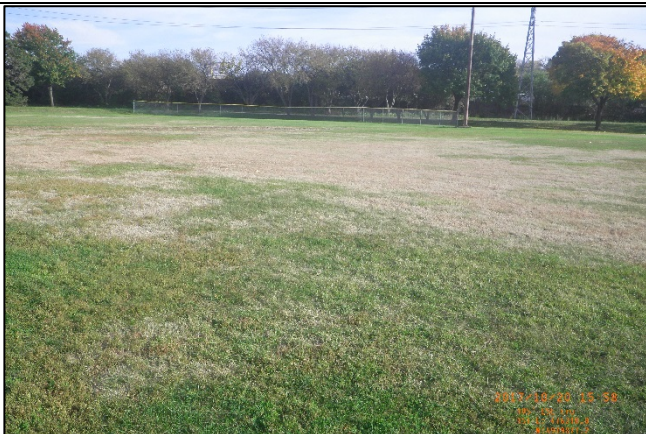
Photo 11: Area that occasionally becomes inundated after a rain event located southwest side of Bryn Mawr Meadow Park.

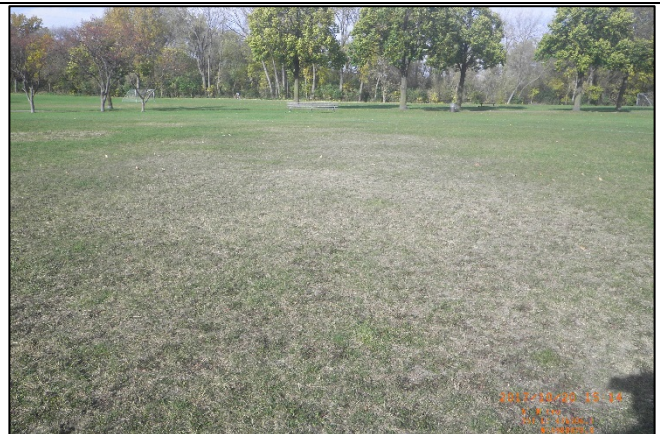
Photo 12: Area that occasionally becomes inundated after a rain event located northeast side of Bryn Mawr Meadow Park.

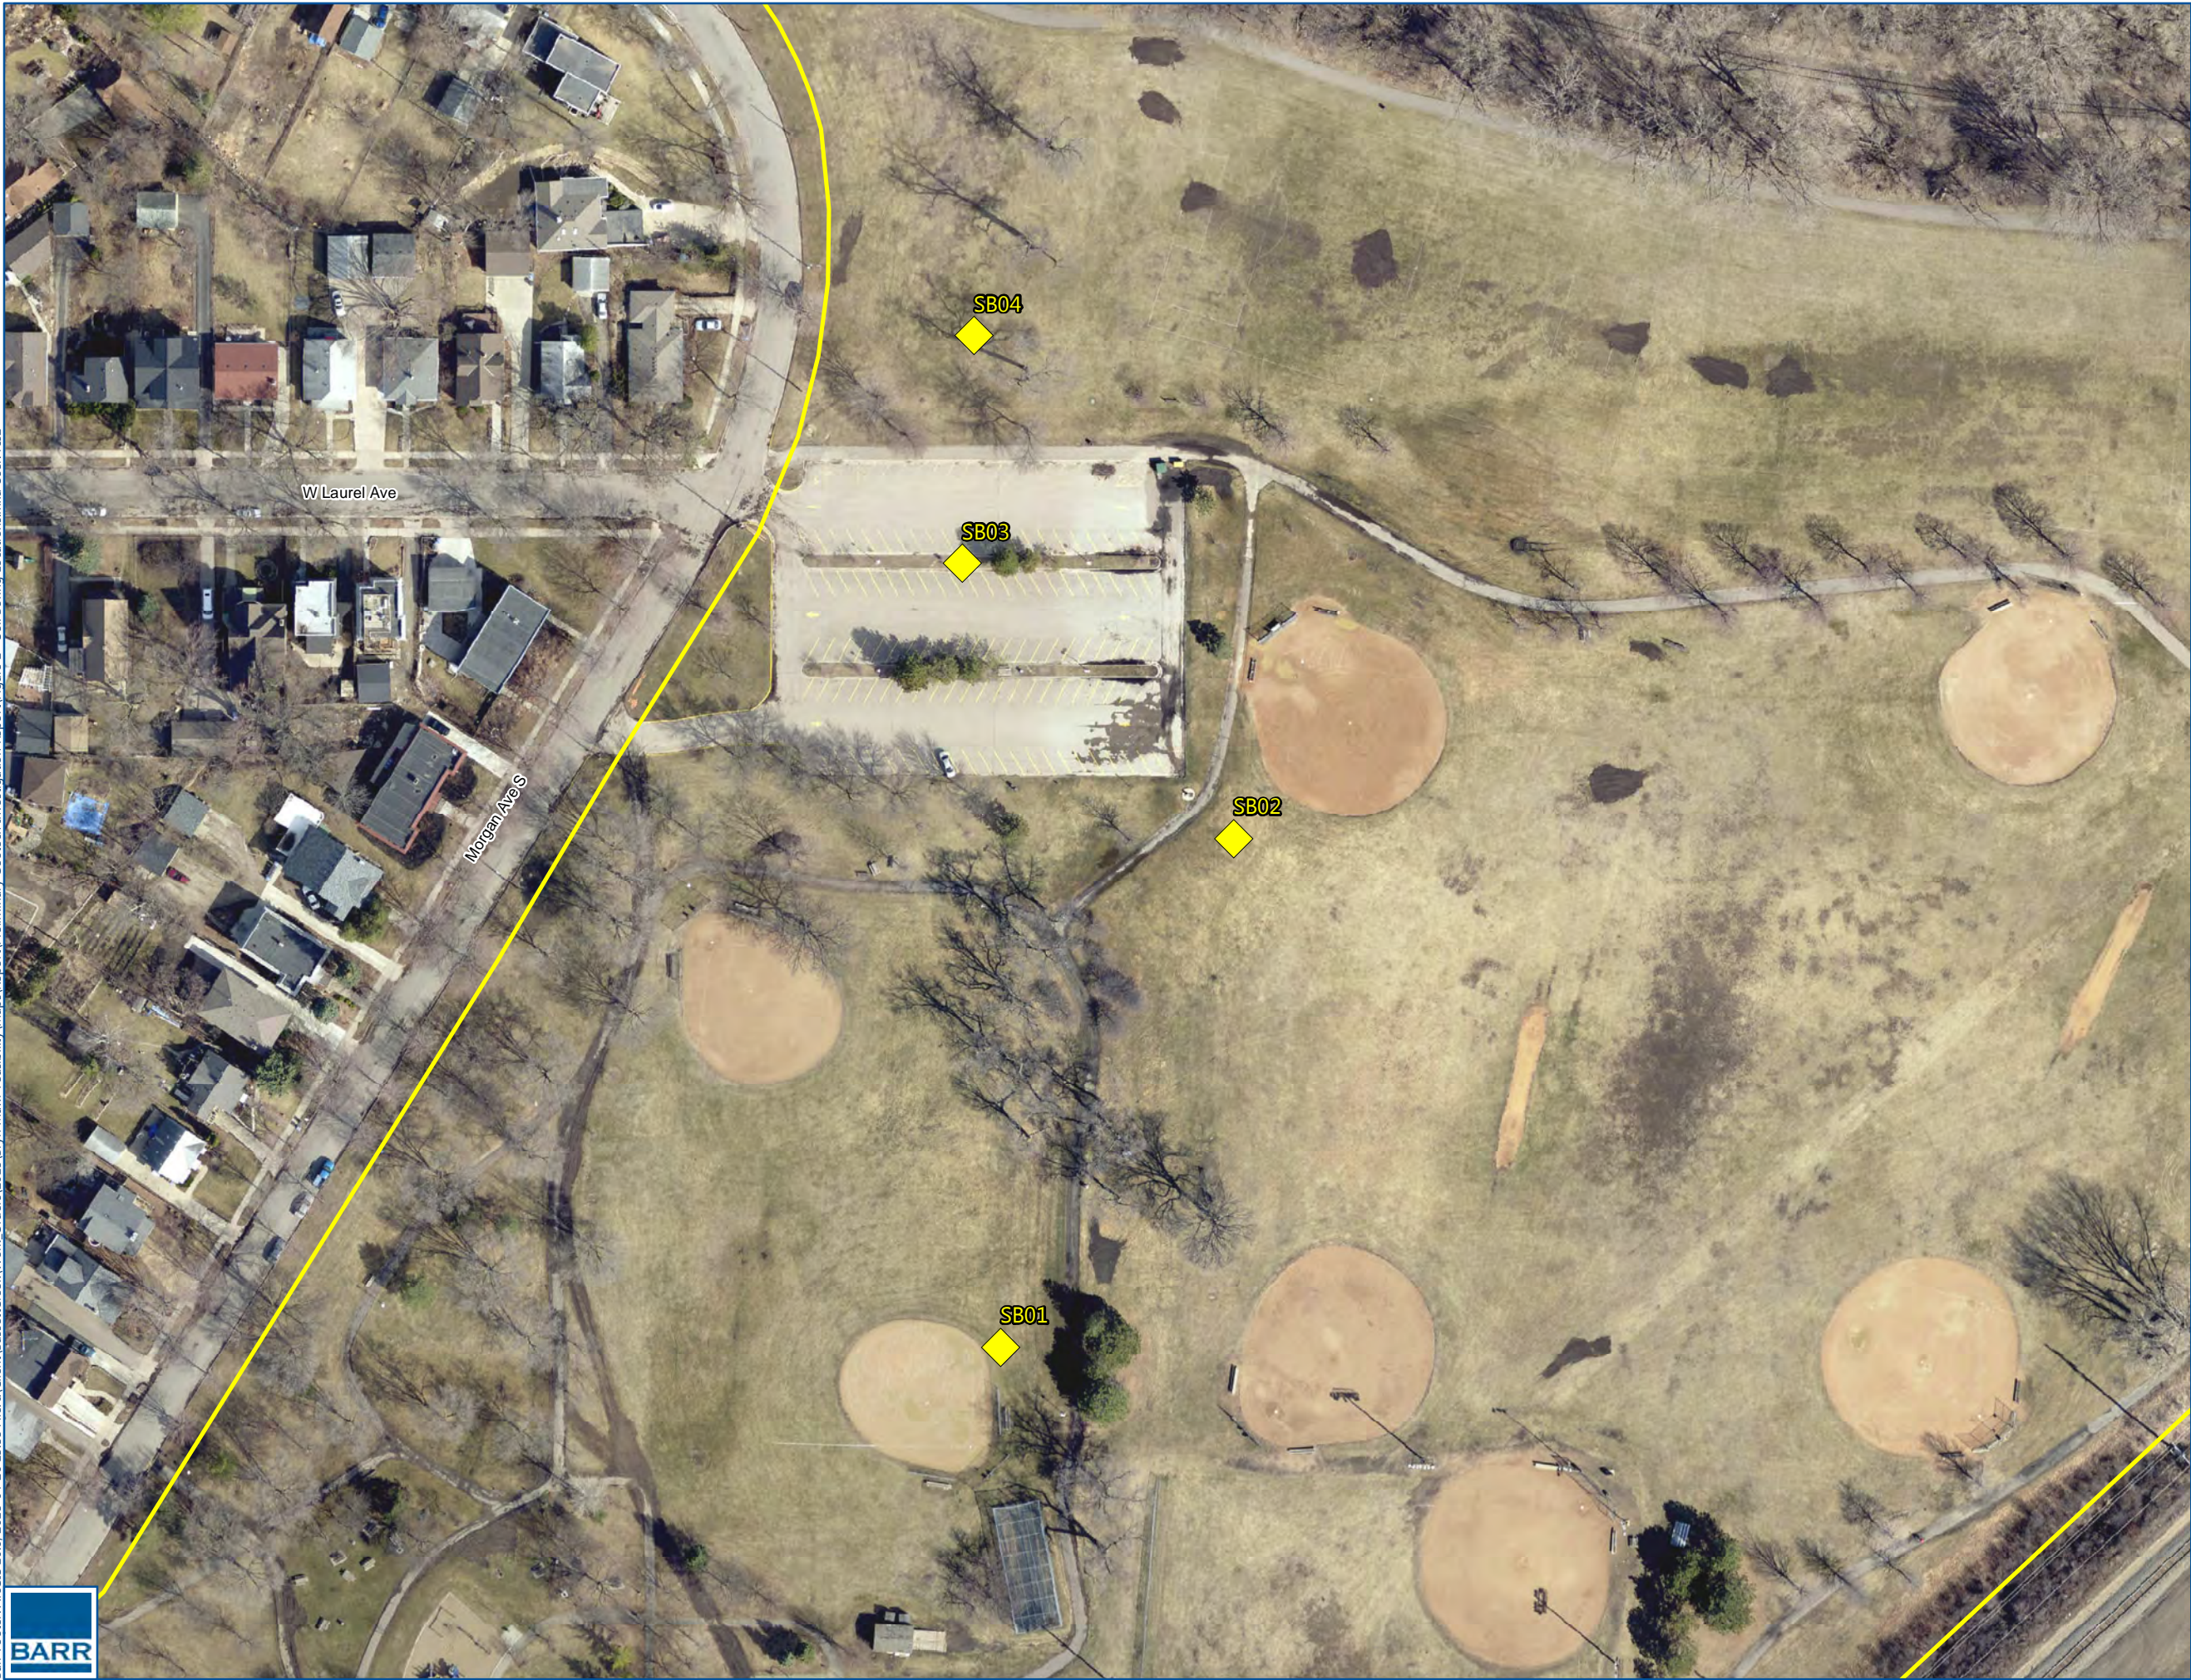
FIGURE 1

Geotechnical Boring

SOIL BORING LOCATIONS
Feasibility Study for
Bryn Mawr Meadows
Water Quality Improvement Project
BCWMC

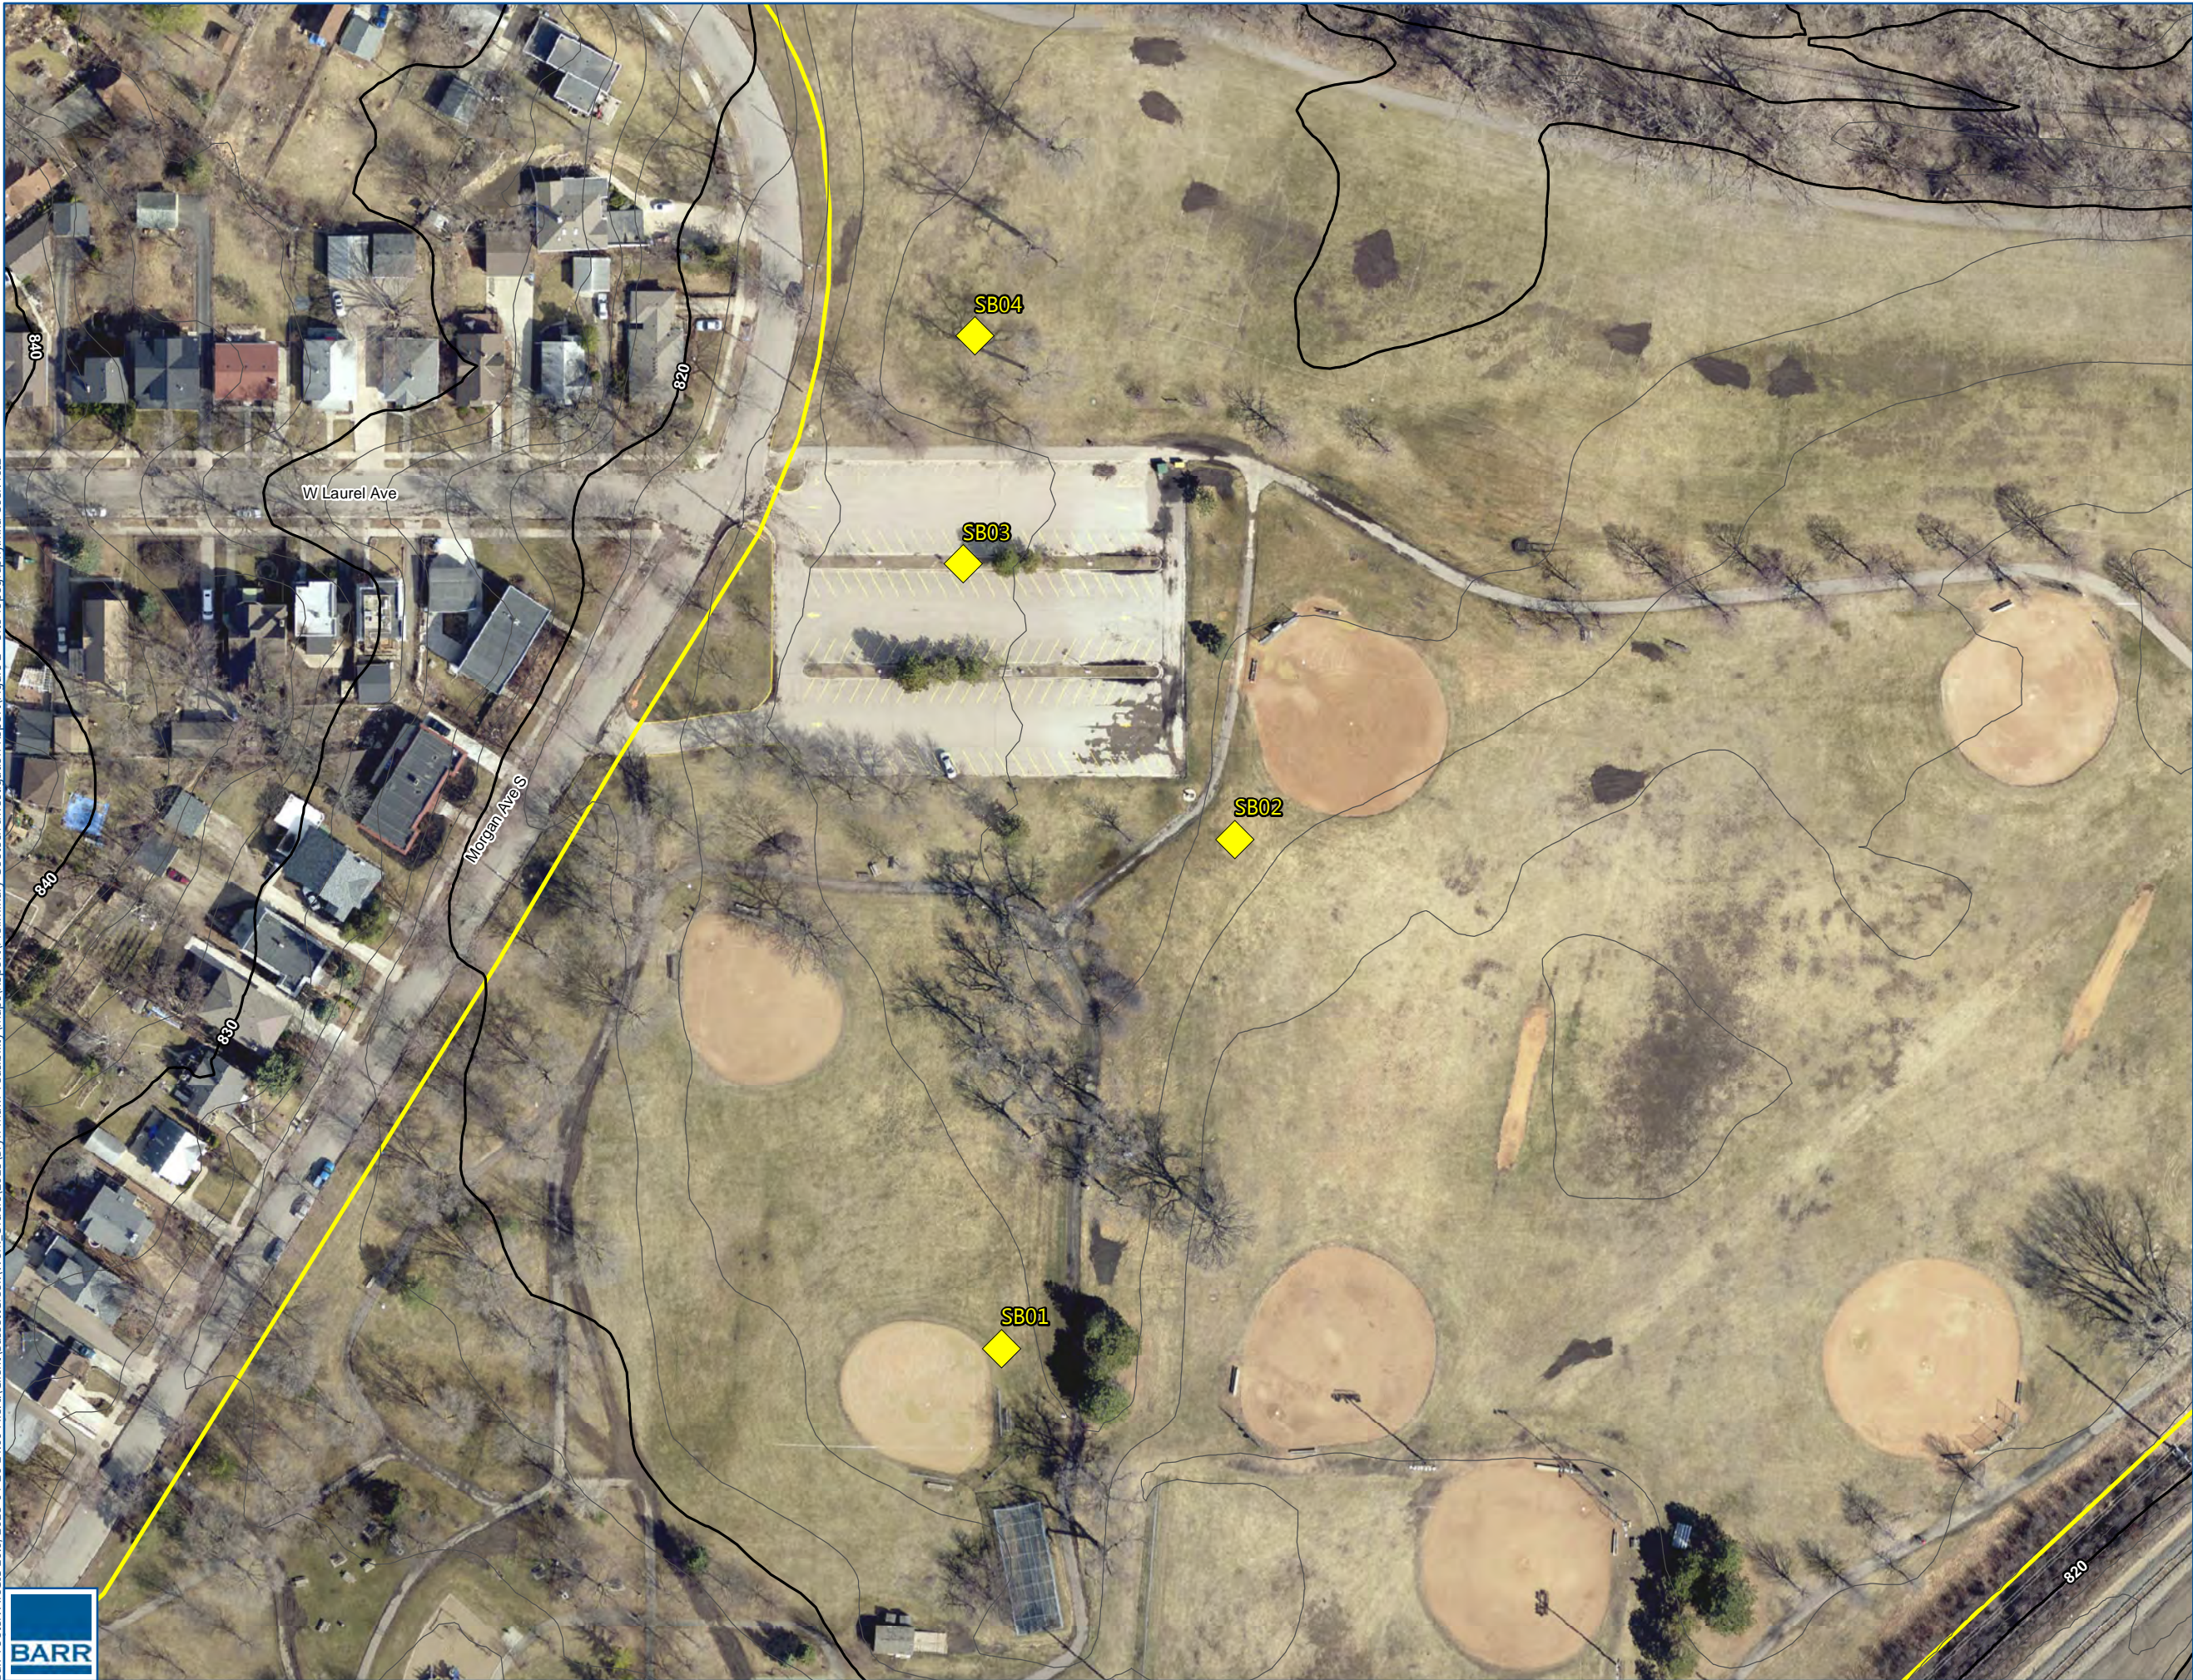
The preliminary geotechnical investigation consisted of geotechnical borings, standard penetration tests (SPT) and split spoon sampling, undisturbed soil sampling, and laboratory testing. [Figure 1](#) shows the plan location of all geotechnical borings completed for the project and [Table 1](#) summarizes the associated GPS coordinates and elevations. The primary site investigation and laboratory testing was conducted in March and April of 2018, respectively.
