Wetland Delineation Report

Jevne Park Stormwater Improvement Project Feasibility Study

Prepared for
Bassett Creek Watershed Management Commission

October 2018

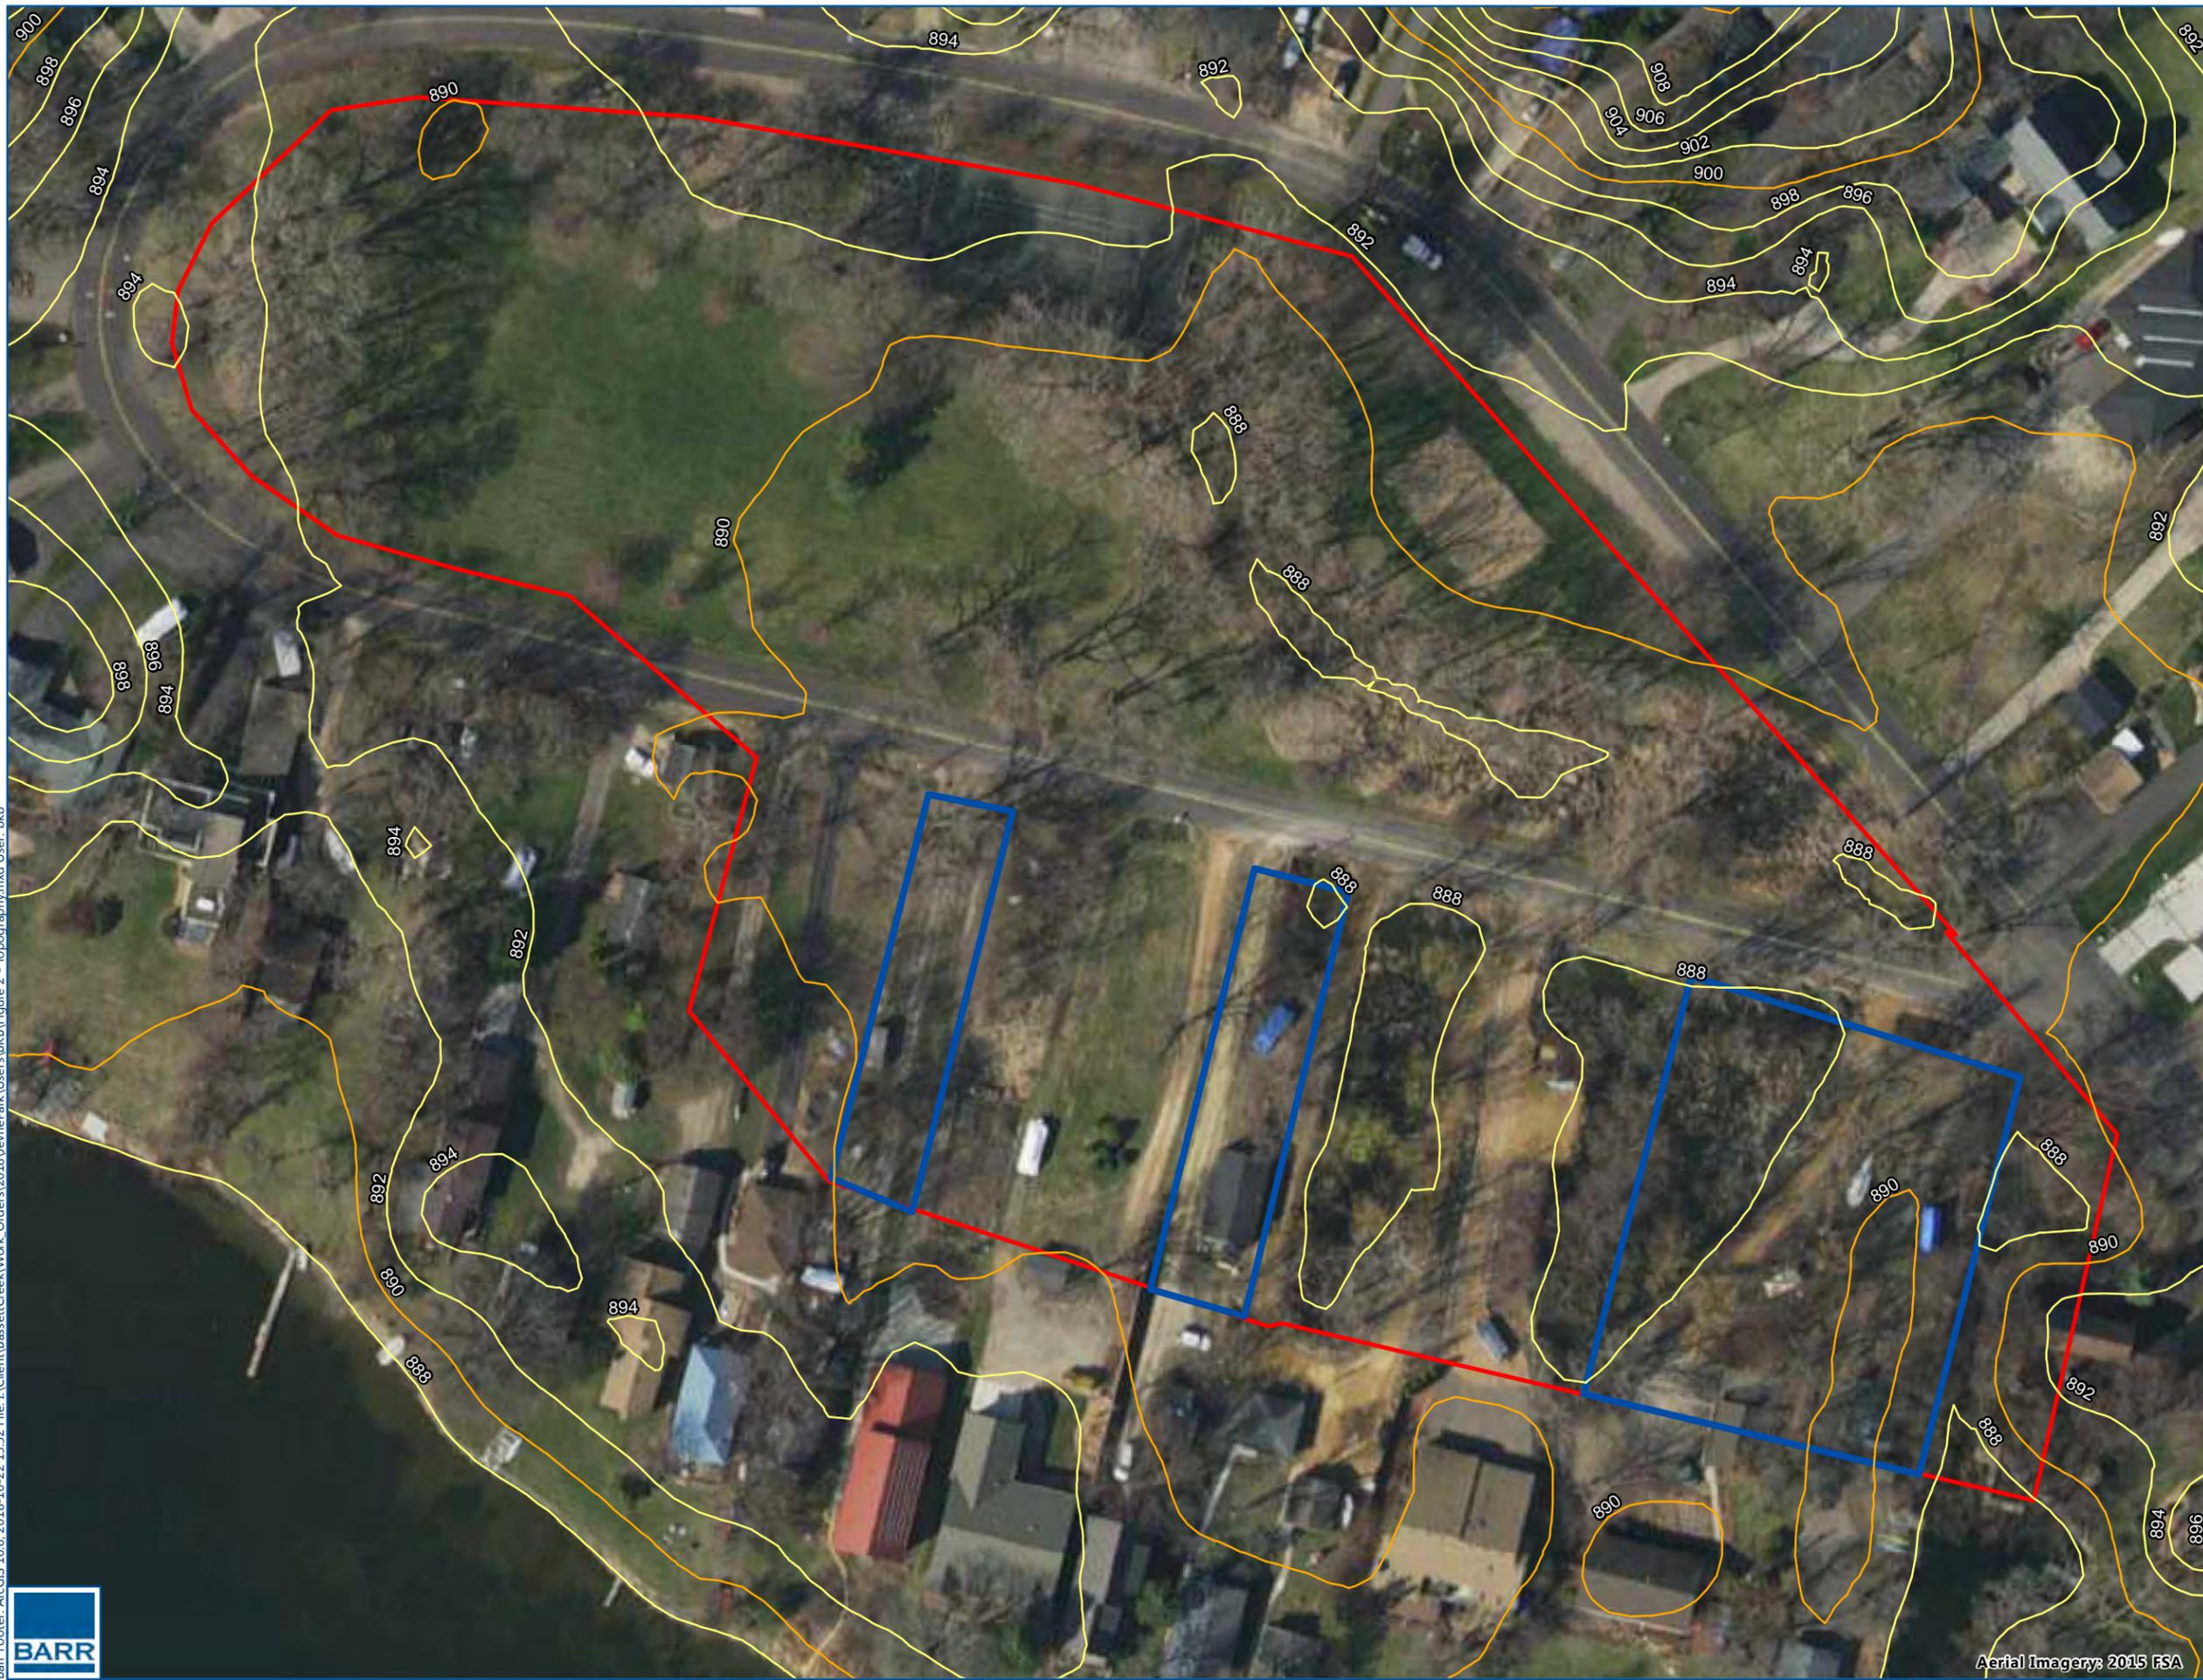
FIGURE 2

The majority of the Project area maintains a flat topography with slight depressions in wetland areas. Topography outside of the Project area and throughout the remainder of the peninsula is generally higher in elevation with more undulating topography (**Figure 2**).

TOPOGRAPHY
Feasibility Study for
Jevne Park
Stormwater Improvement Project
BCWMC

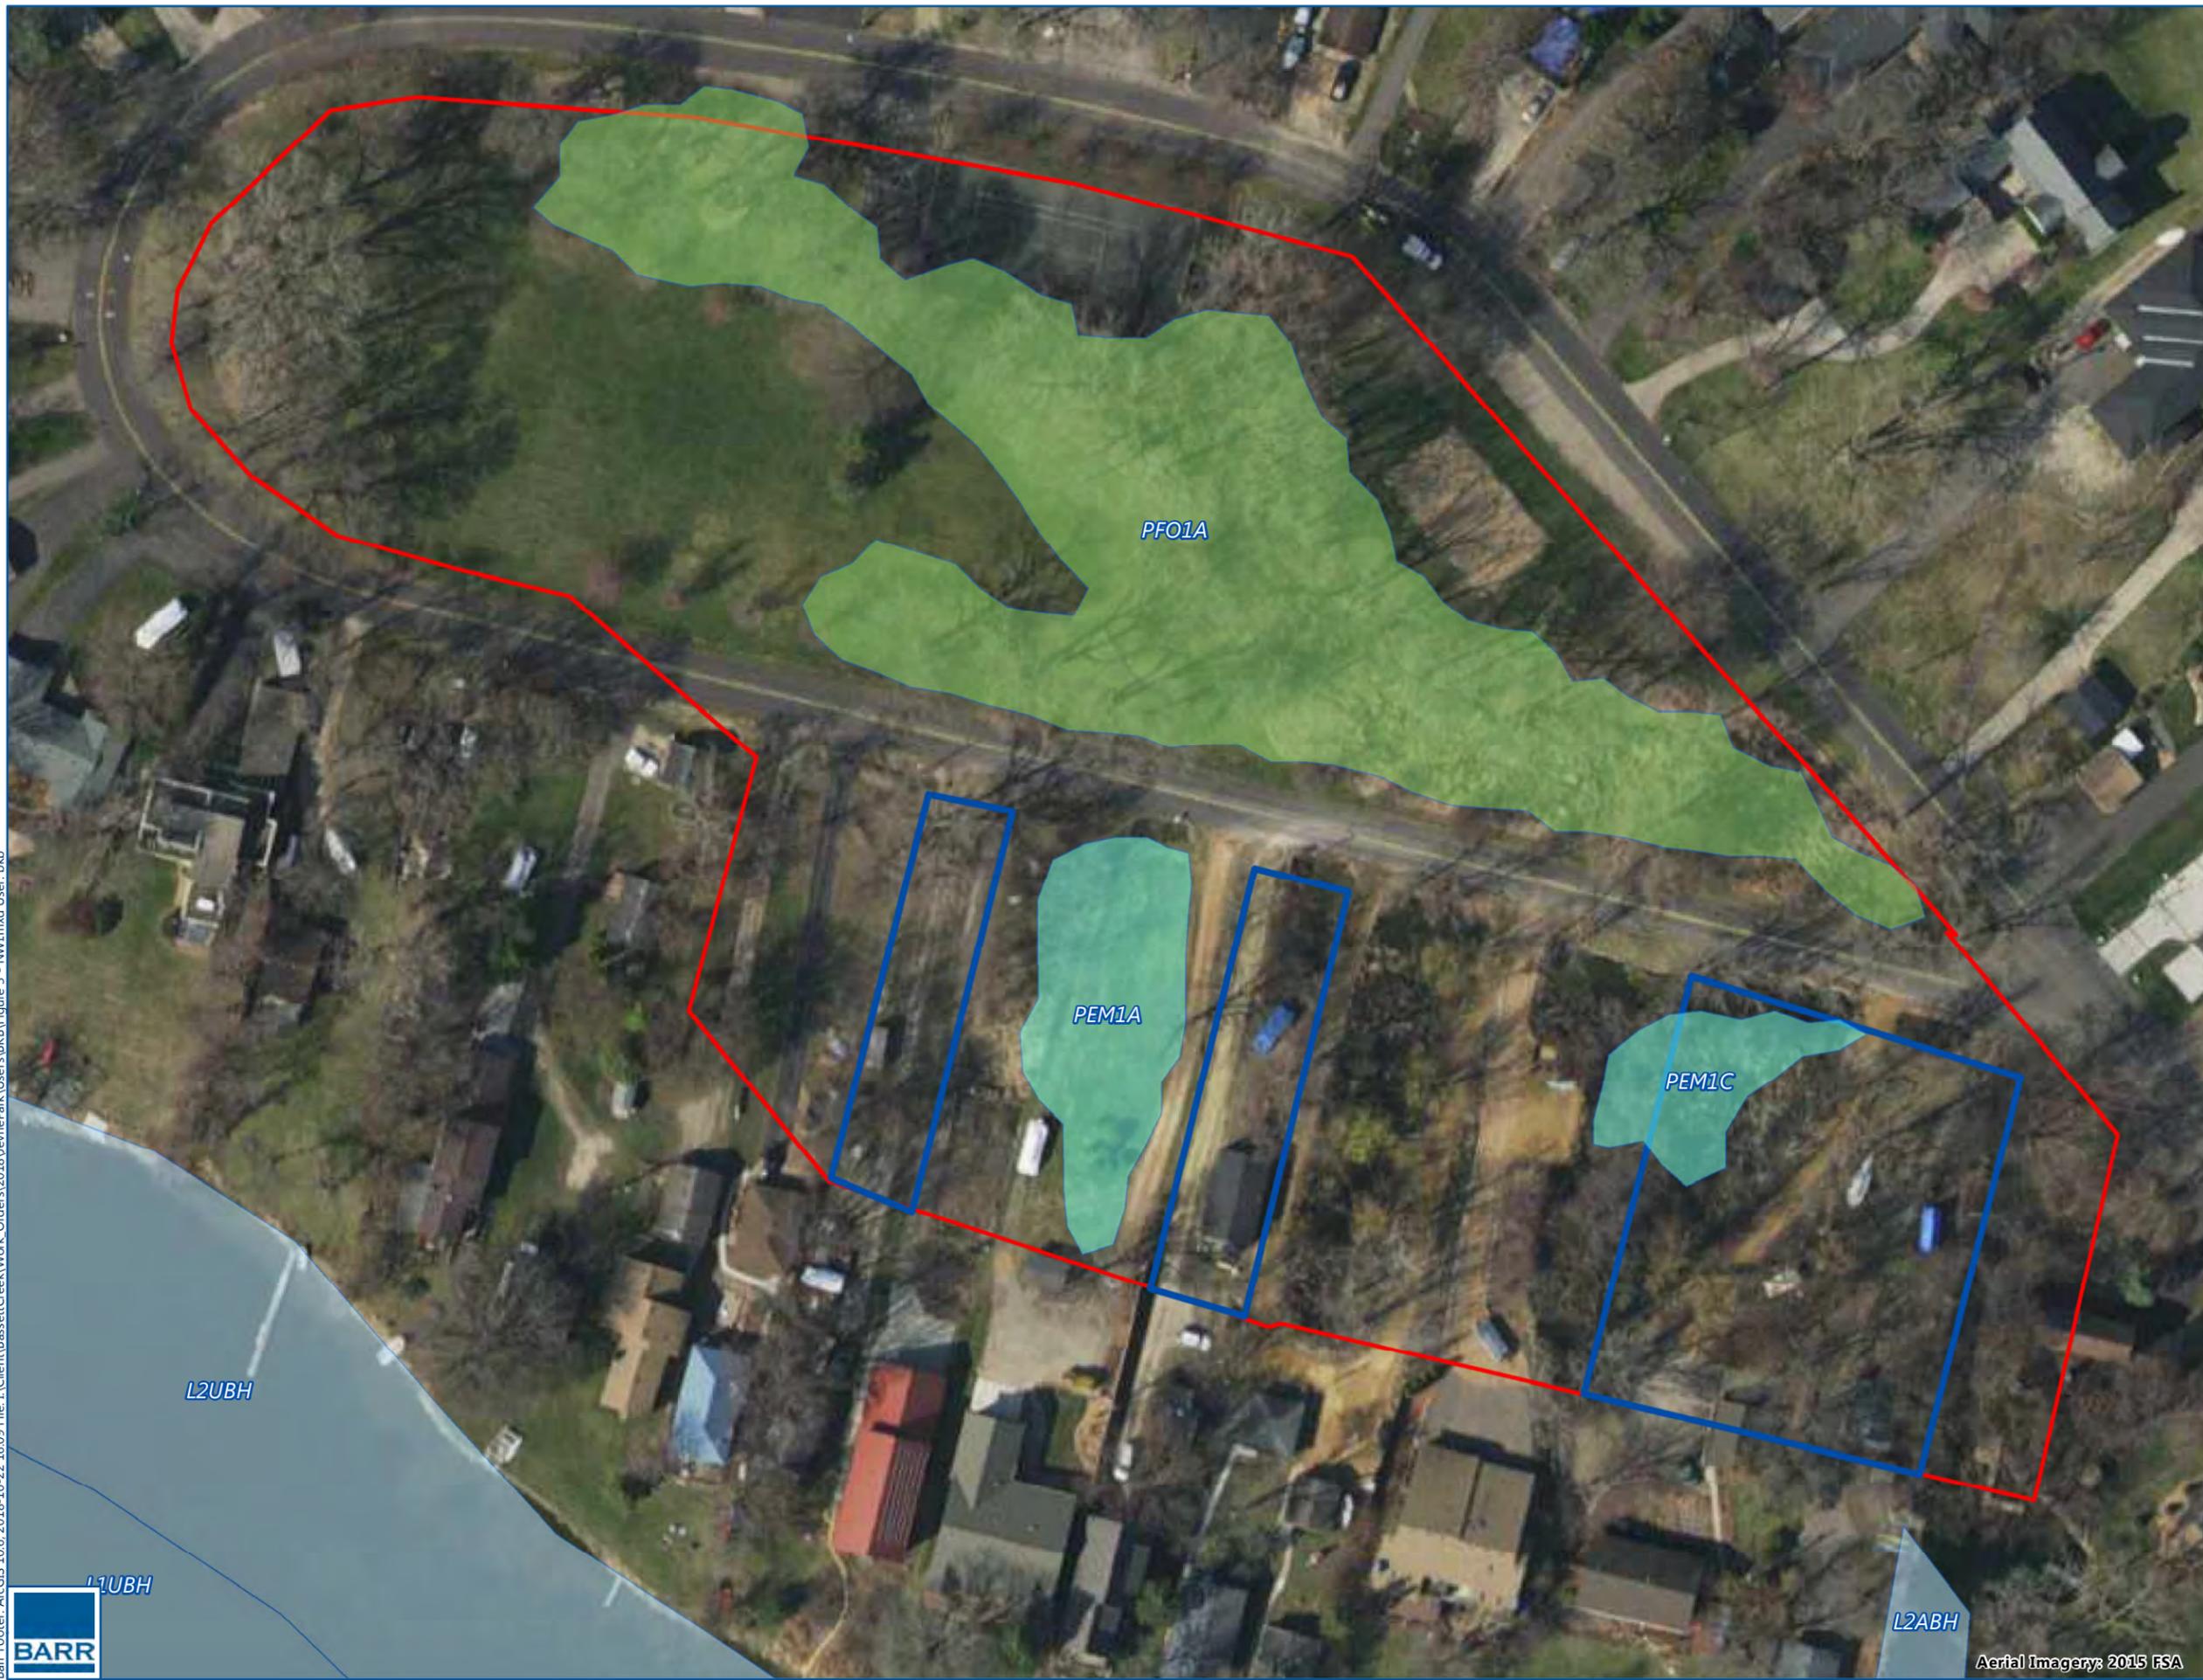
FIGURE 3

The National Wetland Inventory (NWI) has identified two emergent wetlands and one forested wetland within the Project area (**Figure 3**).

NATIONAL WETLAND INVENTORY
 Feasibility Study for
 Jevne Park
 Stormwater Improvement Project
 BCWMC

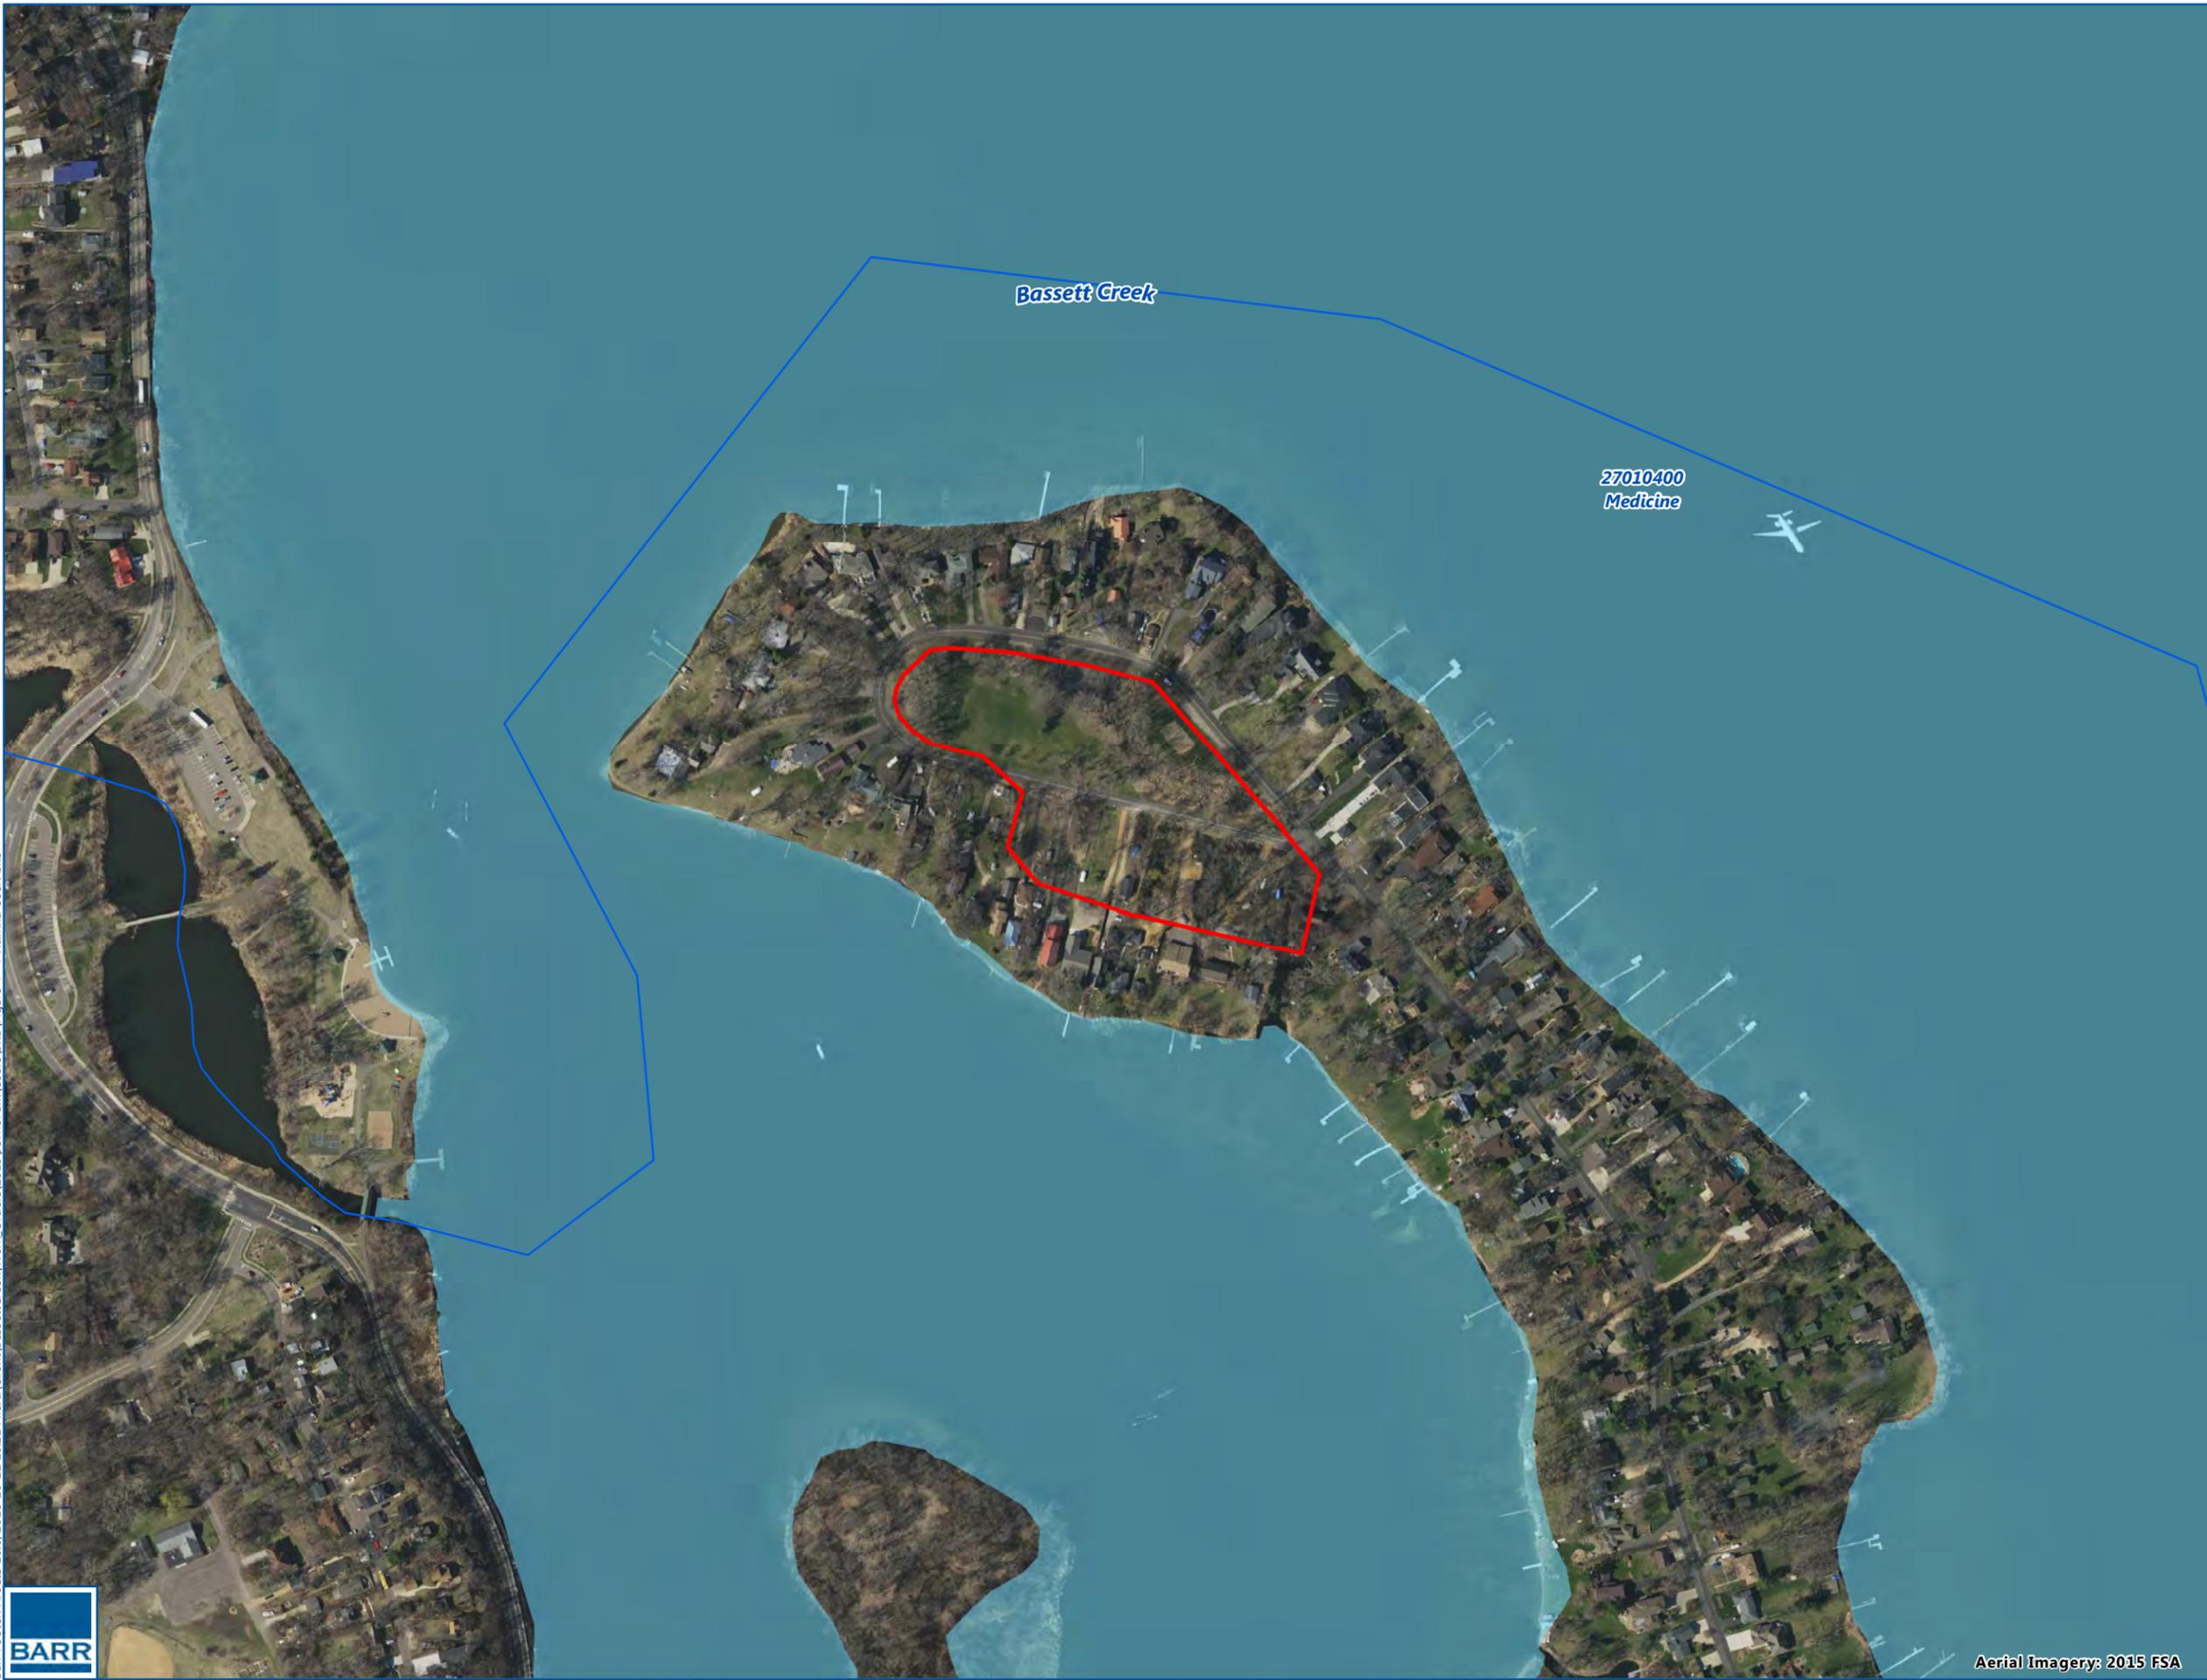
FIGURE 4

The Minnesota Department of Natural Resources (MnDNR) Public Waters Inventory (PWI) has not identified any public waters within the Project area (**Figure 4**).

PUBLIC WATERS INVENTORY
Feasibility Study for
Jevne Park
Stormwater Improvement Project
BCWMC

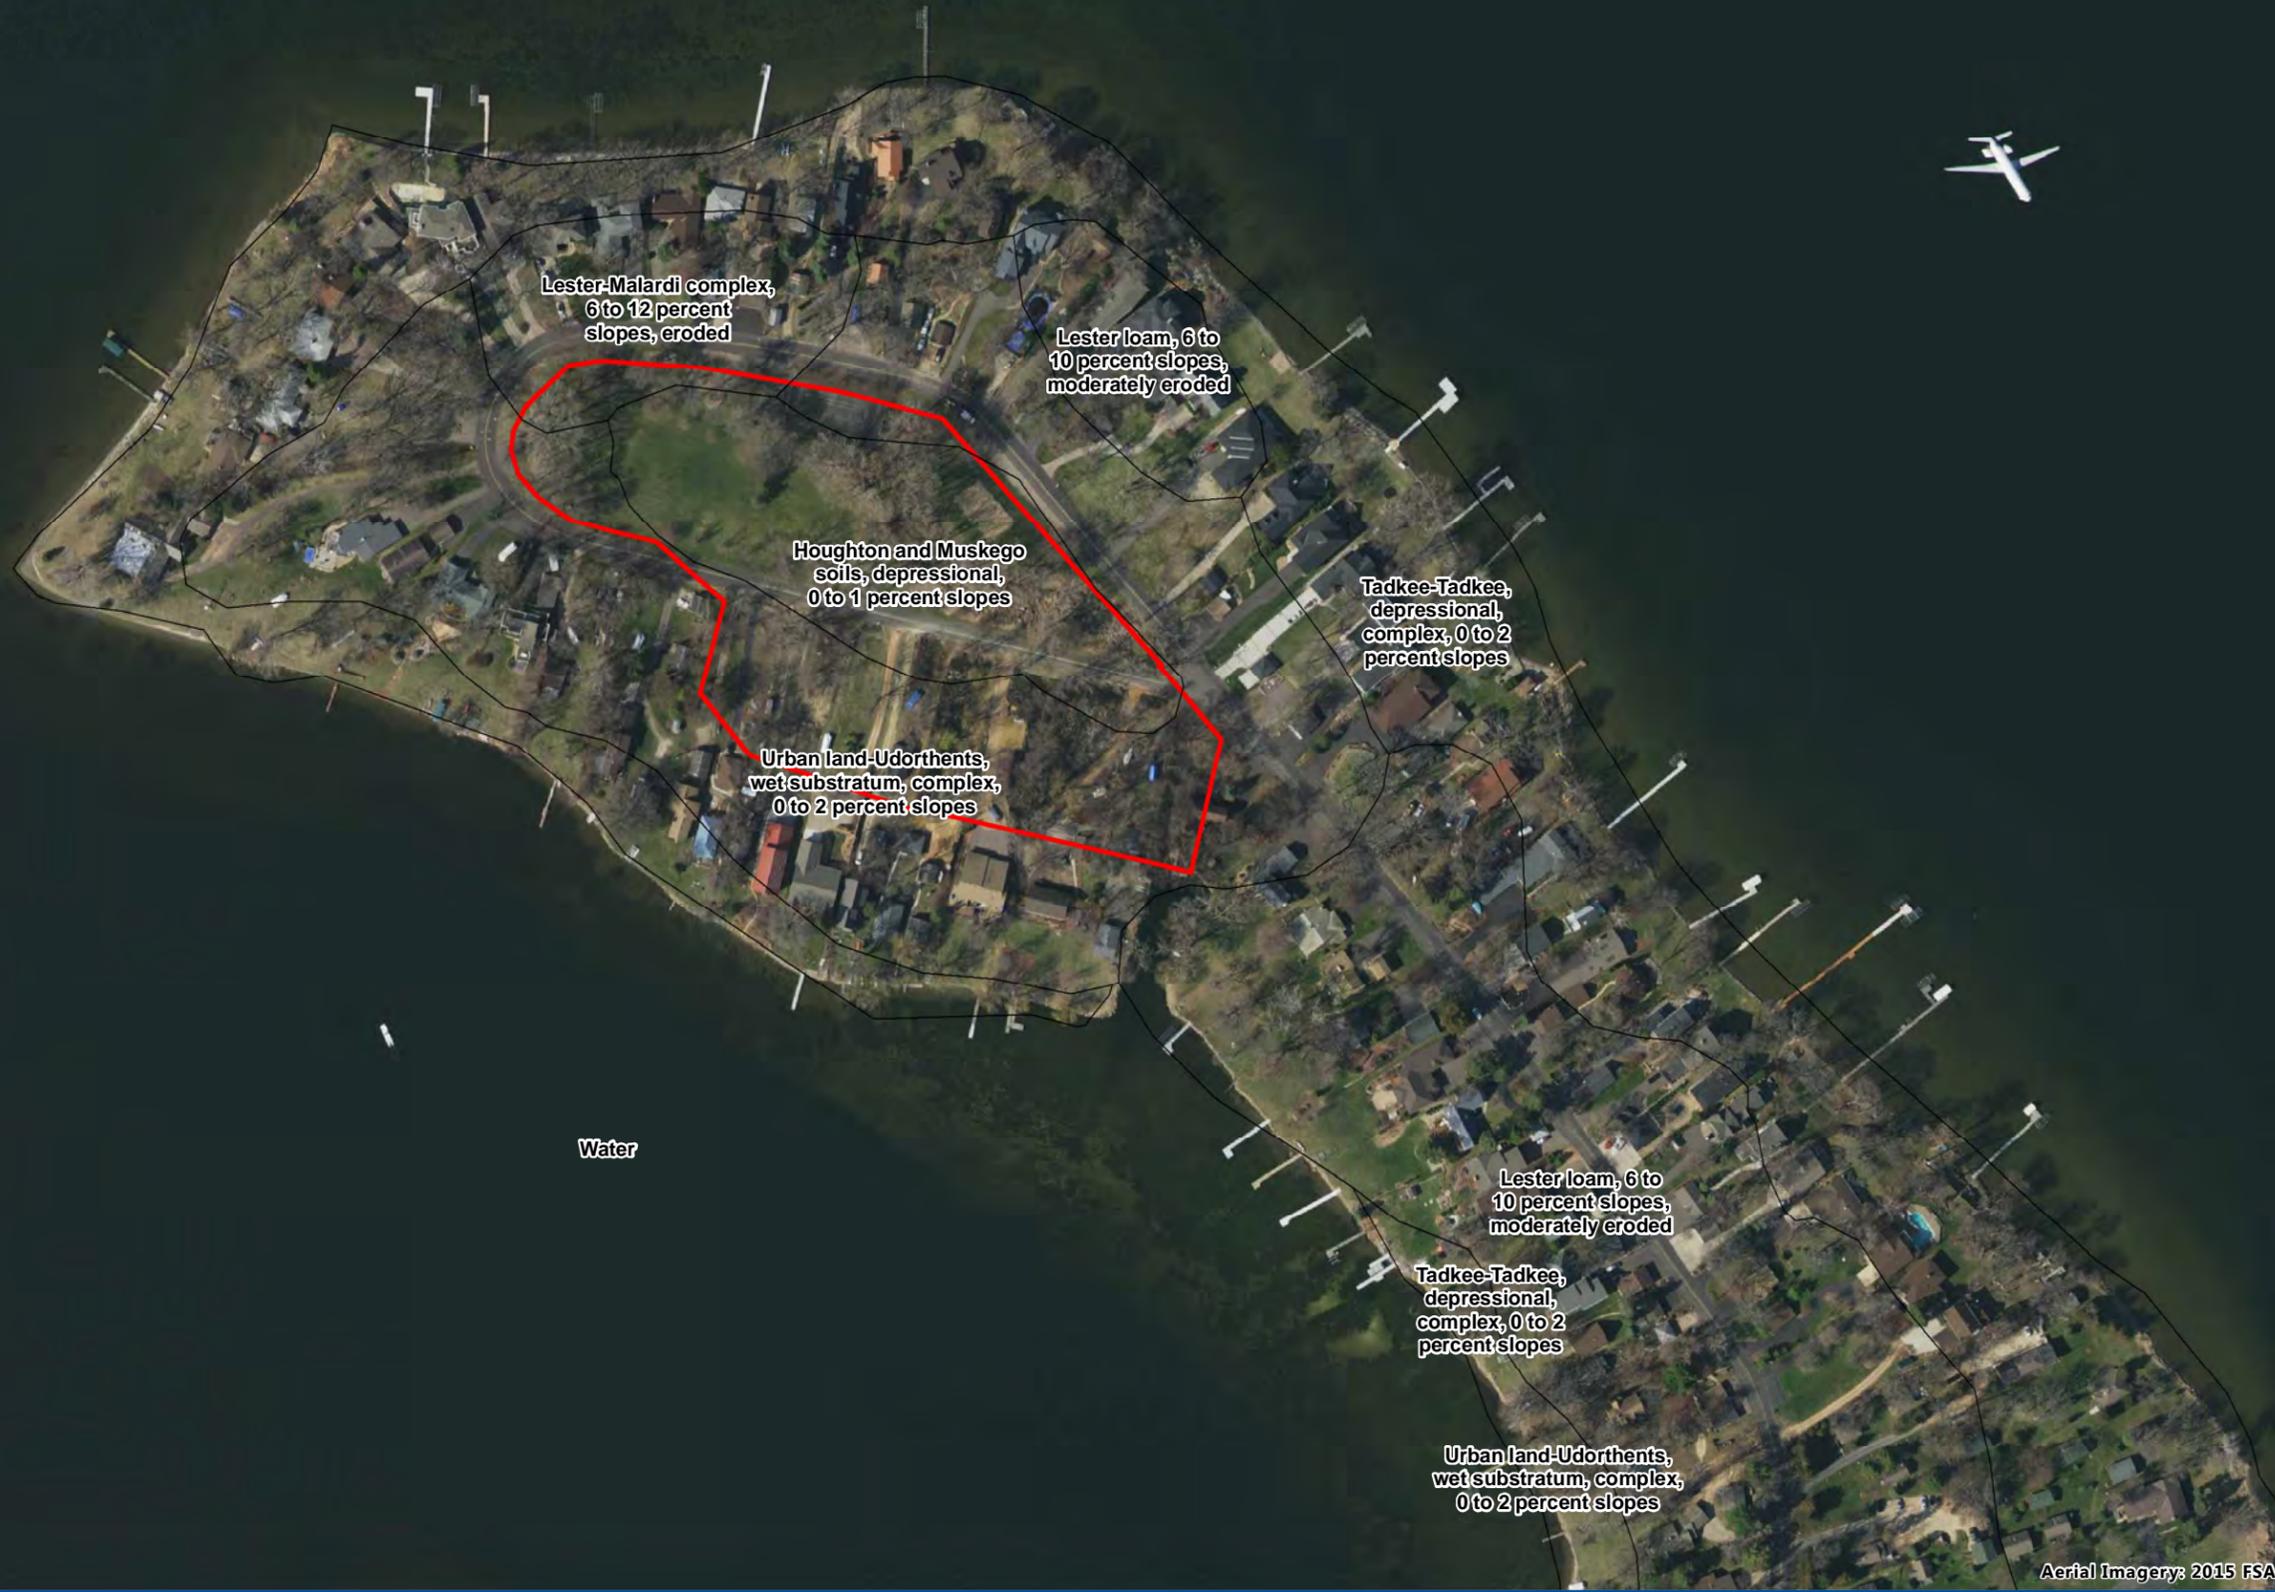
FIGURE 5

Soil information located within the Project area and in surrounding areas was obtained from the Natural Resources Conservation Service SSURGO Database (USDA, 2017b) (**Figure 5**). Three soil map units were identified within the Project area:

- Houghton and Muskego soils, depressional, 0 to 1 percent slopes (L50A)
- Lester-Malardi complex, 6 to 12 percent slopes, eroded (L70C2)
- Urban land-Udorthents, wet substratum, complex, 0 to 2 percent slopes (U1A)

Houghton and Muskego soils, depressional is the only soil map unit within the Project area that is hydric. Tadkee-Tadkee, depressional is the only hydric soil map unit located in the vicinity of the Project area.

SOIL SURVEY
Feasibility Study for
Levne Park
Stormwater Improvement Project
BCWMC

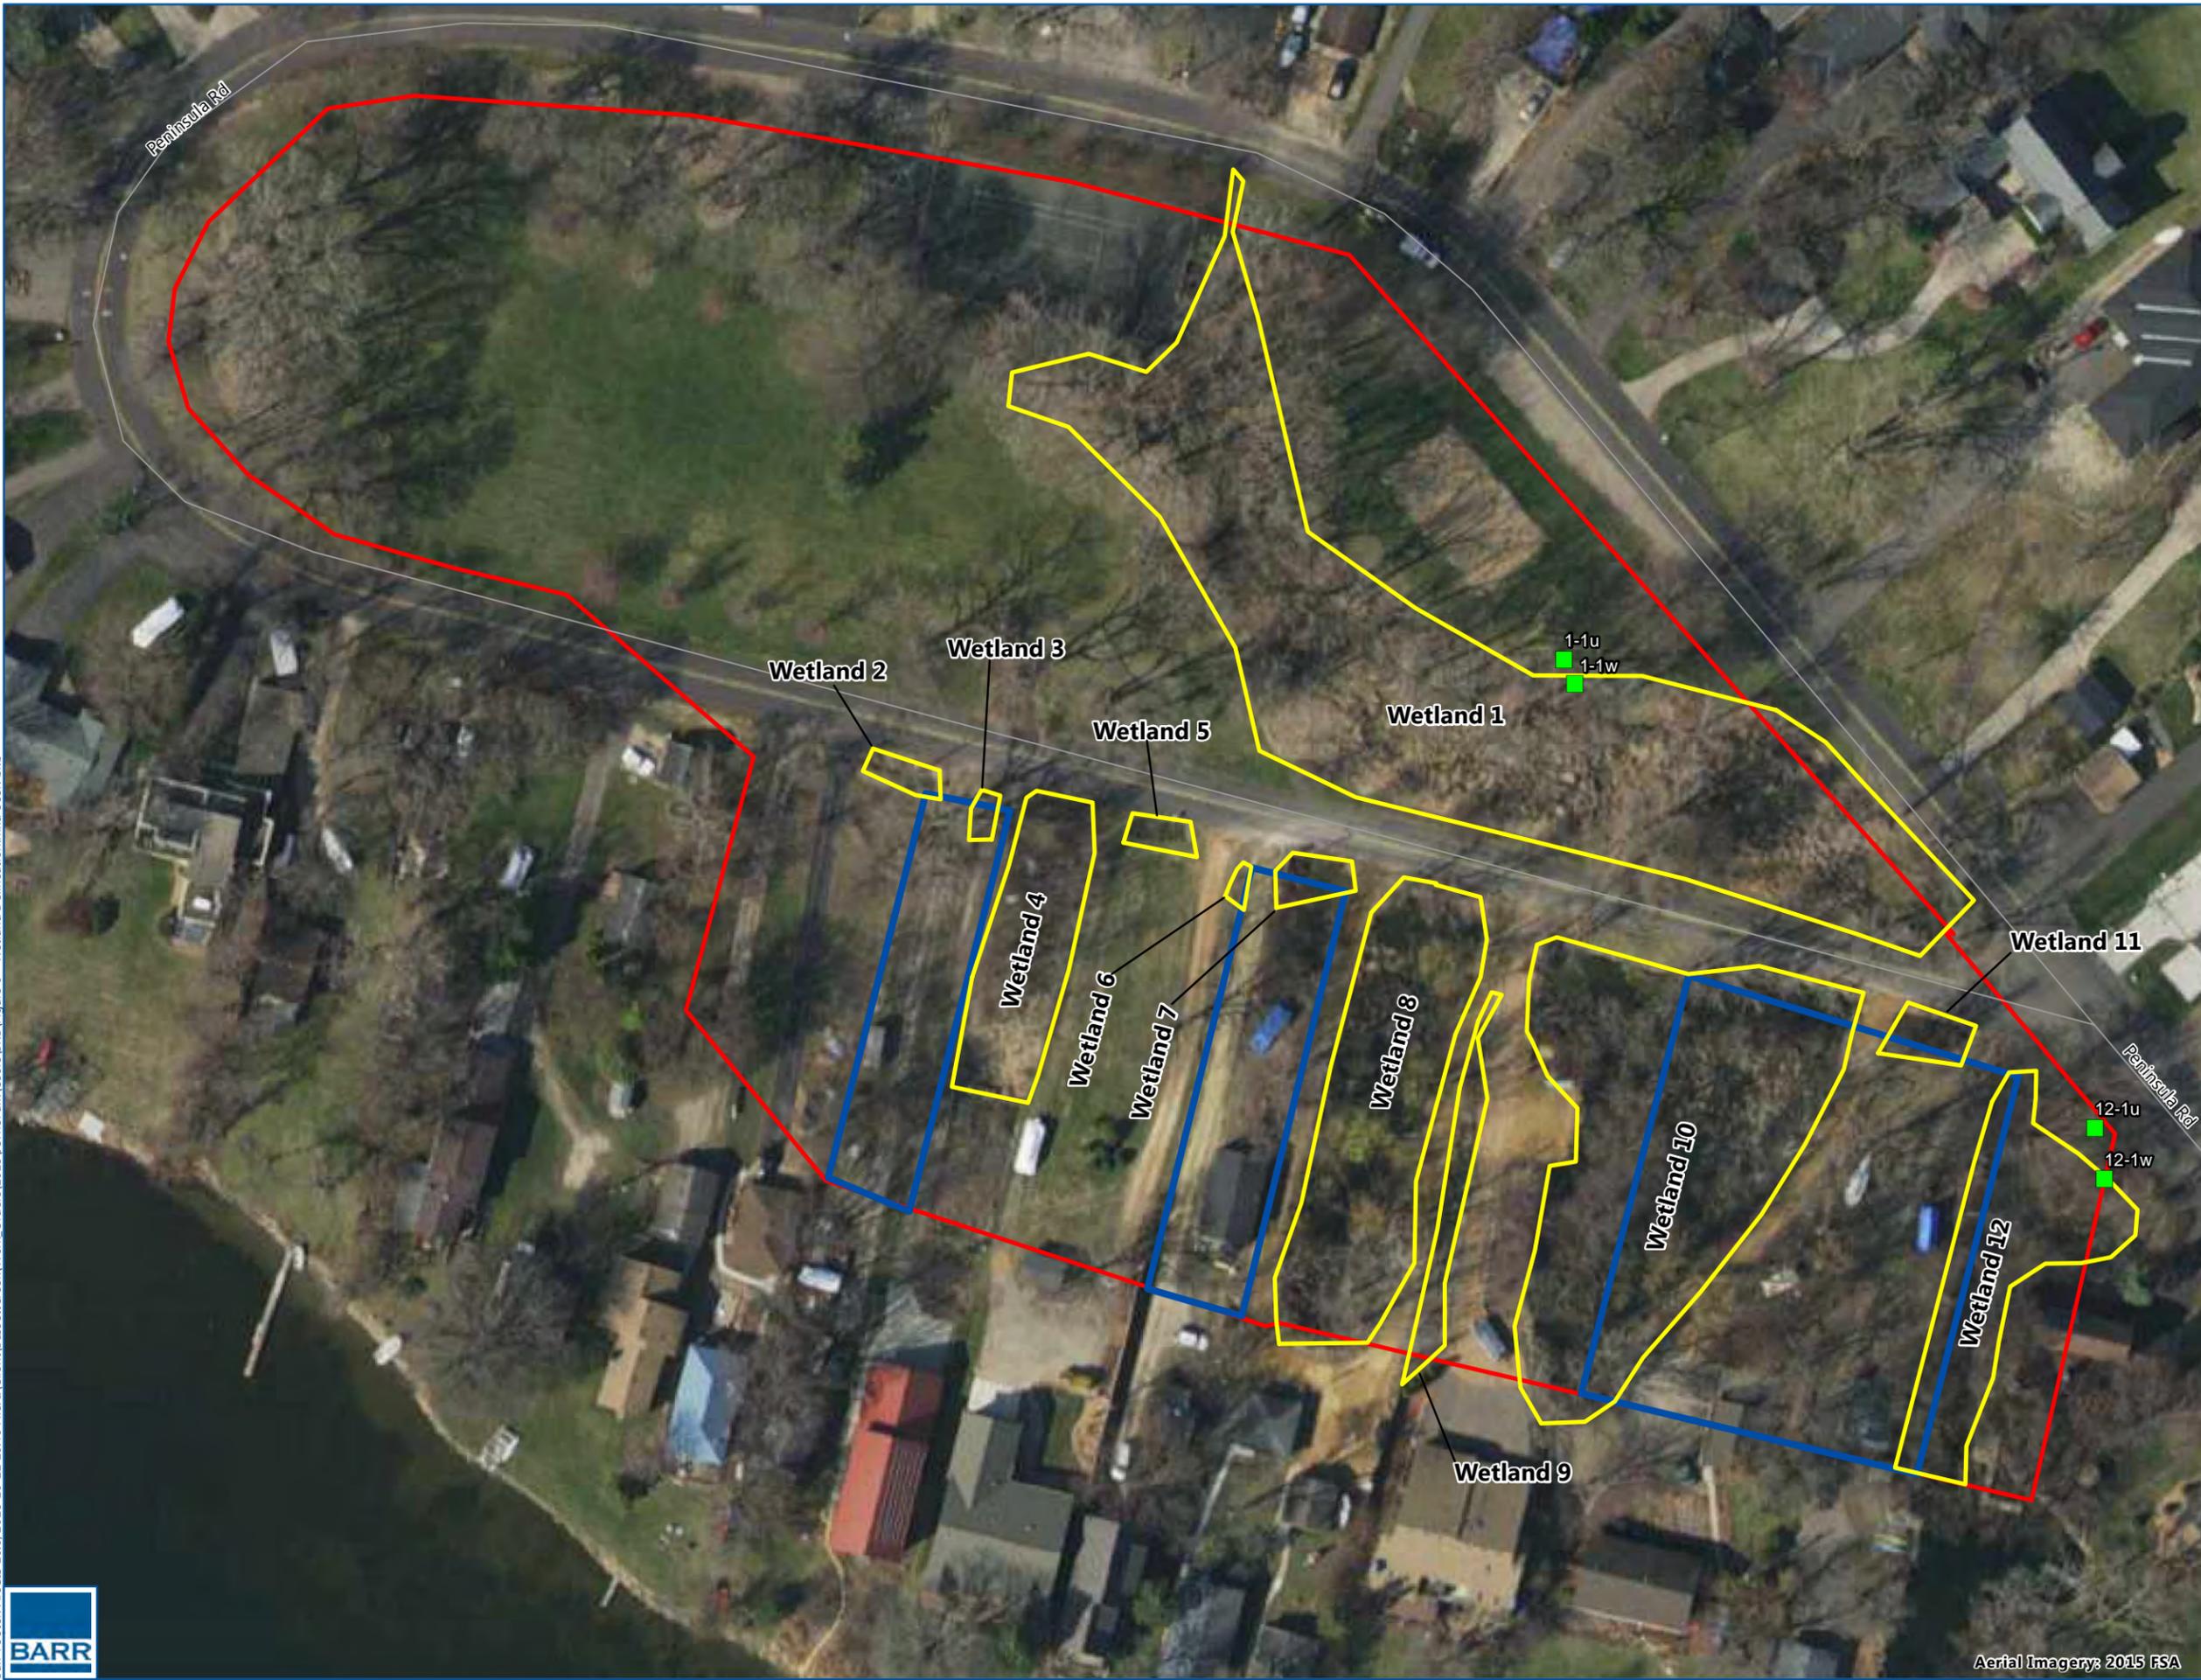
FIGURE 6

The delineated wetland boundaries and sample points were surveyed using a Global Positioning System (GPS) with sub-meter accuracy (**Figure 6**).

Twelve wetlands were delineated within the Project area (**Figure 6**). Four parcels located on the south side of the Project area were not investigated because landowner access was not granted. Wetland boundaries shown on **Figure 6** that are within these four parcels were estimated with the aid of LiDAR data and wetland signature appearing on recent aerial photos.

WETLAND BOUNDARIES
 Feasibility Study for
 Jevne Park
 Stormwater Improvement Project
 BCWMC

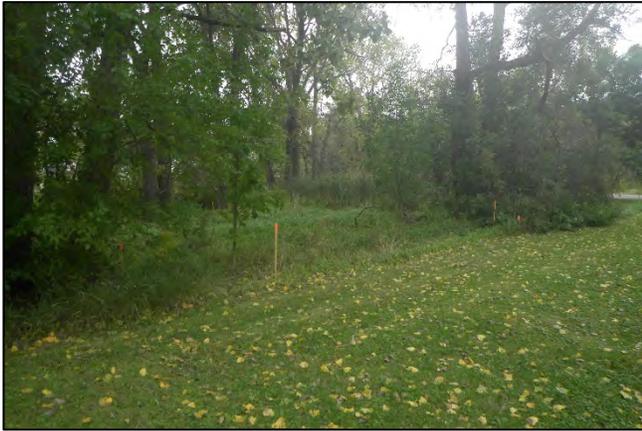
Photo 1: Wetland 1 facing southwest on the north side of the boundary. Upland areas are open recreation areas dominated by manicured Kentucky bluegrass.

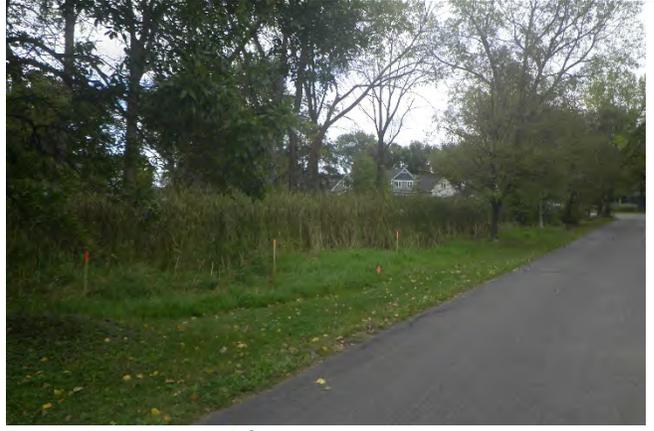
Photo 2: Wetland 1 facing northeast on the south side of the boundary. Adjacent upland areas are manicured lawn and pavement.

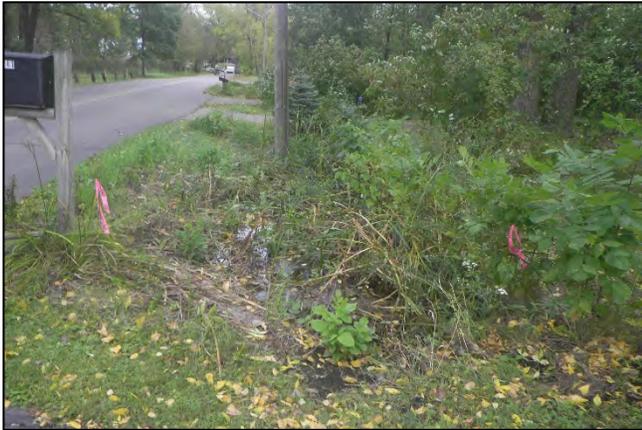
Photo 3: Wetland 2 facing southeast. This wetland is within a road ditch right-of-way.

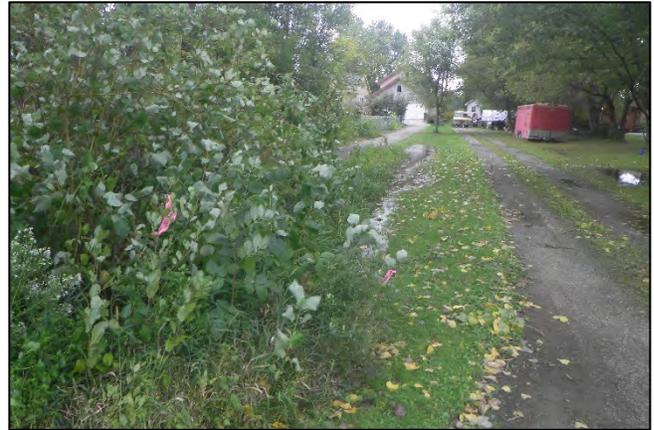
Photo 4: Wetland 3 facing south. This wetland is located partially within a road ditch right-of-way and extends south within a parcel with no access permissions.

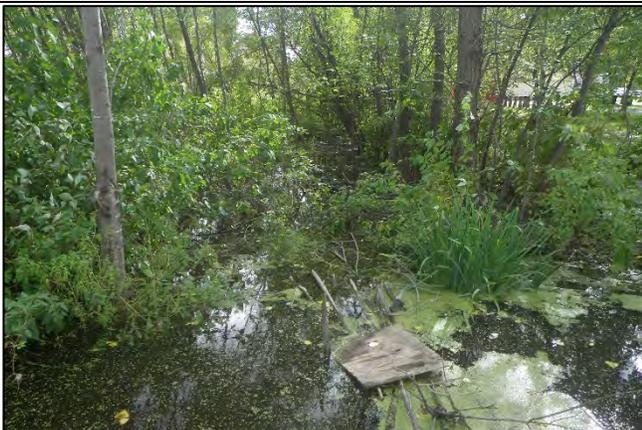
Photo 5: Wetland 4 facing southwest. Upland areas are manicured lawn and graded driveway.

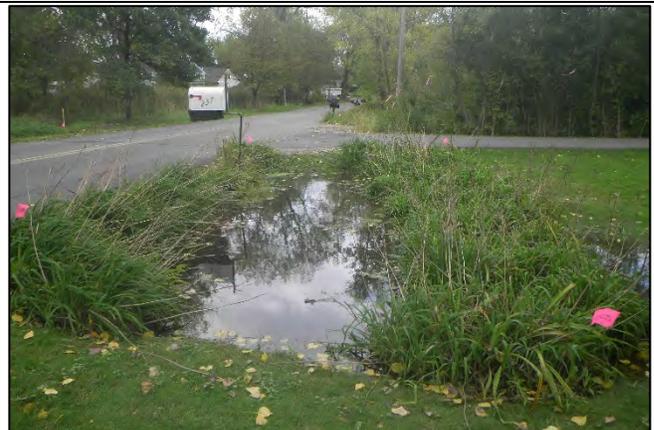
Photo 6: Wetland 5 facing east. This wetland is a roadside ditch right-of-way.

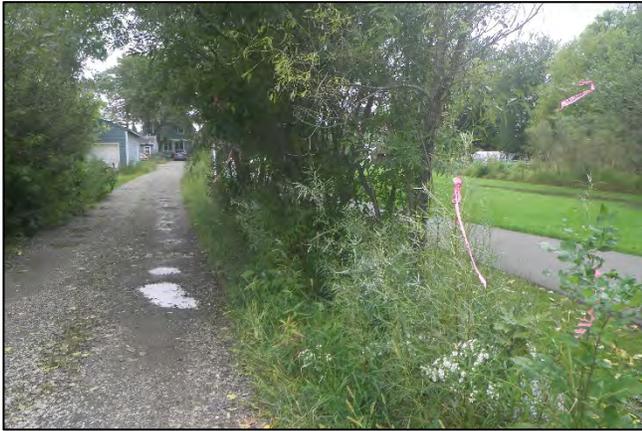
Photo 7: Wetland 6 facing south. This wetland is mostly a drainage way located partially with road ditch right-of-way dominated by shrubs. It extends south into a parcel with no access permissions.

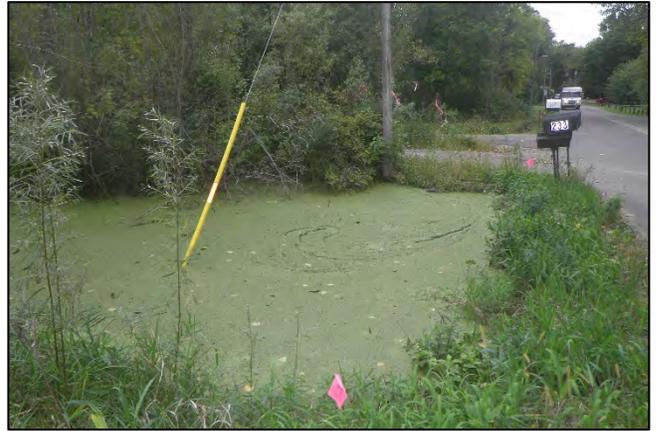
Photo 8: Wetland 7 facing west. The section of the wetland pictured is located within road ditch right-of-way. It extends south into a parcel with no access permissions.

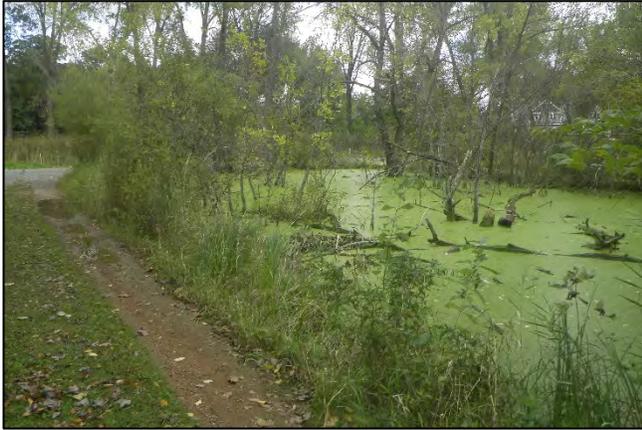
Photo 9: Wetland 8 facing north. Upland areas are graded driveway.

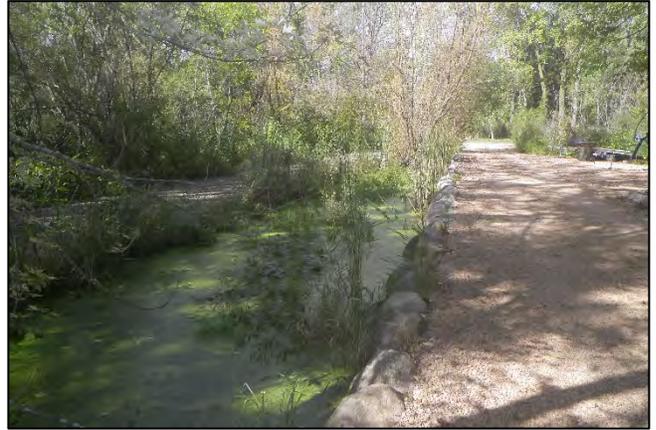
Photo 10: Wetland 9 facing northwest. Upland areas are graded gravel driveway.

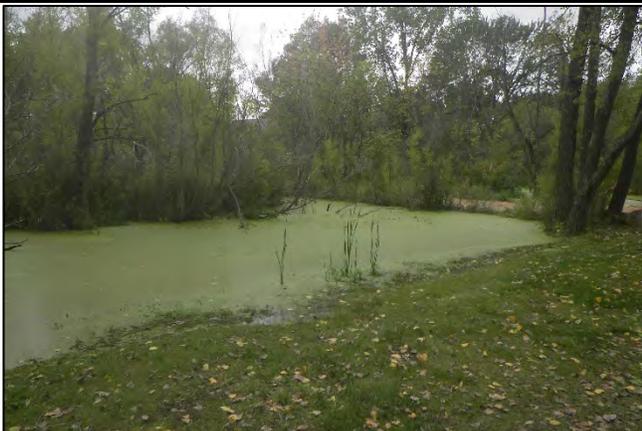
Photo 11: Wetland 10 facing southwest. Surrounding uplands are manicured lawn and graded gravel driveway.

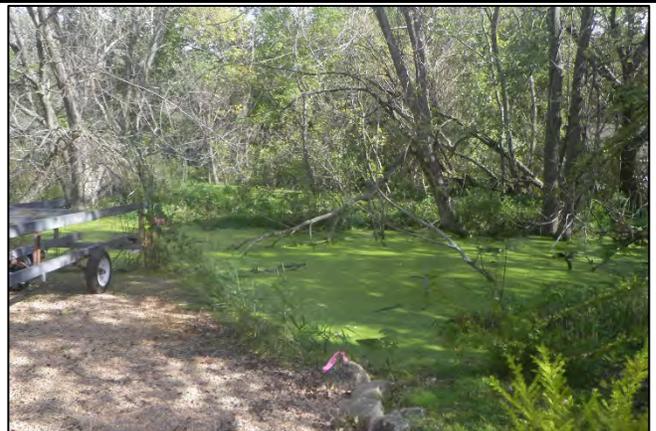
Photo 12: Wetland 10 facing northeast along the driveway within the interior of the parcel.
