Wetland Delineation Report

Jevne Park Stormwater Improvement Project Feasibility Study

Prepared for
Bassett Creek Watershed Management Commission

October 2018

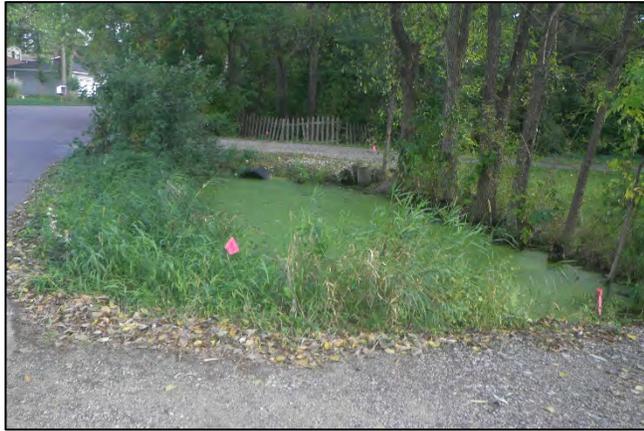
Photo 13: Wetland 11 facing east. Wetland is partially located entirely within a roadside ditch right-of-way. Surrounding uplands are gravel driveway. The south end of the wetland is located within a parcel without access permissions.

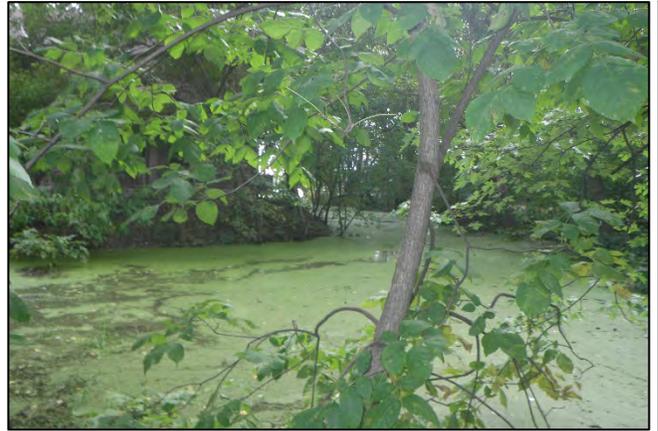
Photo 14: Wetland 12 facing southeast. This wetland is part of a channel that connects to Medicine Lake. Surrounding uplands are forested with a shrub understory.

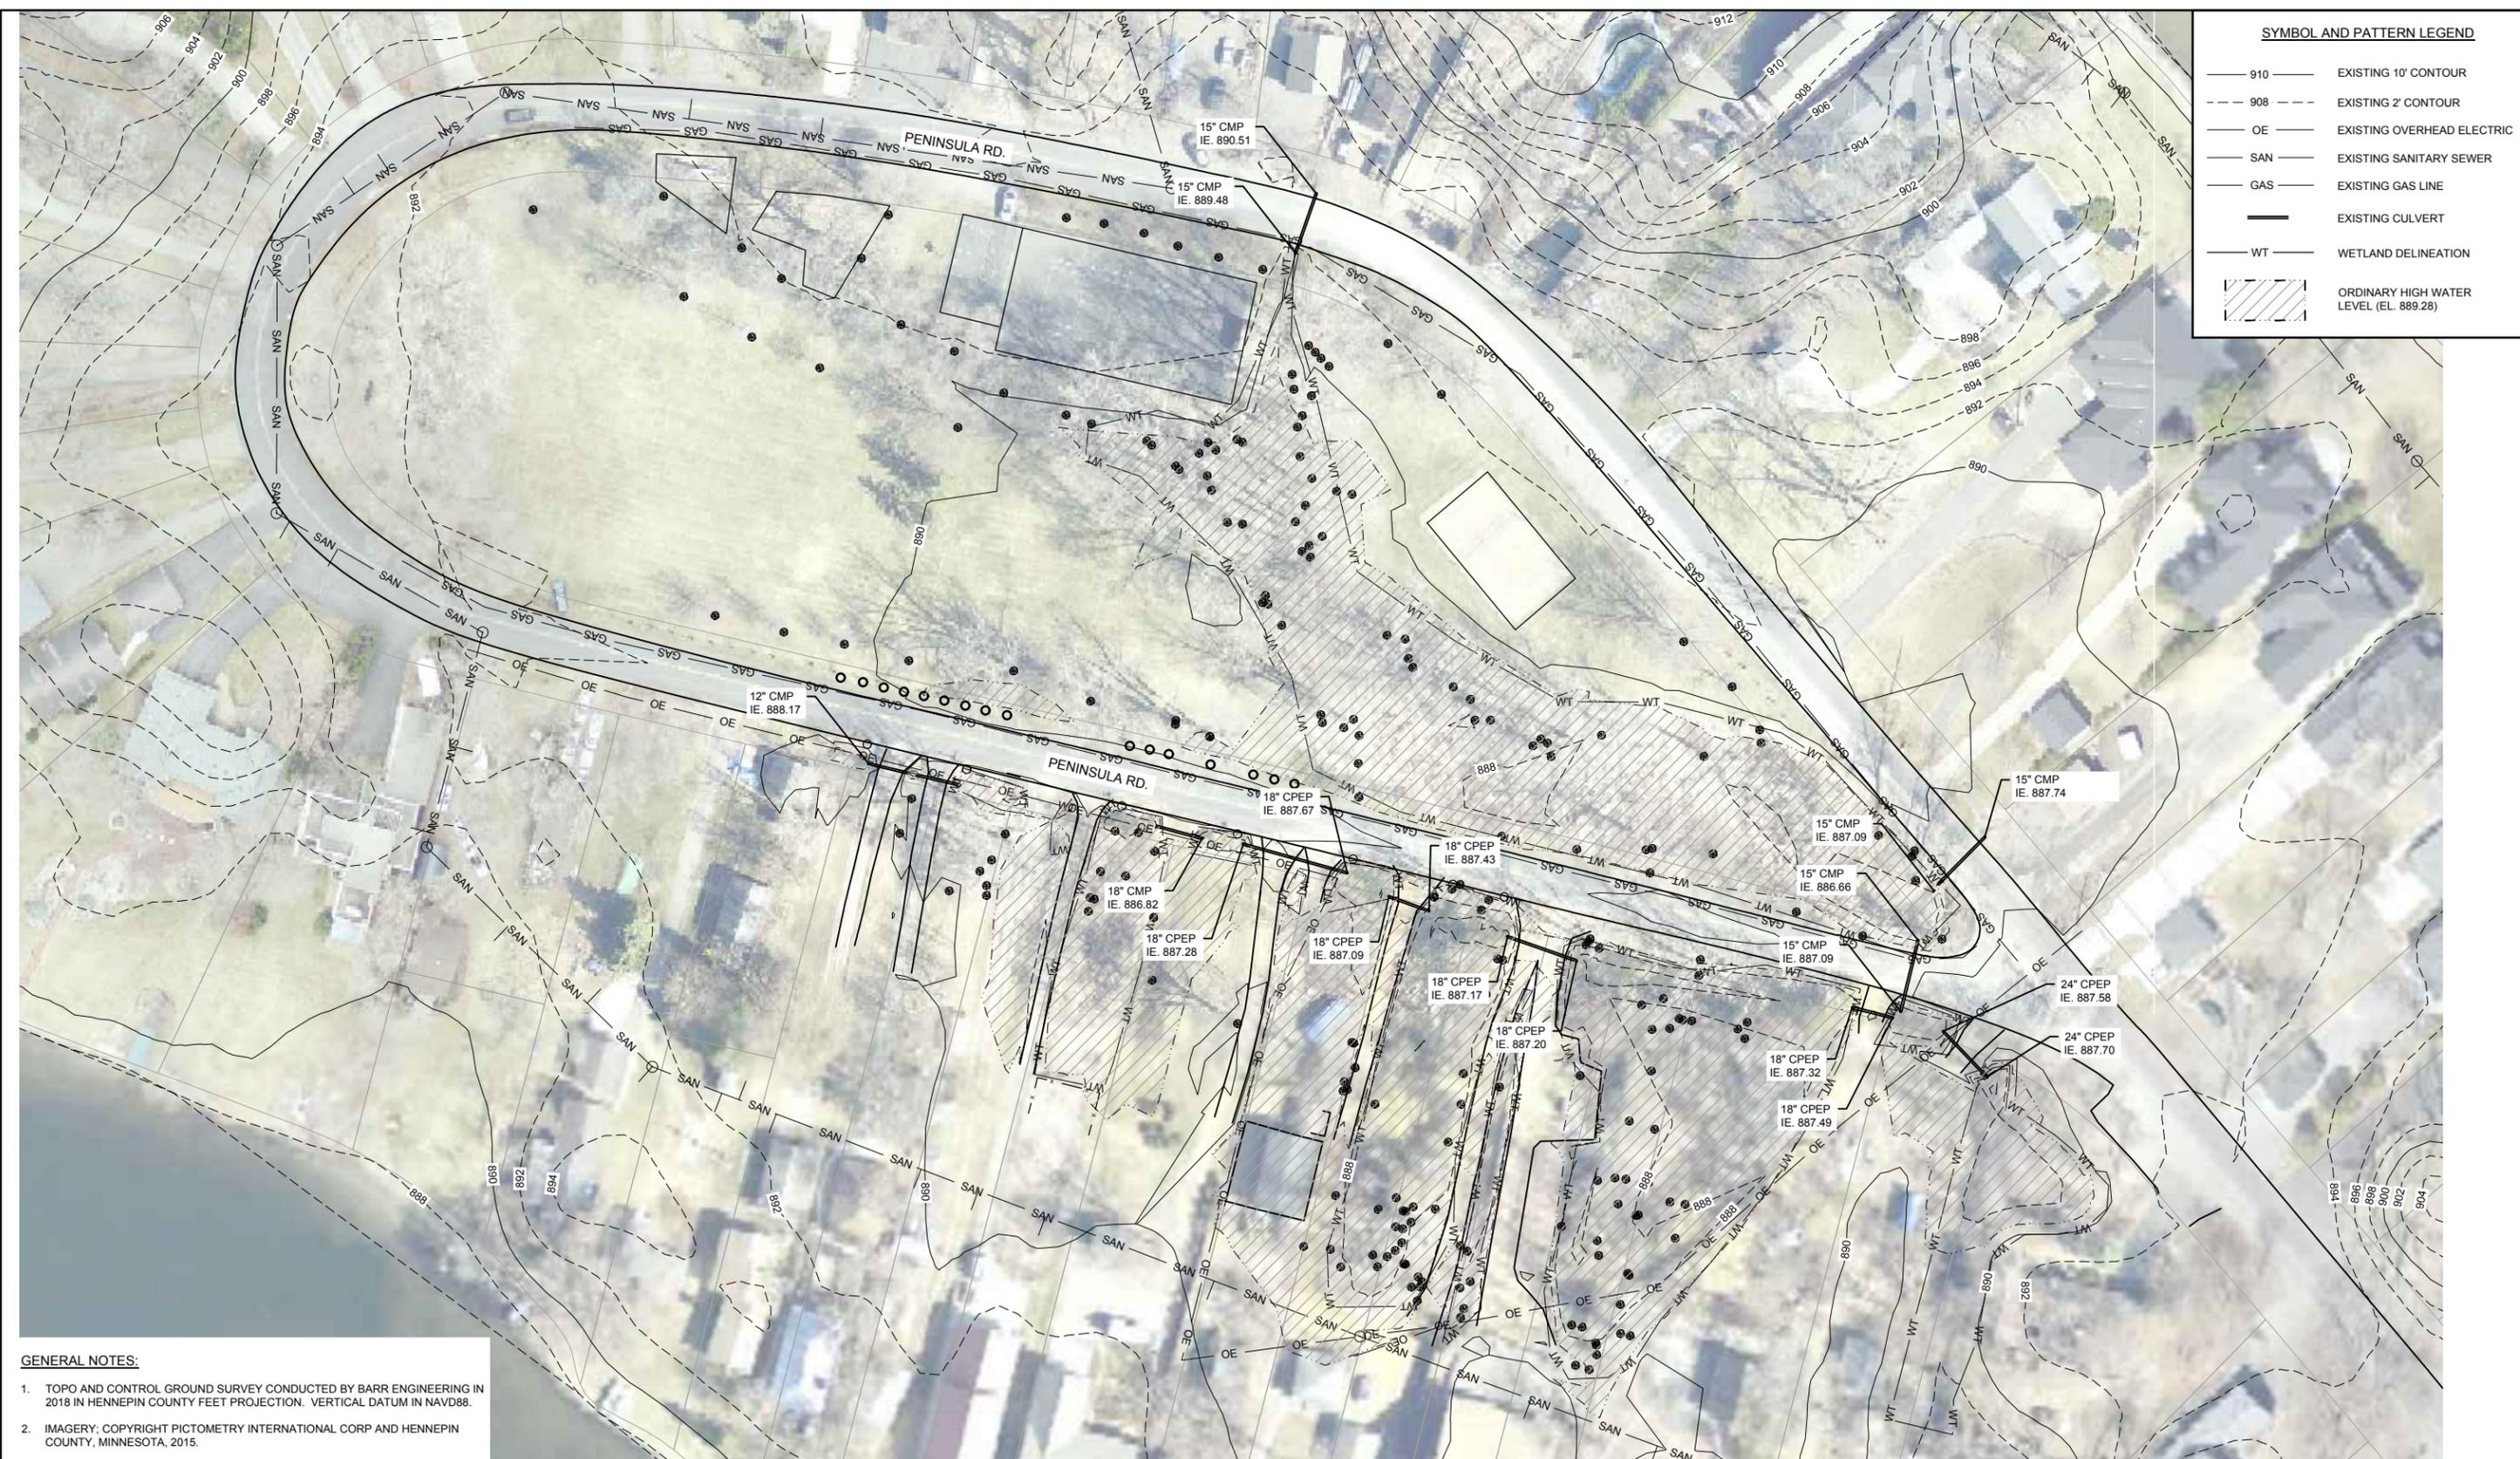
SYMBOL AND PATTERN LEGEND	
— 910 —	EXISTING 10' CONTOUR
- - - 908 - - -	EXISTING 2' CONTOUR
— OE —	EXISTING OVERHEAD ELECTRIC
— SAN —	EXISTING SANITARY SEWER
— GAS —	EXISTING GAS LINE
—	EXISTING CULVERT
— WT —	WETLAND DELINEATION
	ORDINARY HIGH WATER LEVEL (EL. 889.28)
