# **Wetland Delineation Report**

# DeCola Ponds – SEA School/Wildwood Park Flood Storage Project

Prepared for City of Golden Valley

October 2020

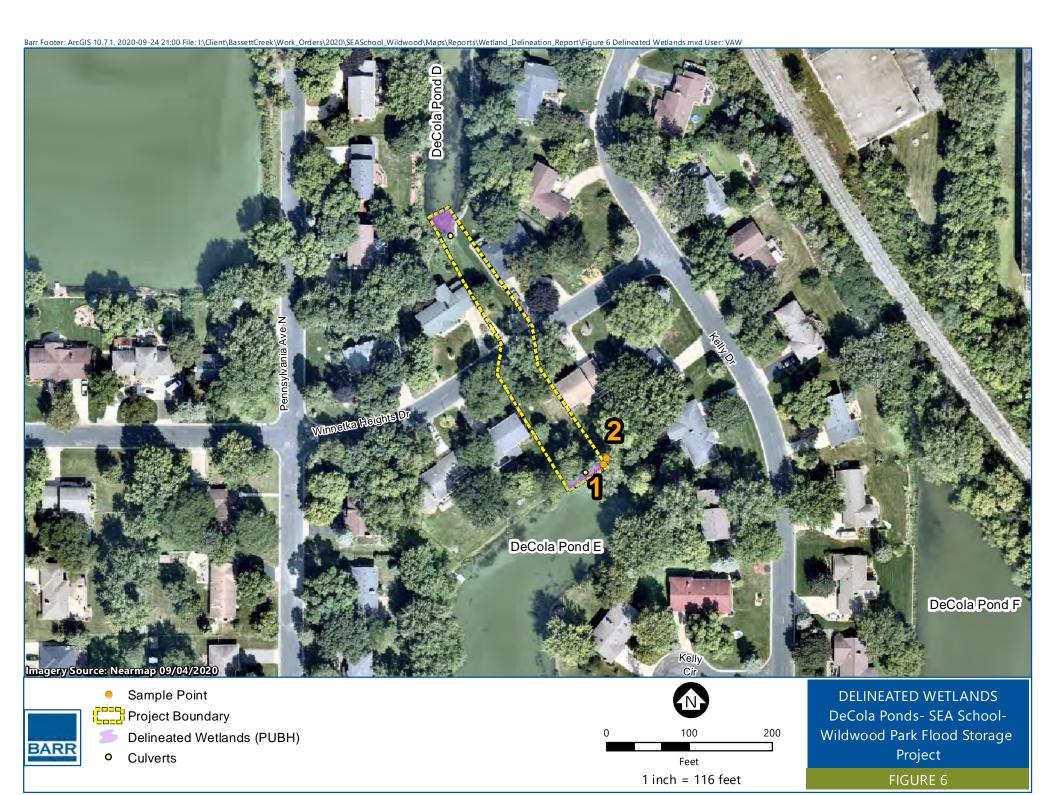
FIGURE 6

Delineated Wetlands (PUBH)

Culverts

DELINEATED WETLANDS

During the wetland delineation, two wetlands totaling 0.03 acres were delineated within the project area (**Table 4**). The delineated wetlands included DeCola Pond D and E (**Figure 6**). Delineations were limited to the areas around the DeCola Pond D outlet pipe, the northern storm sewer discharge into DeCola Pond E, and the southern storm sewer discharge into DeCola Pond E, where potential modifications to storm sewer infrastructure might be made. Descriptions and assessments of the wetland areas are provided below, with representative photographs in **Appendix B**.

DeCola Ponds D and E are connected hydrologically through a culvert located under Winnetka Heights Dr. Water flows from DeCola Pond D into Pond E and then flows outside of the project area into DeCola Pond F, ultimately draining to Bassett Creek. Since DeCola Ponds D and E are similar and, one upland/wetland transect was conducted to represent both of the delineated wetland areas for this project. At Sample Point 1, two primary hydrology indicators were observed, including saturation (A3), inundation visible on aerial imagery (B7). Both of the wetlands were classified as a Type 4/deep marsh due to the depth of the wetlands and lack of emergent vegetation (PUBH; **Figure 6**). The two ponds are hydrologically connected through a culvert under Winnetka Heights Drive, that drains Decola Pond D into Decola Pond E.

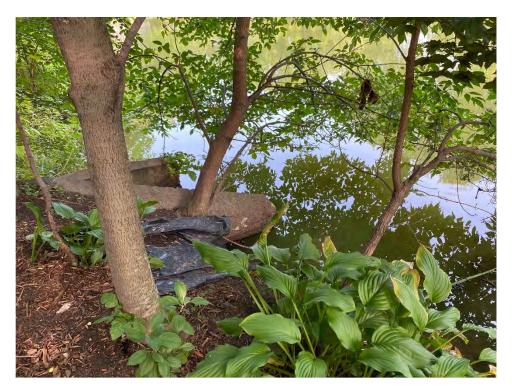
Photograph 7, Southern DaCola Pond E outlet.

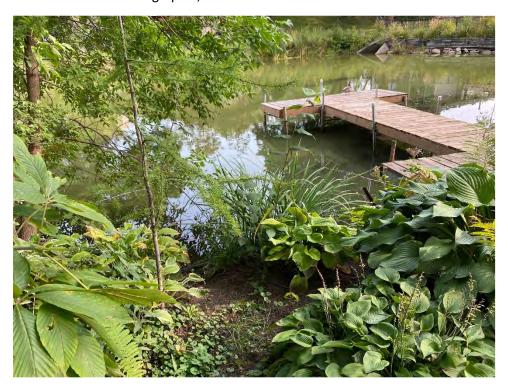
Photograph 8, Southern boundary of DaCola Pond E, view north.

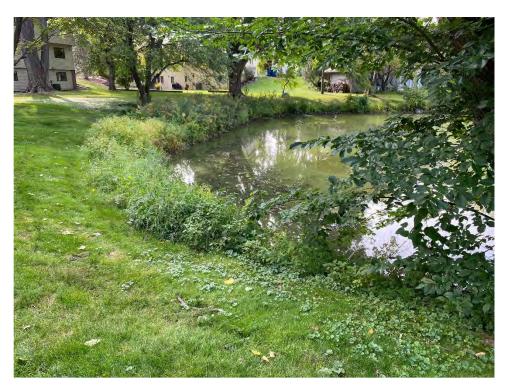
Photograph 11, northern boundary of DaCola pond E, view south.

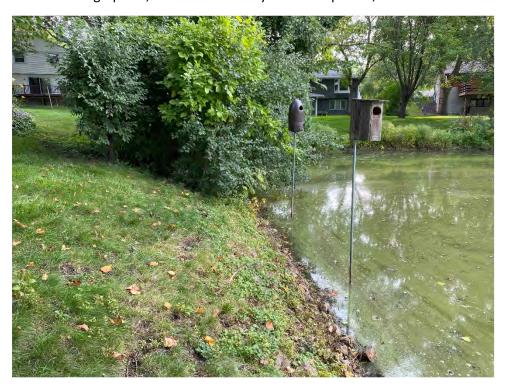
Photograph 12, northern boundary of DaCola pond E, view east.

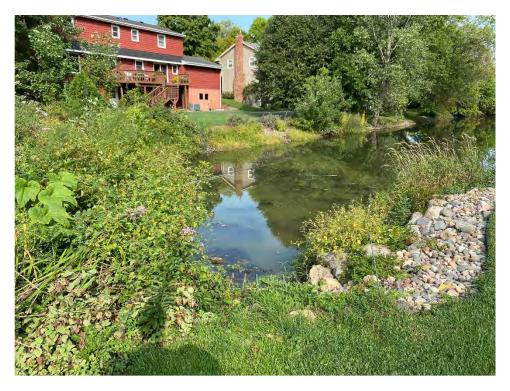
Photograph 13, southern boundary of DaCola pond D, view south.

The transition to upland was defined by a sudden 2 foot change in elevation around the perimeter of the wetland. The vegetation in the adjacent upland area consisted of maintained lawns. The southern boundary of DeCola Pond D was defined by a constructed retaining wall made of rocks.

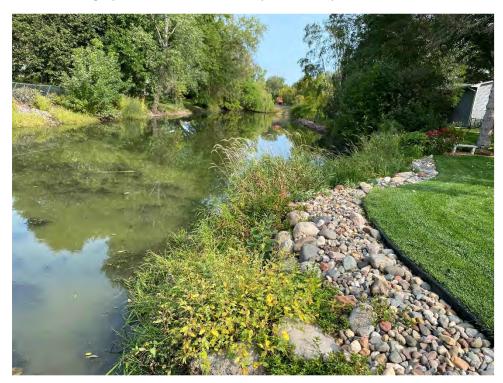
Photograph 14, DaCola pond E, view north.

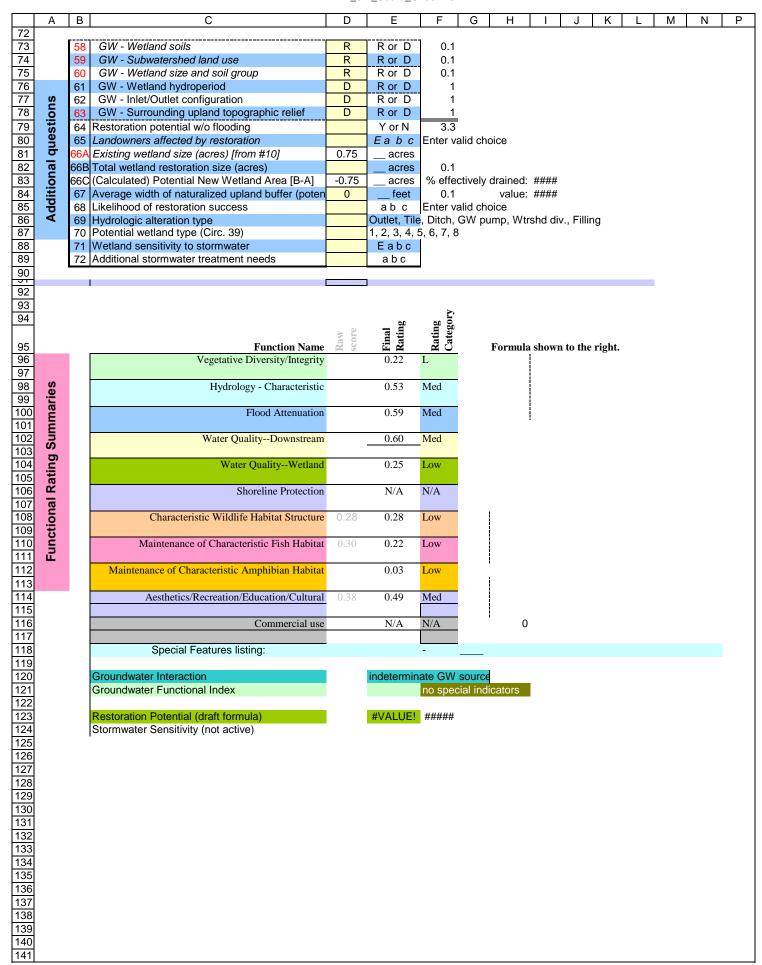
# Appendix C MnRAM Wetland Management Classification DeCola Pond D

Α	В	C	D	Е	F	G H I J	K L M N P
1			MnRAM 3.2 Digital Works	heet.		2		
2			mint, an oiz Digital Works		, O.G.	_		
3			Question Description	User	Rating			
4			•	entry			This comes in from Side 1 automatical weighted average. To use the highest	
5		1	Veg. Table 2, Option 4		0.20		Community rating, please manually or	verwrite that 0.3
6			TOTAL VEG Rating		L		value (shown to the right) into the field	d at E5.
7		4	Listed, rare, special plant species?		next			
8		5 6	Rare community or habitat?  Pre-European-settlement conditions?		next			
		7	·		next			
10 11		8	hydrogeo & topo Water depth (inches)		#1N/A			
12		0	Water depth (Miches) Water depth (% inundation)					
13		9	Local watershed/immedita drainage (acres)		4		data starting here. Yellow	
12 13 14 15 16 17 18 19		10	Existing wetland size	0.75		boxes	are used in calculations.	
15	_	11	SOILS: Up/Wetland (survey classification + site)		1			
16	o	12	Outlet characteristics for flood retention		1

Using the MnRAM wetland assessment methodology, both DeCola Pond E and D were classified as a Manage 2 wetlands. As the wetland is rated medium for aesthetics and low for amphibian habitat . See the attached for the MnRAM Excel spreadsheet.

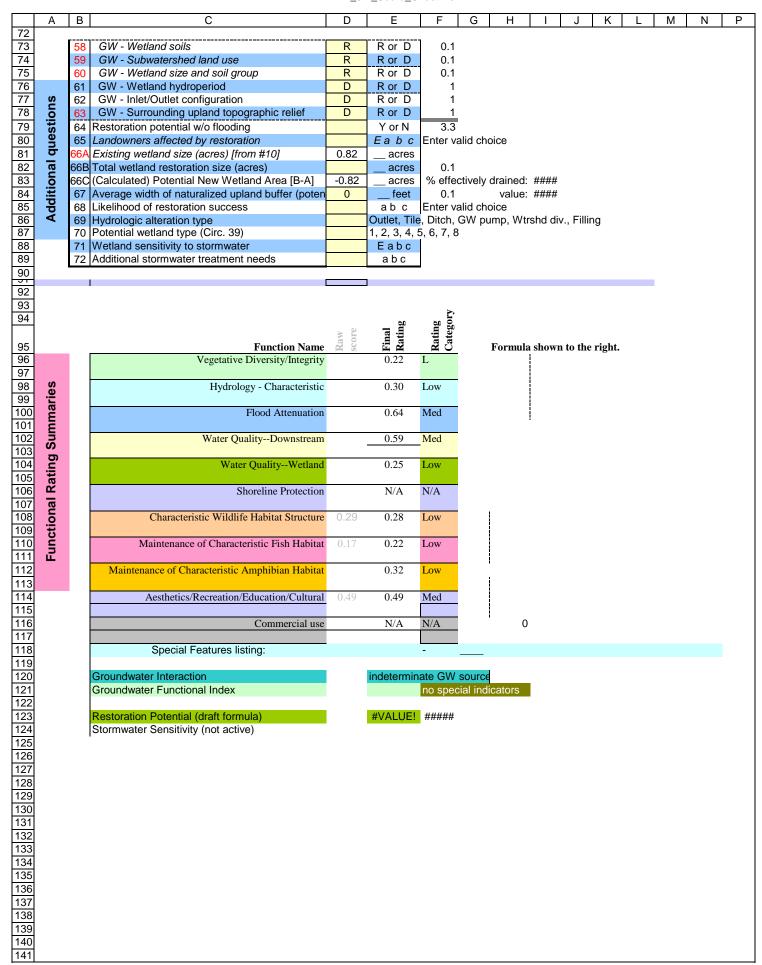
# Appendix C MnRAM Wetland Management Classification DeCola Pond E

Α	В	C	D	E	F	G H	l I J I	K L M N P
1			MnRAM 3.2 Digital Works	heet		2		<u> </u>	
2			mint, an oiz Digital Works		, O.G.	_			
3			Question Description	User	Rating		_		
4			·	entry			This comes in from	m Side 1 automatica e. To use the highes	ally using the Highest-rate
5		1	Veg. Table 2, Option 4		0.22		Community rating	, please manually of	verwrite that 0.3
6			TOTAL VEG Rating		L		value (shown to th	he right) into the field	d at E5.
7		4	Listed, rare, special plant species?		next				
8		5 6	Rare community or habitat?  Pre-European-settlement conditions?		next				
		, L	·		next				
10 11		7 8	hydrogeo & topo Water depth (inches)		/#IN/A				
		0	Water depth (Menes) Water depth (% inundation)						
13		9	Local watershed/immedita drainage (acres)		4		data starting h		
12 13 14 15 16 17 18 19		10	Existing wetland size	0.82		boxes	are used in ca	aiculations.	
15	_	11	SOILS: Up/Wetland (survey classification + site)		•
