# Memorandum

**To:** Bassett Creek Watershed Management Commission (BCWMC)  
**From:** Barr Engineering Co. (Josh Phillips, Jim Herbert, and Joe Welna)  
**Subject:** Item 4F: Non-NASSCO Deep Tunnel Inspection (3rd Ave. & Unsubmerged Portions of 2nd St. Tunnels)  
BCWMC December 18, 2025 Meeting Agenda  
**Date:** December 11, 2025  
**Project:** 23270051.65 1080 002

## 4F Non-NASSCO Deep Tunnel Inspection Report (3rd Ave. & Unsubmerged Portions of 2nd St. Tunnels)

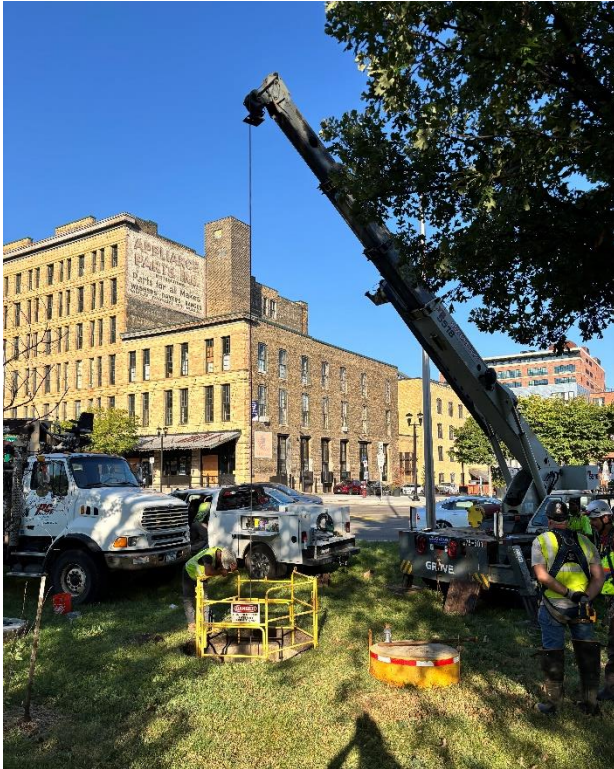
Barr's subcontractor, PCi, provided access and egress via the Washington Ave. shaft. PCi mobilized its crane, removed the top slab over the Washington Ave. shaft and then connected the basket to prepare for tunnel access. Photos of the Washington Ave. shaft are included in Figure 1.

For access and egress, PCi lowered entrants into the tunnel via the 8-foot-diameter, 70-foot-deep shaft using a 2-person basket and the crane. At the bottom of the shaft, there is a 4-foot-deep sump that prevents the basket from having a dry landing. Therefore, PCi marked the cable of the crane and ensured that the 2-person basket stayed suspended above the water. Once near the bottom, PCi's crane operator positioned the basket near the 6-foot-diameter drift tunnel for the entrants to exit the basket.

**Figure 1: Washington Ave. Shaft and Drift Tunnel (facing shaft)**

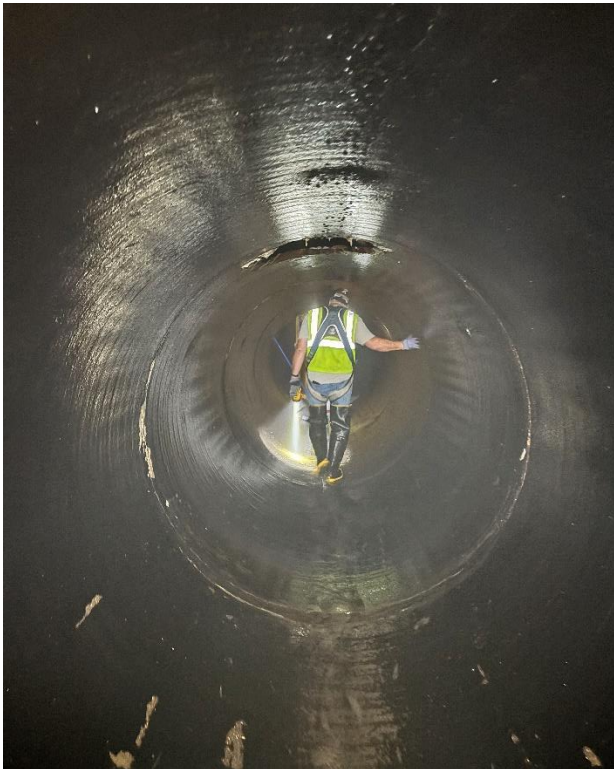
Once the entrants exited the basket, they walked through the 6-foot-diameter, 75-foot-long drift tunnel to the connection to the 3<sup>rd</sup> Ave. tunnel. The drift tunnel connects to the 3<sup>rd</sup> Ave. tunnel approximately 8 feet above the invert of the 3<sup>rd</sup> Ave. tunnel, therefore, PCi installed a ladder at the connection and secured it to an existing eyebolt to reach the invert of the 3<sup>rd</sup> Ave. tunnel, as shown in shown in Figure 2.

**Figure 2: Drift Tunnel and Ladder Access (in 3rd Ave. Tunnel)**

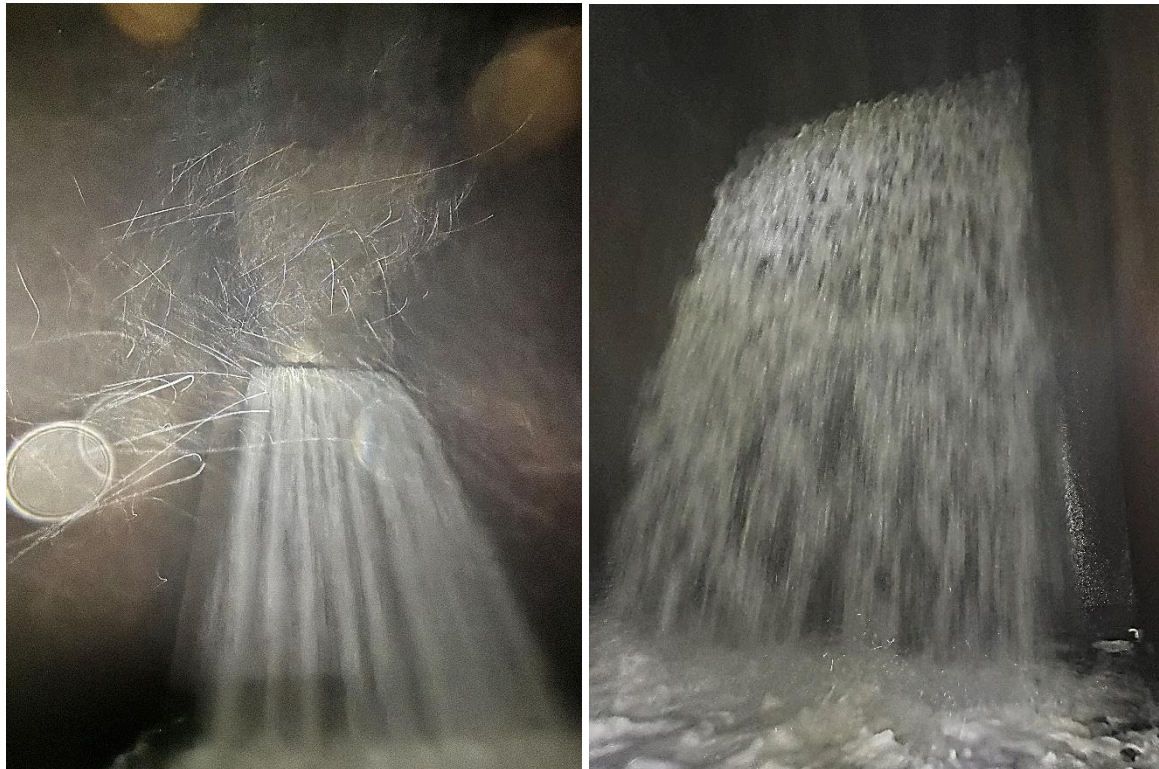
Barr did not identify any significant changes in the tunnel condition since the 2020 inspection. General photos of the drop structure, 3<sup>rd</sup> Ave. tunnel and the inspected portions of the I-94/2<sup>nd</sup> St. tunnel are shown in Figure 3, Figure 4, and Figure 5, respectively. Photos of the drop structure are slightly blurry due to heavy mist. While they do not appear to change the overall condition of the tunnel, Barr noted the following minor changes and defects within the 3<sup>rd</sup> Ave. tunnel and the inspected portions of the I-94/2<sup>nd</sup> St. tunnel:

**Figure 3: Drop Structure from Double Box Culvert to 3rd Ave. Tunnel (blurry due to heavy mist)**

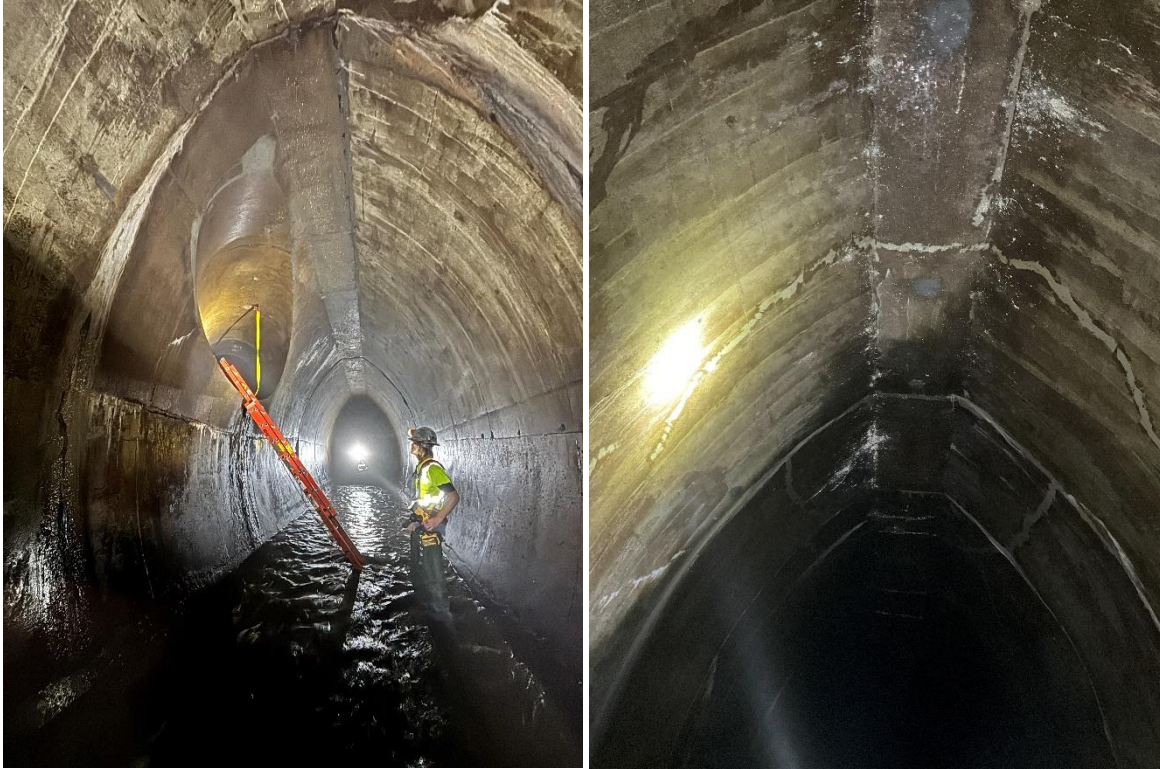
**Figure 4: 3<sup>rd</sup> Ave. Tunnel**

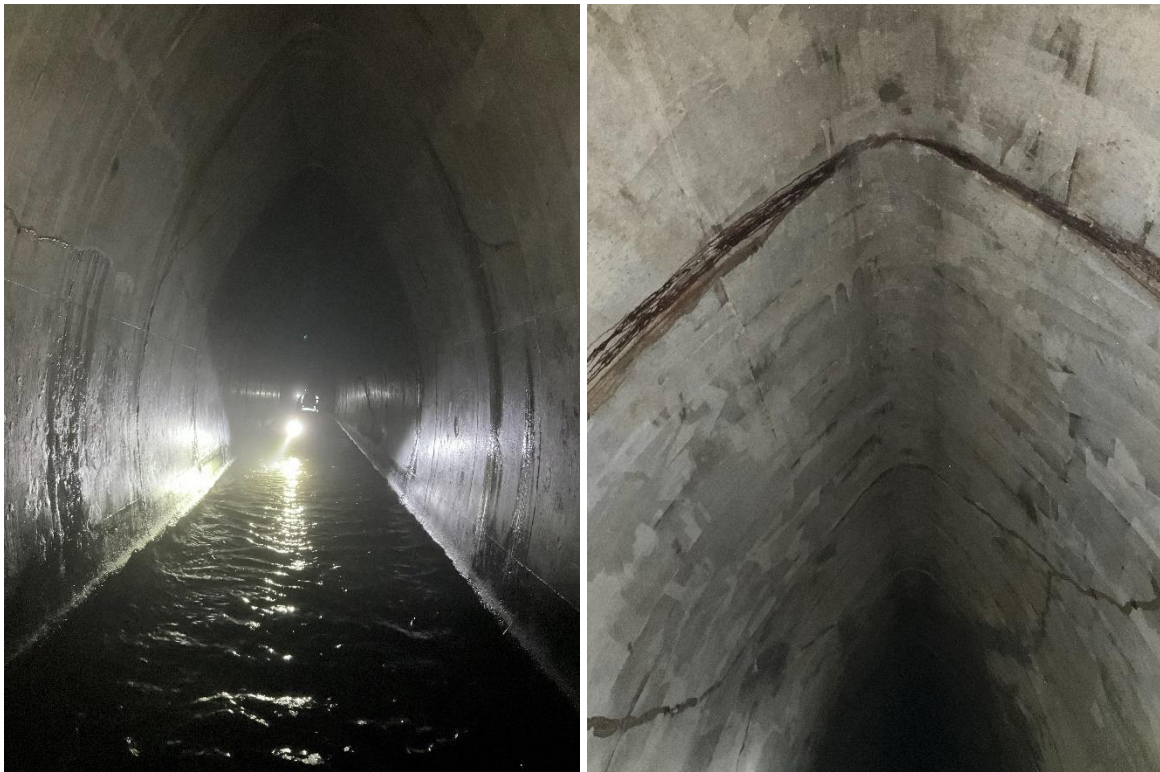
**Figure 5: I-94/2<sup>nd</sup> St. Tunnel**

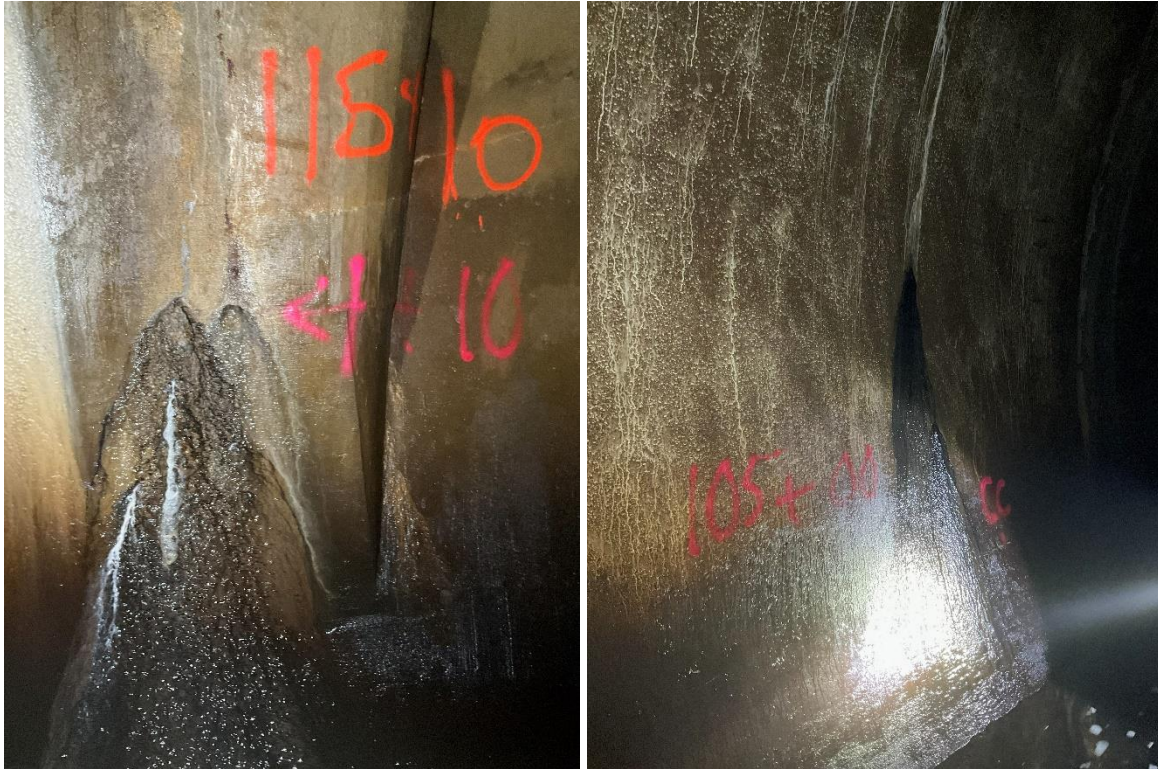
- There were five previously identified infiltration runners (IR) that were not observed in 2025 or were downgraded to an infiltration weeper (IW) at STA 101+52, 102+66, 105+24, 109+11, and 109+90. This is likely due to variation in groundwater levels between inspections or deposits attaching, calcifying, and temporarily sealing portions of the cracks in the tunnel wall. The difference between water weeping into the tunnel vs flowing into the tunnel is difficult to see in photos, but an example of an infiltration weeper (IW) and an infiltration runners (IR) is shown in Figure 6. An infiltration runner is considered a more significant defect than an infiltration weeper.

- There were approximately nine new infiltration runners (IR) observed in 2025 at STA 64+57, 103+85, 103+86, 104+20, 104+30, 105+59, 106+44, 108+77, 109+98, 112+73, 113+18, 114+90 . Similar to above, this is likely due to variation in groundwater levels between inspections.

**Figure 6: Example of an Infiltration Weeper (IW) (left photo) and an Infiltration Runner (IR) (right photo)**

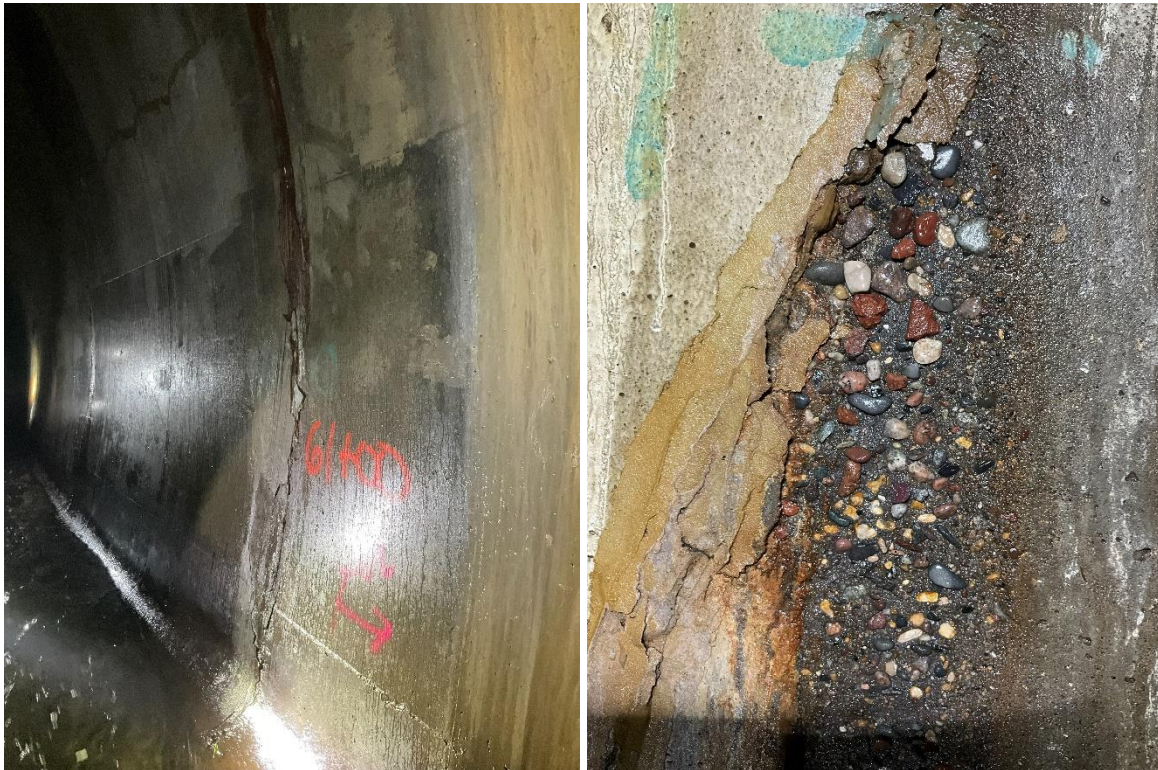
- A new area of surface aggregate visible (SAV) was observed at approximately STA 61+80 in the 2<sup>nd</sup> St. tunnel (Figure 7). This is likely due to continued wear-and-tear on the tunnel.

**Figure 7: Location and closeup of new area of surface aggregate visible (SAV)**
