***Feasibility Report for
Bassett Creek Restoration Project***

Golden Valley and Crystal, Minnesota

***Prepared for
Bassett Creek Watershed Management Commission***

August 2009

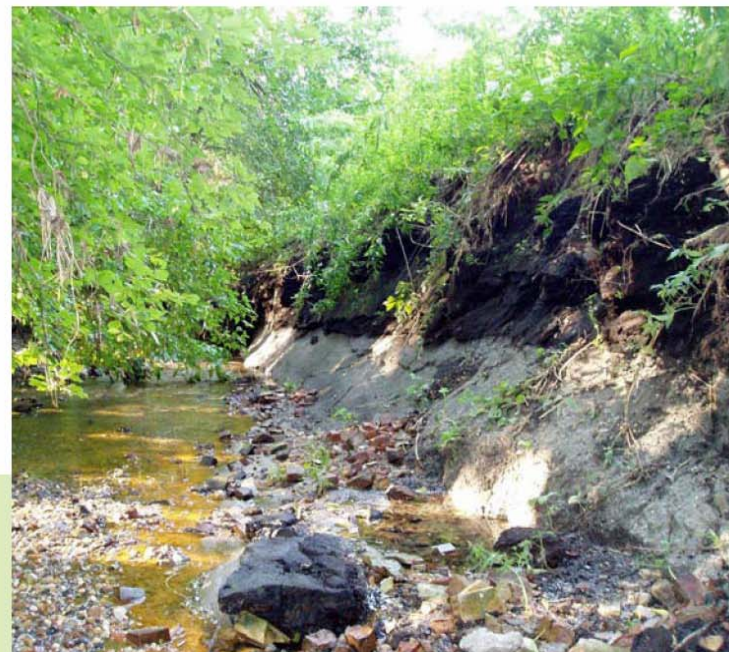
EXISTING CONDITIONS

Fluvial bank erosion is caused by water in the stream moving past the streambanks. The shear stress caused by the flow entrains soil particles into the flow, causing the stream bank to erode away. This is the most common type of erosion that occurs in streams. Virtually all streams experience this type of erosion as their flow path evolves over time. However, the rate of fluvial bank erosion can increase when the stream is out of equilibrium with its watershed. Increased flow from a watershed will increase the rate of fluvial bank erosion. In many cases, it appears to be a part of the natural process of stream evolution. In places where the channel is confined by the valley walls, however, fluvial bank erosion can lead to failure of the high banks. It can also undermine storm sewer inlets.

Stone Toe Protection is constructed from cobble-sized rock on the creek edges. It extends to approximately the bankfull level, which will protect the channel banks for flow events that occur every 1 to 2 years or less. The material will extend into the ground to resist scour. Coarse gravel is used to separate the larger rock material from underlying soil. Stone toe protection is typically used in conjunction with revegetation of the upper banks.

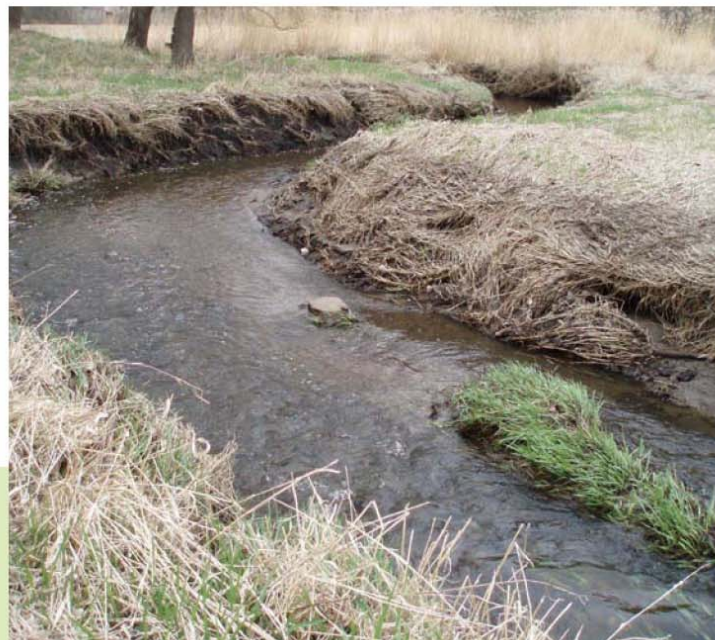
EXISTING CONDITIONS

Fluvial bank erosion is caused by water in the stream moving past the streambanks. The shear stress caused by the flow entrains soil particles into the flow, causing the stream bank to erode away. This is the most common type of erosion that occurs in streams. Virtually all streams experience this type of erosion as their flow path evolves over time. However, the rate of fluvial bank erosion can increase when the stream is out of equilibrium with its watershed. Increased flow from a watershed will increase the rate of fluvial bank erosion. In many cases, it appears to be a part of the natural process of stream evolution. In places where the channel is confined by the valley walls, however, fluvial bank erosion can lead to failure of the high banks. It can also undermine storm sewer inlets.

Root wads are constructed using sections of tree trunks with their root balls attached. The trunks extend into the stream bank leaving only the roots exposed, partially submerged. The root wads are spaced to protect a given length of bank. Footer logs and boulders are often used to help stabilize the root wads. Root wads work well where the water is deep, such as on the outside of bends, and where there is adequate sunlight to allow vegetation to grow around the exposed root wads. As the vegetation becomes established, it becomes difficult to distinguish the root wads from their natural surroundings.

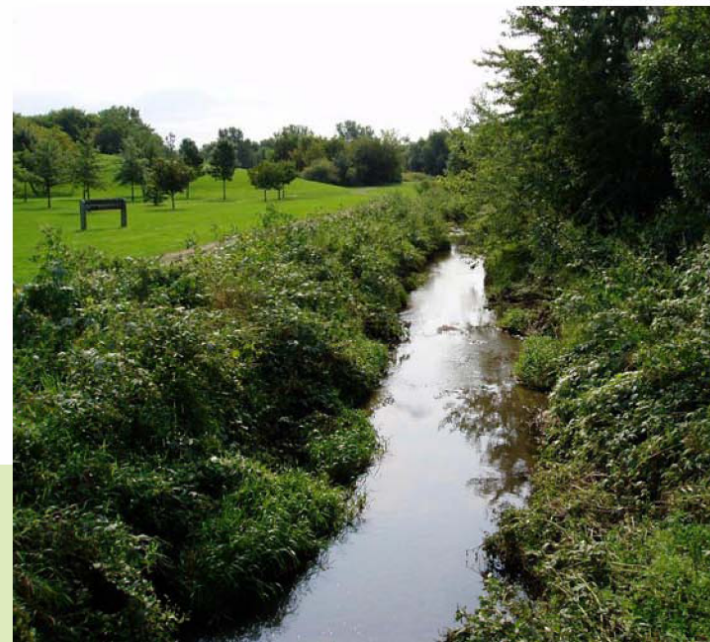
EXISTING CONDITIONS

Channel incision occurs when there is an imbalance between the sediment supply and the sediment carrying capacity of the stream. Erosion will occur when the sediment carrying capacity of a stream exceeds the sediment supply. In streams with cohesive banks and steep channel slope, the erosion will first occur primarily on the channel bottom because that is where the erosive forces are the strongest. As the channel deepens, the stream will gradually become wider as the banks eventually fail. The stream will gradually return to equilibrium; however, the process can take many years and significant amounts of erosion will occur during the process.

Grade control measures are used where channel downcutting has occurred. Various types of weirs are commonly used to provide grade control on streams, particularly in steeper systems. Weirs can be constructed of sheetpile, concrete, or natural materials such as rock. In most cases, natural rock is used to emulate natural riffles. Large boulders would comprise the core of the structure, with smaller rock material placed on the upstream and downstream sides of the boulders to provide a gradual transition to the channel.

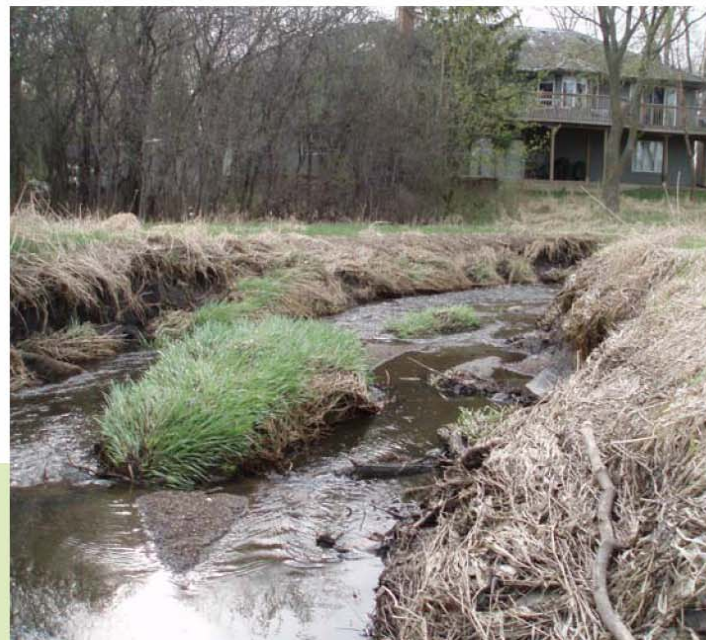
EXISTING CONDITIONS

Fluvial bank erosion is caused by water in the stream moving past the streambanks. The shear stress caused by the flow entrains soil particles into the flow, causing the stream bank to erode away. This is the most common type of erosion that occurs in streams. Virtually all streams experience this type of erosion as their flow path evolves over time. However, the rate of fluvial bank erosion can increase when the stream is out of equilibrium with its watershed. Increased flow from a watershed will increase the rate of fluvial bank erosion. In places where the channel is confined by the valley walls, however, fluvial bank erosion can lead to failure of the high banks. It can also undermine storm sewer inlets.

Rock vanes are constructed from boulders on the creek bottom. They function by diverting channel flow toward the center and away from the bank. They are typically oriented in the upstream direction and occupy no more than one third of the channel width. Vanes are largely submerged and inconspicuous. The rocks are chosen such that they will be large enough to resist movement during flood flows or by vandalism, with additional smaller rock material to add stability. Rock vanes function in much the same way as root wads in that they push the stream thalweg (zone of highest velocity) away from the outside bend. They also promote sedimentation behind the vane, which adds to the toe protection.

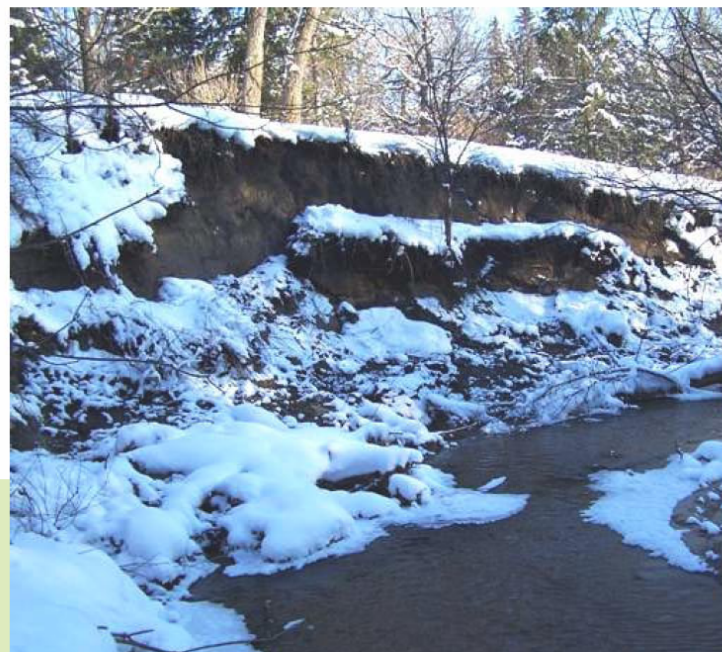
EXISTING CONDITIONS

Fluvial bank erosion is caused by water in the stream moving past the streambanks. The shear stress caused by the flow entrains soil particles into the flow, causing the stream bank to erode away. This is the most common type of erosion that occurs in streams.

Virtually all streams experience this type of erosion as their flow path evolves over time. However, the rate of fluvial bank erosion can increase when the stream is out of equilibrium with its watershed. Increased flow from a watershed will increase the rate of fluvial bank erosion.

Soil Pillows are utilized in a bioengineering method known as Vegetated Reinforced Slope Stabilization (VRSS). The method combines rock, geosynthetics, soil and plants to stabilize steep, eroding slopes in a structurally sound manner. VRSS typically involves protecting layers of soils with a blanket or geotextile material (e.g. erosion control blanket) and vegetating the slope by either planting selected species (often willow or dogwood species) between the soil layers or by seeding the soil with desired species before it is covered by the protective material. In either case, with adequate light and moisture, the vegetation grows quickly and provides significant root structure to strengthen the bank. This method tends to be labor intensive and, therefore, relatively expensive.

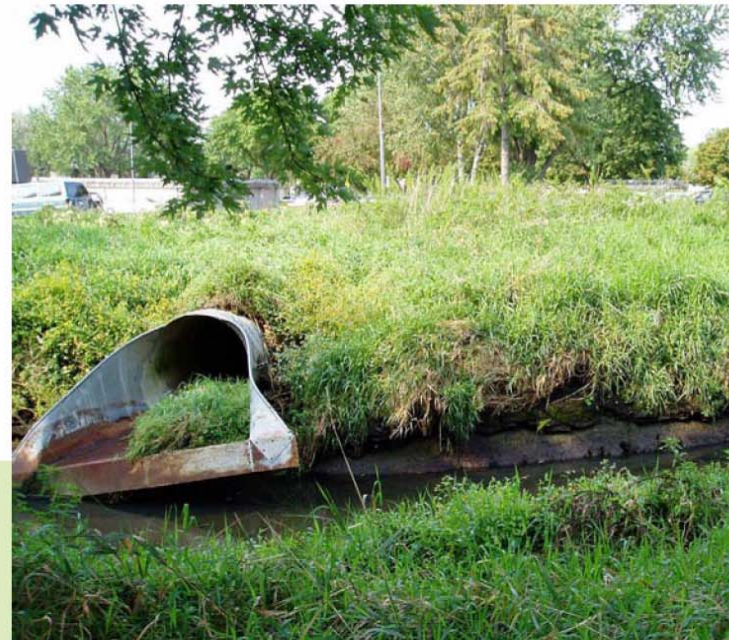
EXISTING CONDITIONS

Erosion is frequently observed at culvert outlets for a variety of reasons, including insufficient erosion protection at the culvert outlet, streambank erosion, and channel downcutting, which leaves the culvert perched above the channel. Filter fabric is often used at culvert outlets to separate riprap protection from underlying soils, however the fabric provides a slippery surface for the riprap, which commonly slides into the channel.

Culvert Stabilization is somewhat unique to each situation, depending on the site circumstances. Most sites require additional rock placement with a granular filter layer (rather than filter fabric). Some cases may require re-alignment and/or lowering of the outlet to better align with the stream channel. Typically, outlets should be aligned in the downstream channel direction so that flow doesn't impinge on the opposite bank. It is usually desirable for the culvert to enter the stream at or just above the normal water level in order to minimize the potential for undercutting.
