# Memorandum

**To:** Bassett Creek Watershed Management Commission (BCWMC)  
**From:** Barr Engineering Co. (Barr) (Josh Phillips, Gabby Campagnola, Jim Herbert)  
**Subject:** Item 4D: Bassett Creek 2025 Flood Control Project Inspection - BCWMC November 19, 2025 Meeting Agenda  
**Date:** November 13, 2025  
**Project:** 23270051.65 1080 001

## 4D Bassett Creek 2025 Flood Control Project Inspection

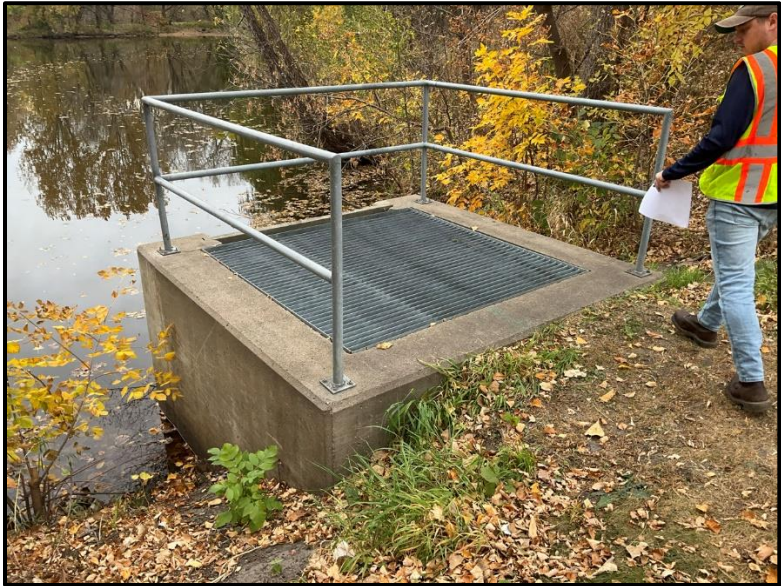
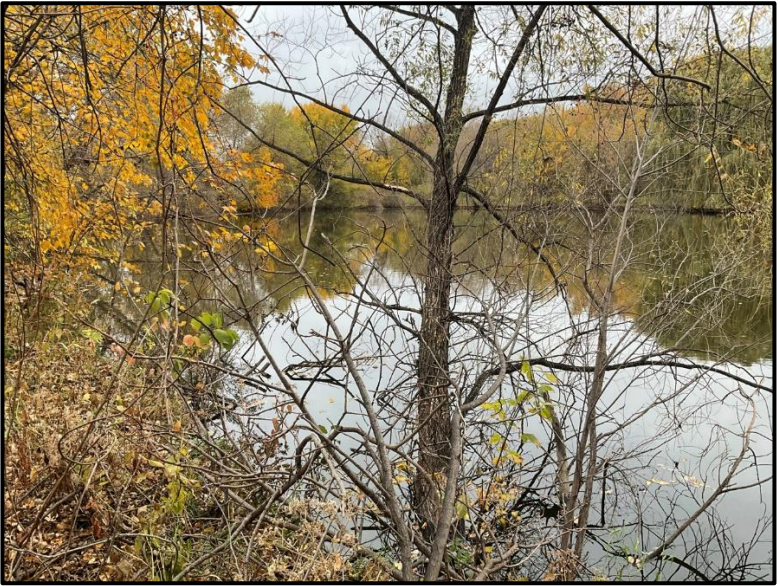
**Detention Pond and Outlet Structure (Crystal) – photos from 2024, no photos taken in 2025**

- a. The outlet structure appeared to be in satisfactory condition.
- b. The detention pond appeared to be in satisfactory condition, but a survey is needed to assess accumulated sediment.

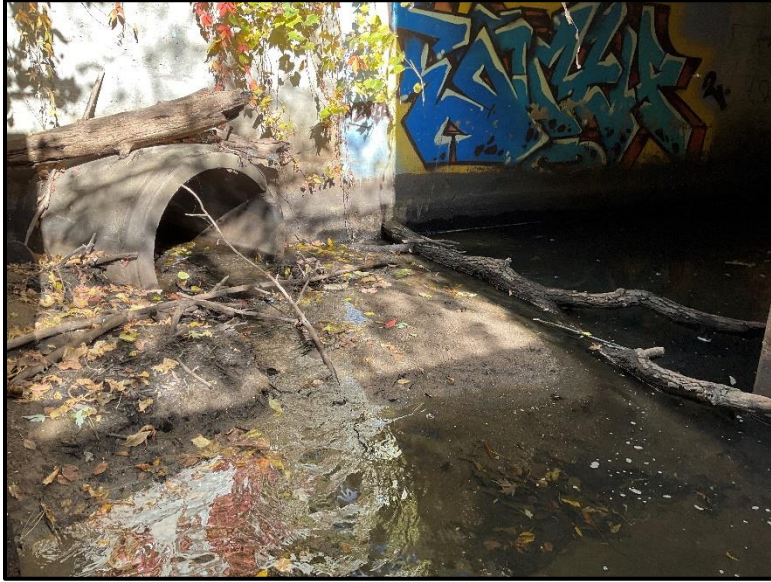
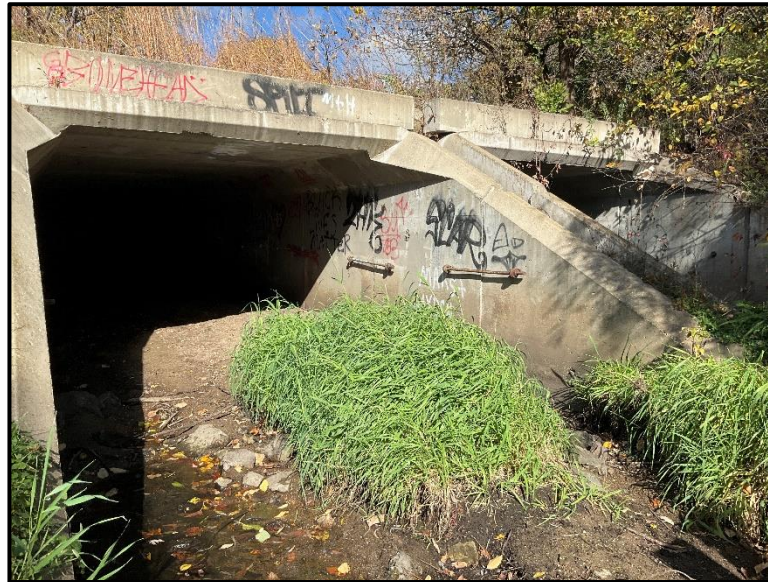
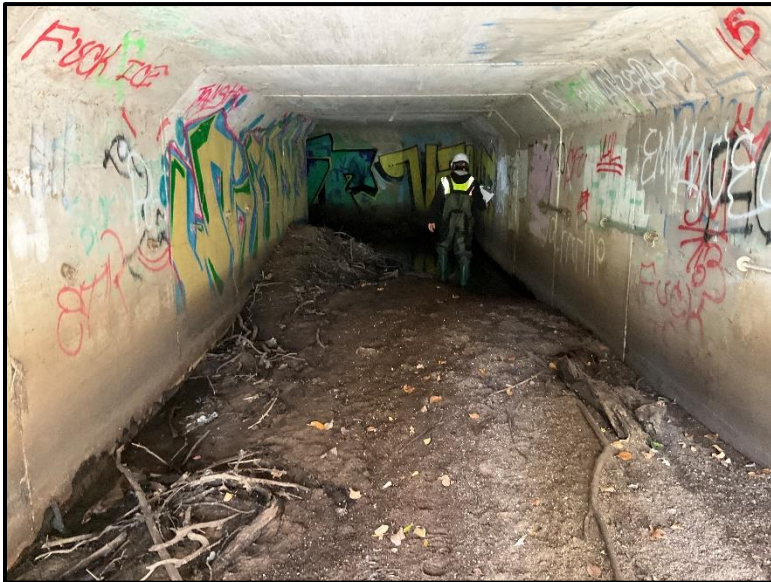
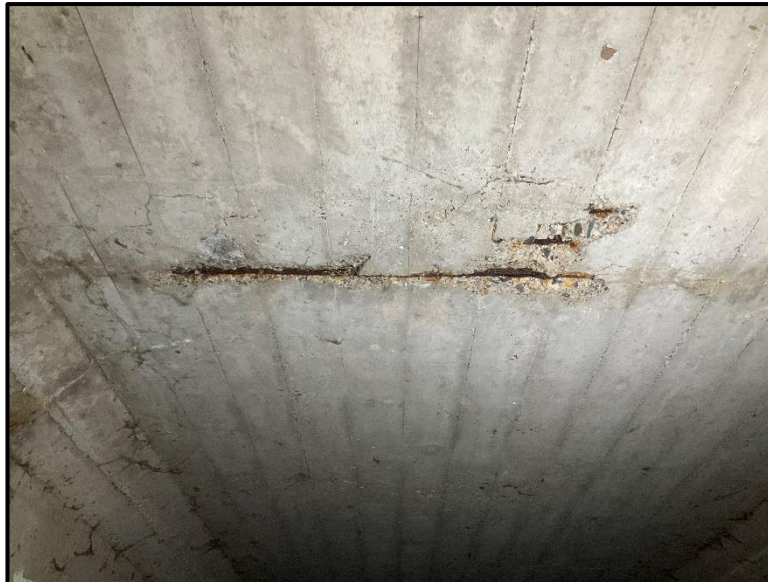
Highway 100 Double Box Culverts (MnDOT Responsibility, Located in Crystal/Golden Valley)

- a. The concrete inlet structure appeared to be in satisfactory condition.
- b. During the inspection, there was 8 inches of water in the right box and the left box, after the upstream end.

- c. Circumferential cracks and approximately 14 locations of spalled concrete, 13 of which had exposed reinforcement, were observed in the north (left) box culvert.

- d. Two areas of spalled concrete on the right wall of the south (right) box culvert were observed.
- e. Five longitudinal cracks, circumferential cracks, and areas of spalled concrete with exposed reinforcement were observed along the top of the south (right) box culvert. MnDOT performed repairs to the culverts in 2007, but cracks have been noted since 2008 and areas of concrete spalling have been noted since 2014.

- f. Deposited sediment was observed in the north (left) box culvert, generally ranging from 6-36 inches deep. This is similar to previous inspections that noted 6-24 inches of deposited sediment has been observed in the north (left) box culvert since 2002.

- g. The outlet portion of the structure appeared to be in satisfactory condition.

- MnDOT should assess the defects and repair, as necessary.

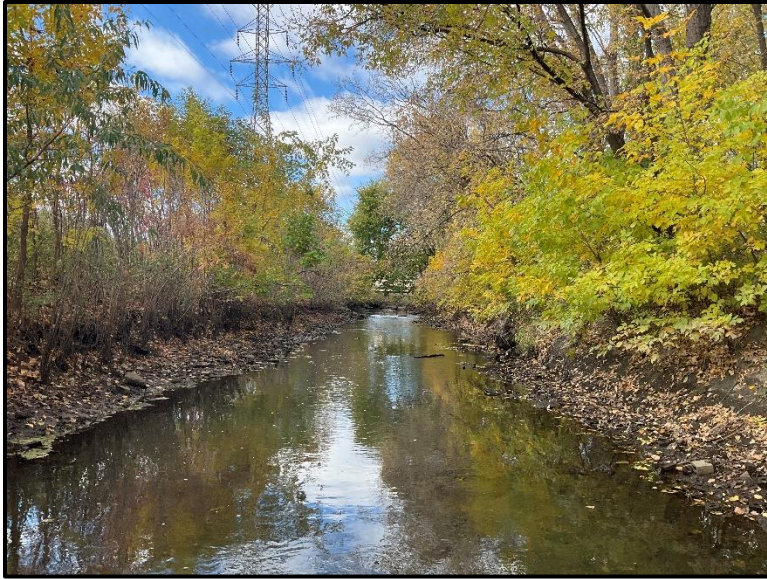
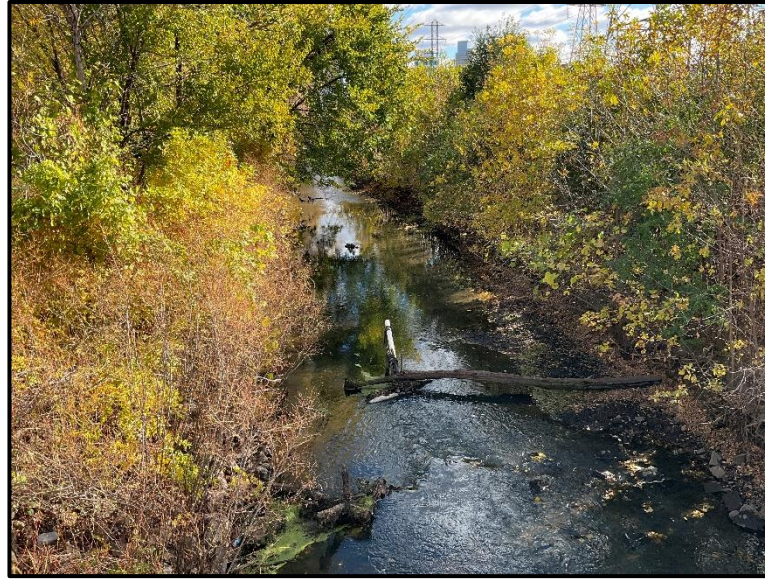
## Open Channel (Minneapolis)

- a. The open channel, from Van White Memorial Boulevard to the inlet structure, appeared to be in satisfactory condition.
- b. The banks were generally vegetated. Some areas had exposed soil and steep slopes but seemed stable and no obvious signs of bank erosion were noted.
- c. Sediment has deposited and formed a delta on the south (right) side of the channel between the debris barrier and inlet structure, extending approximately 10% of the channel width. Vegetation was growing on the delta. This is consistent with previous years' observation.
- d. The probes/intake pipes for the watershed outlet monitoring program (WOMP) station near Van White Memorial Boulevard has been dislodged by a log in the creek.

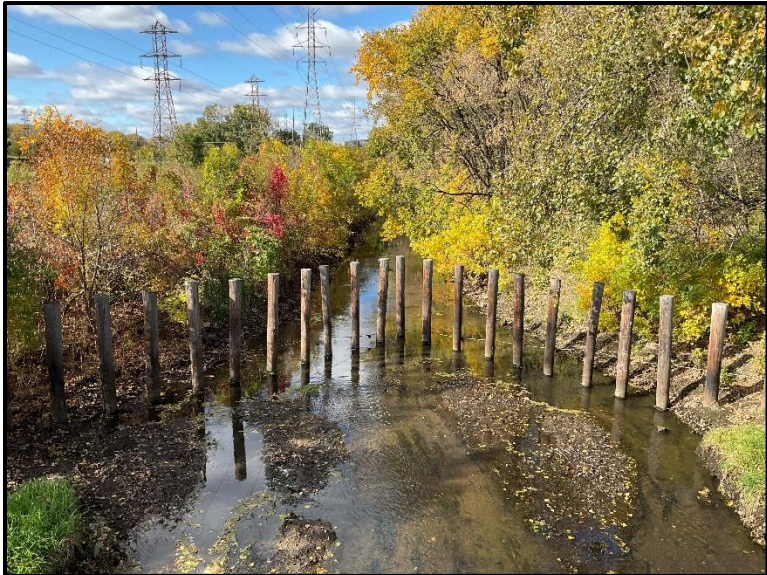
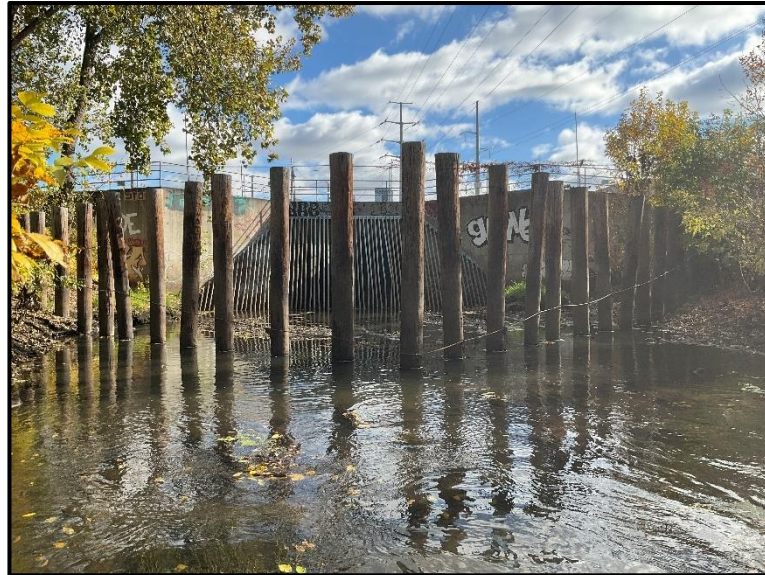
## Debris Barrier (Minneapolis)

- a. The debris barrier piles appeared to be in satisfactory condition.
- b. The steel cable was repaired by the City in 2023 and extended across the channel, attached at each post.

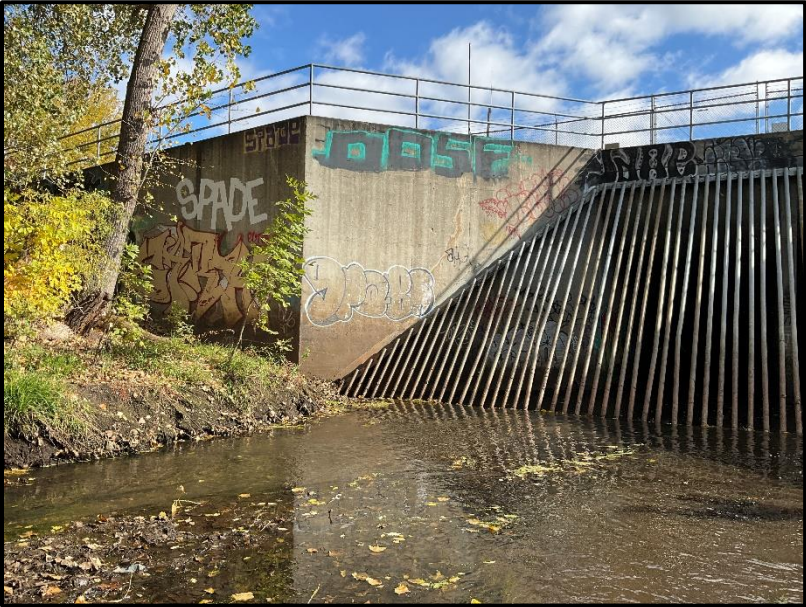
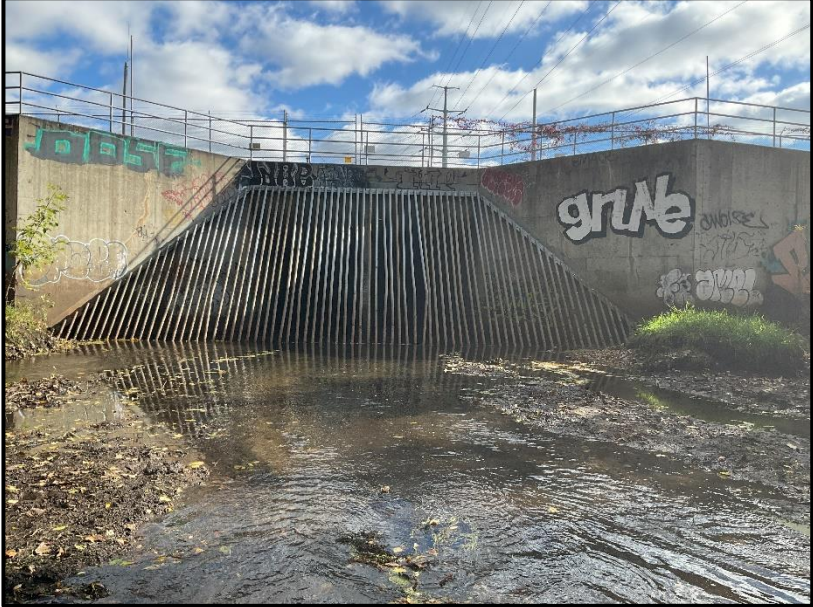
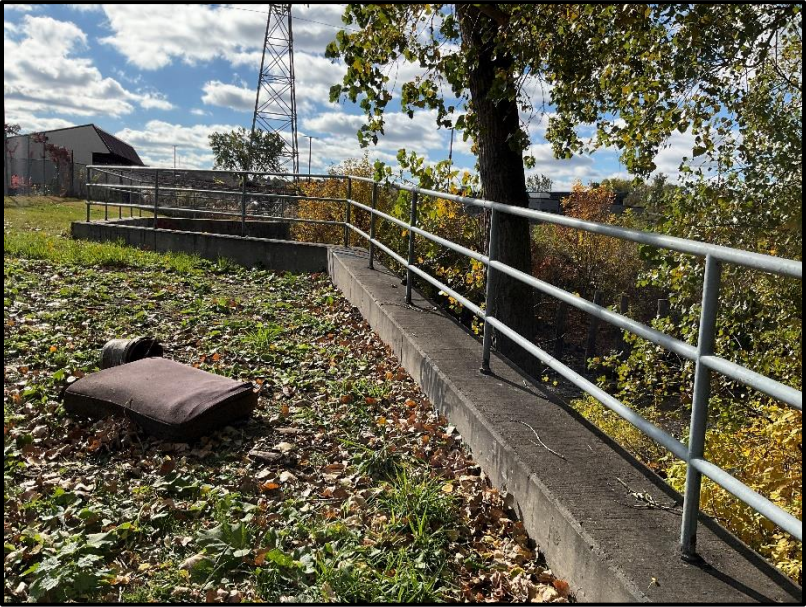
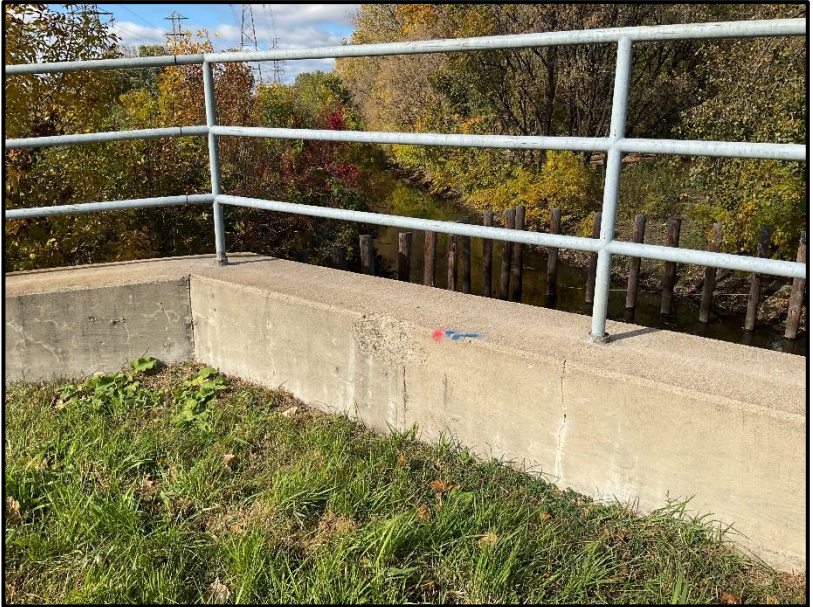
**Inlet Structure (Minneapolis)**

- a. The concrete inlet structure appeared to be in satisfactory condition.
- b. Vertical cracks were observed in the concrete on either side of the structure.
- c. Cracks were observed near where the handrail posts are embedded.
- d. The railings appeared to be in satisfactory condition.
- e. Some of the vertical bars have been bent and projecting a slight bow but generally appeared to be in satisfactory condition.

- f. The inlet structure was clear of leaves and debris.
- g. Spalled concrete was observed behind the railings on the right side of the structure.

- Monitor cracks in the concrete inlet structure.
- Monitor concrete spalling behind the railings.
