To: Bassett Creek Watershed Management Commission (BCWMC)
From: Barr Engineering Co.: Josh Phillips, P.E., Jim Herbert, P.E., Joe Welna, P.E.
Subject: Item 4D: Bassett Creek Box Culvert Inspection Report: Inspection Date: November 2024 -
BCWMC February 20, 2025 Meeting Agenda
Date: February 13, 2025
Project: 23270051.65 1080 002

Bassett Creek Double Box Culvert Inspection Report

Prepared for
Bassett Creek Watershed Management Commission

Inspection Date: November 2024

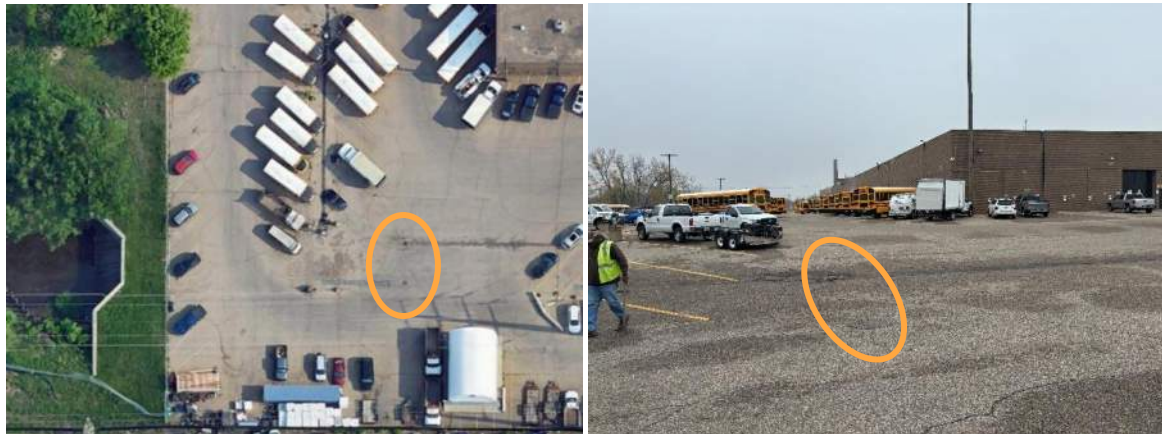
Figure 3-3 Primary Access and Egress Location

The primary access and egress location for the Box Culvert inspection was through a catch basin (Sta 170+81) into the left box culvert and a manhole (Sta 170+81) into the right box culvert in the southwest parking lot of the Minneapolis Public School Transportation facility at: 1001 2nd Ave N, Minneapolis, MN 55405, as shown in Figure 3-3. Within the box culverts, the access manhole and access catch basin are approximately 150 feet downstream of the inlet structure. The rims of the access manhole and catch basin are approximately 15 feet above the invert of the tunnel. Inspection staff entered and exited the box culverts at this location using a ladder and fall arrestor.

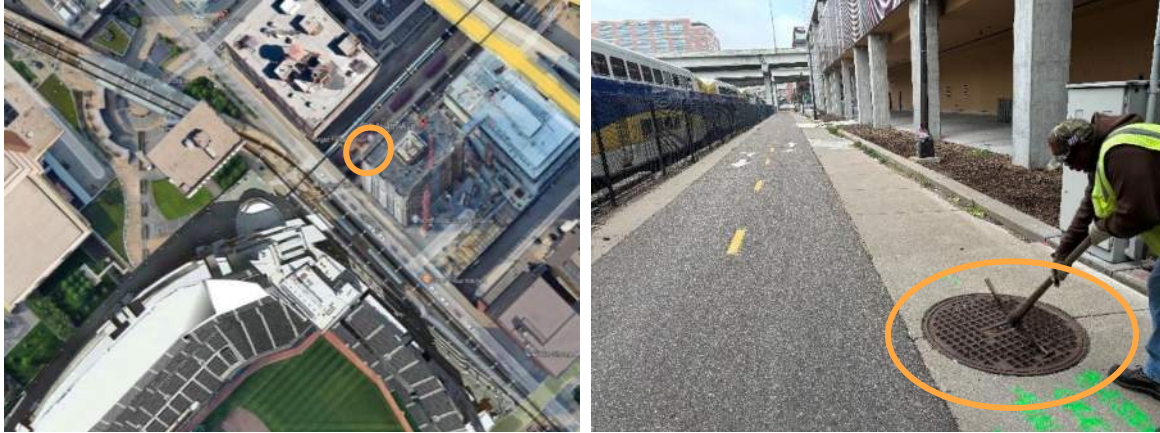
Figure 3-4 Secondary Access and Emergency Egress Location

The secondary access and emergency egress location used for the inspection is the manhole (Sta 119+59) along Cedar Lake Trail, immediately northeast of Target Field, south of the Northstar Rail's Target Field Station, between 5th Street N and 4th Street N, as shown in Figure 3-4. Within the tunnel, the access manhole is approximately 40 feet downstream of the confluence of the left and right box culverts into the single box culvert. The rim of the access manhole is approximately 30 feet above the invert of the tunnel at this location. A tripod and power winch were available for emergency egress from the tunnel at this location. Egress through the secondary access was not necessary during the inspection.

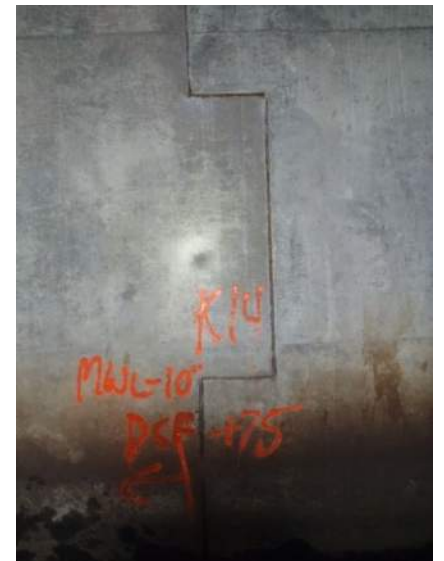
<p>2014 photo showing a close-up of a shear key. The text 'K14R' is written in red spray paint. Below the key, 'MWL-10'' and 'DSF -175' are also written in red.</p>

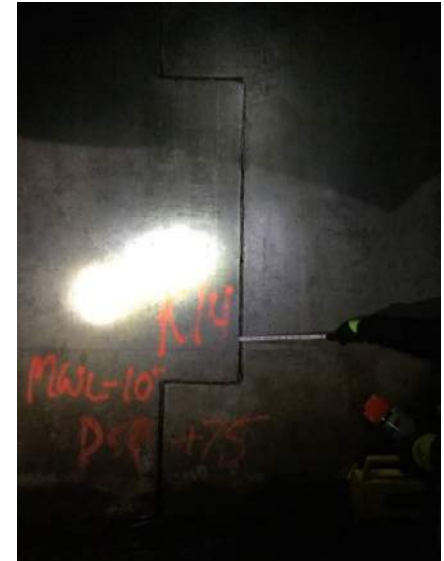
<p>2019 photo showing a close-up of the same shear key. The text 'K14R', 'MWL-10'', and 'DSF -175' are written in red spray paint. A bright light source is visible on the left.</p>	  <p>2024 photo showing a person inspecting the shear key. The text 'K14R', 'MWL-10'', 'DSF -175', and 'ISF+SS' are written in red spray paint. A measuring tool is being used.</p>
