Double Box Culvert Repair Project (FCP-1) Feasibility Report

Minneapolis, Minnesota

Prepared for
Bassett Creek Watershed Management Commission

June 2025

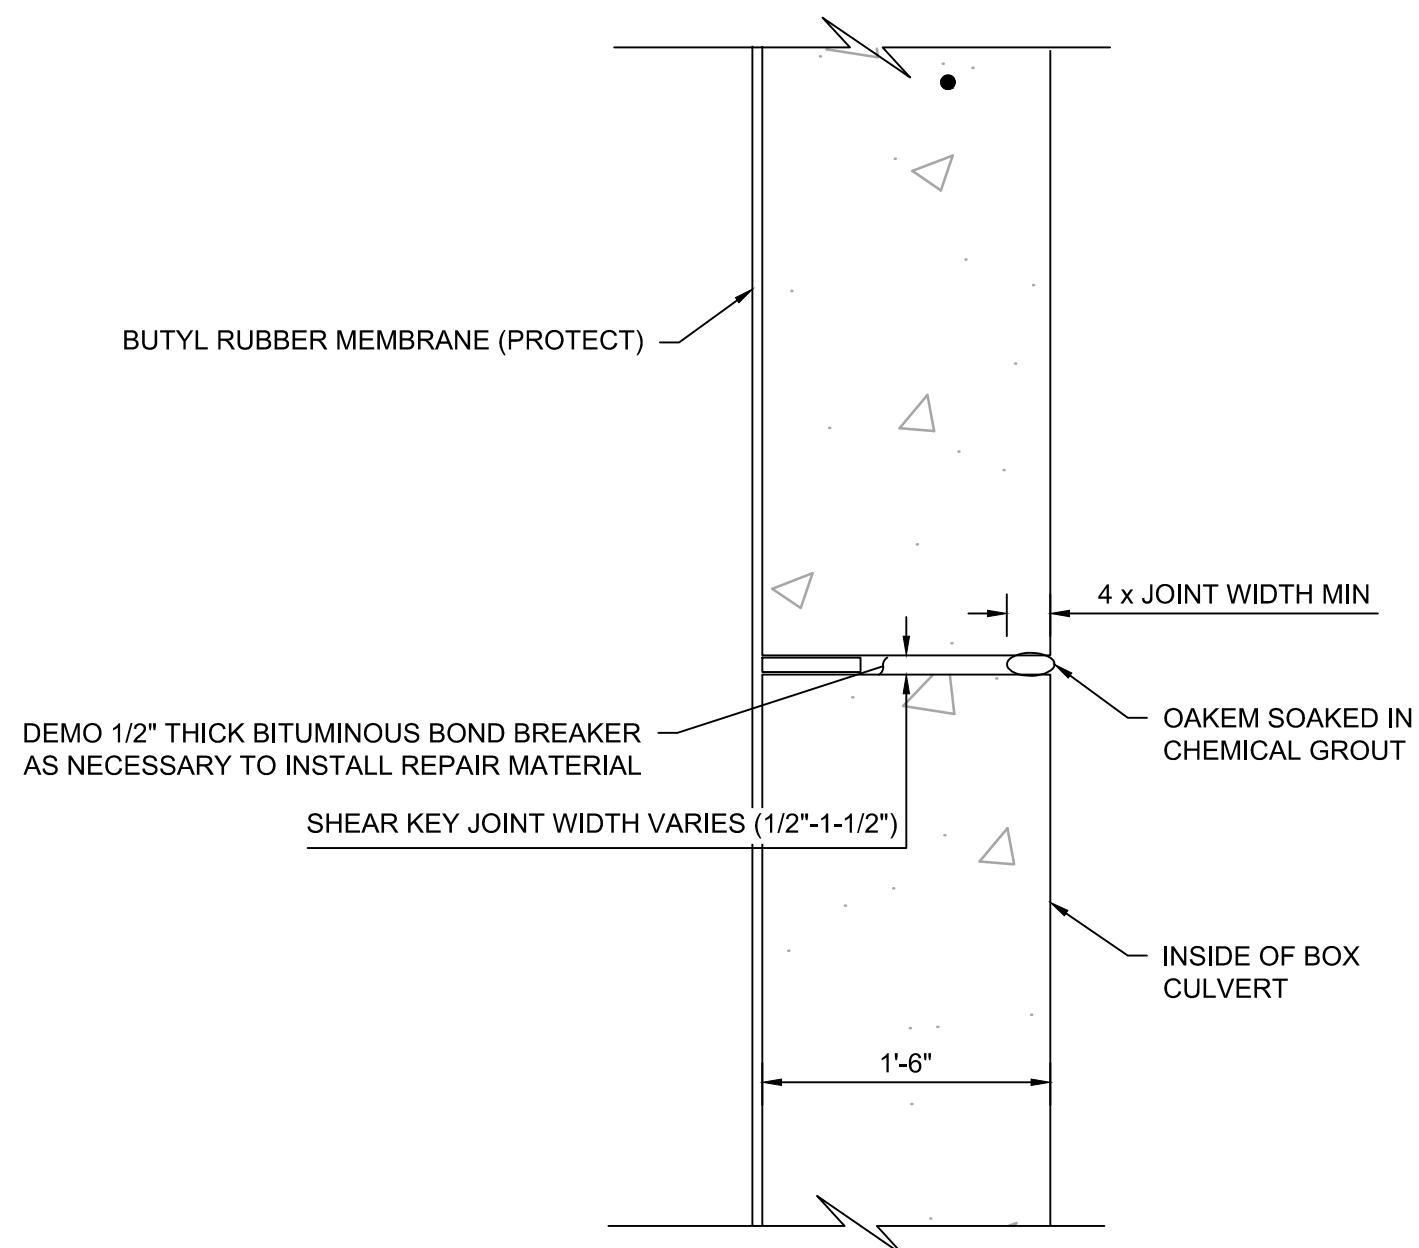
6 DETAIL: TYPE 6 - SHEAR KEY REPAIR

The Double Box Culvert was constructed with shear key joints at 35 locations along the Double Box Culvert alignment. The purpose of the shear keys is to transfer load between culvert segments and minimize differential settlement. During the 2019 and 2024 inspections (2) (3), the Commission Engineer observed infiltration, deposits, and concrete deterioration at many of the shear key joints. In addition, approximately 70% of the shear keys had missing or deteriorated bitumastic material within the 1- to 1.5-inch-wide joints. These defects and observations indicate some level of differential settlement has occurred at the shear keys since construction. In addition, water and soil intrusion through these joints could lead to void spaces developing outside of the box culvert walls, which can lead to settlement or sinkholes at the ground surface above the box culvert.

The primary objective of this repair is to replace deteriorated joint filler material to minimize potential migration of water and soil particles into the tunnel. Shear keys that are experiencing concrete deterioration will be repaired under “concrete surface repair,” “crack repair,” or “fracture repair” as noted in the subsections below. The approach to repair the shear key joints includes installing oakum, soaked in a hydrophilic chemical grout, to seal the joints and fractures. This would minimize water and soil intrusion and reduce the risk of void spaces developing outside of the box culvert. Photos showing typical shear key joints recommended for repair are included in Figure 2.

1. PERFORM REPAIR ALONG FULL SHEAR KEY JOINT EXTENT, ALONG FULL WALL HEIGHT.
