# DRAFT Feasibility Report for the Wirth Lake Outlet Modification Project

Prepared by the Bassett Creek Watershed Management Commission

May 2011

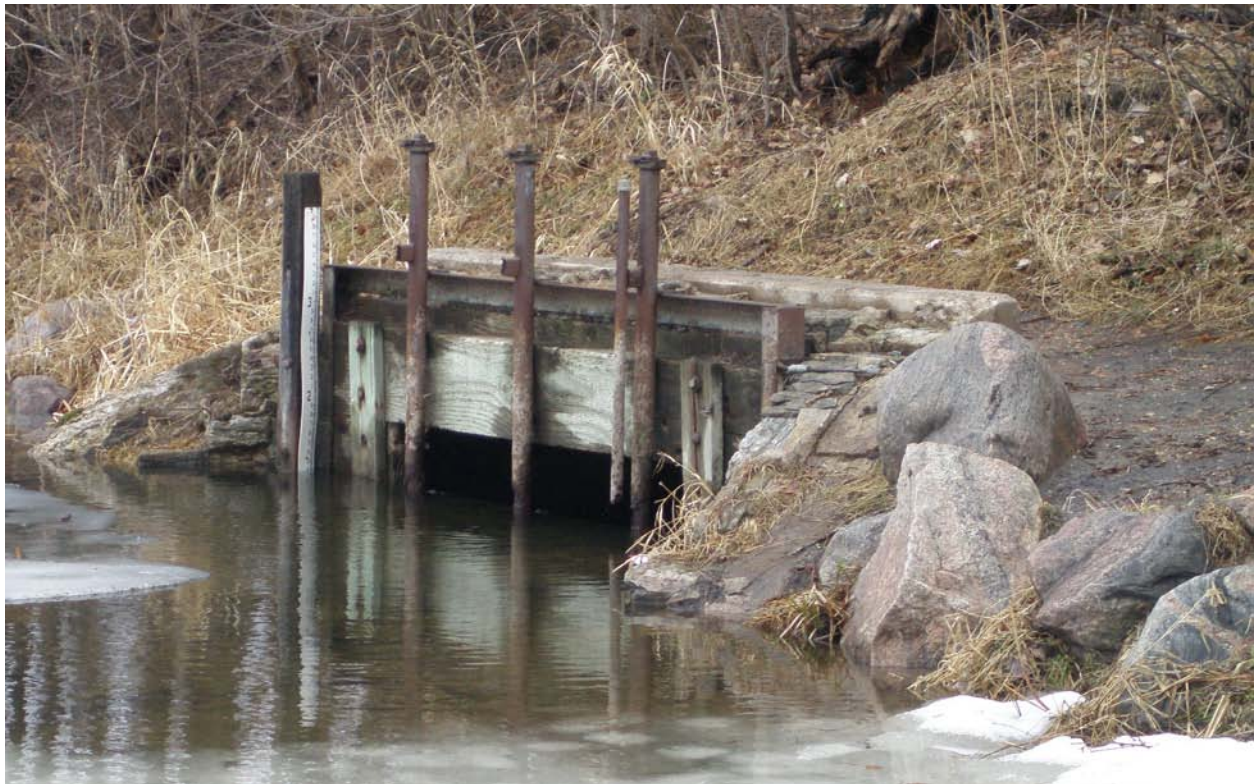
**Figure 2. Existing Wirth Lake Outlet Structure.**

The existing stone-faced concrete culvert once served as a roadway crossing of the flow out of the lake. The roadway was removed but the culvert was left in place. The existing timber weir was built onto this concrete culvert in the 1970's to hold three submerged perforated outlet pipes that extend into the lake and are covered with a gravel bed. Originally this was designed to prevent rough fish from entering the lake. These perforated pipes are not visible and are no longer functioning. Three shafts that controlled valves in these perforated pipes still exist and can be seen in **Figure 2**. These valves no longer function.

The existing culvert is made of concrete and was faced with Platteville limestone. It was inspected for condition on April 7, 2011. The culvert was found to be in very good condition and suitable for the installation of a new upstream bulkhead. A summary of the inspection observations is included in the Appendix of this study.

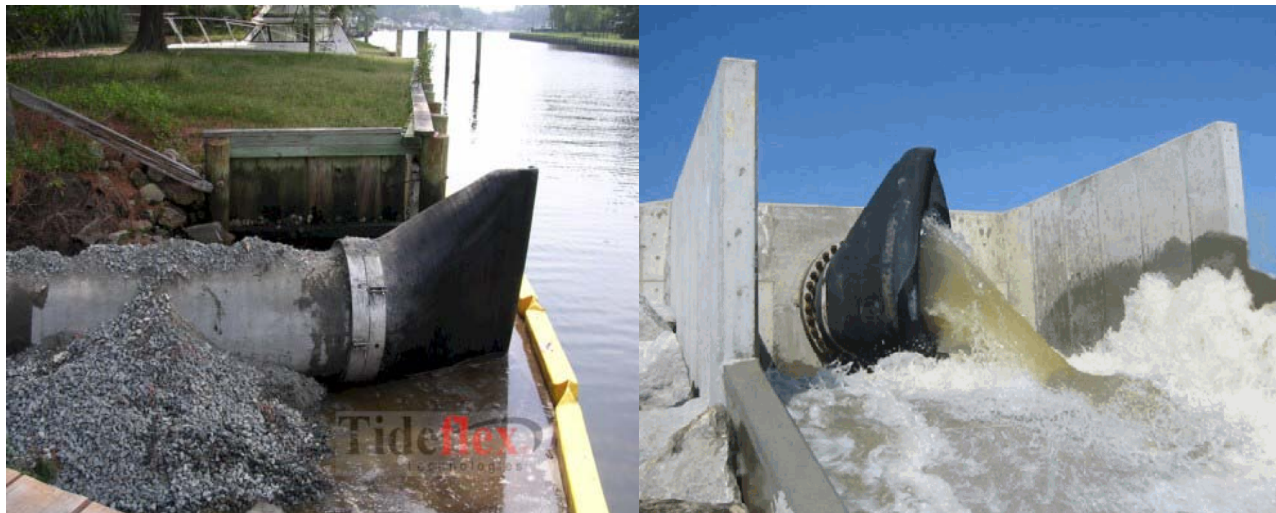
**Figure 4. Photos of the Rubber Check Valve.**

The rubber check valves operate by opening in response to elevated hydraulic head (or water level) at the upstream (lake side) opening and closing in response to neutral or elevated hydraulic head at the downstream end (creek side). In its resting position it resembles a vertical duck's bill, with the downstream end of the heavy duty rubber cylinder curled shut as shown in **Figure 4**. Rubber check valves are in common use to prevent back flow in tidal zones and have become increasingly used for flood protection.

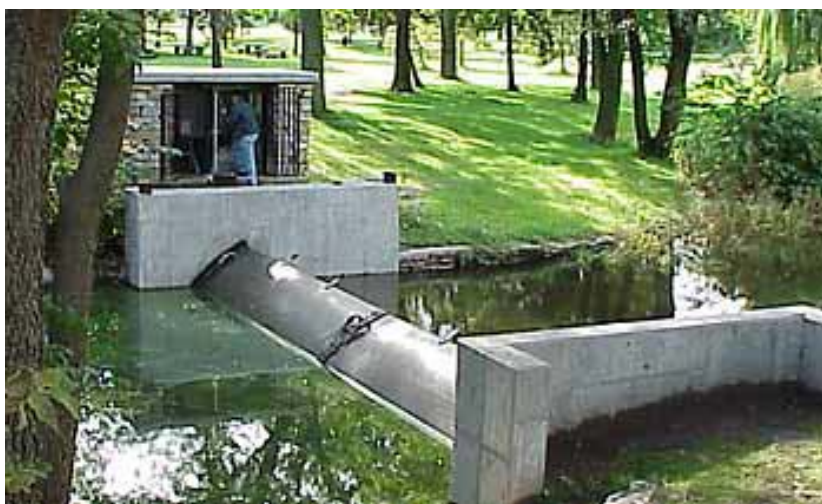
**Figure 5. Inflatable barrier at Minnehaha Creek and Lake Nokomis.**

Inflatable Barrier: The alternative of adding an inflatable dam, or weir, to the existing structure was also reviewed. The inflatable barrier would consist of a steel wall that is raised by forcing compressed air into a bladder beneath it when high water conditions exist. To house the heavy structure a large concrete apron would be required along with an electrical control system, air compressor and a control building.

This method was deemed to be fairly complex and cost more than either the steel lift gate or rubber check valve alternatives. Due to the complexity of the device maintenance cost is also anticipated to be higher than other alternatives. The inflatable device requires much more space than is available at the Wirth Lake site and presents vulnerabilities to vandalism due to its exposure and construction. This alternative was not investigated further.
