TECHNICAL MEMORANDUM

RE: Lakeview Park Pond Preliminary Design
BCWMC Technical Advisory Committee – Project Update
SEH No. GOLDV 122415 14.00

The purpose of this technical memorandum is to summarize the work that has been completed to date by the City of Golden Valley and SEH.

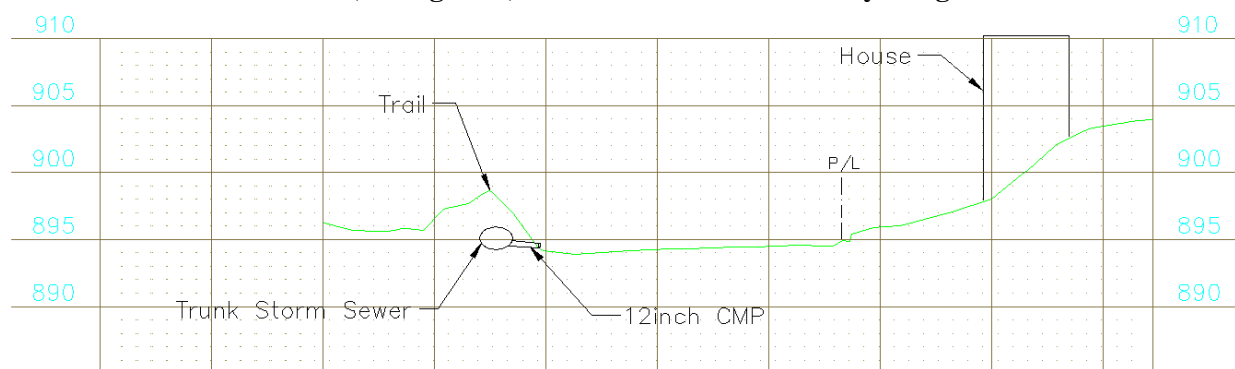
Section A-A (see Figure 4). Cross Section at 1517 Gettysburg Avenue

- **(3) Limited Live Storage** – The third cause of flooding is the limited live storage or allowable bounce in the park. The elevation at the property line of the residential parcels ranges from 0.5 feet to 1.5 feet higher than the low point in the green space area. Effectively the ponding area only has 0.5 feet of live storage before storm water is ponding on residential properties. The detail provided below illustrates the buildings, trail and property line relative to the existing topography at 1517 Gettysburg Avenue.

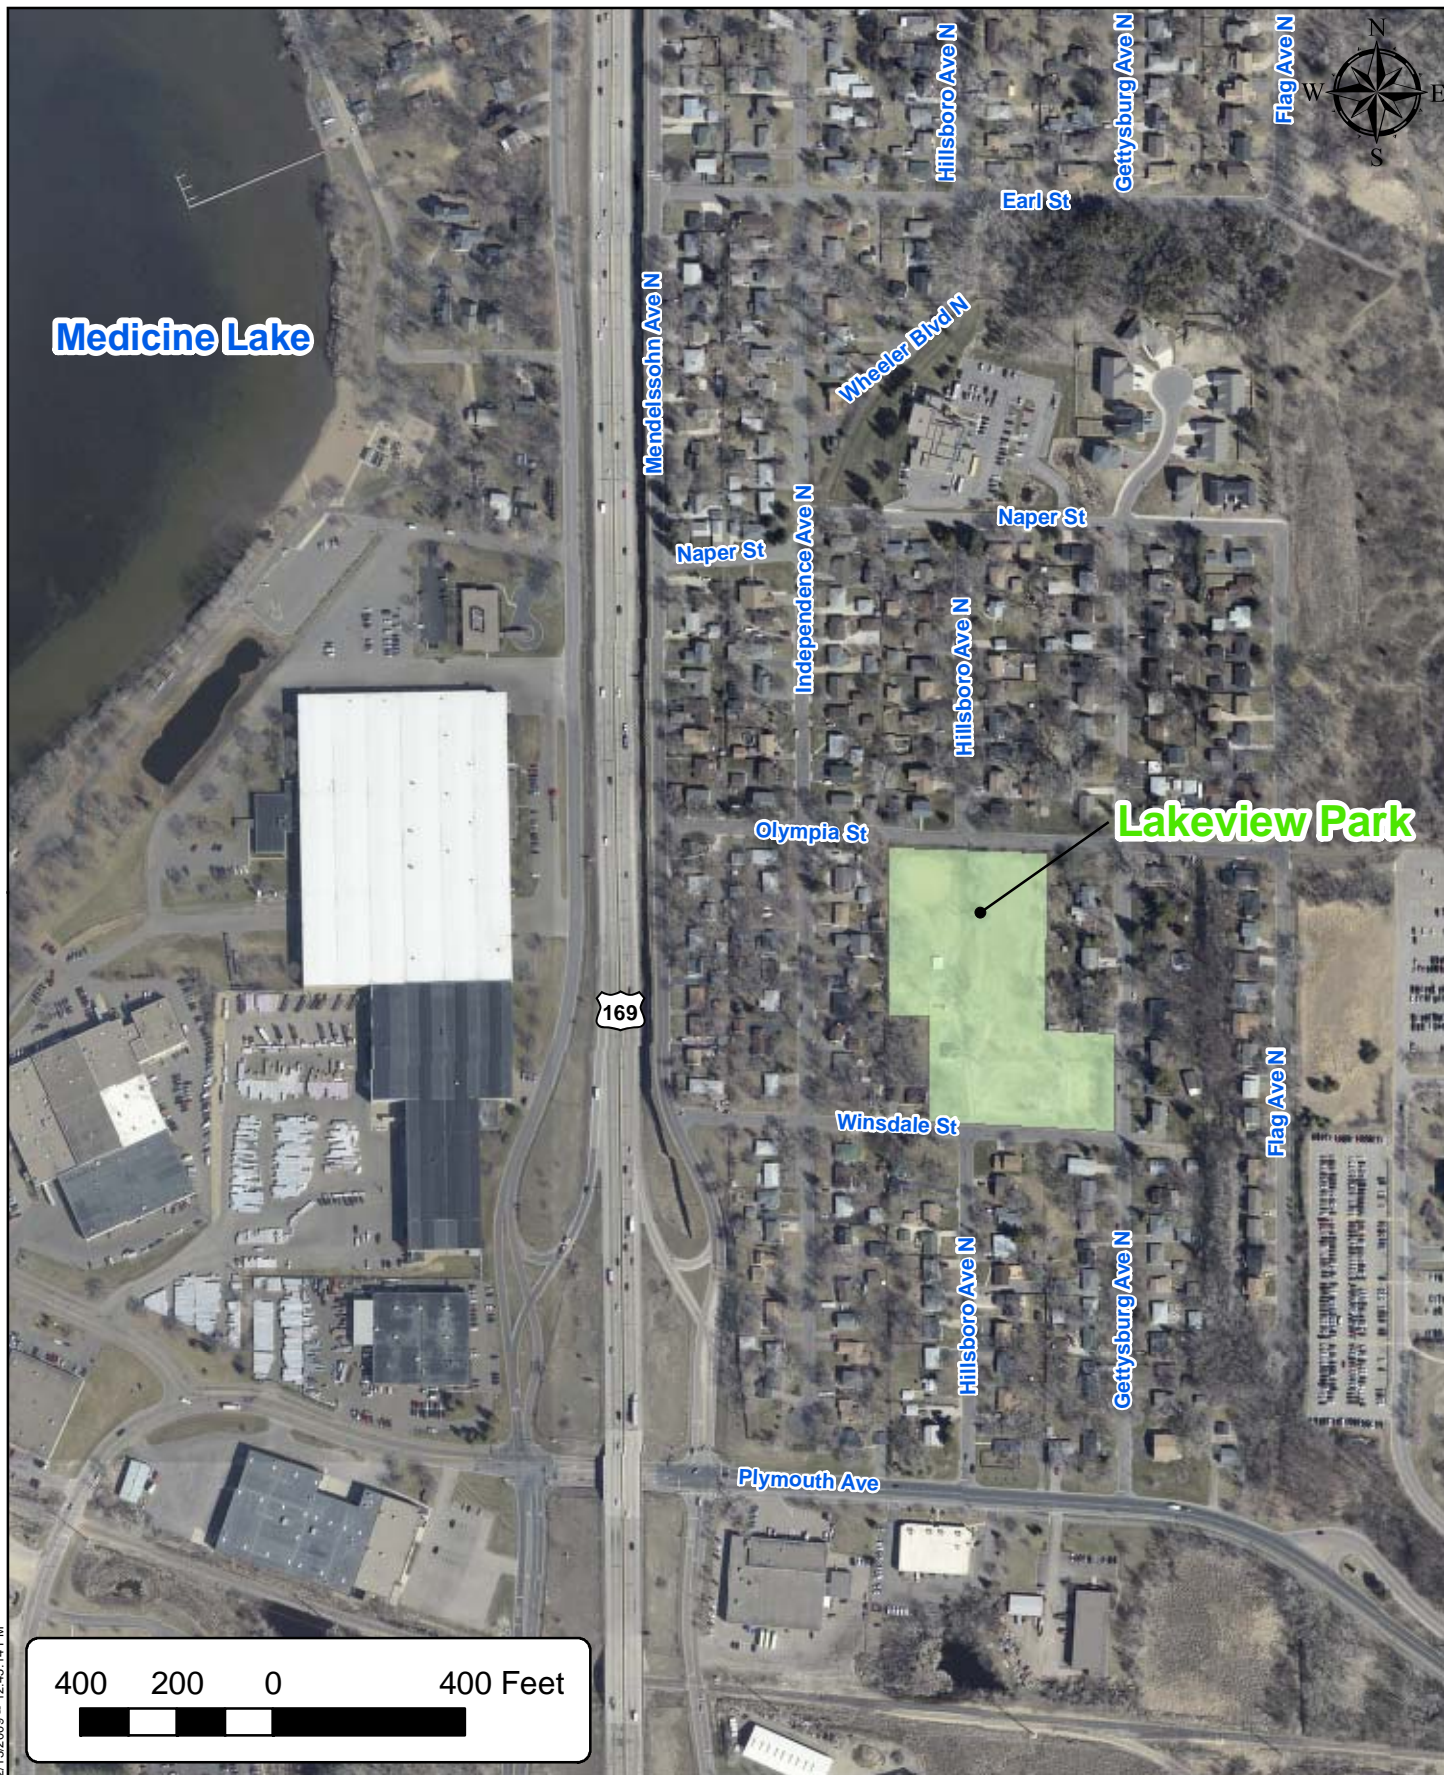
Figure
1

Lakeview Park Pond
City of Golden Valley

Lakeview Park is located approximately two blocks east of Trunk Highway 169 (T.H. 169), between Olympia Street and Winsdale Street North (see **Figure 1**). The park features include a baseball field, picnic area, shelter, soccer field, trail, and green space. Based on historical data, the area appeared to be a wetland and was hydraulically connected to Medicine Lake. When the area was developed, the wetland was filled to accommodate homes and roadways. The park is located in the center of a closed basin (i.e. a low area with no natural outlet). A trunk storm sewer line was installed during the time of the original development to drain the basin/low area into Medicine Lake. The trunk storm sewer line is the only outlet for the park and it extends west, under T.H. 169 and discharges into Medicine Lake.

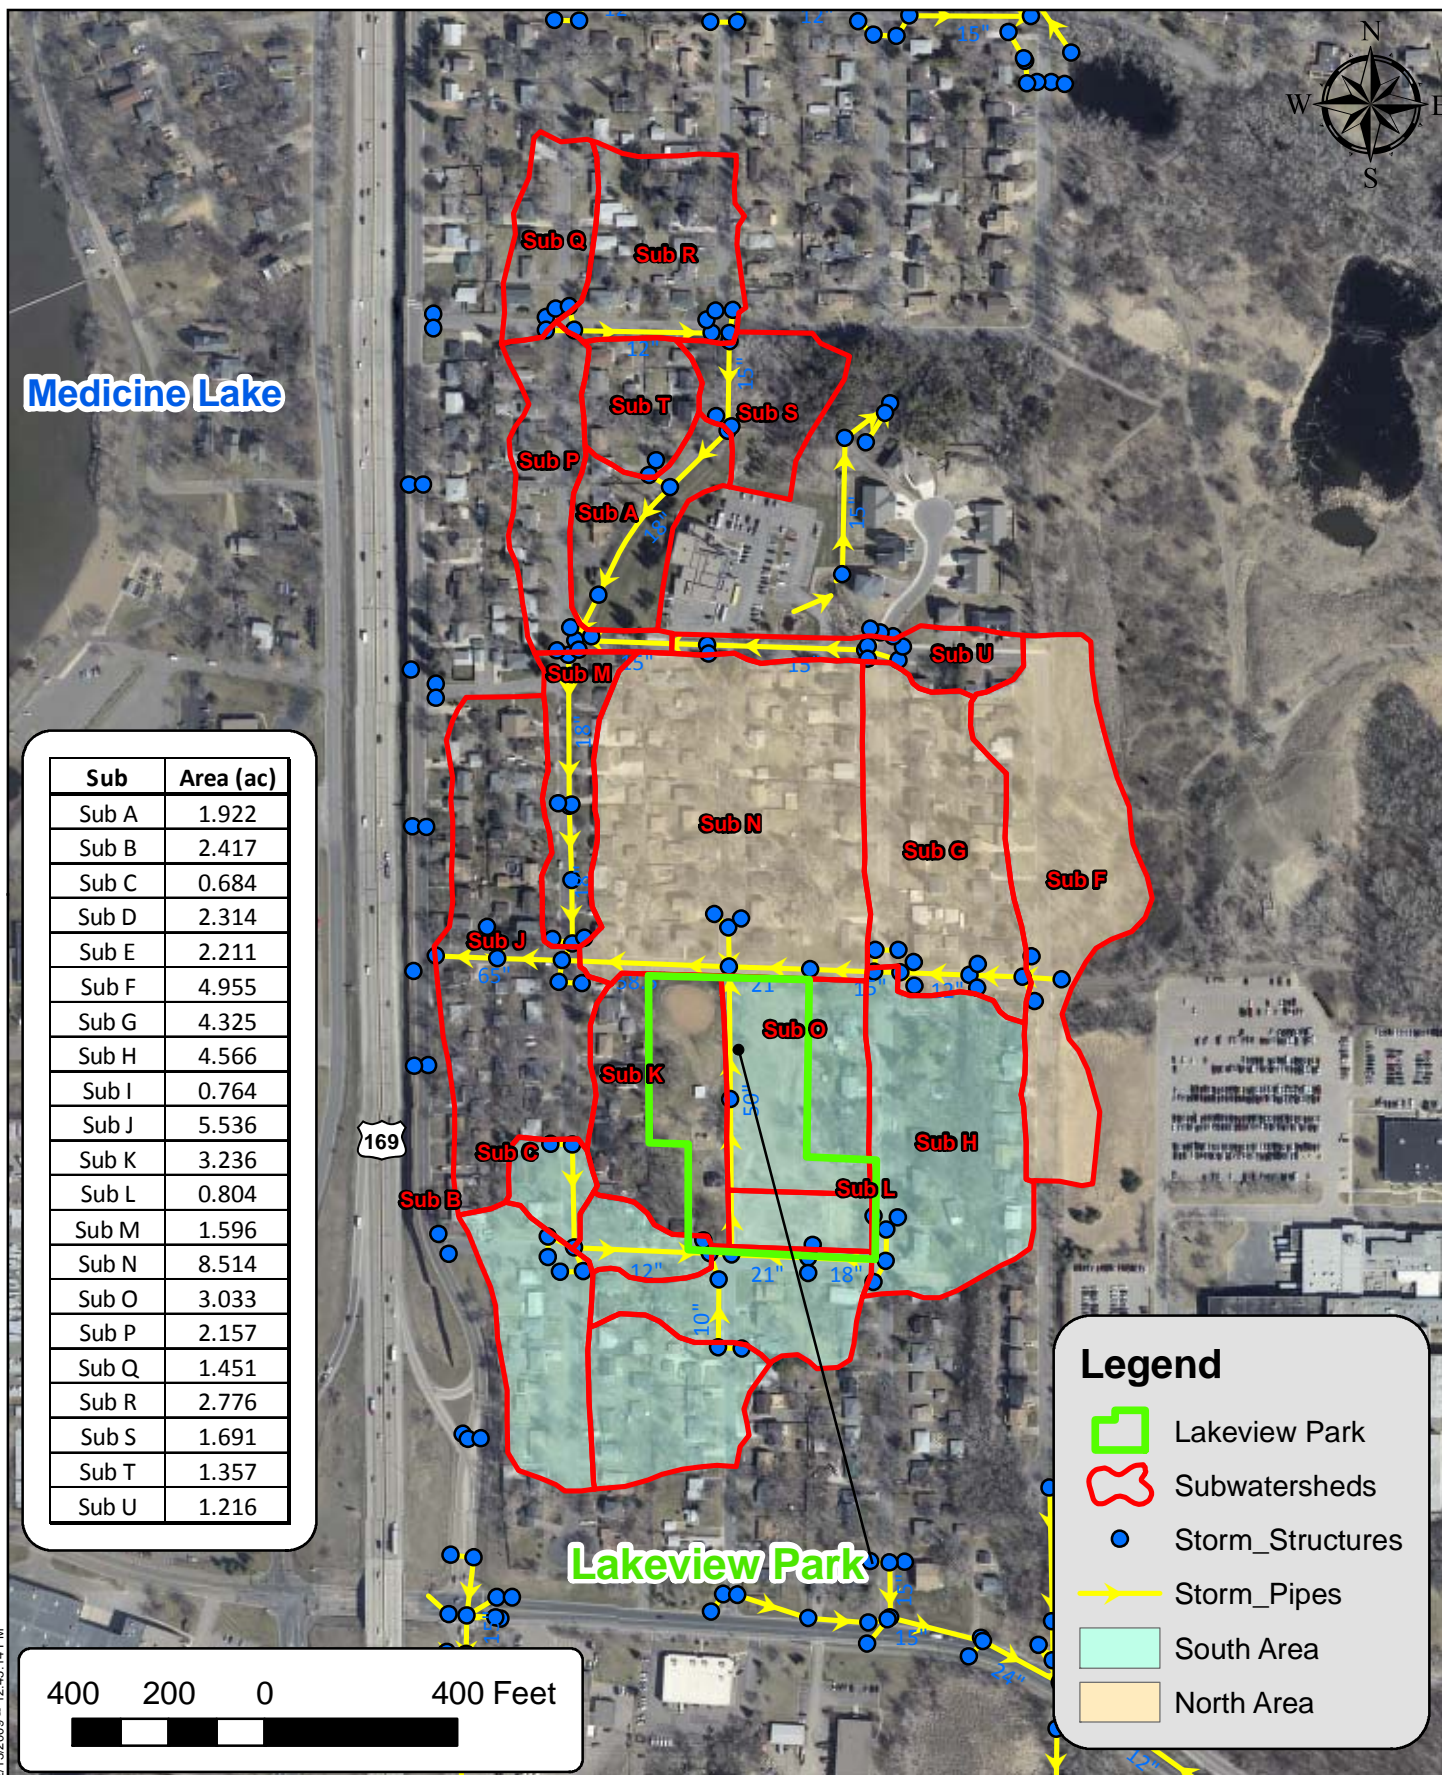
Figure
2

Drainage Areas
Lakeview Park Pond
City of Golden Valley

The goal of the project, as mentioned previously, is to design a storm water pond to meet BCWMC Level I standards for the contributing drainage area to the pond. Two areas were identified to be routed into the pond for treatment (see **Figure 2**).

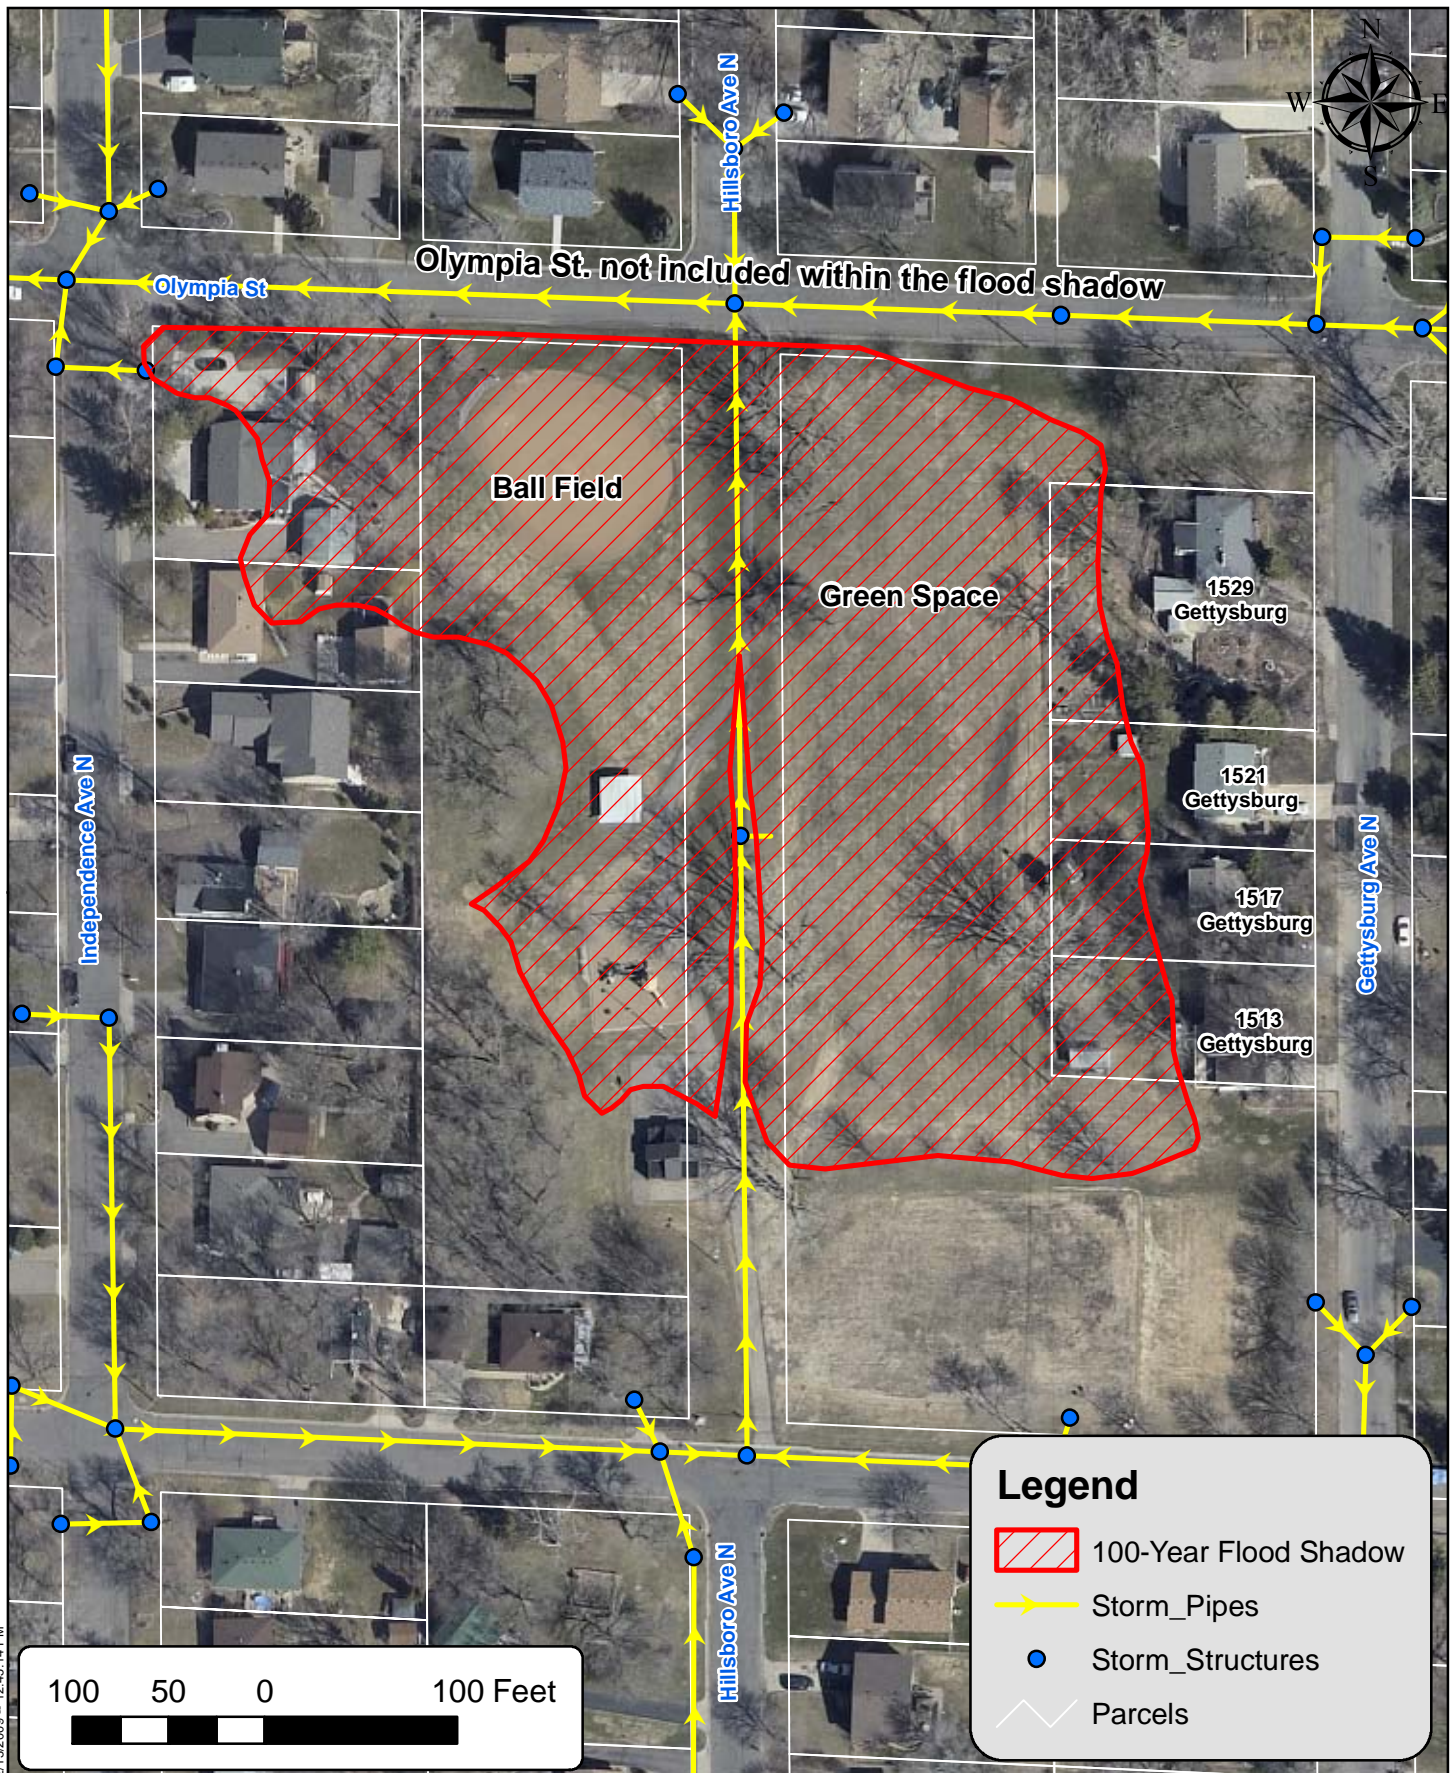
Figure
3

Existing Conditions - 100 Yr HWL

The model included the entire trunk storm sewer line which extends from upstream of Lakeview Park (Winsdale St. N.) to Medicine Lake. The existing conditions model determined that during the 100-year storm event, the green space area experiences just over 3 feet of ponding or a HWL of 897.2'. There are 4 homes located adjacent to the park whose rear-yards back up to the low lying area of the park. The ground elevation adjacent to each structure was surveyed (see **Table 1**). The surveyed point at each building approximately represents the finished floor elevation (FFE). Three of the four homes located along the park are within 0.4 feet of the 100-year HWL of the park. On all four parcels, the 100-year HWL extends onto each property (see **Figure 3**).

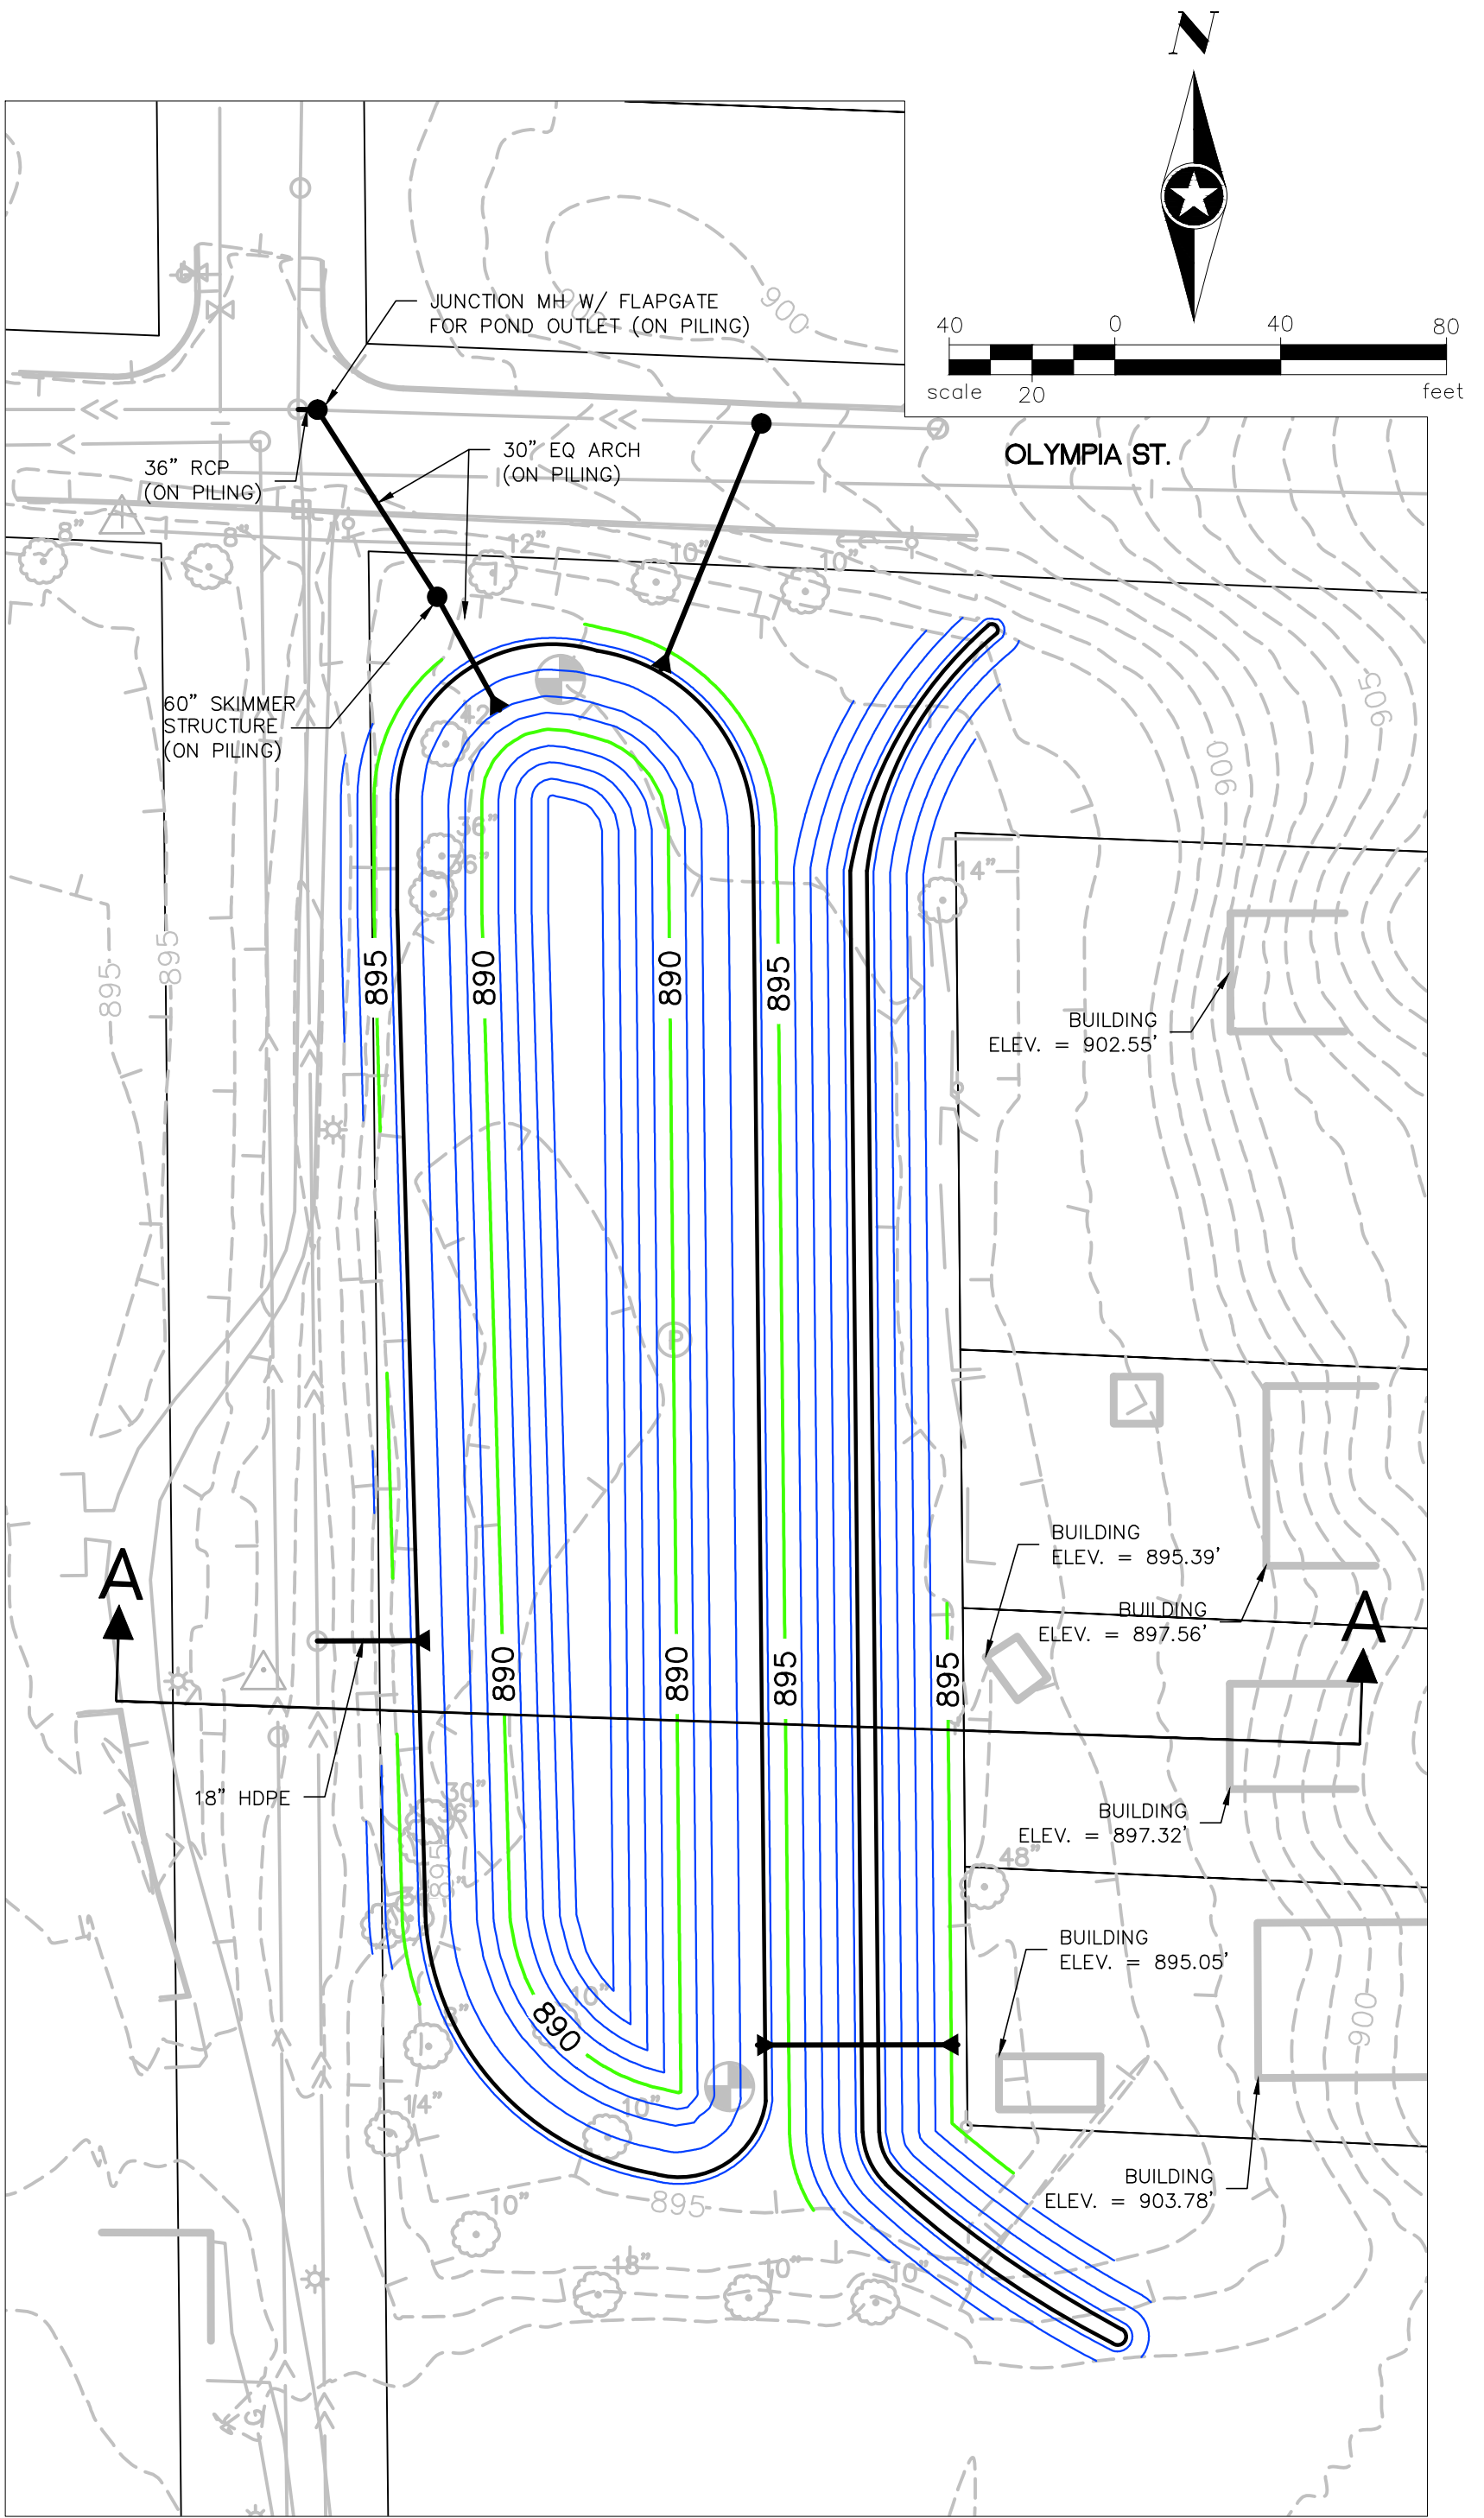
FIGURE
NO. 4

POND NWL = 893.60'

Several pond grading options were explored based on the treatment levels required for the contributing drainage areas. Ultimately one footprint was selected with varying depths based on the contributing drainage area to the pond. The two pond options are Partial Build and Full Build. **Figure 4** attached details the footprint used for both pond options and depicts the depth for the Full Build option.
