FEASIBILITY Report

DRAFT 2015 Bassett Creek Main Stem Restoration Project

WSB Project No. 2032-06

DRAFT FEASIBILITY STUDY FOR 2015 BASSETT CREEK MAIN STEM RESTORATION PROJECT

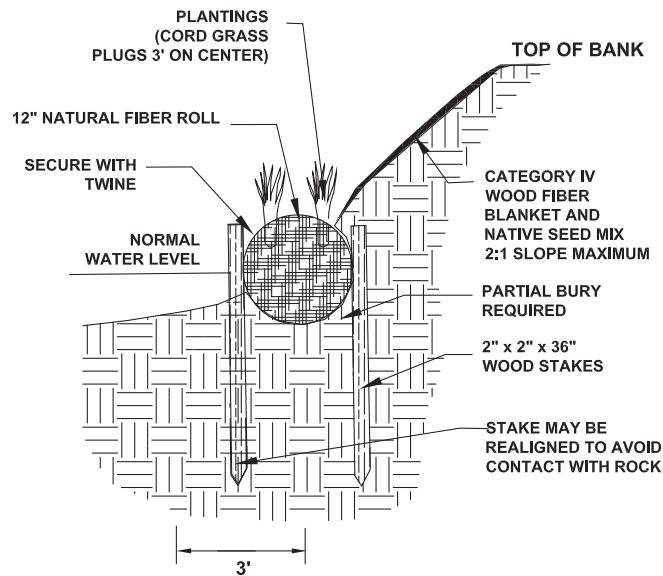
Bio-log Bank Protection (With or Without Stone)

Bio-log Bank Protection

Bio-logs are natural fiber rolls made from coir fiber that are laid along the toe of the stream bank slope to stabilize the toe of the stream bank. The bio-logs are typically 12 inches in diameter. Because they are made of natural fiber, vegetation can grow on the bio-logs. When needed, grading of the stream bank slope above the bio-log will achieve a more stable slope (2:1 to 3:1). Cord grass plugs will be placed within the bio-log three feet on center.

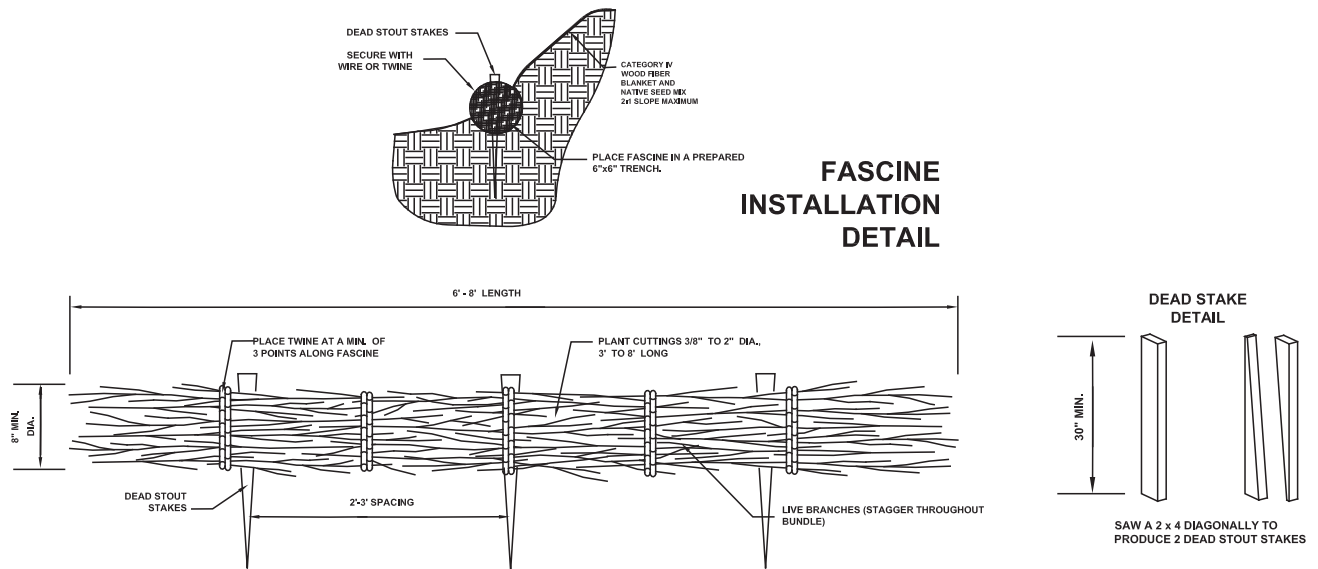
Live Facines

Live Fascines

Live fascines also use dormant willow and dogwood cuttings installed during the dormant season. In this case, the cuttings are bundled together and planted in a row parallel to the stream flow. They can be effective in reducing sheet erosion along a slope because a portion of the fascine extends above the ground surface

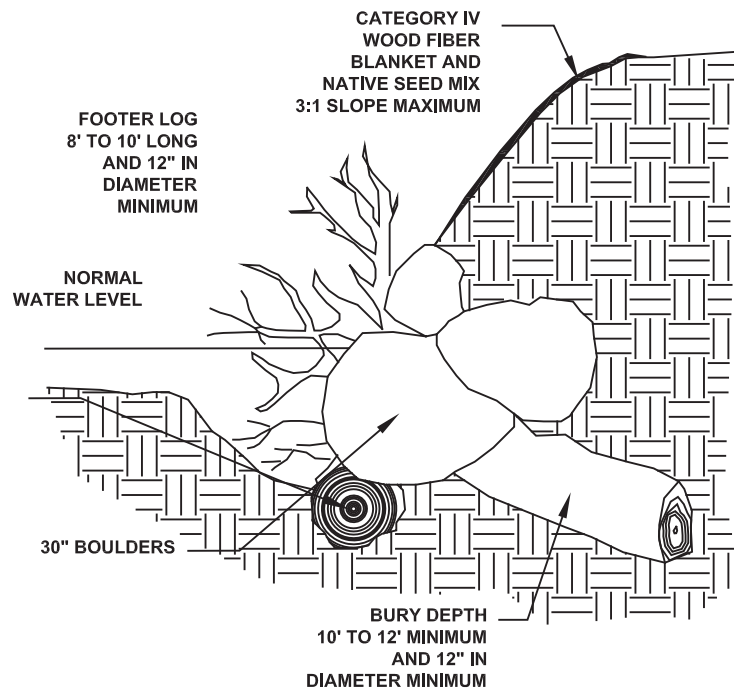
Root Wads

Root wads are constructed from root balls of trees removed as part of this project. The trunks are buried into the bottom of the stream bank, with the root wad end sticking out into the stream. Supporting "footer logs" and boulders are used to stabilize the root wads.

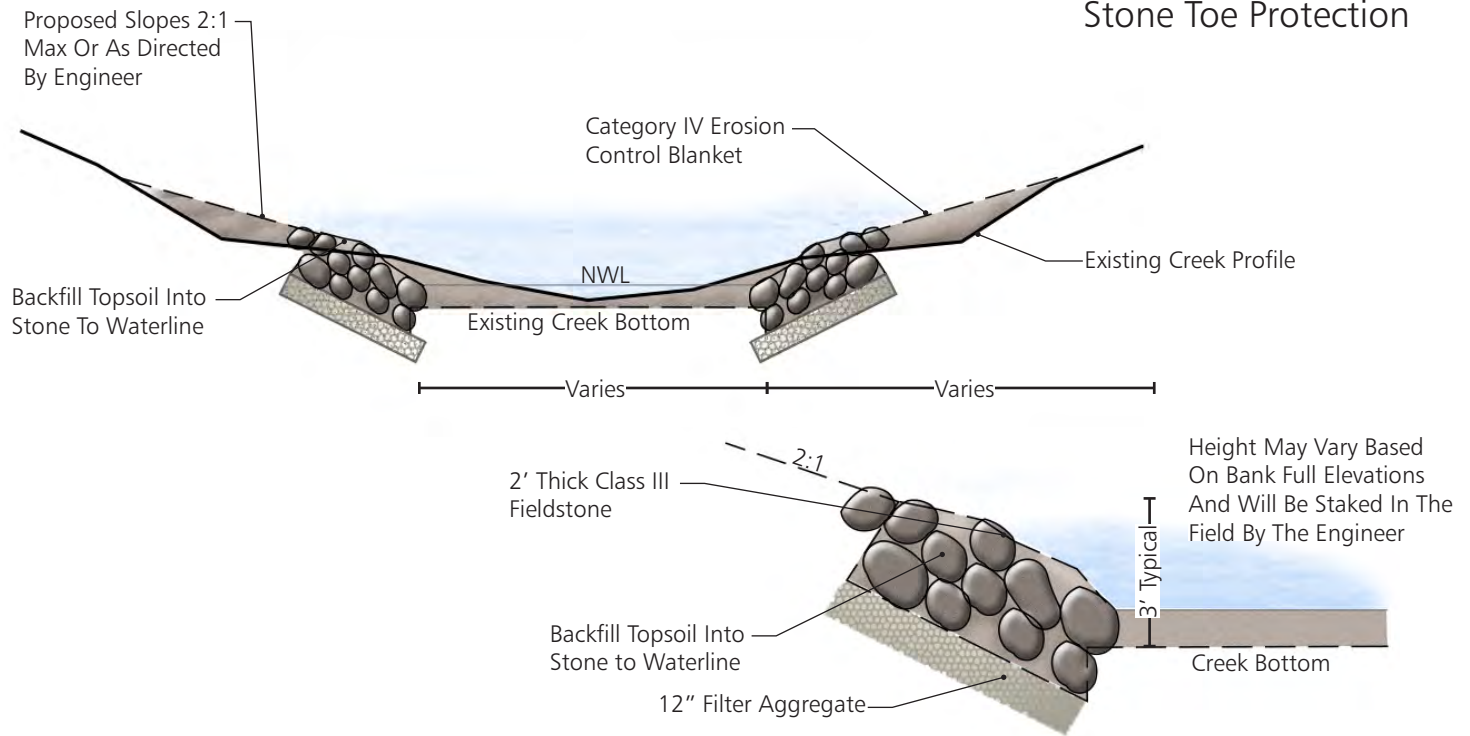
Stone Toe Protection

Fieldstone Rip Rap

Fieldstone rip rap will be used to protect the toe of the stream bank. In stream systems, rip rap consists of cobble-sized rock (12 inches to 18 inches in diameter). The riprap is keyed in to the streambed and extends up the reshaped slope and cannot extend past the top of bank. The exact location and elevation of the stone toe will be staked in the field by the engineer. Hand placement of fieldstone rip rap will be required and will be directed by the engineer. Placement of fieldstone rip rap must not result in a decrease of channel cross section.

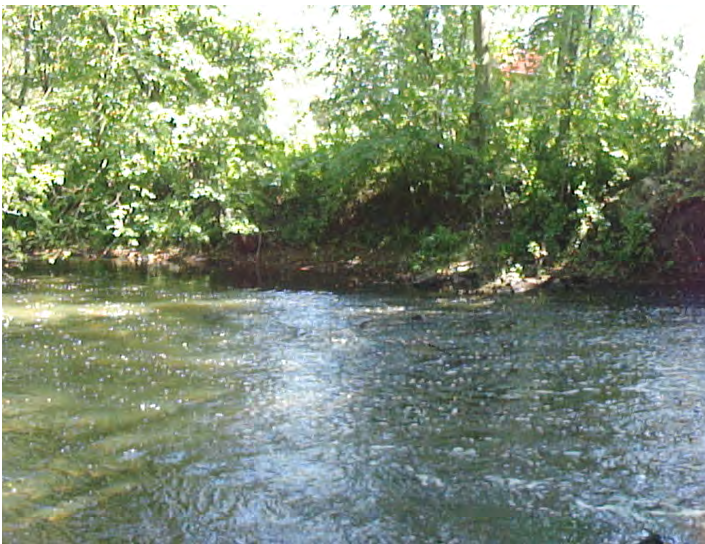
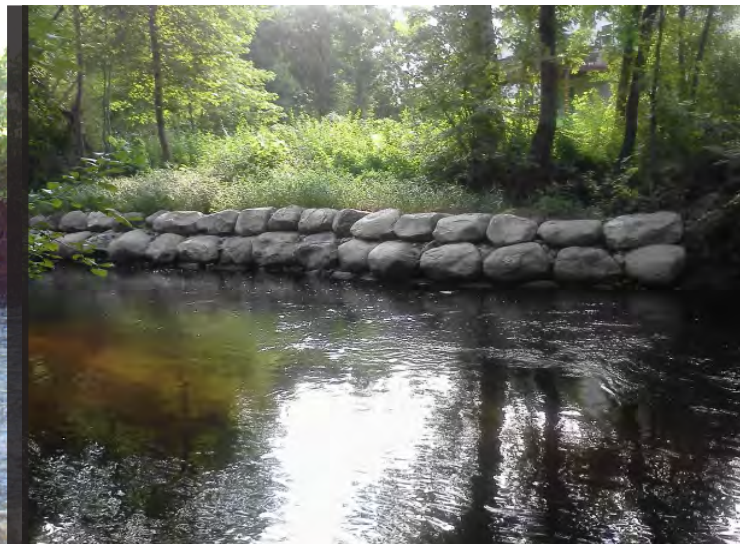
Fieldstone Boulder

Fieldstone boulder will be used to protect the toe of the stream bank. In stream typically consists of boulder-sized rock (30 inches to 34 inches in diameter) placed over a half foot thick layer of class i fieldstone rip rap and a half foot layer of coarse filter aggregate. The boulder will extend up the reshaped slope and cannot extend past the top of bank. The exact location and elevation of the boulder toe will be staked in the field by the engineer. Placement of fieldstone boulders must not result in a decrease of channel cross section.

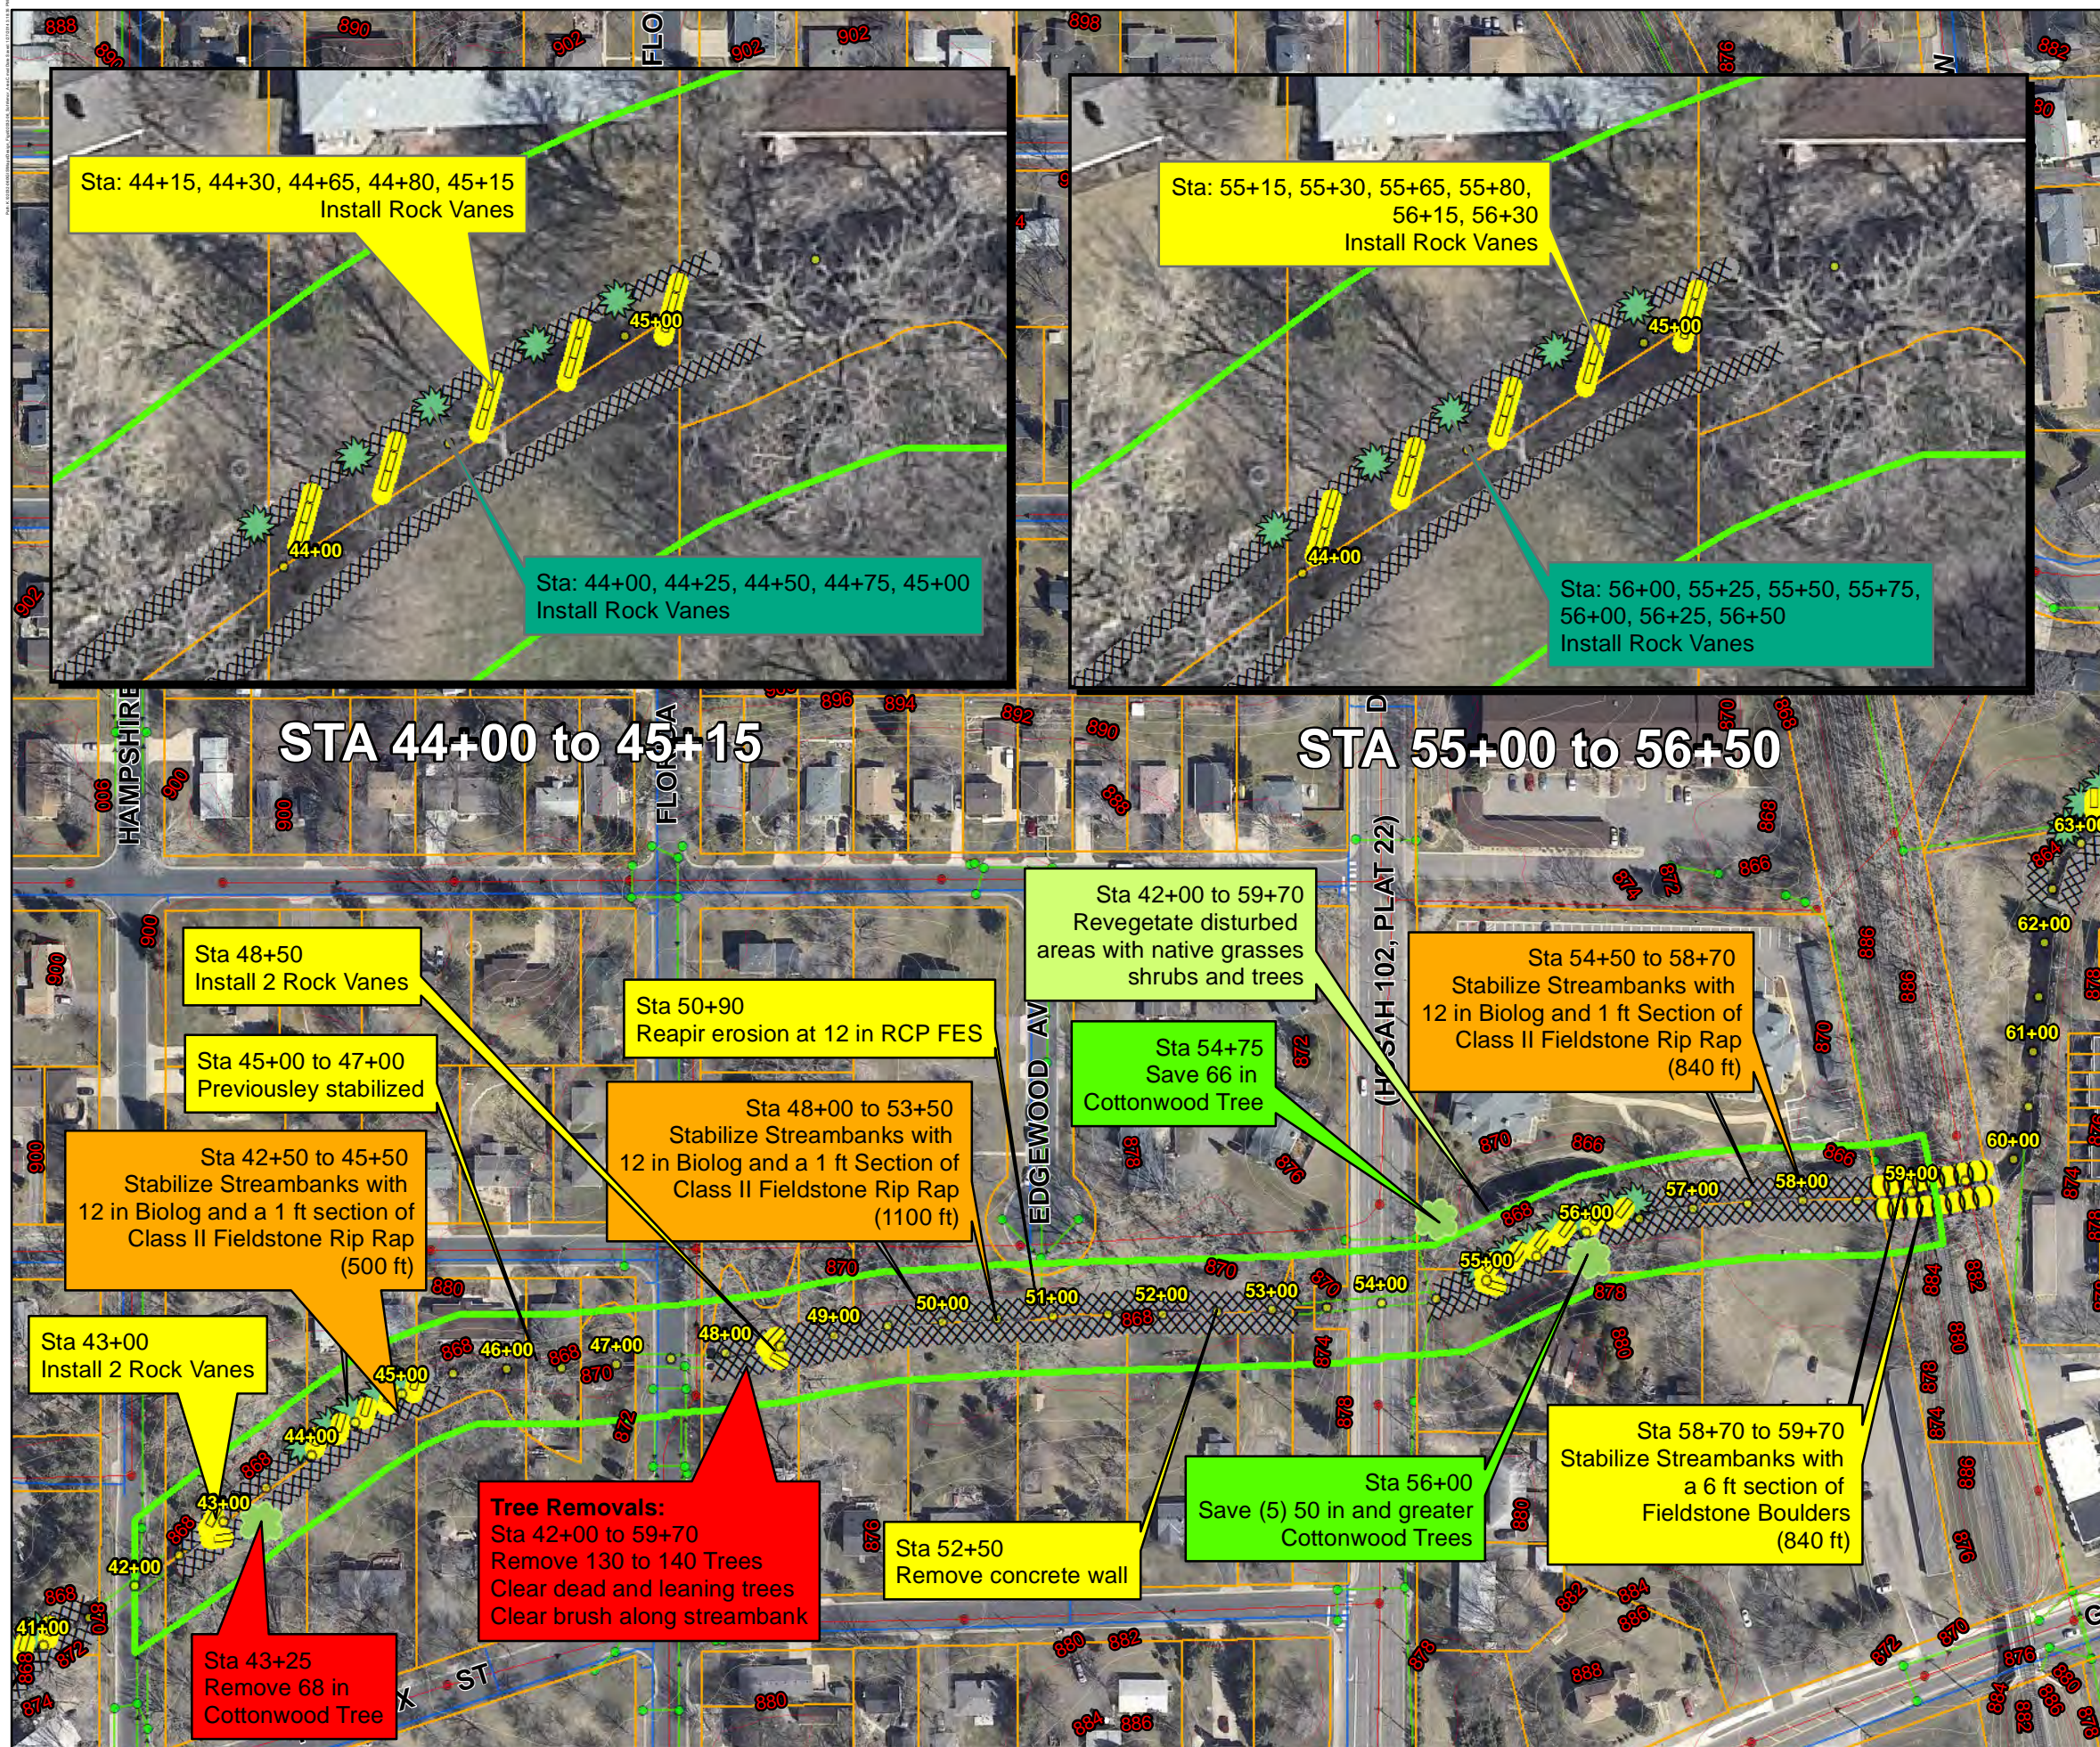
**Feasibility Study
for the
2015 Bassett Creek Main Stem
Restoration Project
City of Golden Valley
Minnesota
Hard Armoring Option
Area C**
