Feasibility Report for the Wirth Lake Outlet Modification Project

Prepared by the Bassett Creek Watershed Management Commission

Golden Valley, Minnesota

Prepared by
Barr Engineering Company
4700 West 77th Street • Minneapolis, MN 55435-4803
Phone: 952-832-2600 • Fax: 952-832-2601

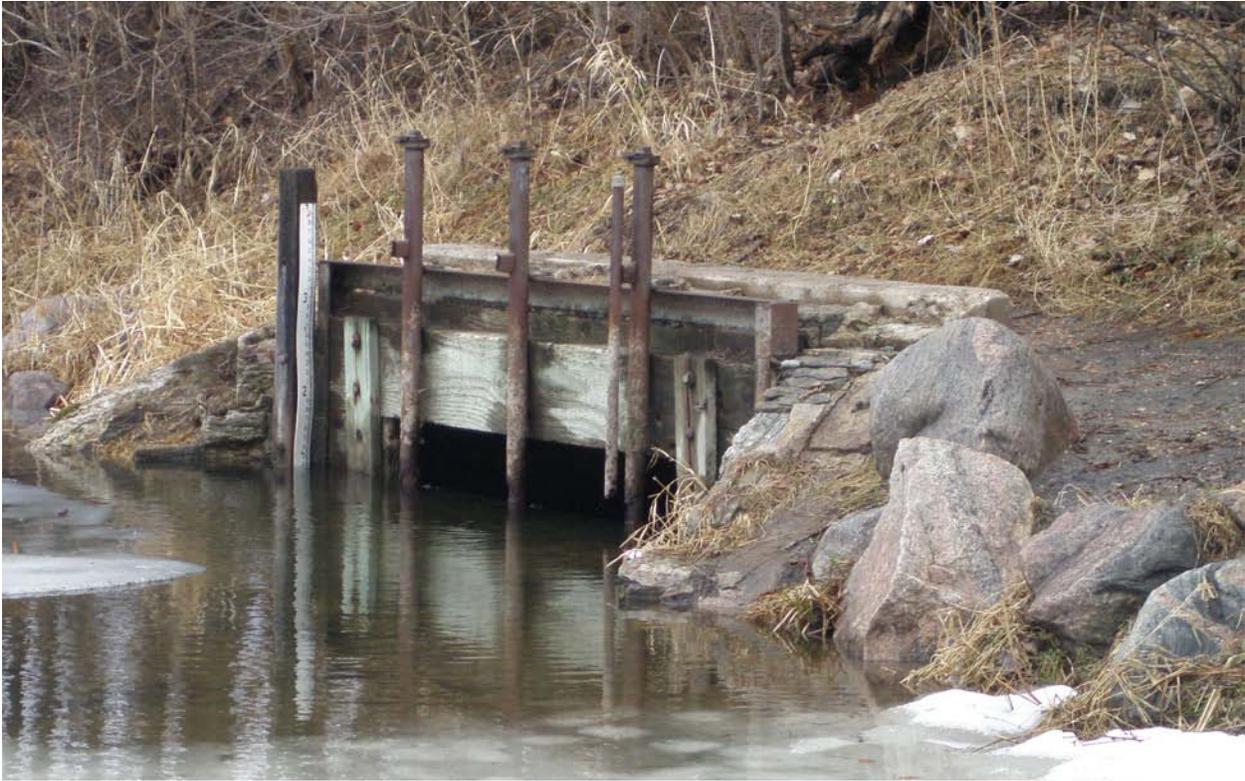
The existing stone-faced concrete culvert once served as a roadway crossing of the flow out of the lake. The roadway was removed but the culvert was left in place. The existing timber weir was built onto this concrete culvert in the 1970's to hold three submerged perforated outlet pipes that extend into the lake and are covered with a gravel bed. Originally this was designed to prevent rough fish from entering the lake. These perforated pipes are not visible and are no longer functioning. Three shafts that controlled valves in these perforated pipes still exist and can be seen in **Figure 2**. These valves no longer function.

Figure 2. Existing Wirth Lake Outlet Structure.

The existing culvert is made of concrete and was faced with Platteville limestone. It was inspected for condition on April 7, 2011. The culvert was found to be in very good condition and suitable for the installation of a new upstream bulkhead. A summary of the inspection observations is included in the Appendix of this study.

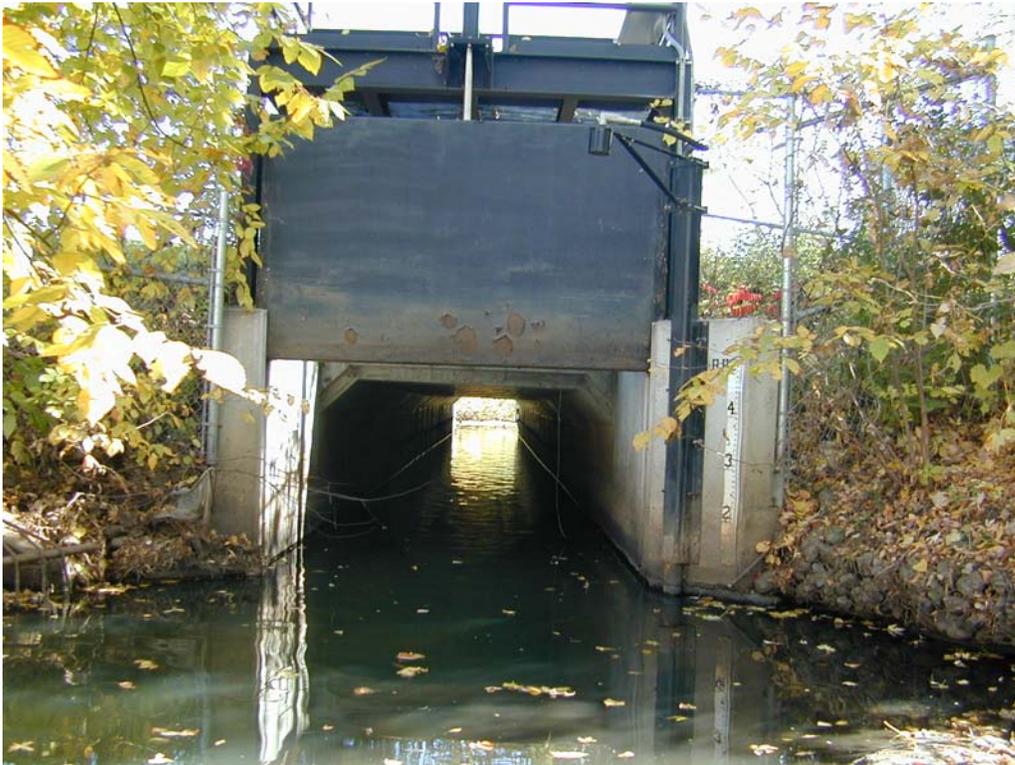
Figure 3. Example of an automated steel lift gate at Wisconsin Avenue in the City of Golden Valley.

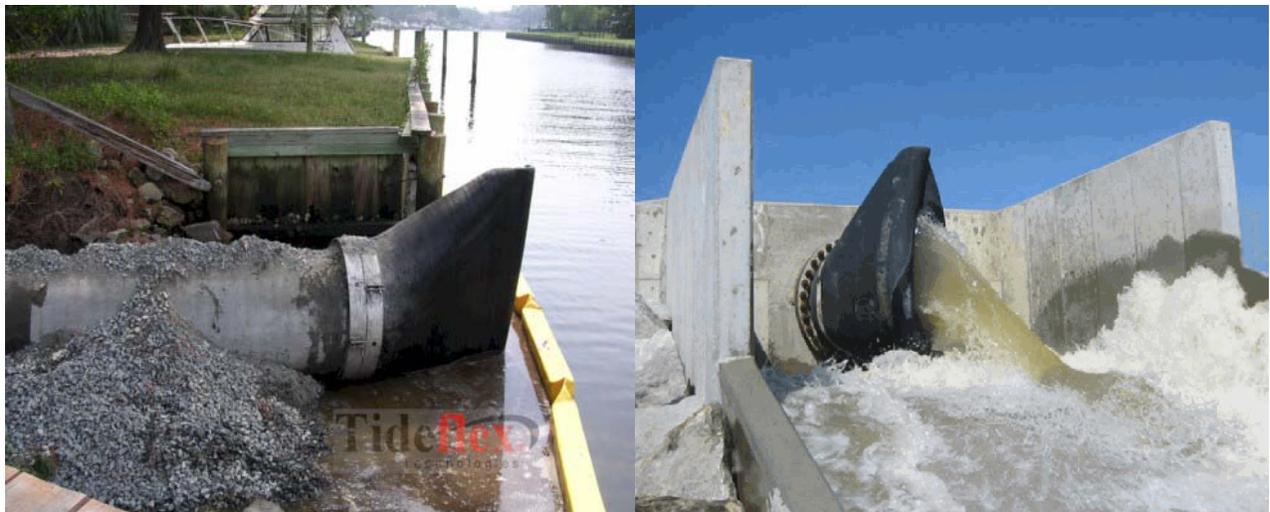
The rubber check valves operate by opening in response to elevated hydraulic head (or water level) at the upstream (lake side) opening, and closing in response to neutral or elevated hydraulic head at the downstream end (creek side). In its resting position it resembles a vertical duck's bill, with the downstream end of the heavy duty rubber cylinder curled shut as shown in **Figure 4**. Rubber check valves are in common use to prevent back flow in tidal zones and have become increasingly used for flood protection.

Figure 4. Photos of the Rubber Check Valve.

The recommended alternative includes removing the existing timber outlet structure from Wirth Lake and placing a new bulkhead with openings for two rubber check valves. The proposed bulkhead would attach to the existing culvert. The exposed surface of the bulkhead could be colored, textured, or treated with a form liner to blend the wall into the surroundings.

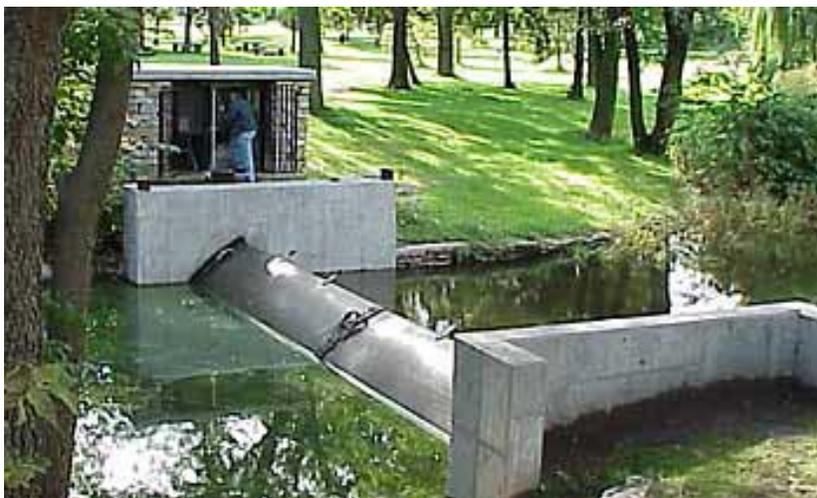
Inflatable Barrier: The alternative of adding an inflatable dam, or weir, to the existing structure was also reviewed. The inflatable barrier would consist of a steel wall that is raised by forcing compressed air into a bladder beneath it when high water conditions exist. To house the heavy structure a large concrete apron would be required along with an electrical control system, air compressor and a control building.

Figure 5. Inflatable barrier at Minnehaha Creek and Lake Nokomis.

This method was deemed to be fairly complex and cost more than either the steel lift gate or rubber check valve alternatives. Due to the complexity of the device, maintenance cost is also anticipated to be higher than other alternatives. The inflatable device requires much more space than is available at the Wirth Lake site and presents vulnerabilities to vandalism due to its exposure and construction. This alternative was not investigated further.
