Bassett Creek Main Stem Restoration Project 10th Avenue to Duluth Street, Golden Valley (2015CR)

FINAL REPORT March 10, 2019

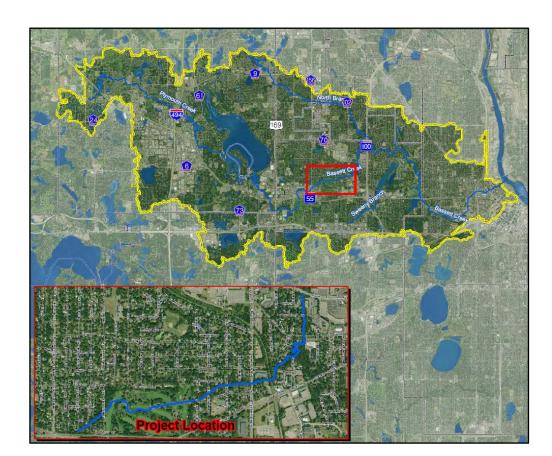
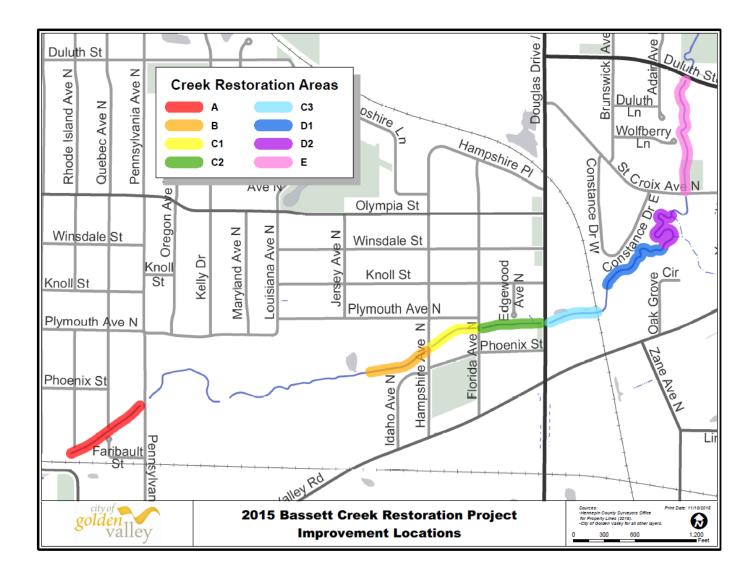
With the exception of a reach of the within Area D (see map on following page), virtually all sections of the Main stem of Bassett Creek reach were converted into ditches in the 1900s through the 1920s. The riparian vegetation varied considerably depending on adjacent land use. Much of the reach contained unmanaged woody vegetation. Some banks within golf course areas were largely free of woody vegetation and the banks were mostly grasses dominated by reed canary grass. Some banks within the parks and the golf course had turf grass to the top of the

The reach identified for this project extended approximately 9,500 feet from 10th Avenue and Rhode Island Avenue at the upstream end to Duluth Street at the downstream end, just east of Adair Avenue. This project tied into a previous streambank restoration project completed by the BCWMC in 2012. The stream is relatively shallow in most places except for occasional deep pools.

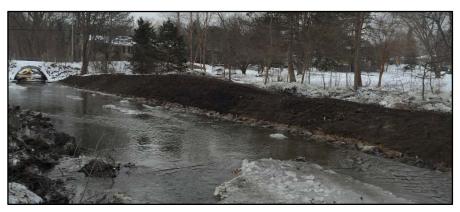
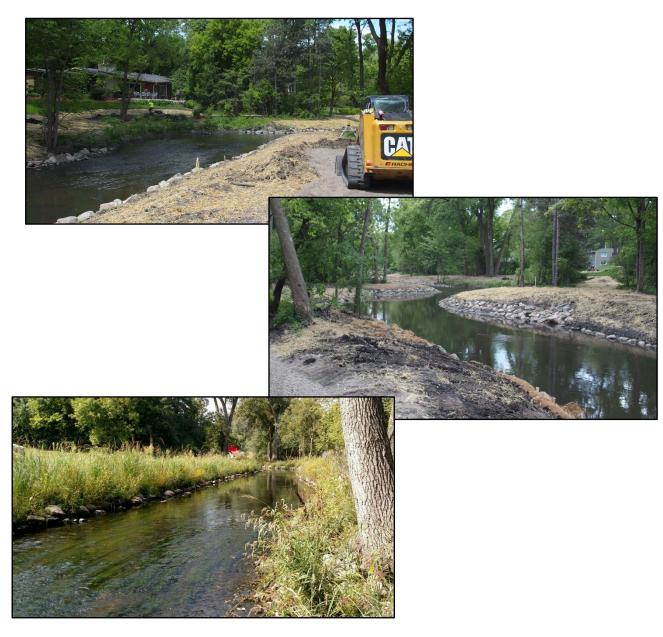
Project construction began in the winter of 2015. The project was constructed in two phases, each under a separate contract. Phase One was construction including stream bank shaping, placement of field stone rock and 12-inch bio-logs, and repair of storm sewer outlets. Phase one was completed in 2016. Phase Two began

immediately following construction and included the establishment of native vegetation along the stream. Phase two continued through the growing season of 2018.
