# BASSETT CREEK DOUBLE BOX CULVERT REPAIRS

## BASSETT CREEK WATERSHED MANAGEMENT COMMISSION

### MINNEAPOLIS, MINNESOTA

**BASSETT CREEK DOUBLE BOX CULVERT REPAIRS**  
MINNEAPOLIS, MINNESOTA  
INDEX, LOCATION MAP, AND VICINITY MAP

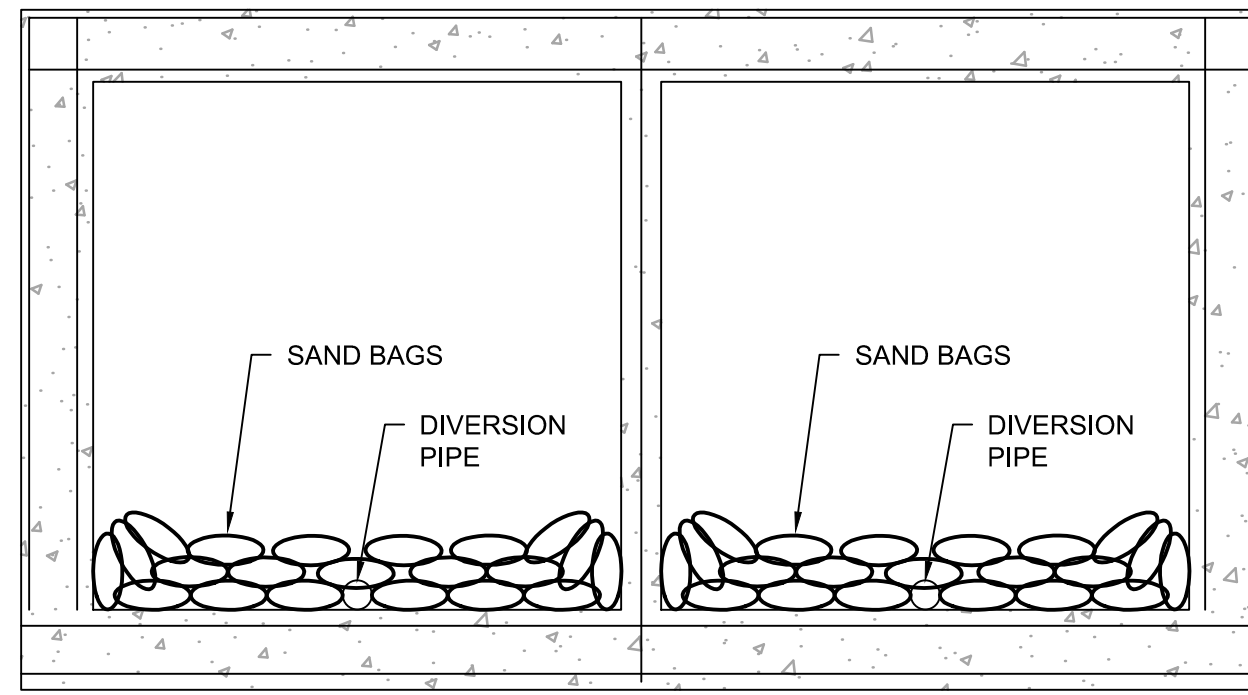
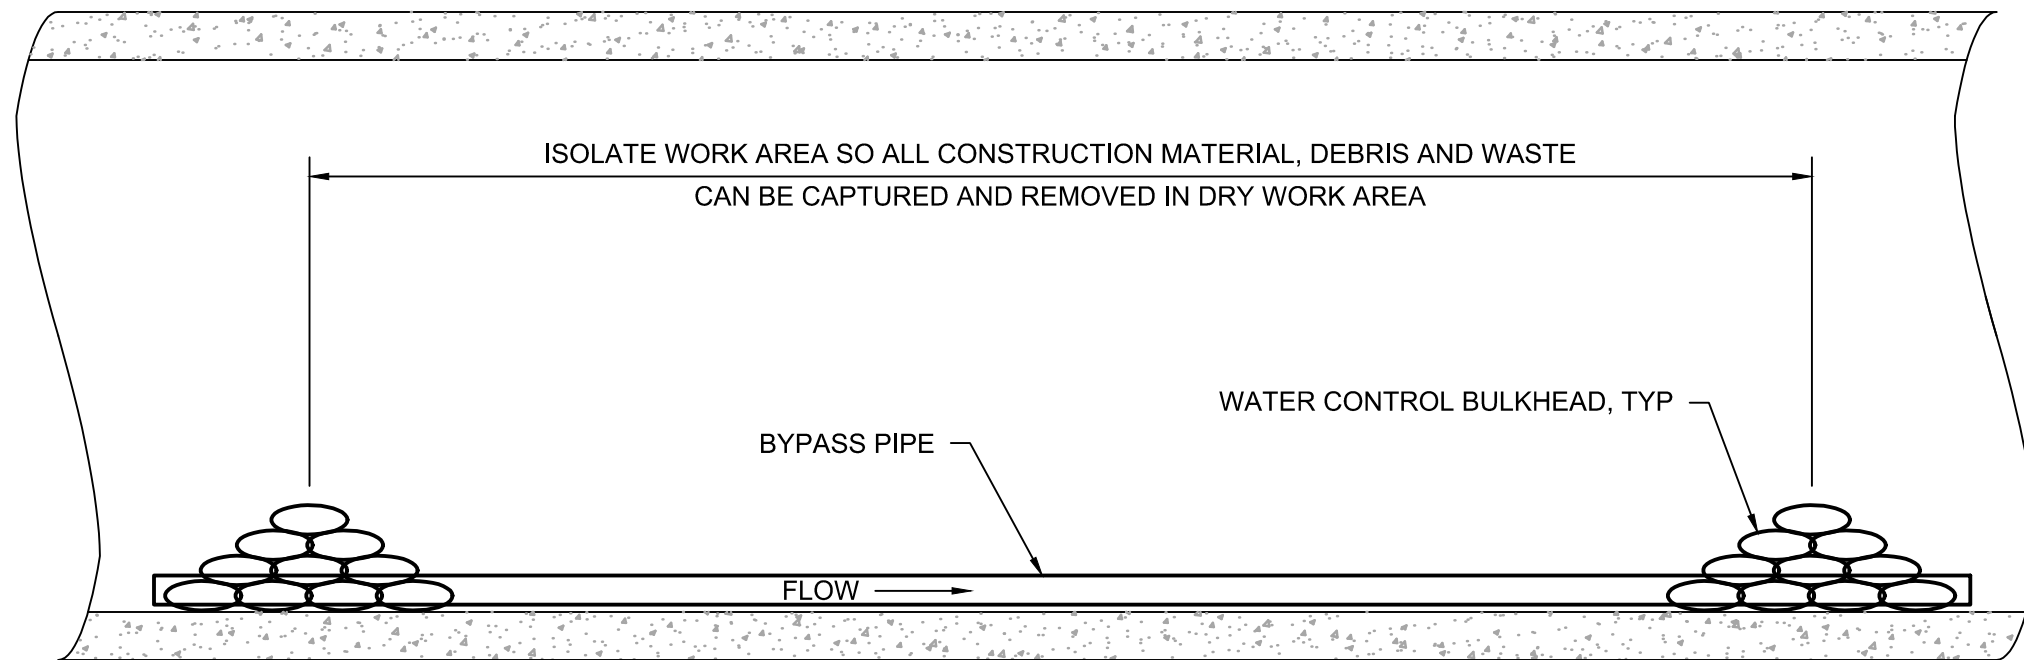
1 DETAIL: WORK AREA ISOLATION OPTION  
NOT TO SCALE

SECTION

PROFILE

- NOTES:
1. MATERIAL CAPTURED SHALL BE REMOVED ON A DAILY BASIS.
  2. WATER CONTROL BULKHEAD DIMENSIONS AND PIPE DIAMETER TO BE DETERMINED BY CONTRACTOR BASED ON SITE CONDITIONS.

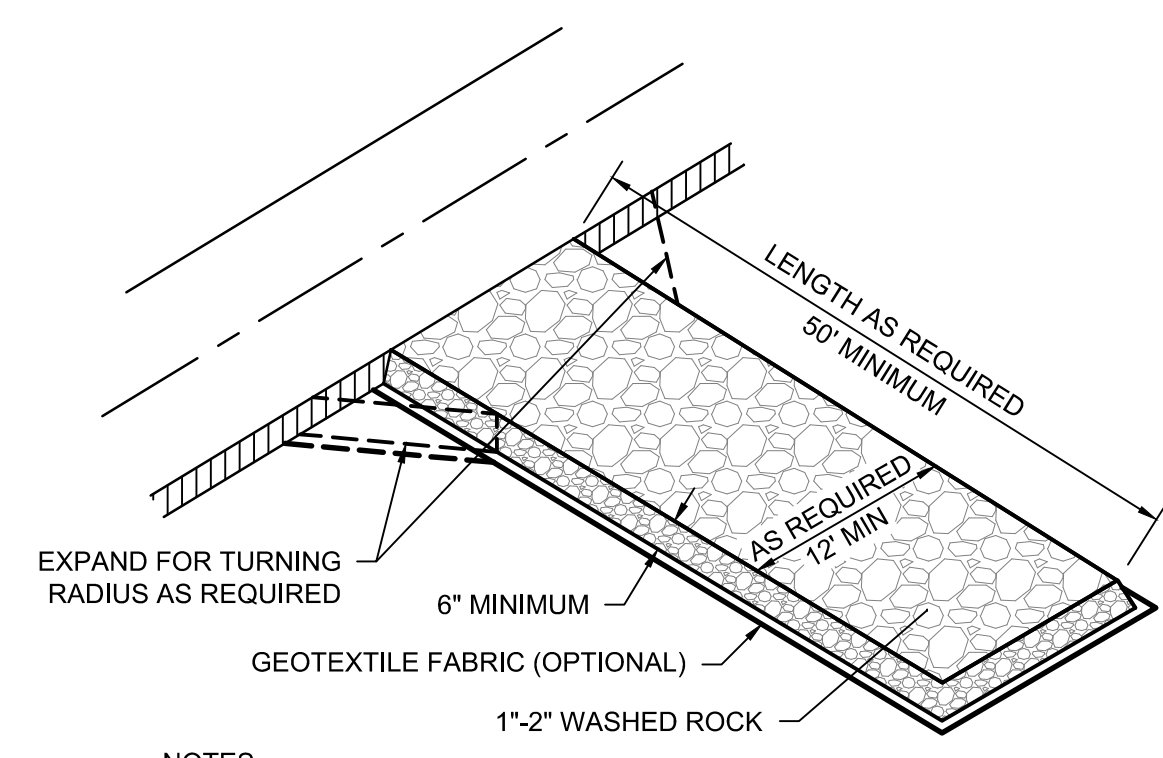
4 DETAIL: CONSTRUCTION ENTRANCE - ROCK  
NOT TO SCALE

1. MAINTAIN ENTRANCE THROUGHOUT THE CONSTRUCTION PERIOD AND REPAIR OR REPLACE AS REQUIRED TO PREVENT TRACKING OFFSITE.
2. REMOVE ENTRANCE IN CONJUNCTION WITH FINAL GRADING AND SITE STABILIZATION.

2. ESTABLISH ROCK CONSTRUCTION ENTRANCES PRIOR TO BEGINNING LAND DISTURBING ACTIVITIES. 1-1/2"-3" WASHED AGGREGATE IS RECOMMENDED FOR ROCK ENTRANCES, A GEOTEXTILE FABRIC IS REQUIRED.

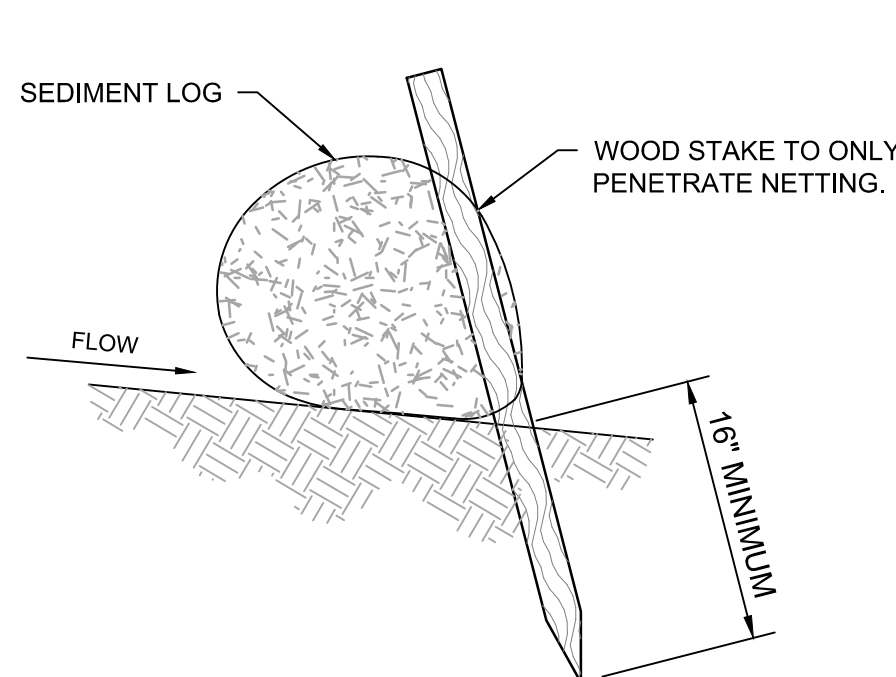
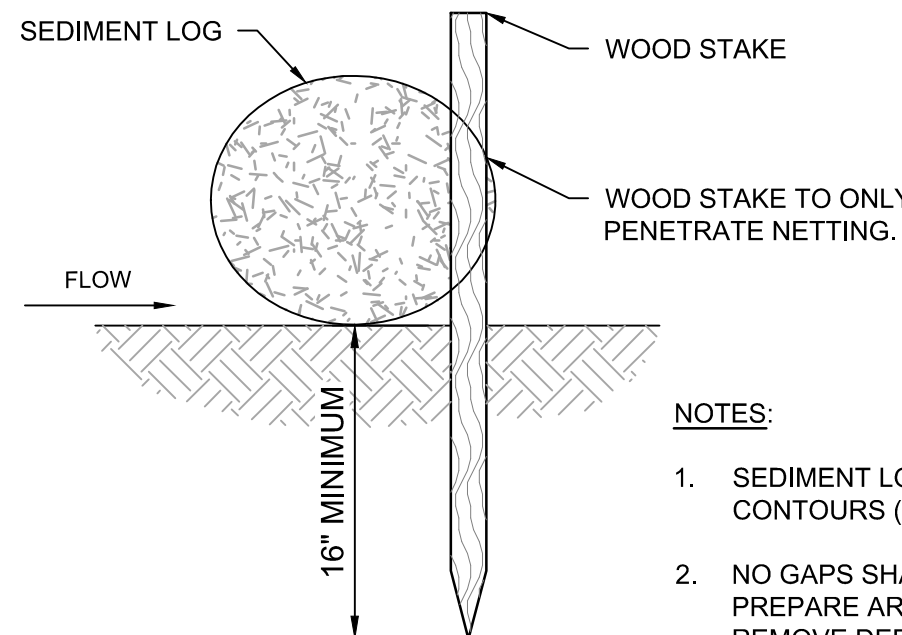
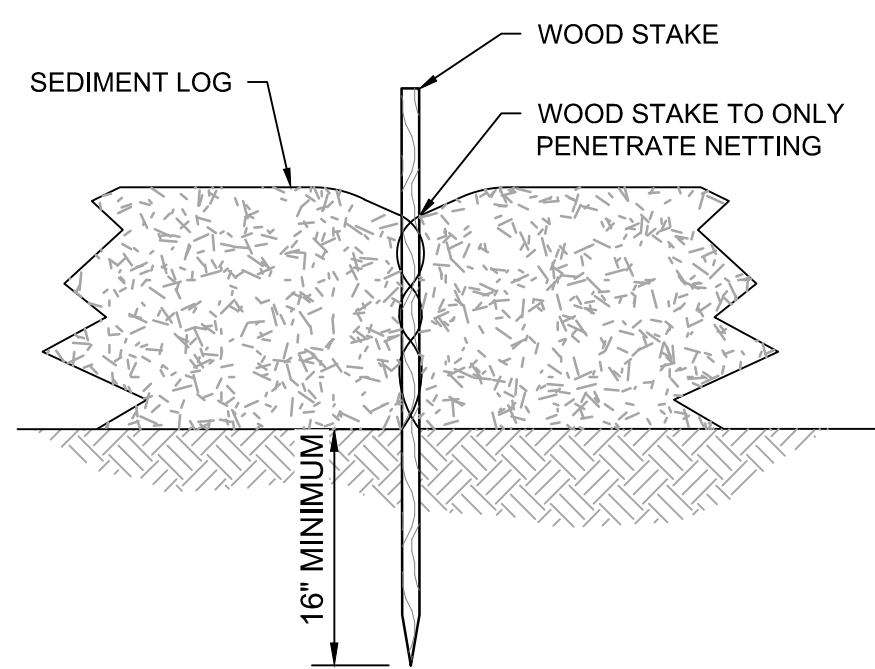
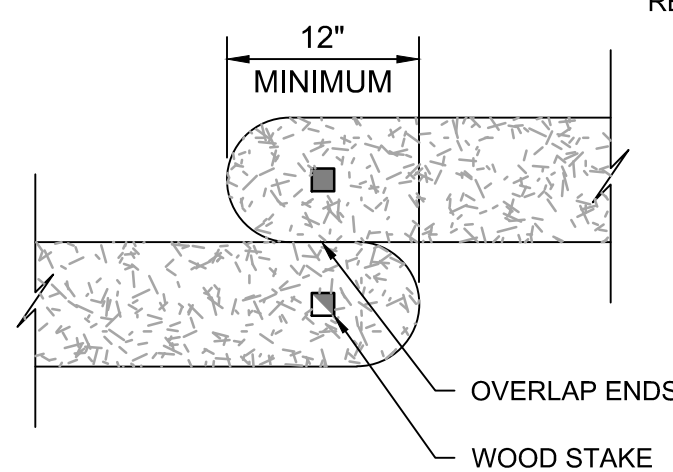
2 DETAIL: EROSION LOG - STAKING  
NOT TO SCALE

SIDE VIEW ON SLOPE

SIDE VIEW FLAT

1. SEDIMENT LOG SHOULD BE INSTALLED ALONG CONTOURS (CONSTANT ELEVATION).
2. NO GAPS SHALL BE PRESENT UNDER SEDIMENT LOG. PREPARE AREA AS NEEDED TO SMOOTH SURFACE OR REMOVE DEBRIS.
3. ACCUMULATED SEDIMENT SHALL BE REMOVED WHEN REACHING 1/2 OF LOG HEIGHT.
4. SEDIMENT LOG SHALL BE MAINTAINED THROUGHOUT THE CONSTRUCTION PERIOD AND REPAIRED OR REPLACED AS REQUIRED.

FRONT VIEW

TOP VIEW

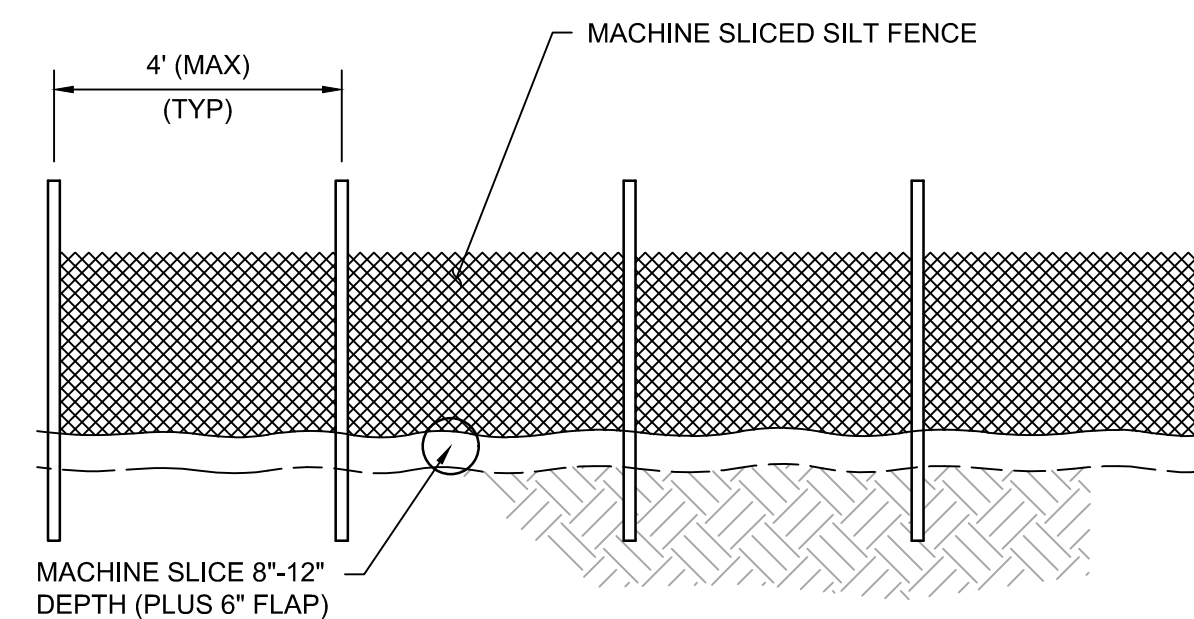
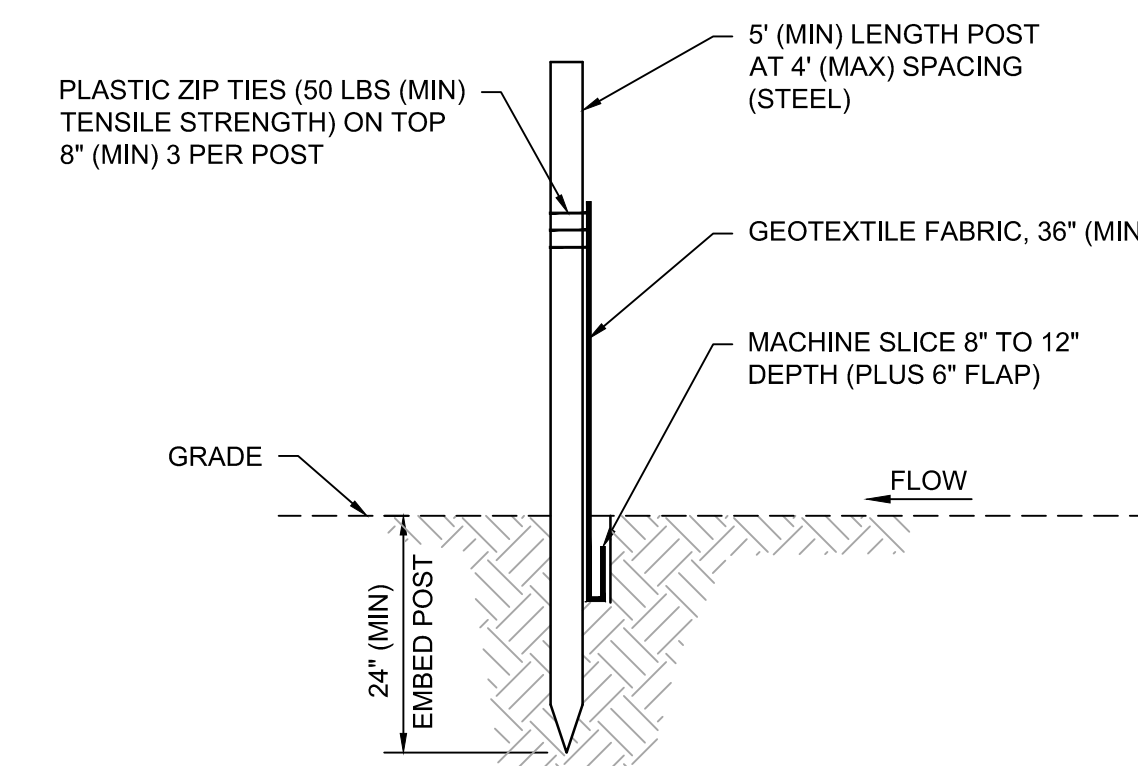
3 DETAIL: SILT FENCE - MACHINE SLICED  
NOT TO SCALE

DOWNSTREAM VIEW

4. WHEN SPLICES ARE NECESSARY MAKE SPLICE AT POST ACCORDING TO SPLICE DETAIL. PLACE THE END POST OF THE SECOND FENCE INSIDE THE END POST OF THE FIRST FENCE. ROTATE BOTH POSTS TOGETHER AT LEAST 180 DEGREES TO CREATE A TIGHT SEAL WITH THE FABRIC MATERIAL. CUT THE FABRIC NEAR THE BOTTOM OF THE POSTS TO ACCOMMODATE THE 6 INCH FLAP, THEN DRIVE BOTH POSTS AND BURY THE FLAP AND COMPACT BACKFILL.

SECTION VIEW

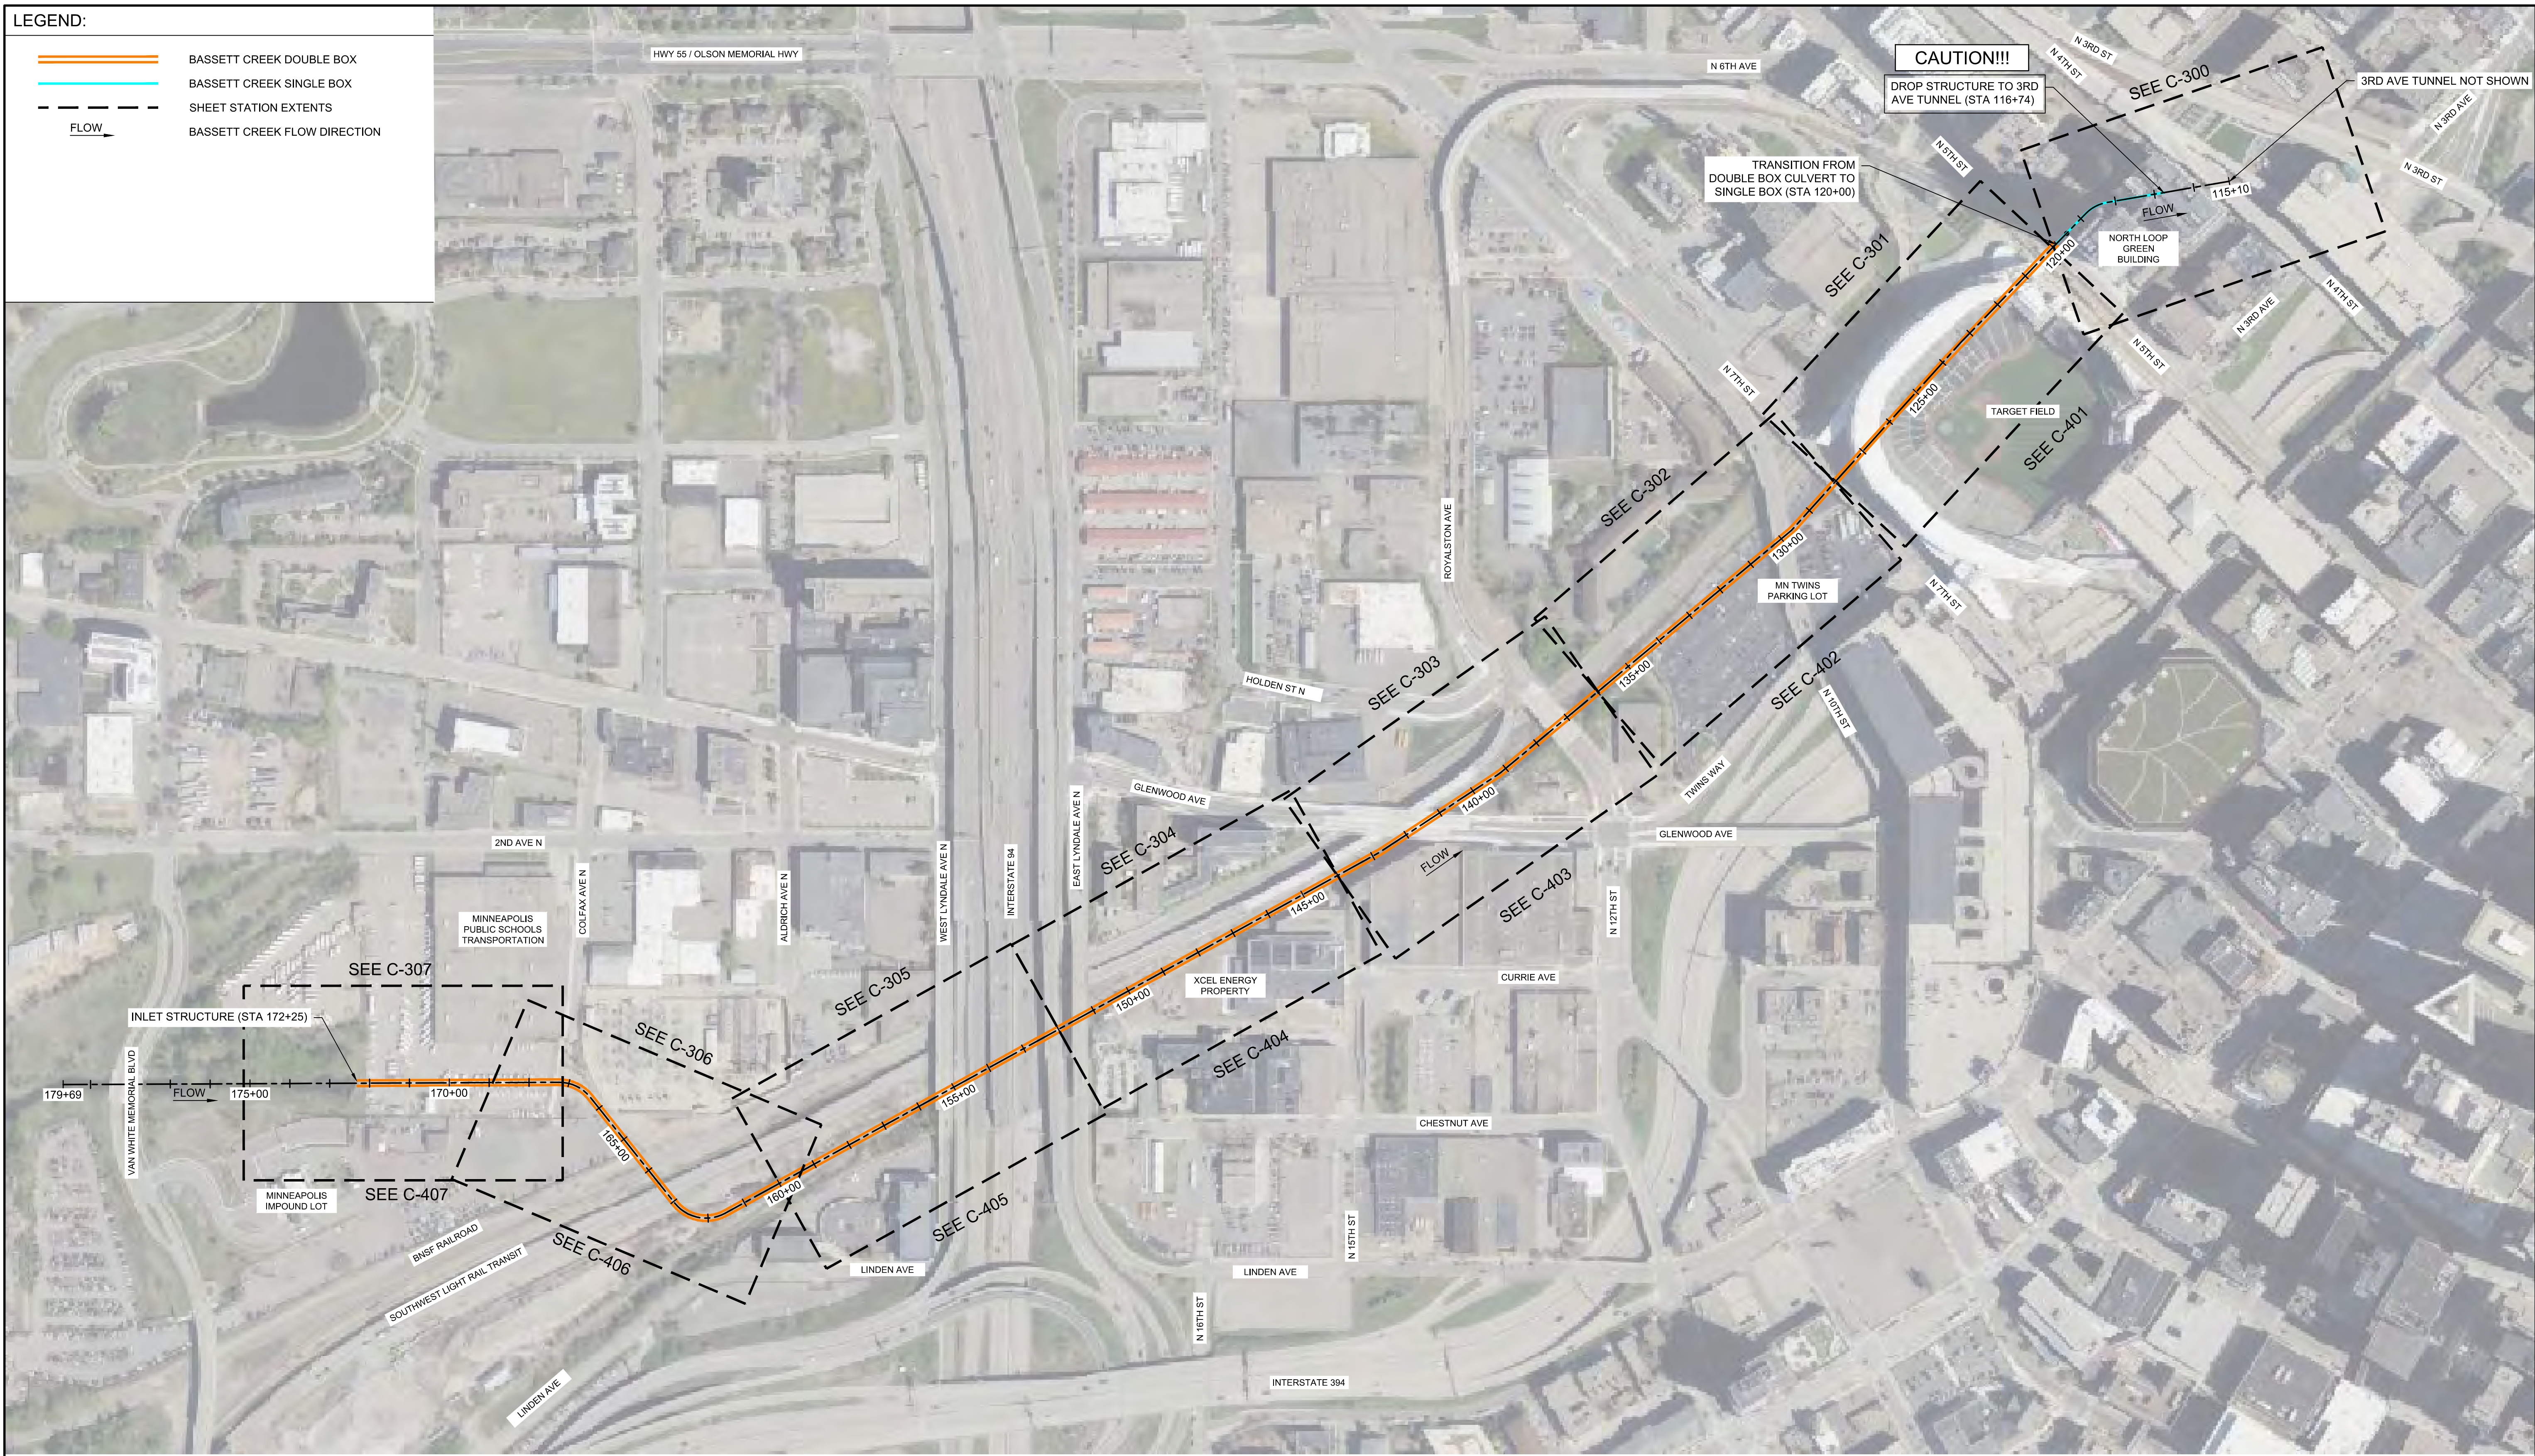
**BASSETT CREEK DOUBLE BOX CULVERT REPAIRS  
 MINNEAPOLIS, MINNESOTA**  
 SHEET LAYOUT REFERENCE

- BASSETT CREEK DOUBLE BOX
- BASSETT CREEK SINGLE BOX
- - - SHEET STATION EXTENTS
- FLOW
- BASSETT CREEK FLOW DIRECTION

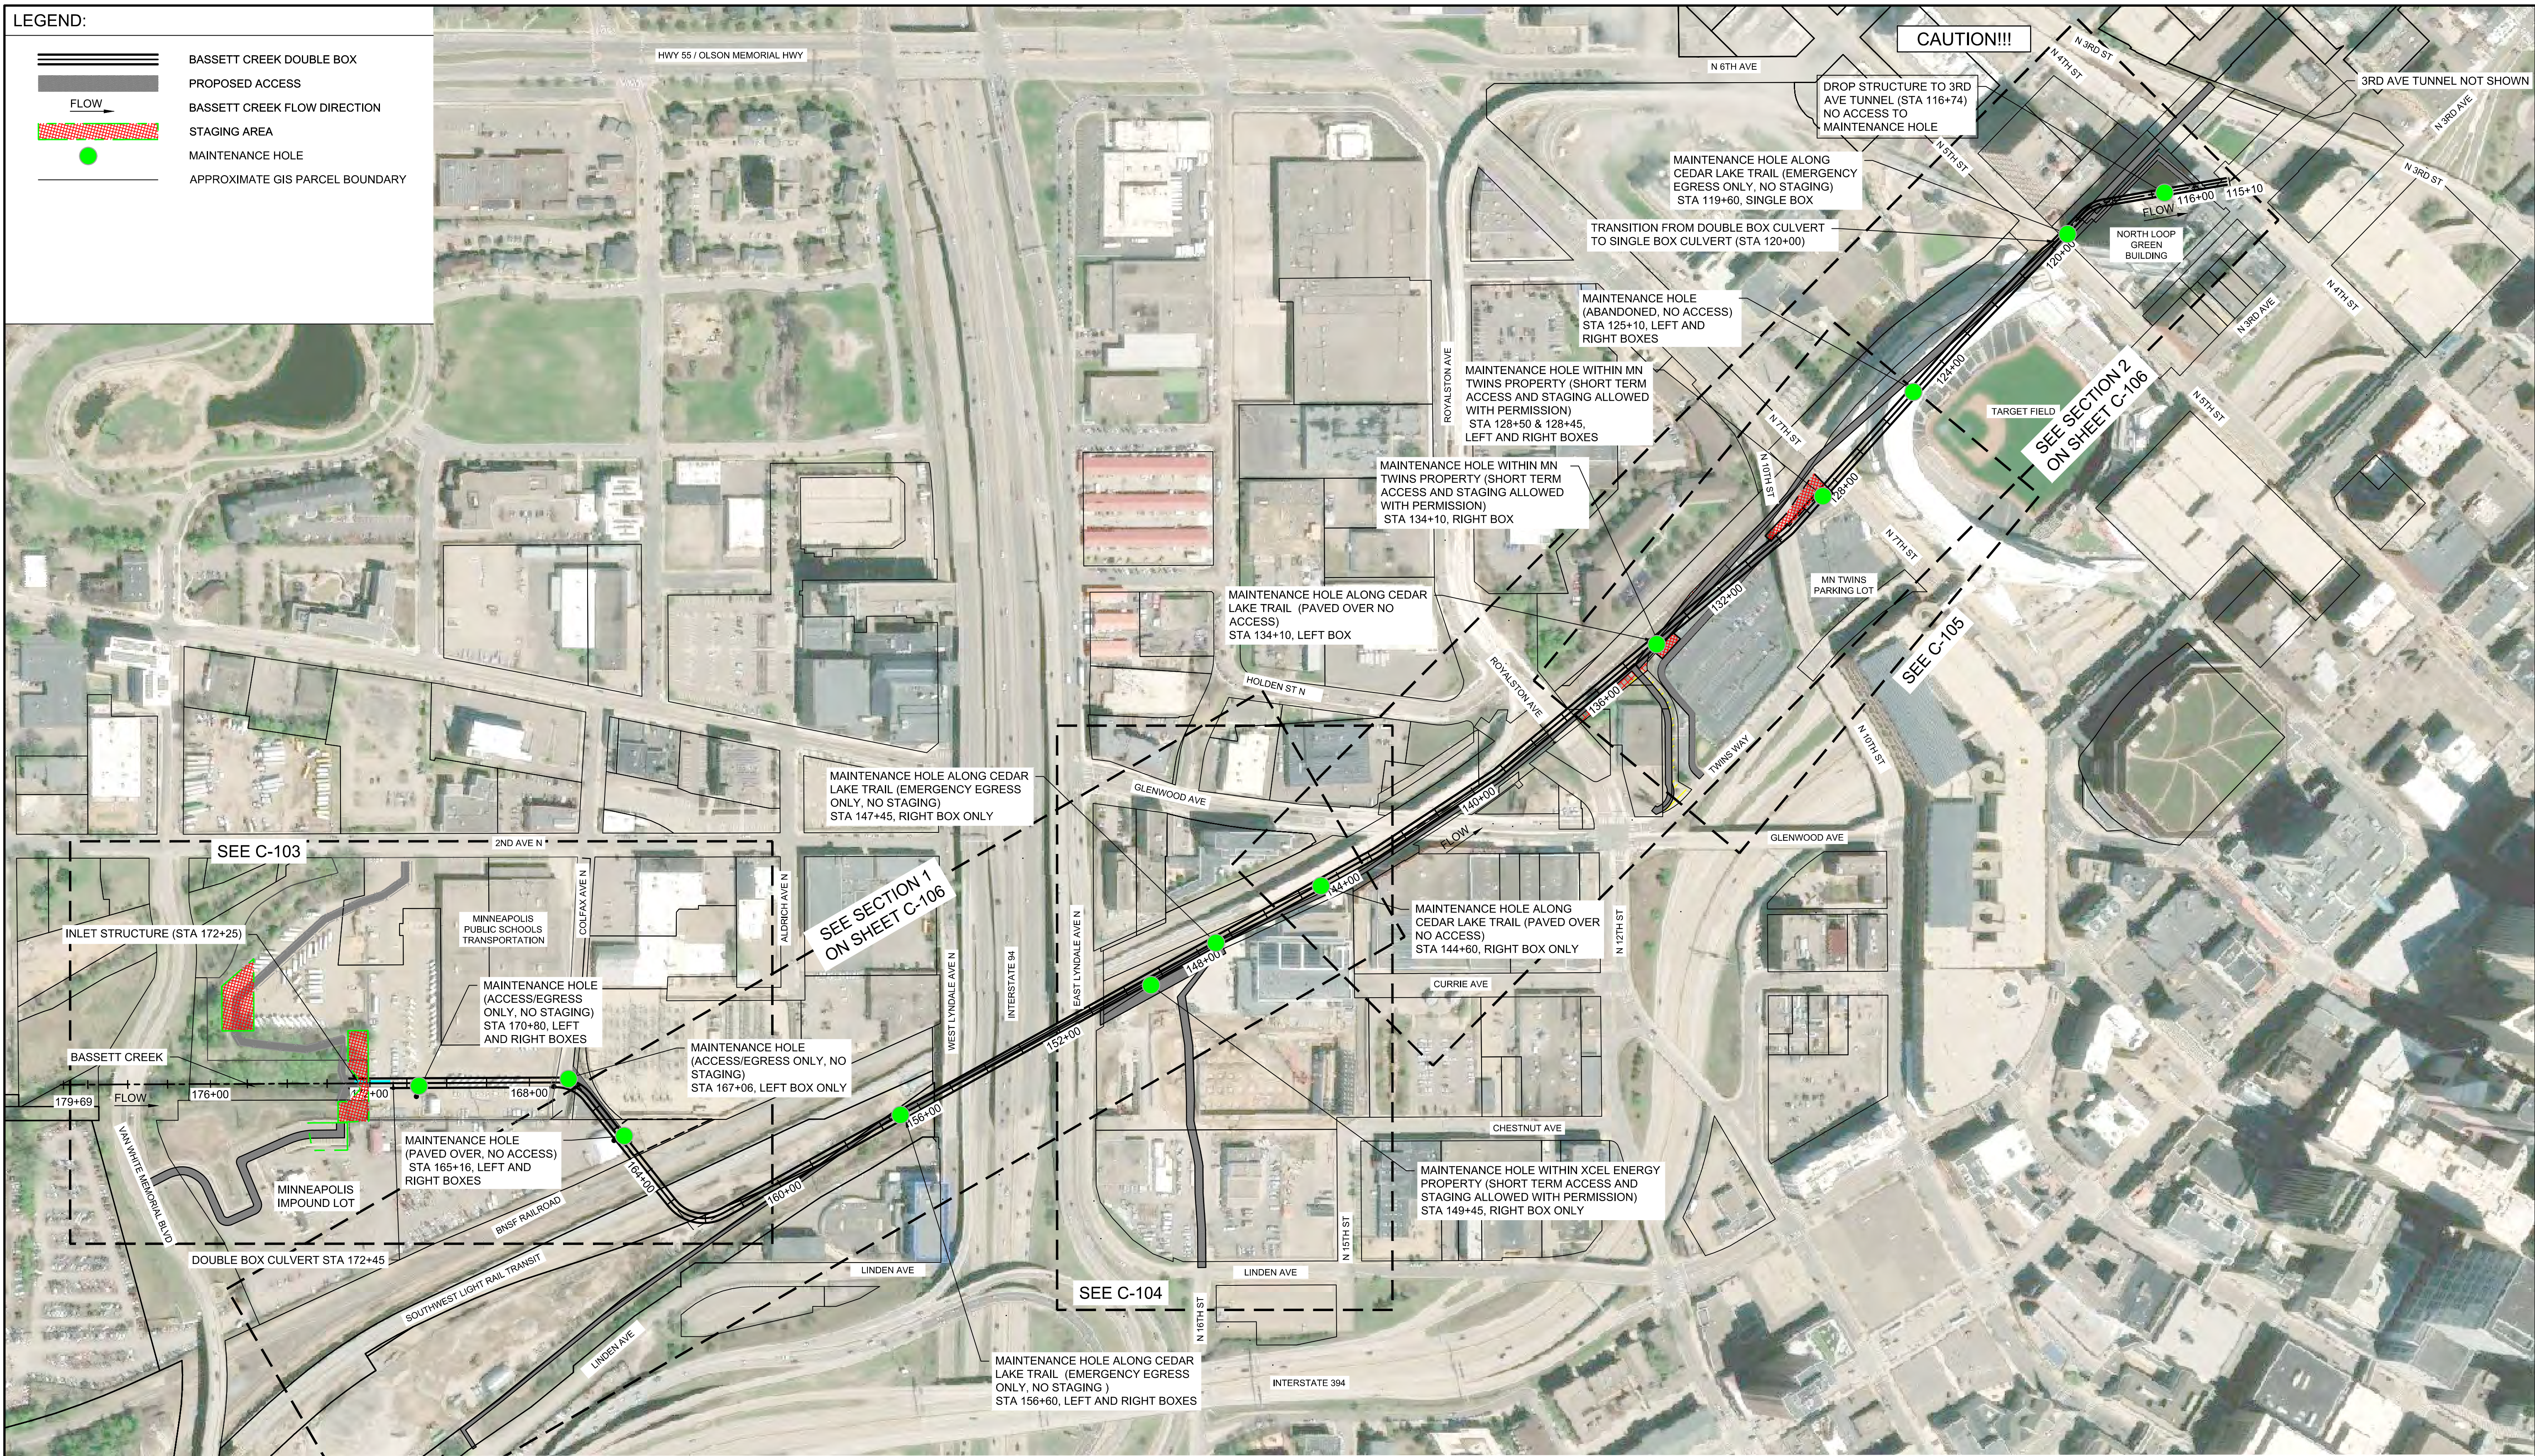
**BASSETT CREEK DOUBLE BOX CULVERT REPAIRS  
 MINNEAPOLIS, MINNESOTA**  
 OVERALL ACCESS PLAN

- BASSETT CREEK DOUBLE BOX
- PROPOSED ACCESS
- BASSETT CREEK FLOW DIRECTION
- STAGING AREA
- MAINTENANCE HOLE
- APPROXIMATE GIS PARCEL BOUNDARY

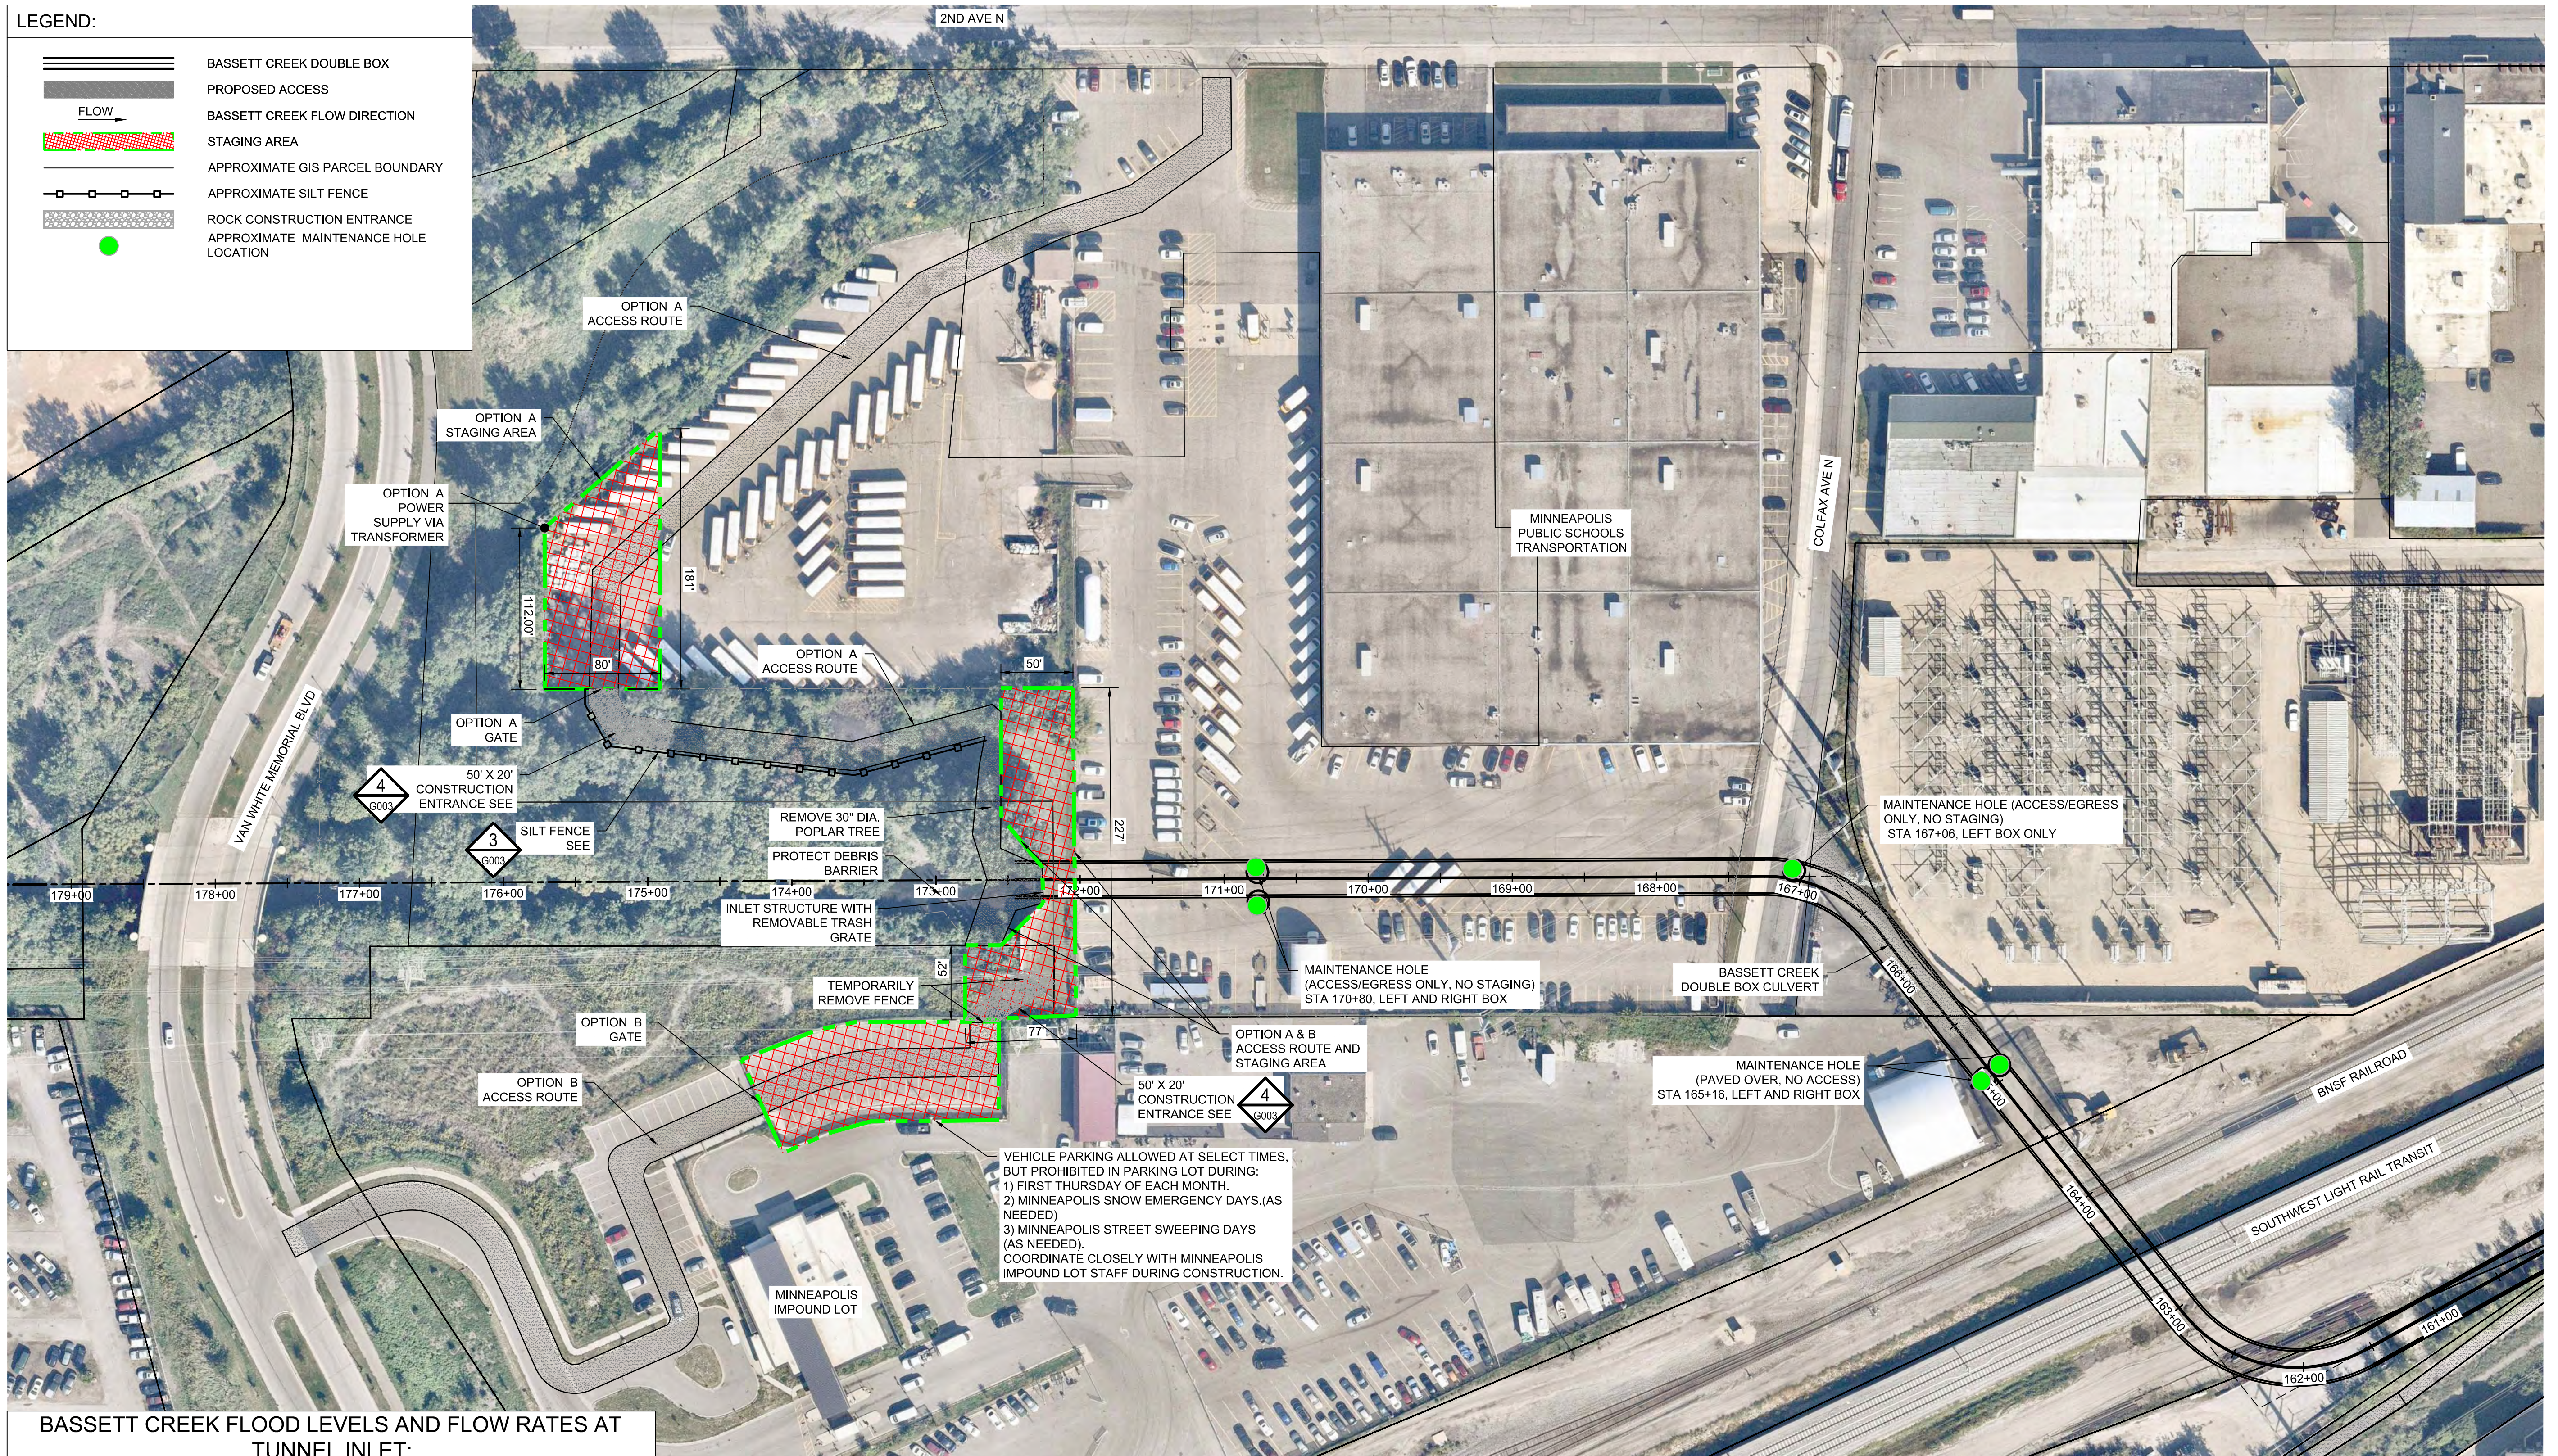
**BASSETT CREEK DOUBLE BOX CULVERT REPAIRS  
 MINNEAPOLIS, MINNESOTA**  
 PRIMARY ACCESS AND STAGING AREA - INLET STRUCTURE

**BASSETT CREEK FLOOD LEVELS AND FLOW RATES AT TUNNEL INLET:**

DATUM HEIGHT	ELEVATIONS: (FEET)	FLOW RATE: (CFS)
INVERT	797.8	N/A
BASE FLOW	TBD	TBD
2 - YEAR STORM	802.4	400
10 - YEAR STORM	804.8	660
100 - YEAR STORM	809.8	1,280

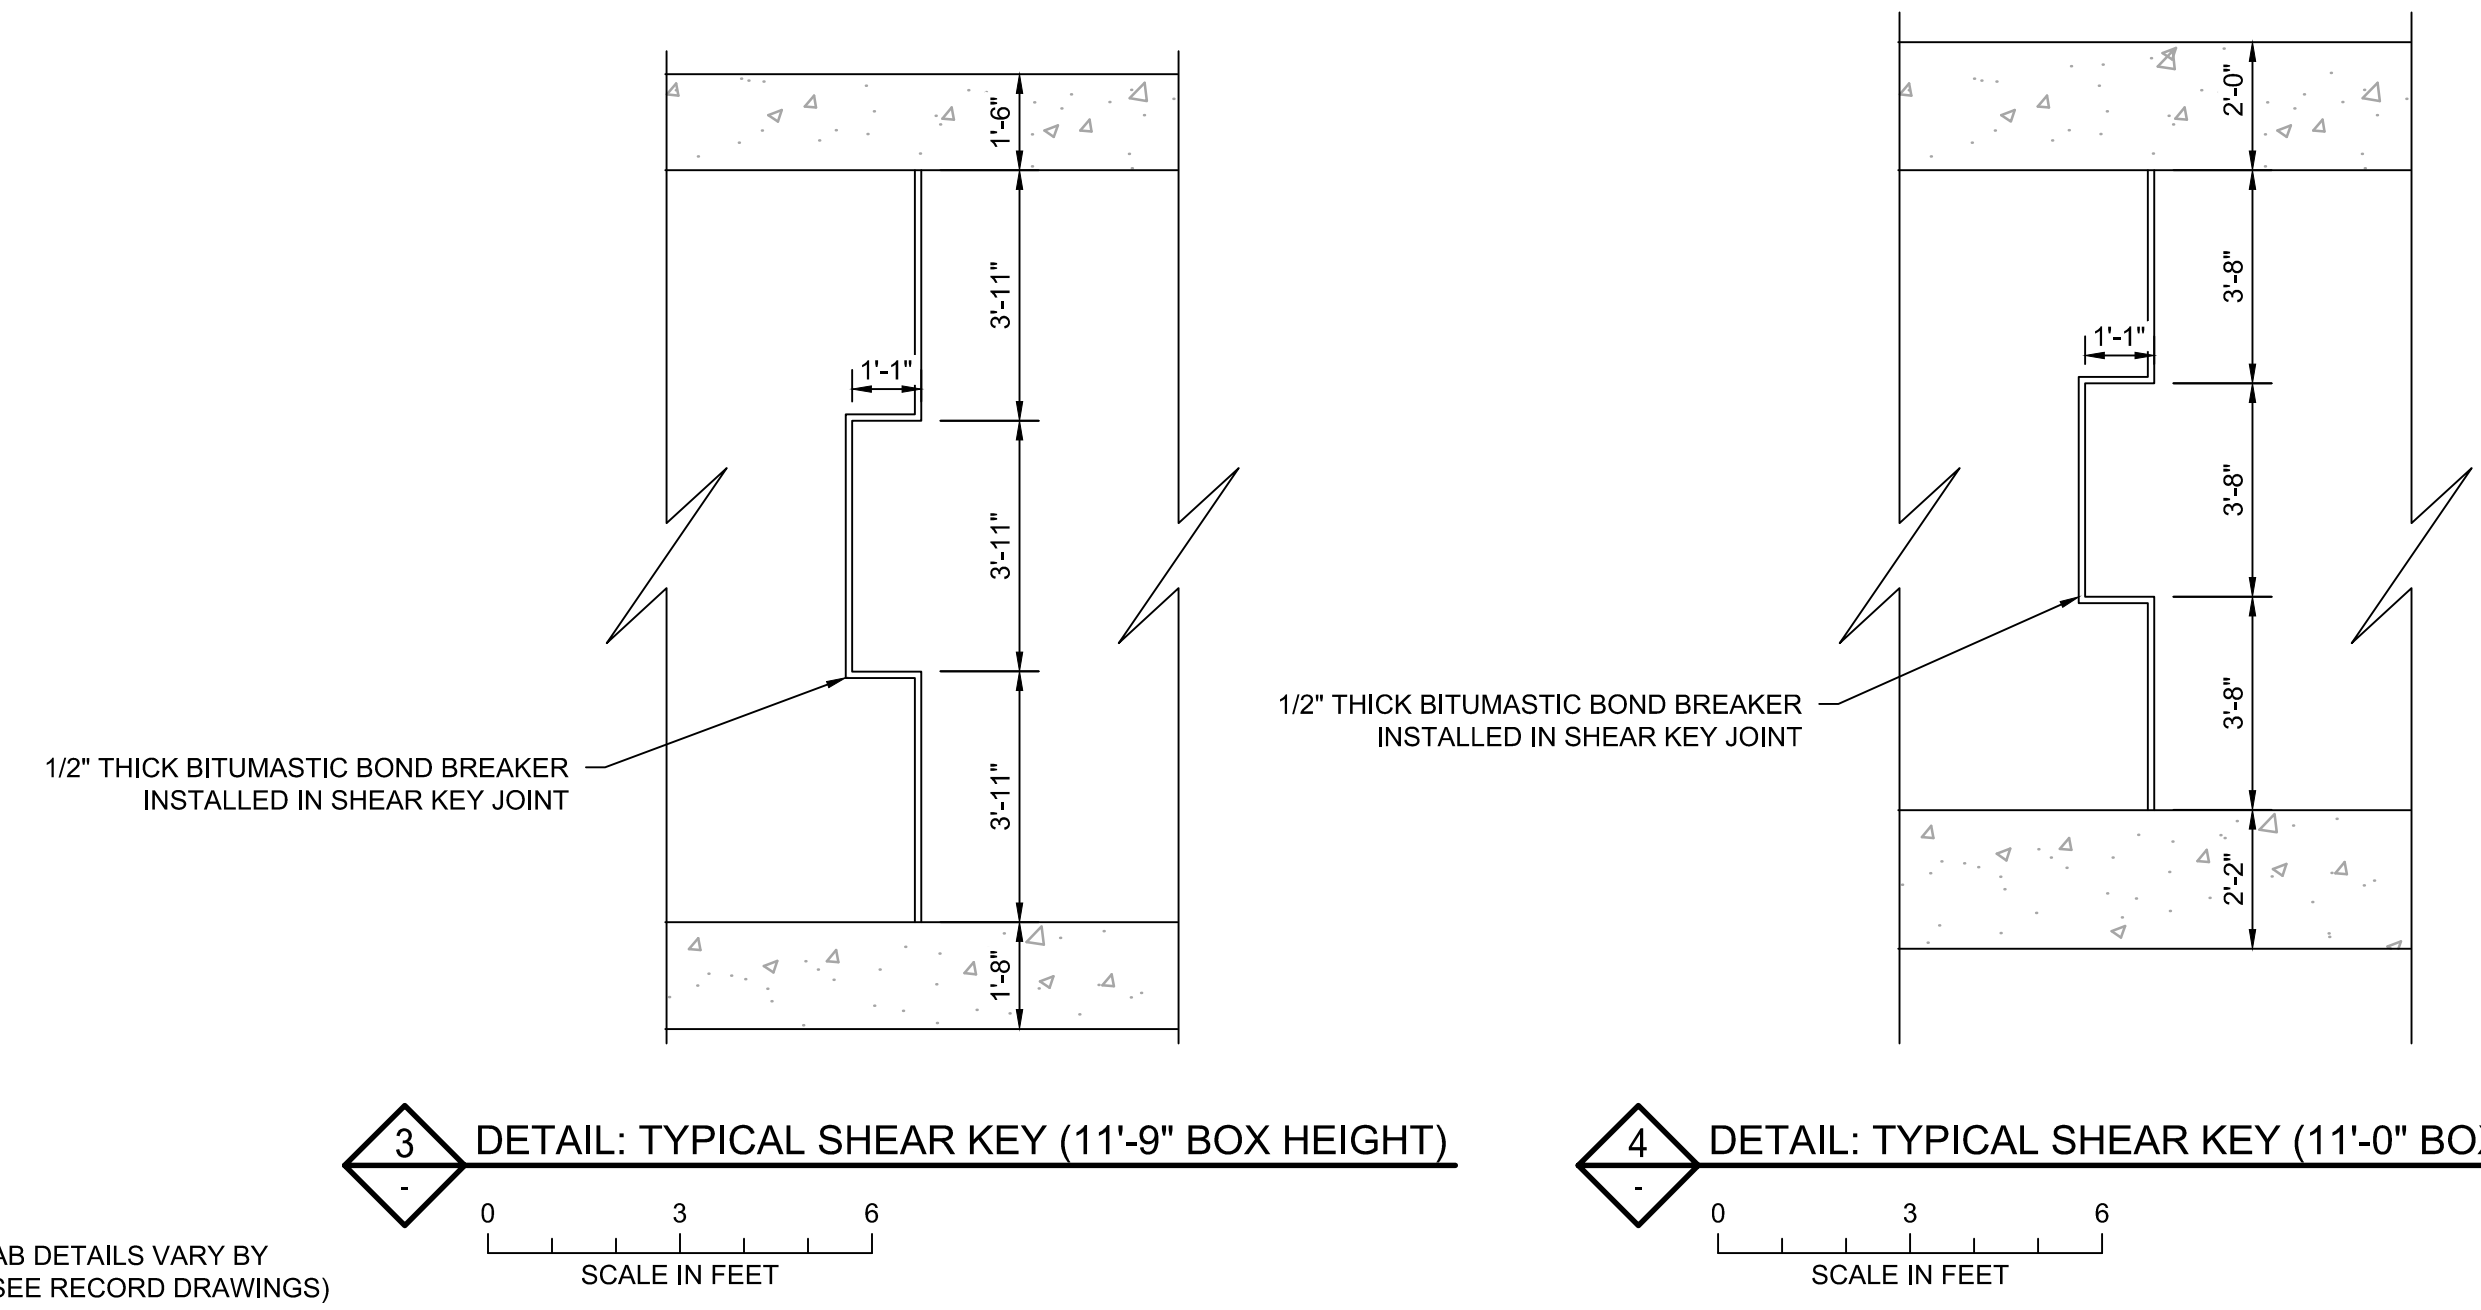
**3 DETAIL: TYPICAL SHEAR KEY (11'-9" BOX HEIGHT)**  
 SCALE IN FEET

**4 DETAIL: TYPICAL SHEAR KEY (11'-0" BOX HEIGHT)**  
 SCALE IN FEET
