# BASSETT CREEK DOUBLE BOX CULVERT REPAIRS

## BASSETT CREEK WATERSHED MANAGEMENT COMMISSION

### MINNEAPOLIS, MINNESOTA

**BASSETT CREEK DOUBLE BOX CULVERT REPAIRS**  
MINNEAPOLIS, MINNESOTA  
INDEX, LOCATION MAP, AND VICINITY MAP

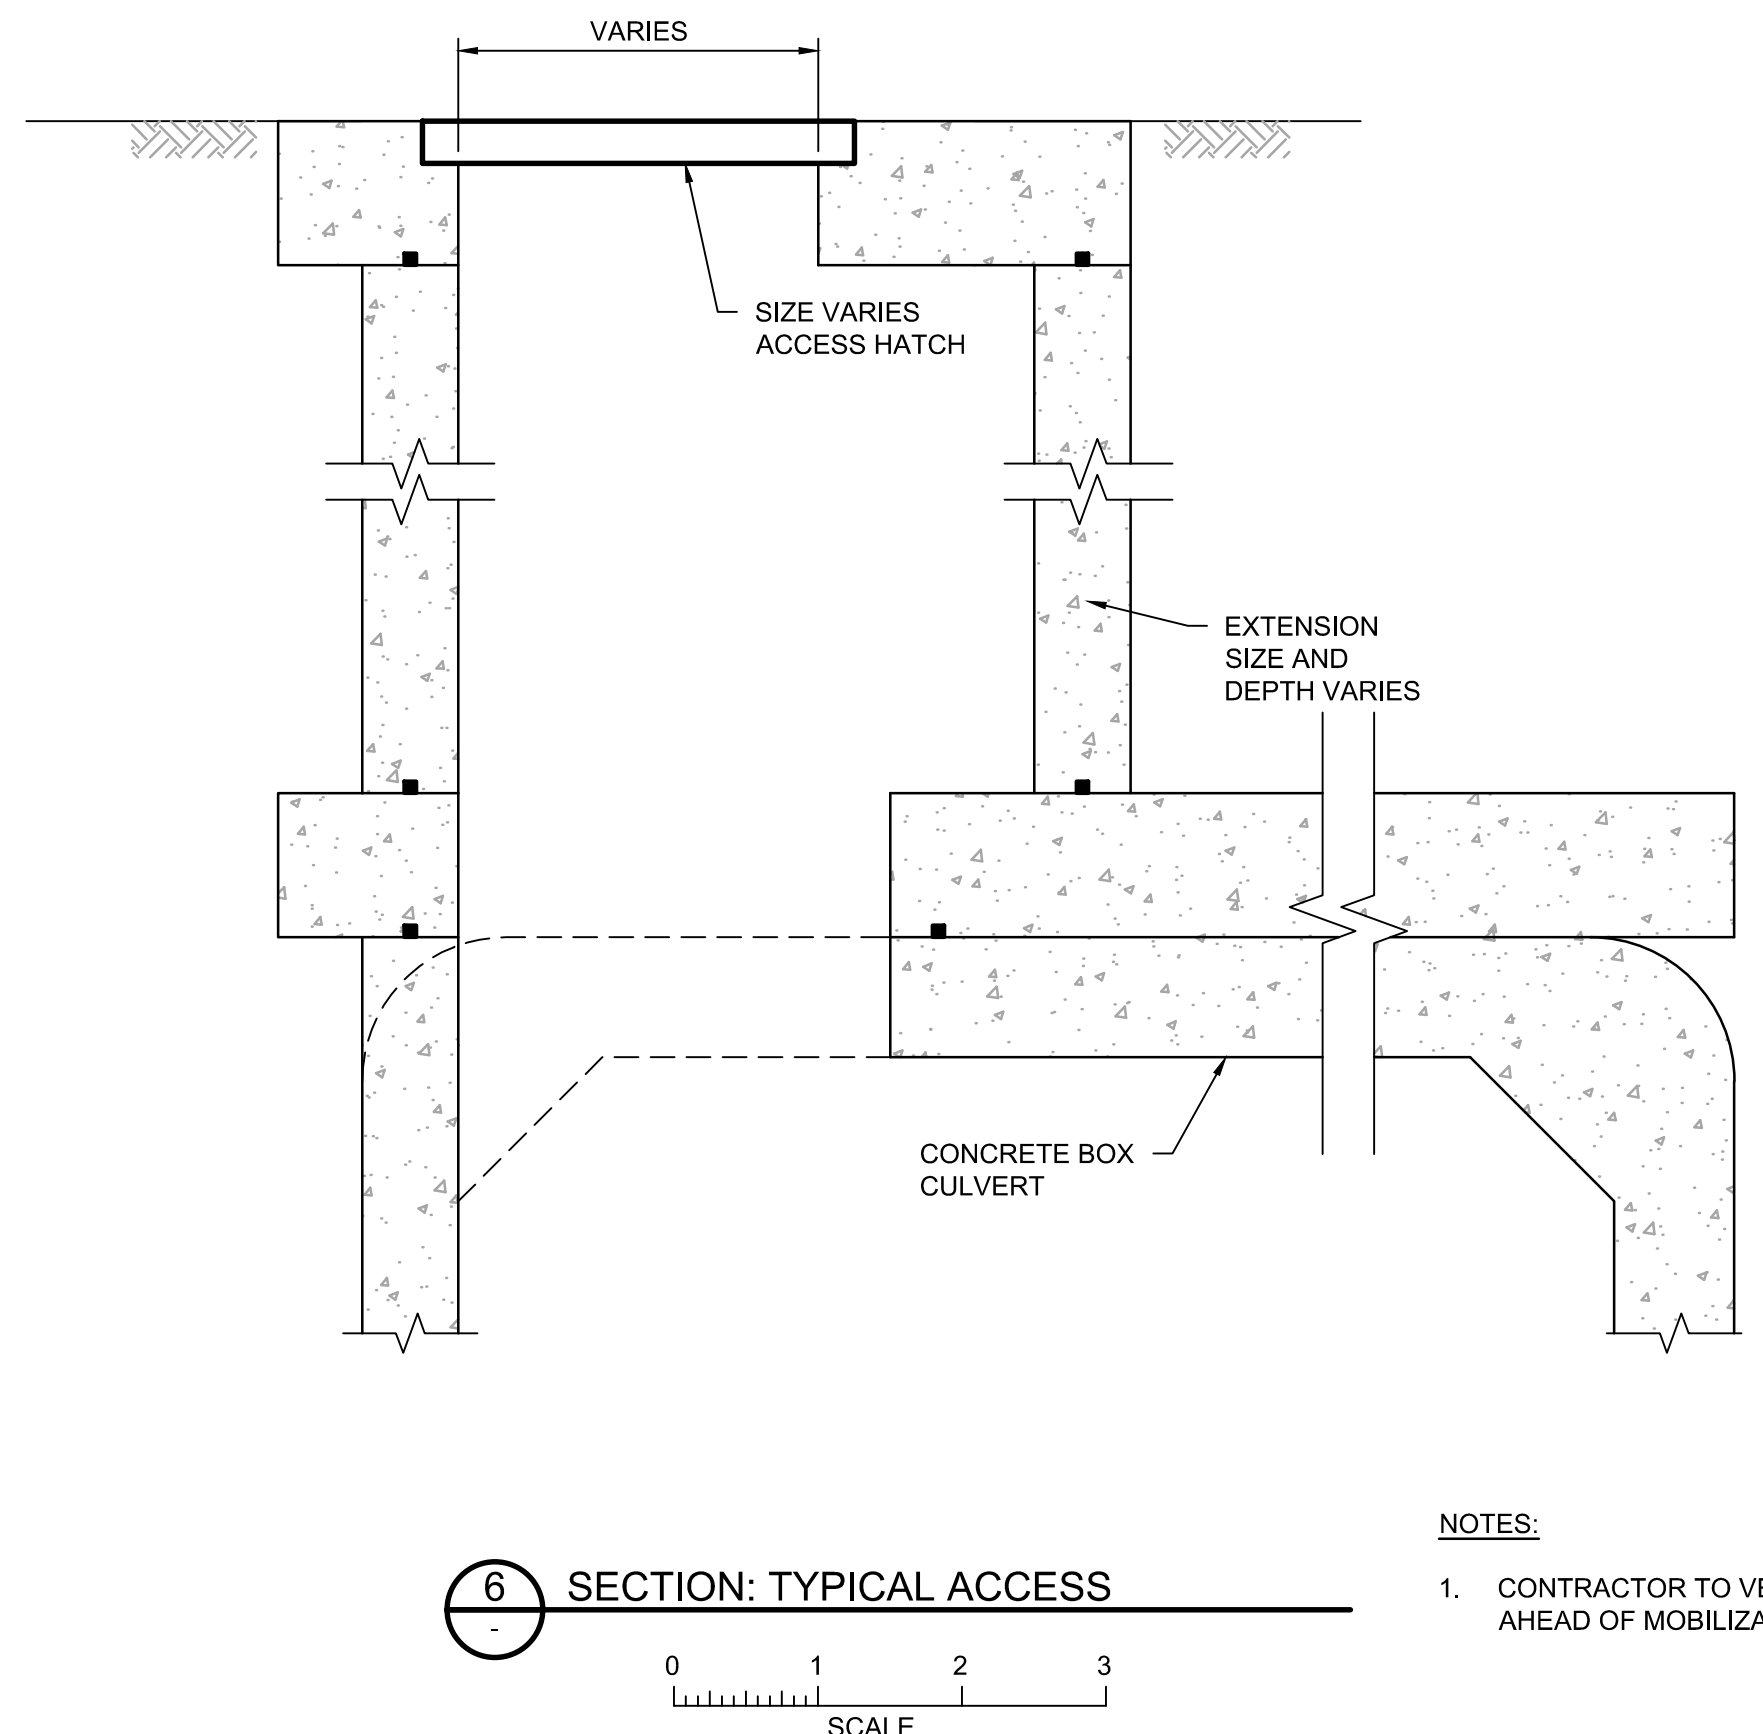
**6 SECTION: TYPICAL ACCESS**  
 SCALE

**NOTES:**  
 1. CONTRACTOR TO VERIFY ACCESS VAULT DIMENSIONS AHEAD OF MOBILIZATION.

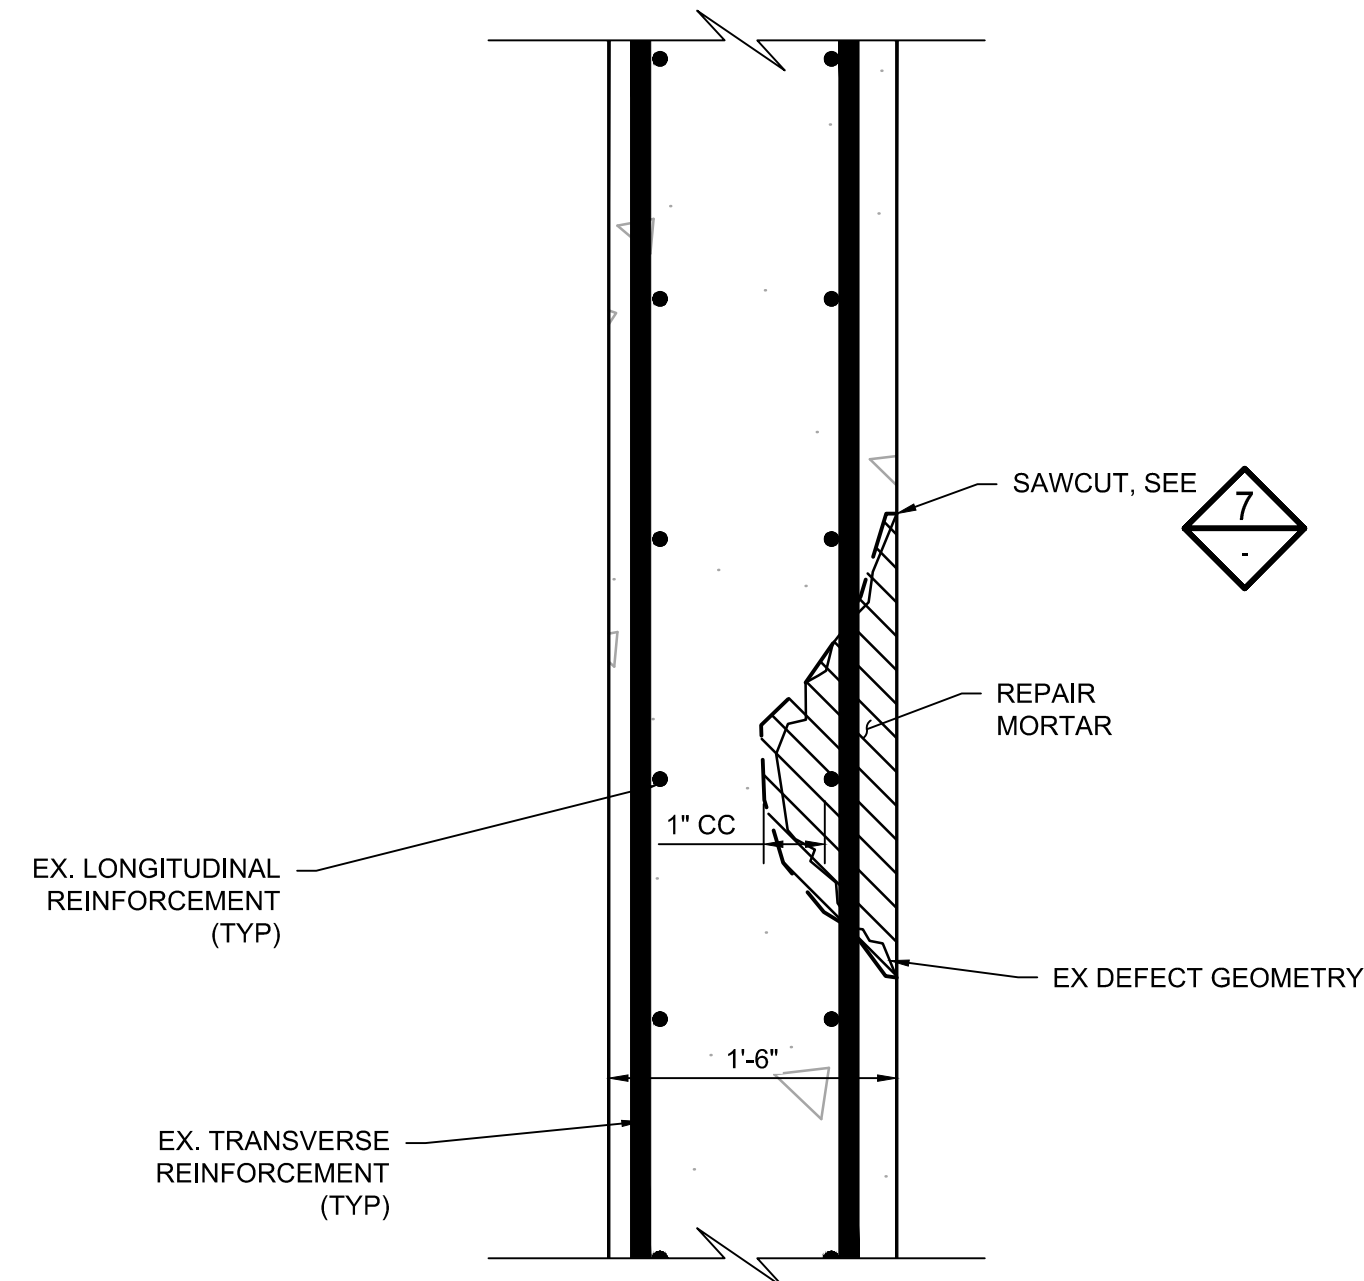
**1** DETAIL: TYPE 1 - CONCRETE SURFACE REPAIR, 1/2" TO 2-1/2" OVERLAY

- NOTES:
1. SAW CUT THE PERIMETER OF THE DEFECT.
  2. PREPARE EXISTING CONCRETE SURFACE.
  3. IF REINFORCEMENT IS ENCOUNTERED IN REPAIR AREA, DEMO CONCRETE BEHIND REINFORCEMENT TO PROVIDE 1" MIN CLEAR COVER (ALL SIDES).
  4. REMOVE CORROSION FROM REINFORCEMENT (IF PRESENT) AND INSTALL CORROSION INHIBITOR.
  5. INSTALL REPAIR MORTAR.

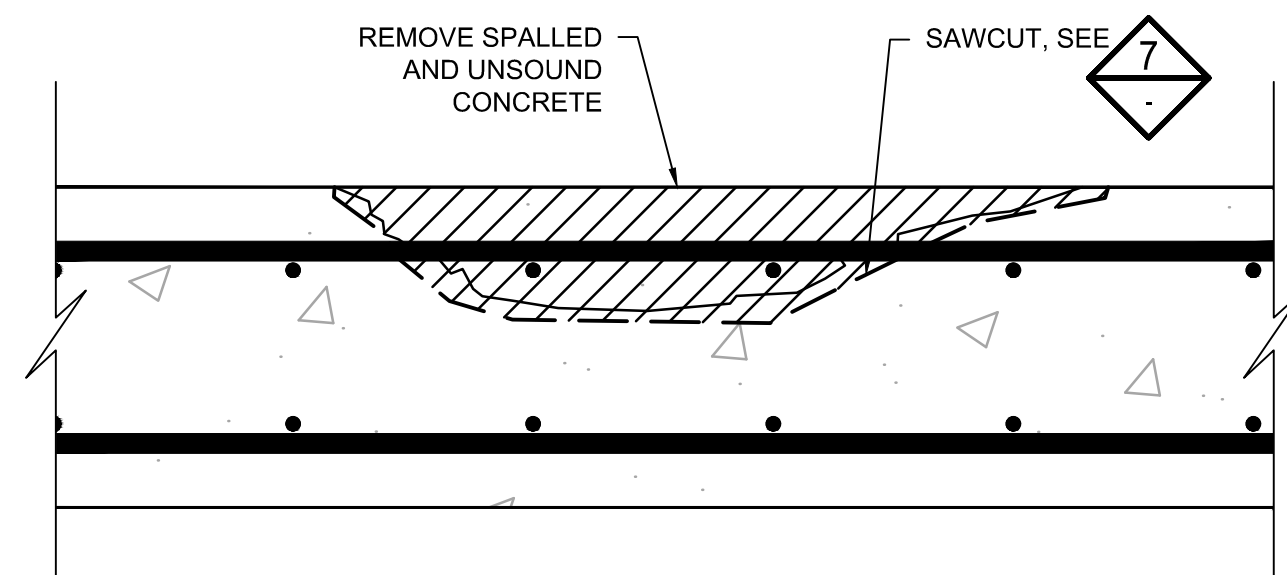
**2** DETAIL: TYPE 2 - INVERT REPAIR

- NOTES:
1. SAW CUT THE PERIMETER OF THE DEFECT.
  2. PREPARE EXISTING CONCRETE SURFACE.
  3. IF REINFORCEMENT IS ENCOUNTERED IN REPAIR AREA, DEMO CONCRETE BEHIND REINFORCEMENT TO PROVIDE 1" MIN CLEAR COVER (ALL SIDES).
  4. REMOVE CORROSION FROM REINFORCEMENT (IF PRESENT) AND INSTALL CORROSION INHIBITOR.
  5. INSTALL CAST-IN-PLACE CONCRETE.

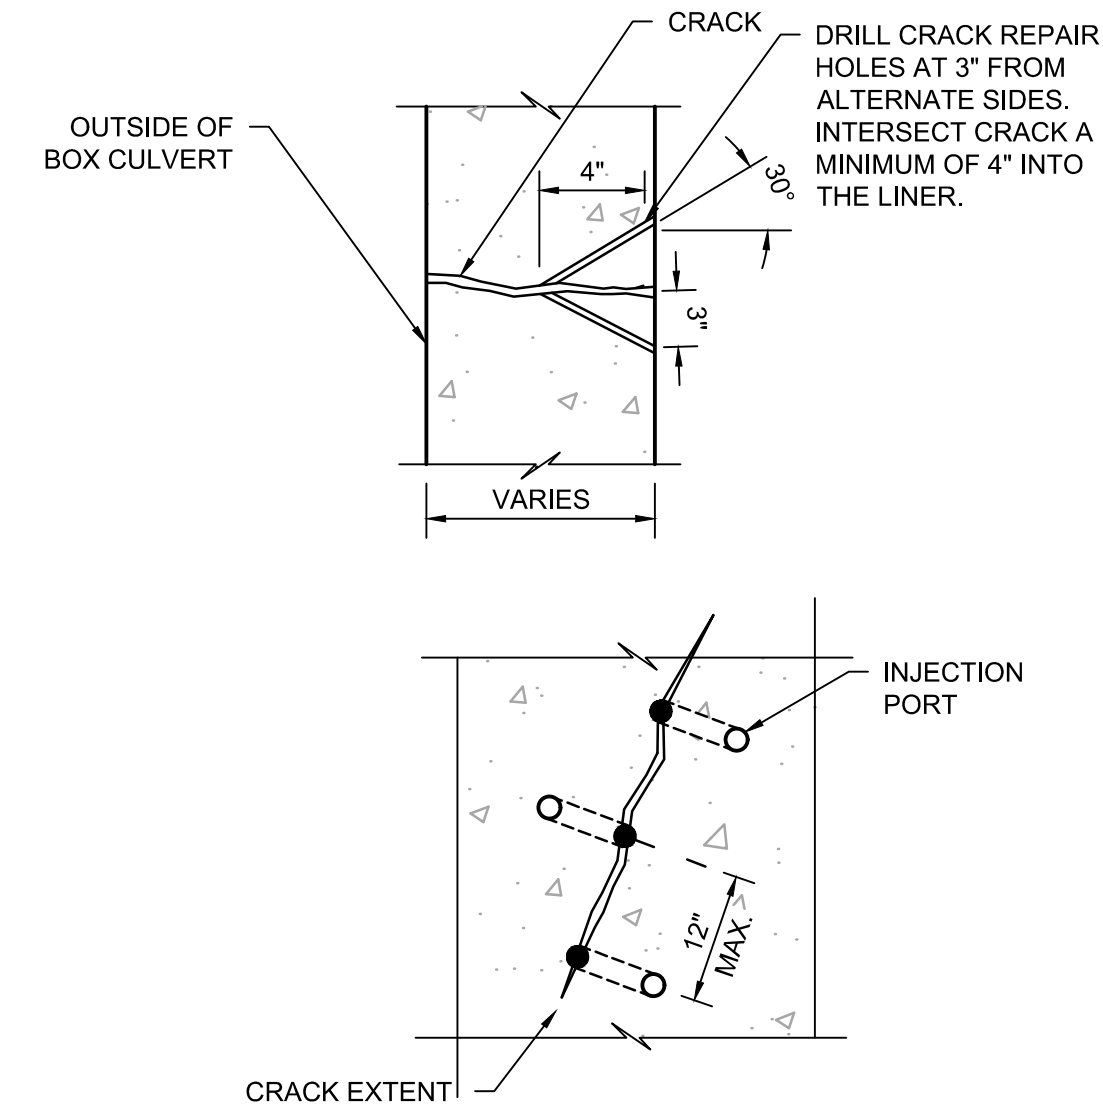
**3** DETAIL: TYPE 3 - CRACK REPAIR

- NOTES:
1. UTILIZE HYDROPHILIC GROUT AS REQUIRED IN THE SPECIFICATIONS.
  2. HYDROPHILIC GROUT MATERIAL IS PAID UNDER A SEPARATE BID ITEM (HYDROPHILIC CHEMICAL GROUT).

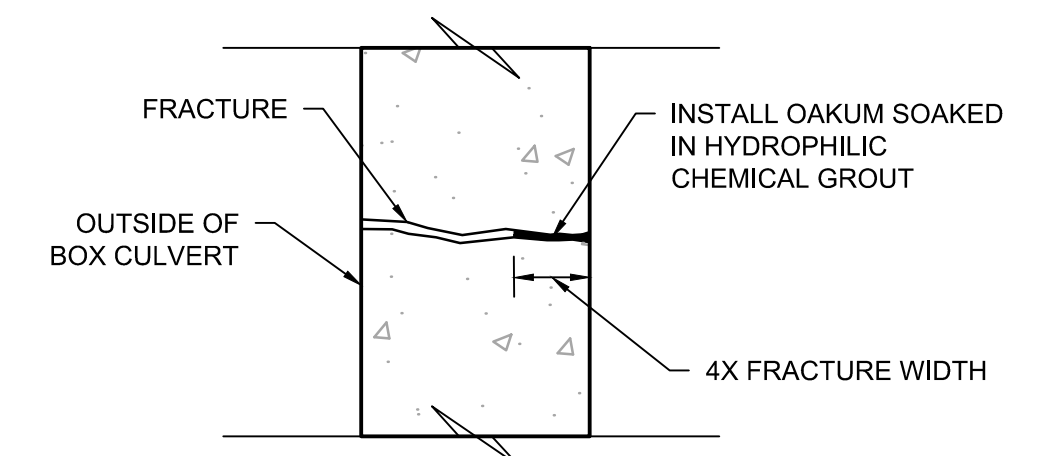
**4** DETAIL: TYPE 4 - FRACTURE REPAIR

- NOTES:
1. INSTALL OAKUM AND CHEMICAL GROUT IN ACCORDANCE WITH AVANTI INTERNATIONAL'S EXPANDED GASKET PLACEMENT (EGP) TECHNIQUE. TRIM EGP MATERIAL FLUSH WITH TUNNEL LINER AFTER EGP MATERIAL HAS CURED PER MANUFACTURER'S RECOMMENDATIONS.

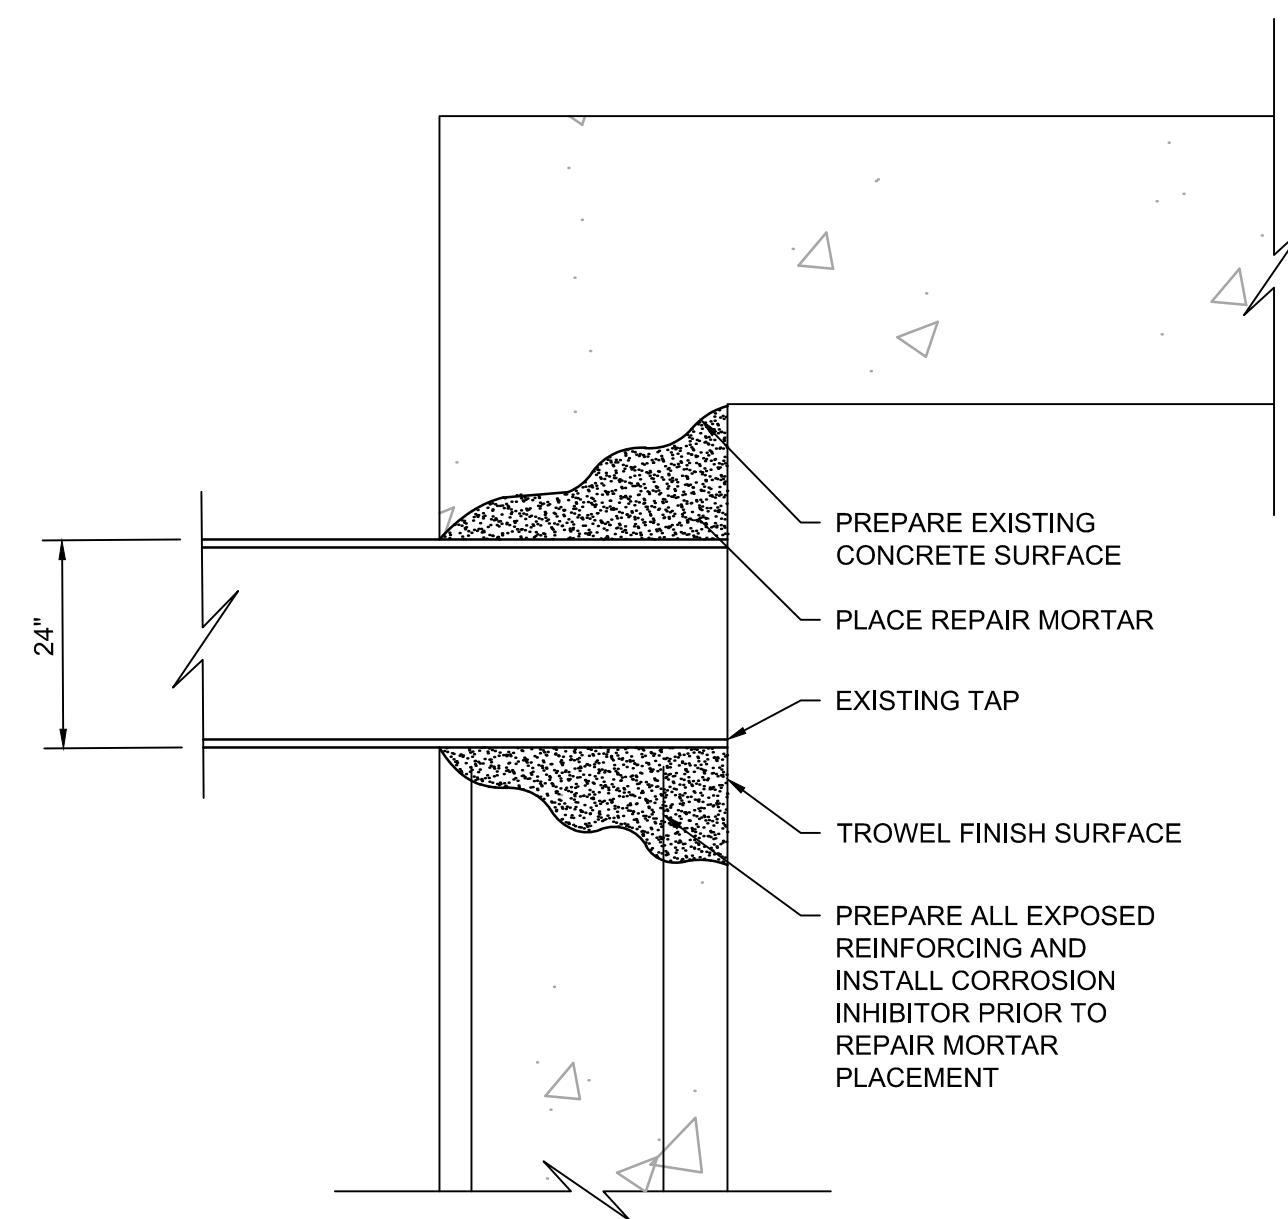
**5** DETAIL: TYPE 5 - TAP REPAIR

- NOTES:
1. USE CHEMICAL GROUT TO STOP INFILTRATION PRIOR TO PERFORMING REPAIR, IF REQUIRED.
  2. MATERIAL MORTAR TYPE DEPENDS UPON APPLICATION. SEE SPECIFICATIONS.

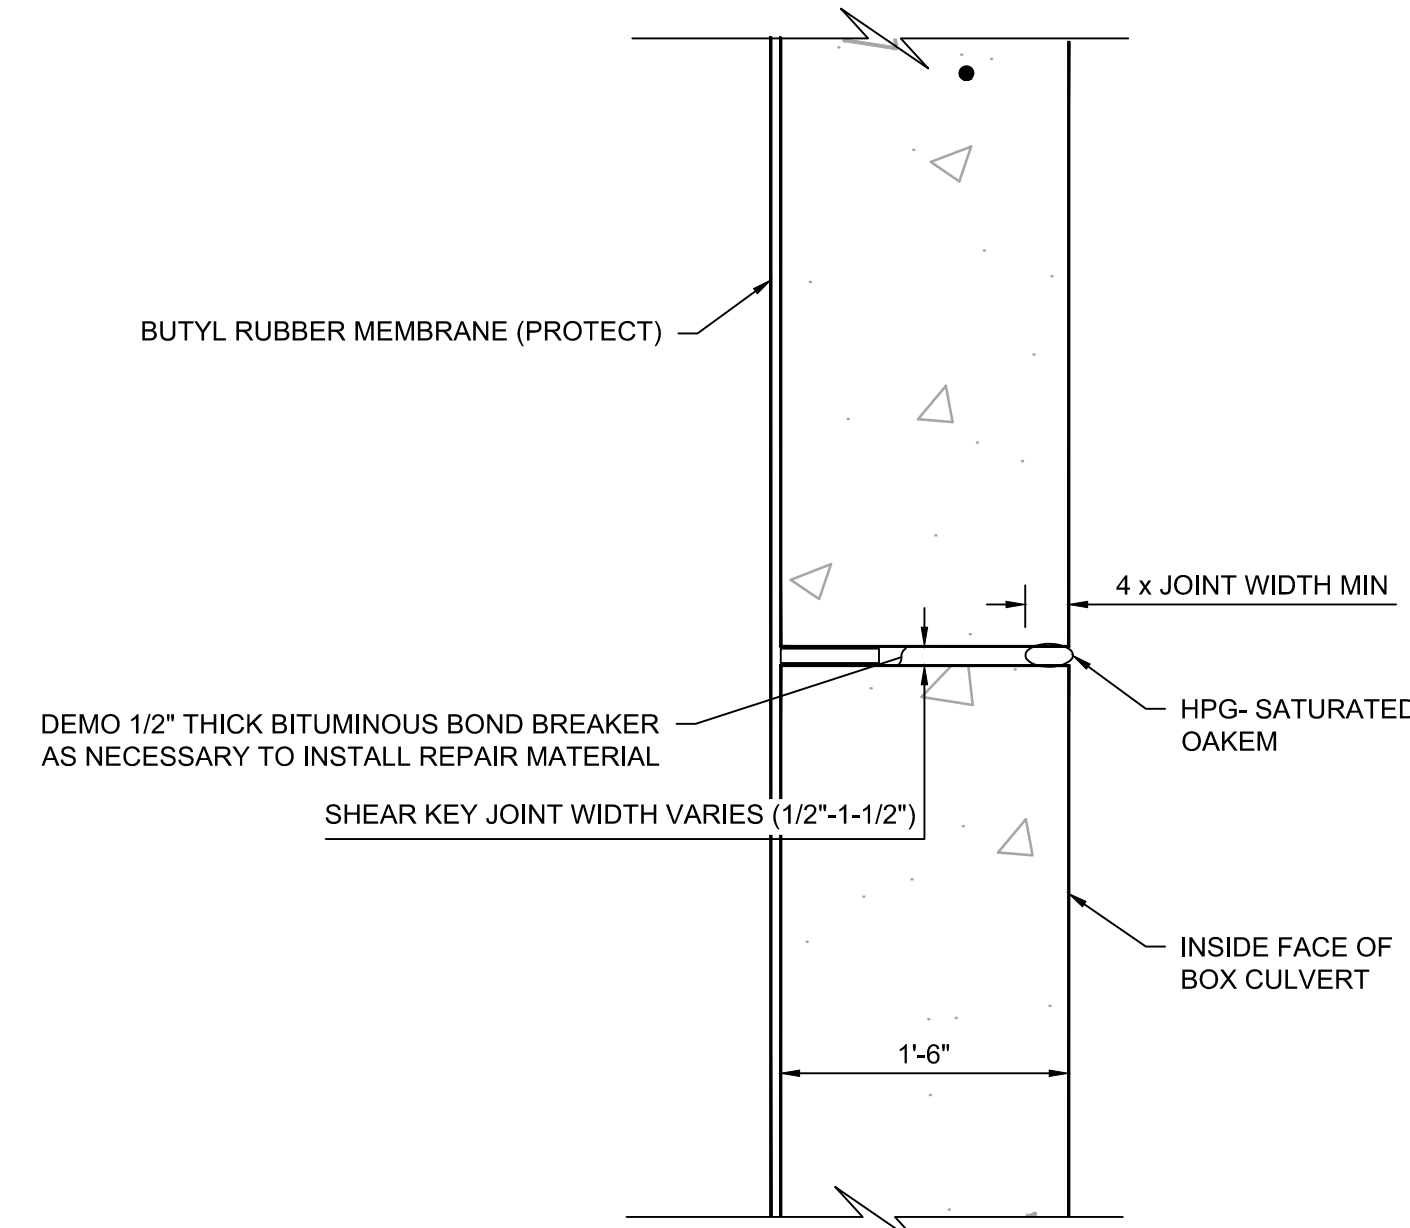
**6** DETAIL: TYPE 6 - SHEAR KEY REPAIR

1. HYDROPHILIC POLYURETHANE GROUT (HPG) SHALL BE AVANTI AV-202 OR ENGINEER-APPROVED EQUAL.
2. OAKUM SHALL BE AVANTI AV-219 FIBROTITE OR ENGINEER-APPROVED EQUAL.
3. HPG REQUIRED FOR SHEAR KEY REPAIR IS INCIDENTAL TO THE PAY ITEM.
4. SHEAR KEY REPAIR SEQUENCE IS PROVIDED BELOW.

- STEP 1: CLEAN THE JOINT BEING REPAIRED. REMOVE EXISTING BITUMASTIC BOND BREAKER TO REPAIR DEPTH AND PRESSURE WASH JOINT. THE JOINT BEING REPAIRED SHOULD BE FREE OF ALL DELETERIOUS MATERIALS.
- STEP 2: CUT OAKUM TO SIZE AND PLACE IN WATER-TIGHT VESSEL (PLASTIC BAG OR BUCKET).
- STEP 3: POUR HPG INTO THE VESSEL AND ALLOW THE OAKUM TO BECOME FULLY SATURATED WITH HPG.
- STEP 4: REMOVE TH HPG-SATURATED OAKUM FROM THE VESSEL AND SUBMERGE IN FRESH WATER UNTIL THE HPG STARTS TO FOAM (APPROXIMATELY 5-10 SECONDS).
- STEP 5: PLACE THE HPG-SATURATED OAKUM INTO THE JOINT USING A BLUNT INSTRUMENT SUCH AS A PUTTY KNIFE. MULTIPLE ITERATIONS OF STEPS 2-5 MAY BE REQUIRED TO ACHIEVE THE FULL REPAIR DEPTH.
- STEP 6: AFTER HPG-SATURATED OAKUM HAS CURED, TRIM FLUSH WITH THE INSIDE FACE OF BOX CULVERT.

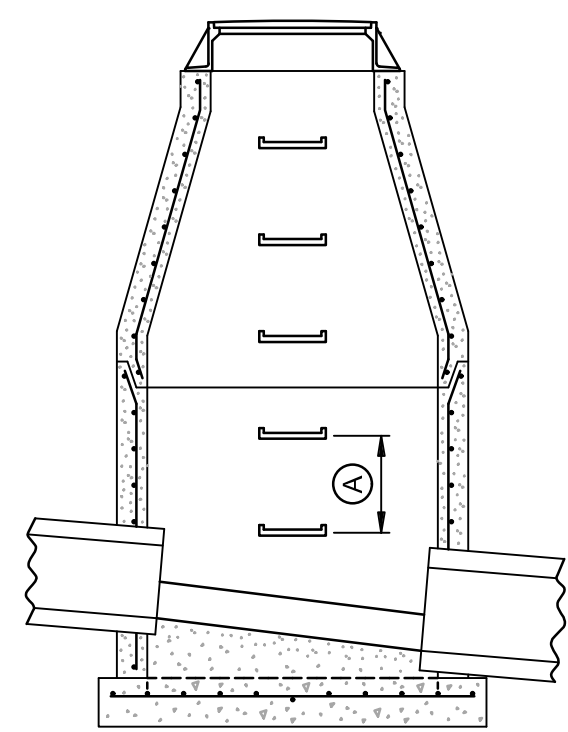
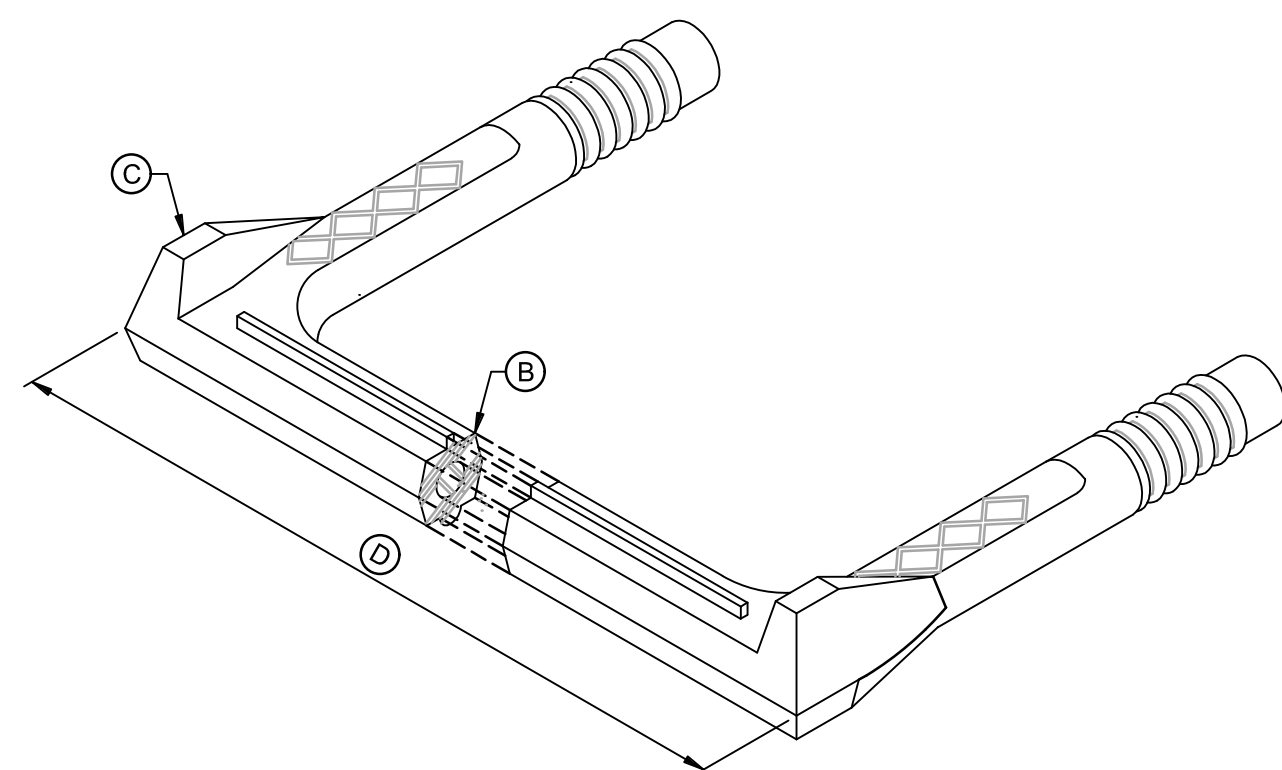
1 DETAIL: TYPE 7 - INSTALL MANHOLE STEP  
N.T.S. MN/DOT STD. PLATE 4180J

TYPICAL STEP ALIGNMENT

TYPICAL REINFORCED PLASTIC STEP

- 1. STEPS SHOWN ARE BASIC DESIGNS ONLY. FINAL CONFIGURATIONS MAY VARY FROM THESE DRAWINGS.
- 2. VARIATIONS IN THE ABOVE DESIGNS WHICH WILL NOT DECREASE STRENGTH WILL BE PERMITTED.
- 3. THE MNDOT OFFICE OF MATERIALS, RESEARCH AND ENGINEERING WILL MAINTAIN A LISTING OF APPROVED MANHOLE STEPS. STEEL REINFORCED PLASTIC STEPS ARE REQUIRED FOR THIS PROJECT.
- 4. EXCEPT AS OTHERWISE NOTED ON THIS PLATE, STEPS SHALL CONFORM TO THE REQUIREMENTS OF ASTM C478
- 5. STEPS SHALL BE EMBEDDED IN THE RISER OR CONICAL TOP SECTION WALL A MINIMUM DISTANCE OF 3 IN.
- 6. THE RUNG OR CLEAT SHALL PROJECT A MINIMUM CLEAR DISTANCE OF 4 IN. FROM THE WALL OF THE RISER OR CONE SECTION MEASURED FROM THE POINT OF EMBEDMENT.
- 7. THE MIN. CLEAR DISTANCE BETWEEN THE RUNG OR CLEAT AND THE OPOSITE WALL OF THE MANHOLE RISER OR CONE SHALL BE 18 IN. MEASURED AT THE CENTER FACE OF THE STEP.

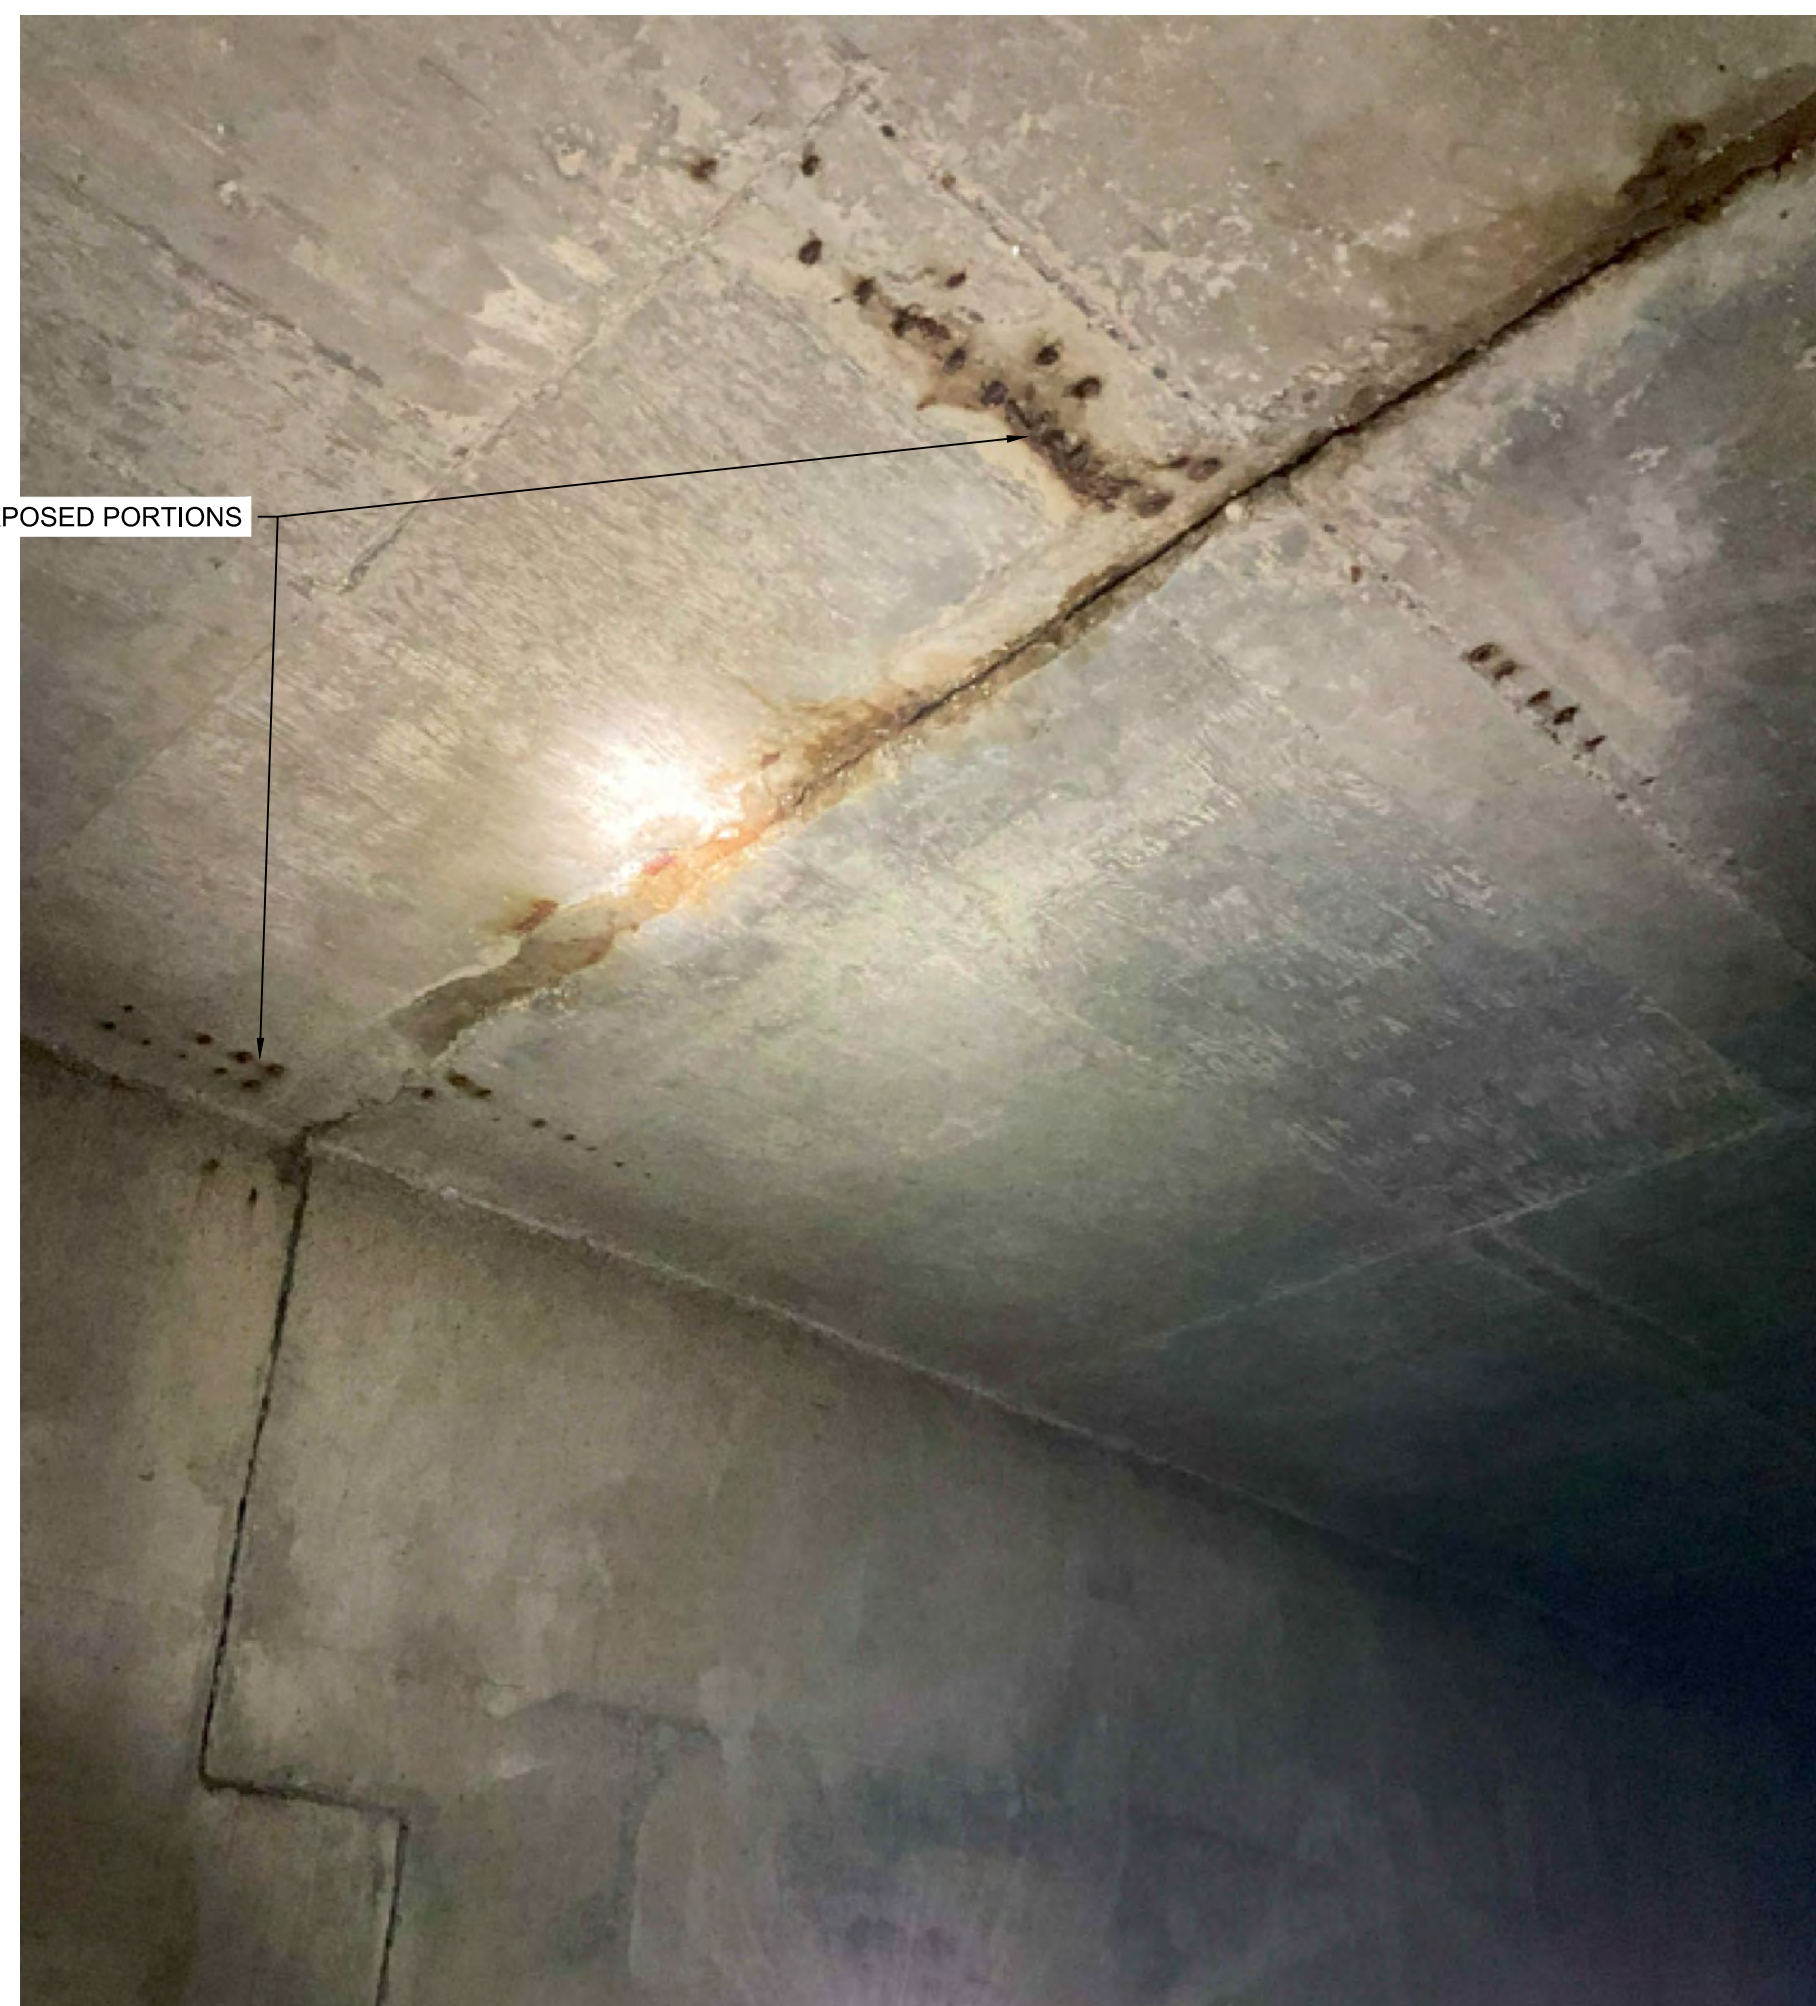
2 DETAIL: TYPE 8 - REINFORCEMENT SPACER  
N.T.S.

PAINT CORROSION INHIBITOR ON EXPOSED PORTIONS

- 1. USE POWER WASH OR SAND BLAST OR ANGLE GRINDER TO REMOVE CORROSION AND ANY OTHER DELETERIOUS MATERIAL BY FROM REINFORCEMENT SPACERS.
- 2. ROLL OR SPRAY TO INSTALL CORROSION INHIBITOR.
- 3. PROTECT EXISTING CONCRETE FROM ANY AND ALL DAMAGE FROM ADJACENT CORROSION REPAIRS.

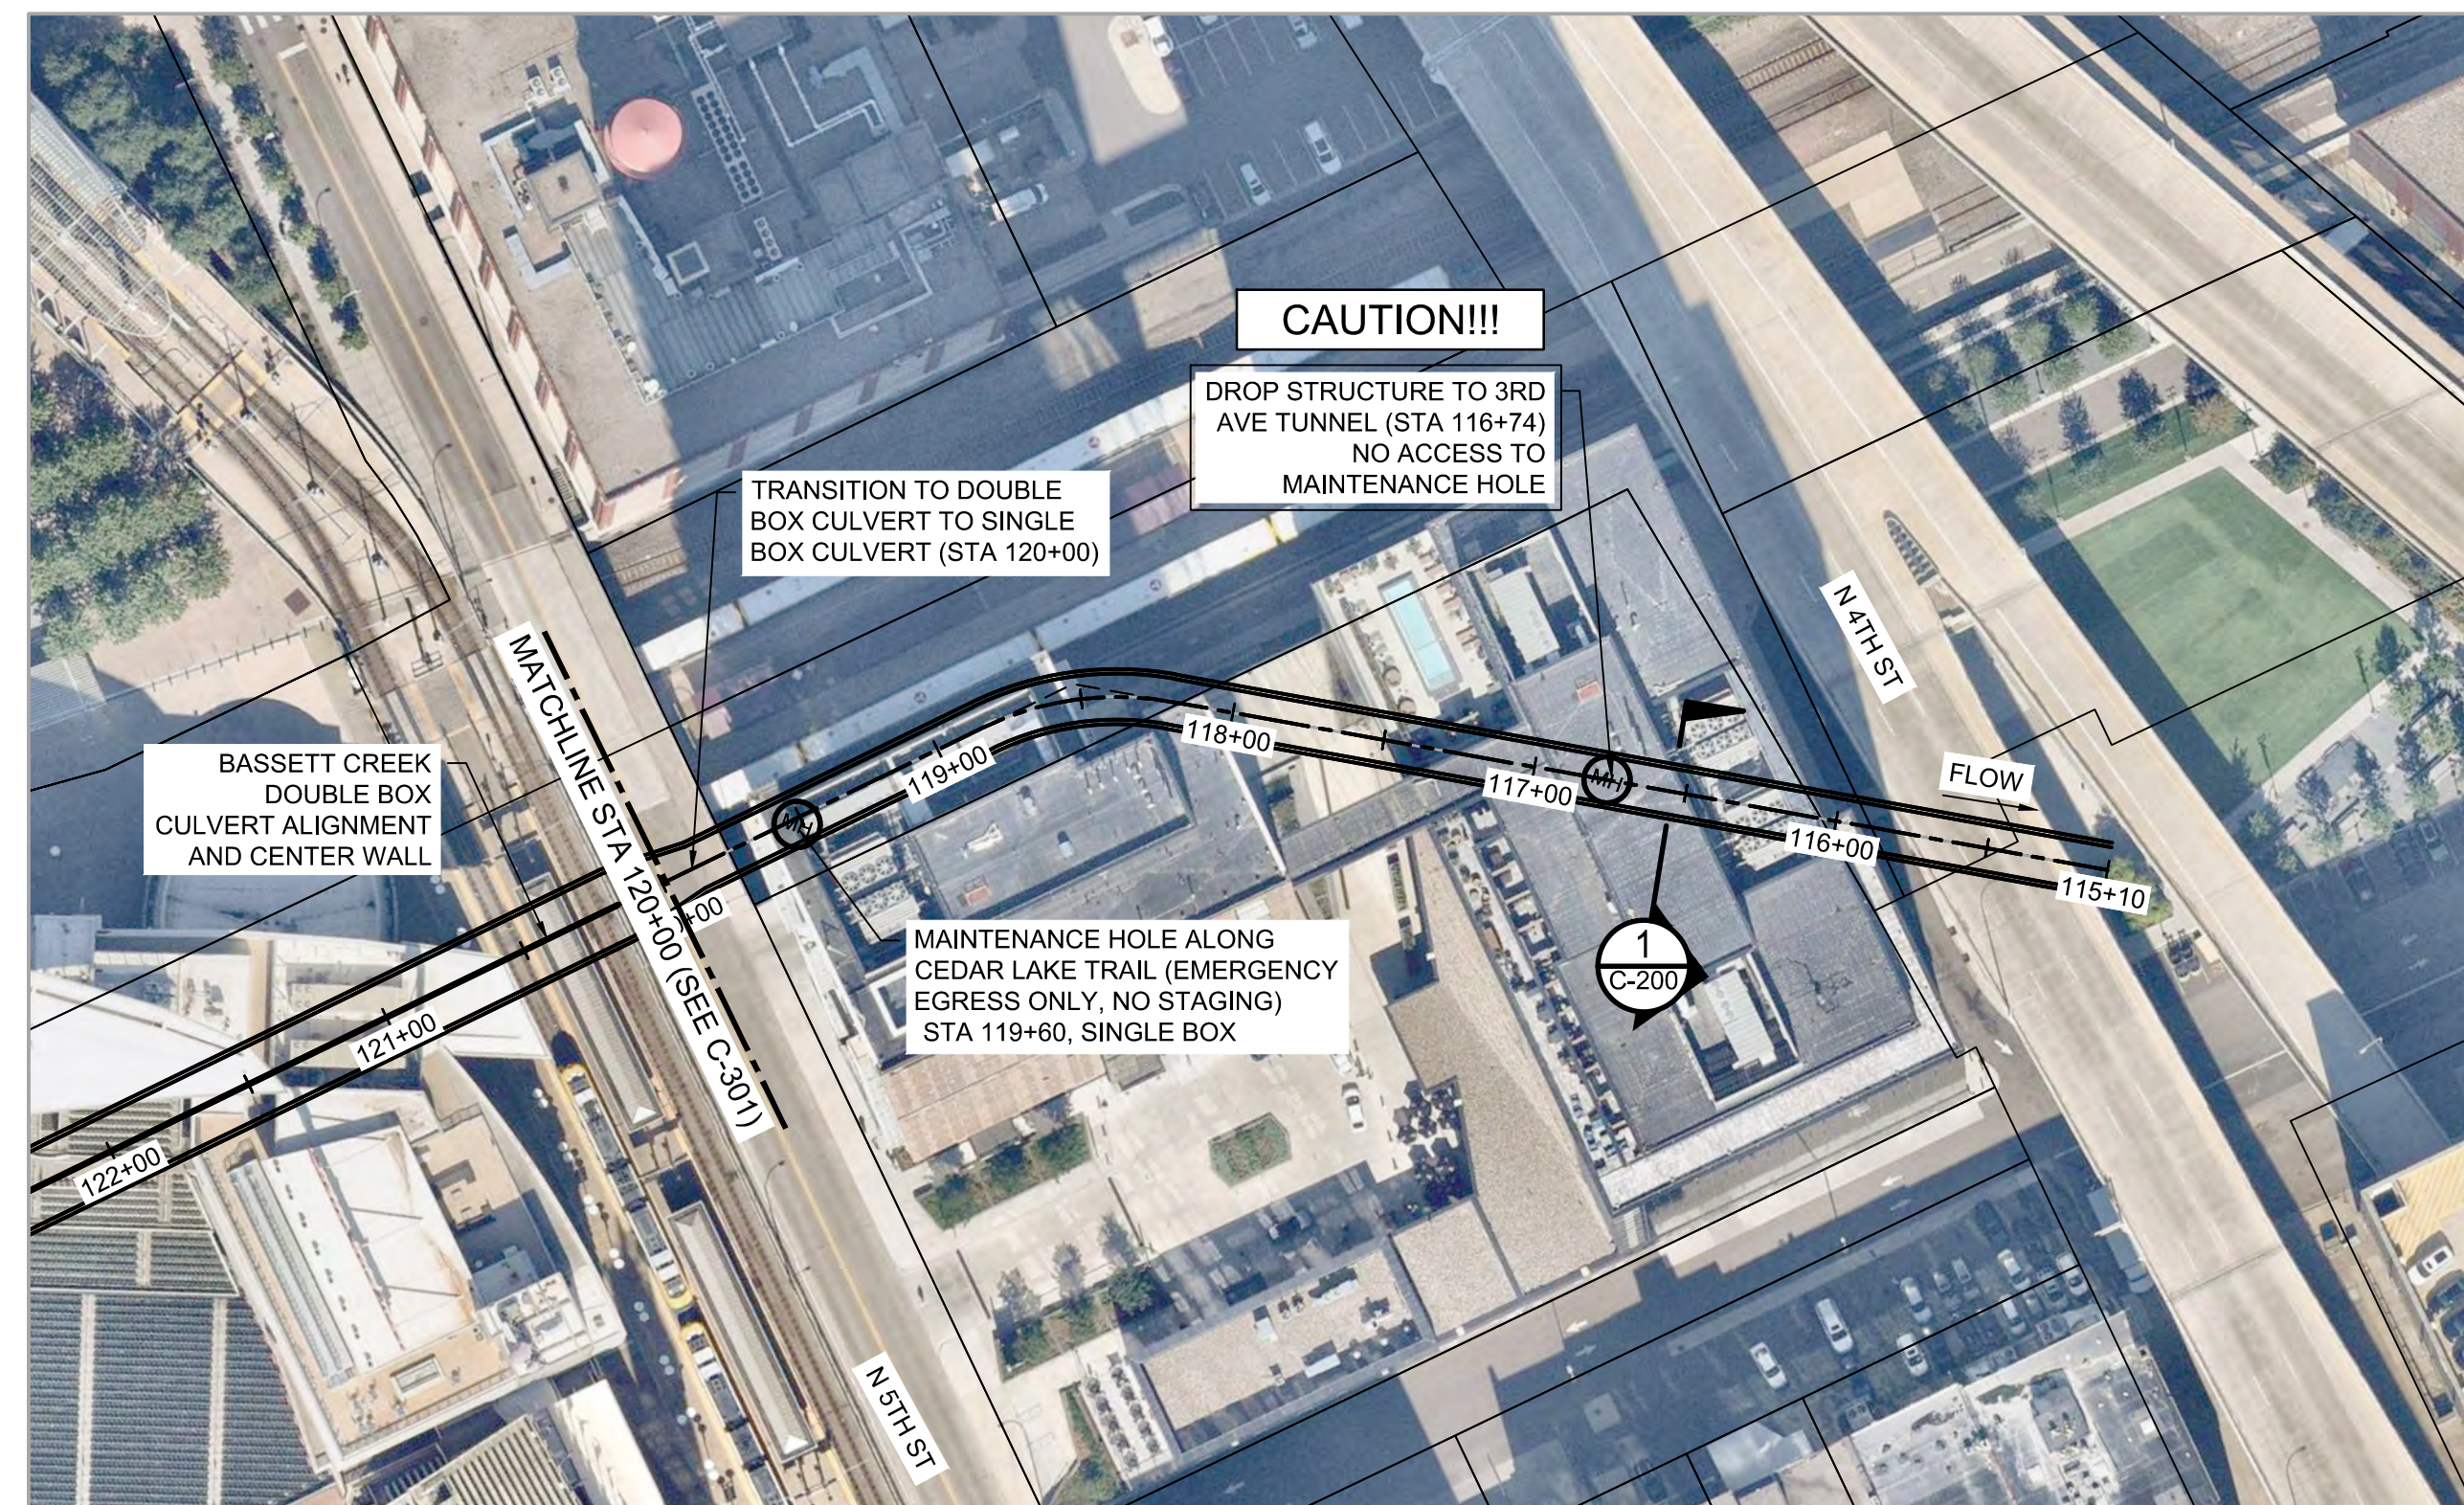
1 PLAN: STA 120+00 TO 115+10  
 SCALE IN FEET

- REFERENCES TO "LEFT" AND "RIGHT" ARE WITH RESPECT TO FACING DOWNSTREAM.
- REPAIRS SHOWN IN TABLES ARE APPROXIMATE. CONTRACTOR AND ENGINEER TO COORDINATE ON PRIORITY AND PERCENTAGE OF REPAIRS TO EXECUTE DURING CONSTRUCTION.
