# BASSETT CREEK DOUBLE BOX CULVERT REPAIRS

## BASSETT CREEK WATERSHED MANAGEMENT COMMISSION

### MINNEAPOLIS, MINNESOTA

**BASSETT CREEK DOUBLE BOX CULVERT REPAIRS**  
MINNEAPOLIS, MINNESOTA  
INDEX, LOCATION MAP, AND VICINITY MAP

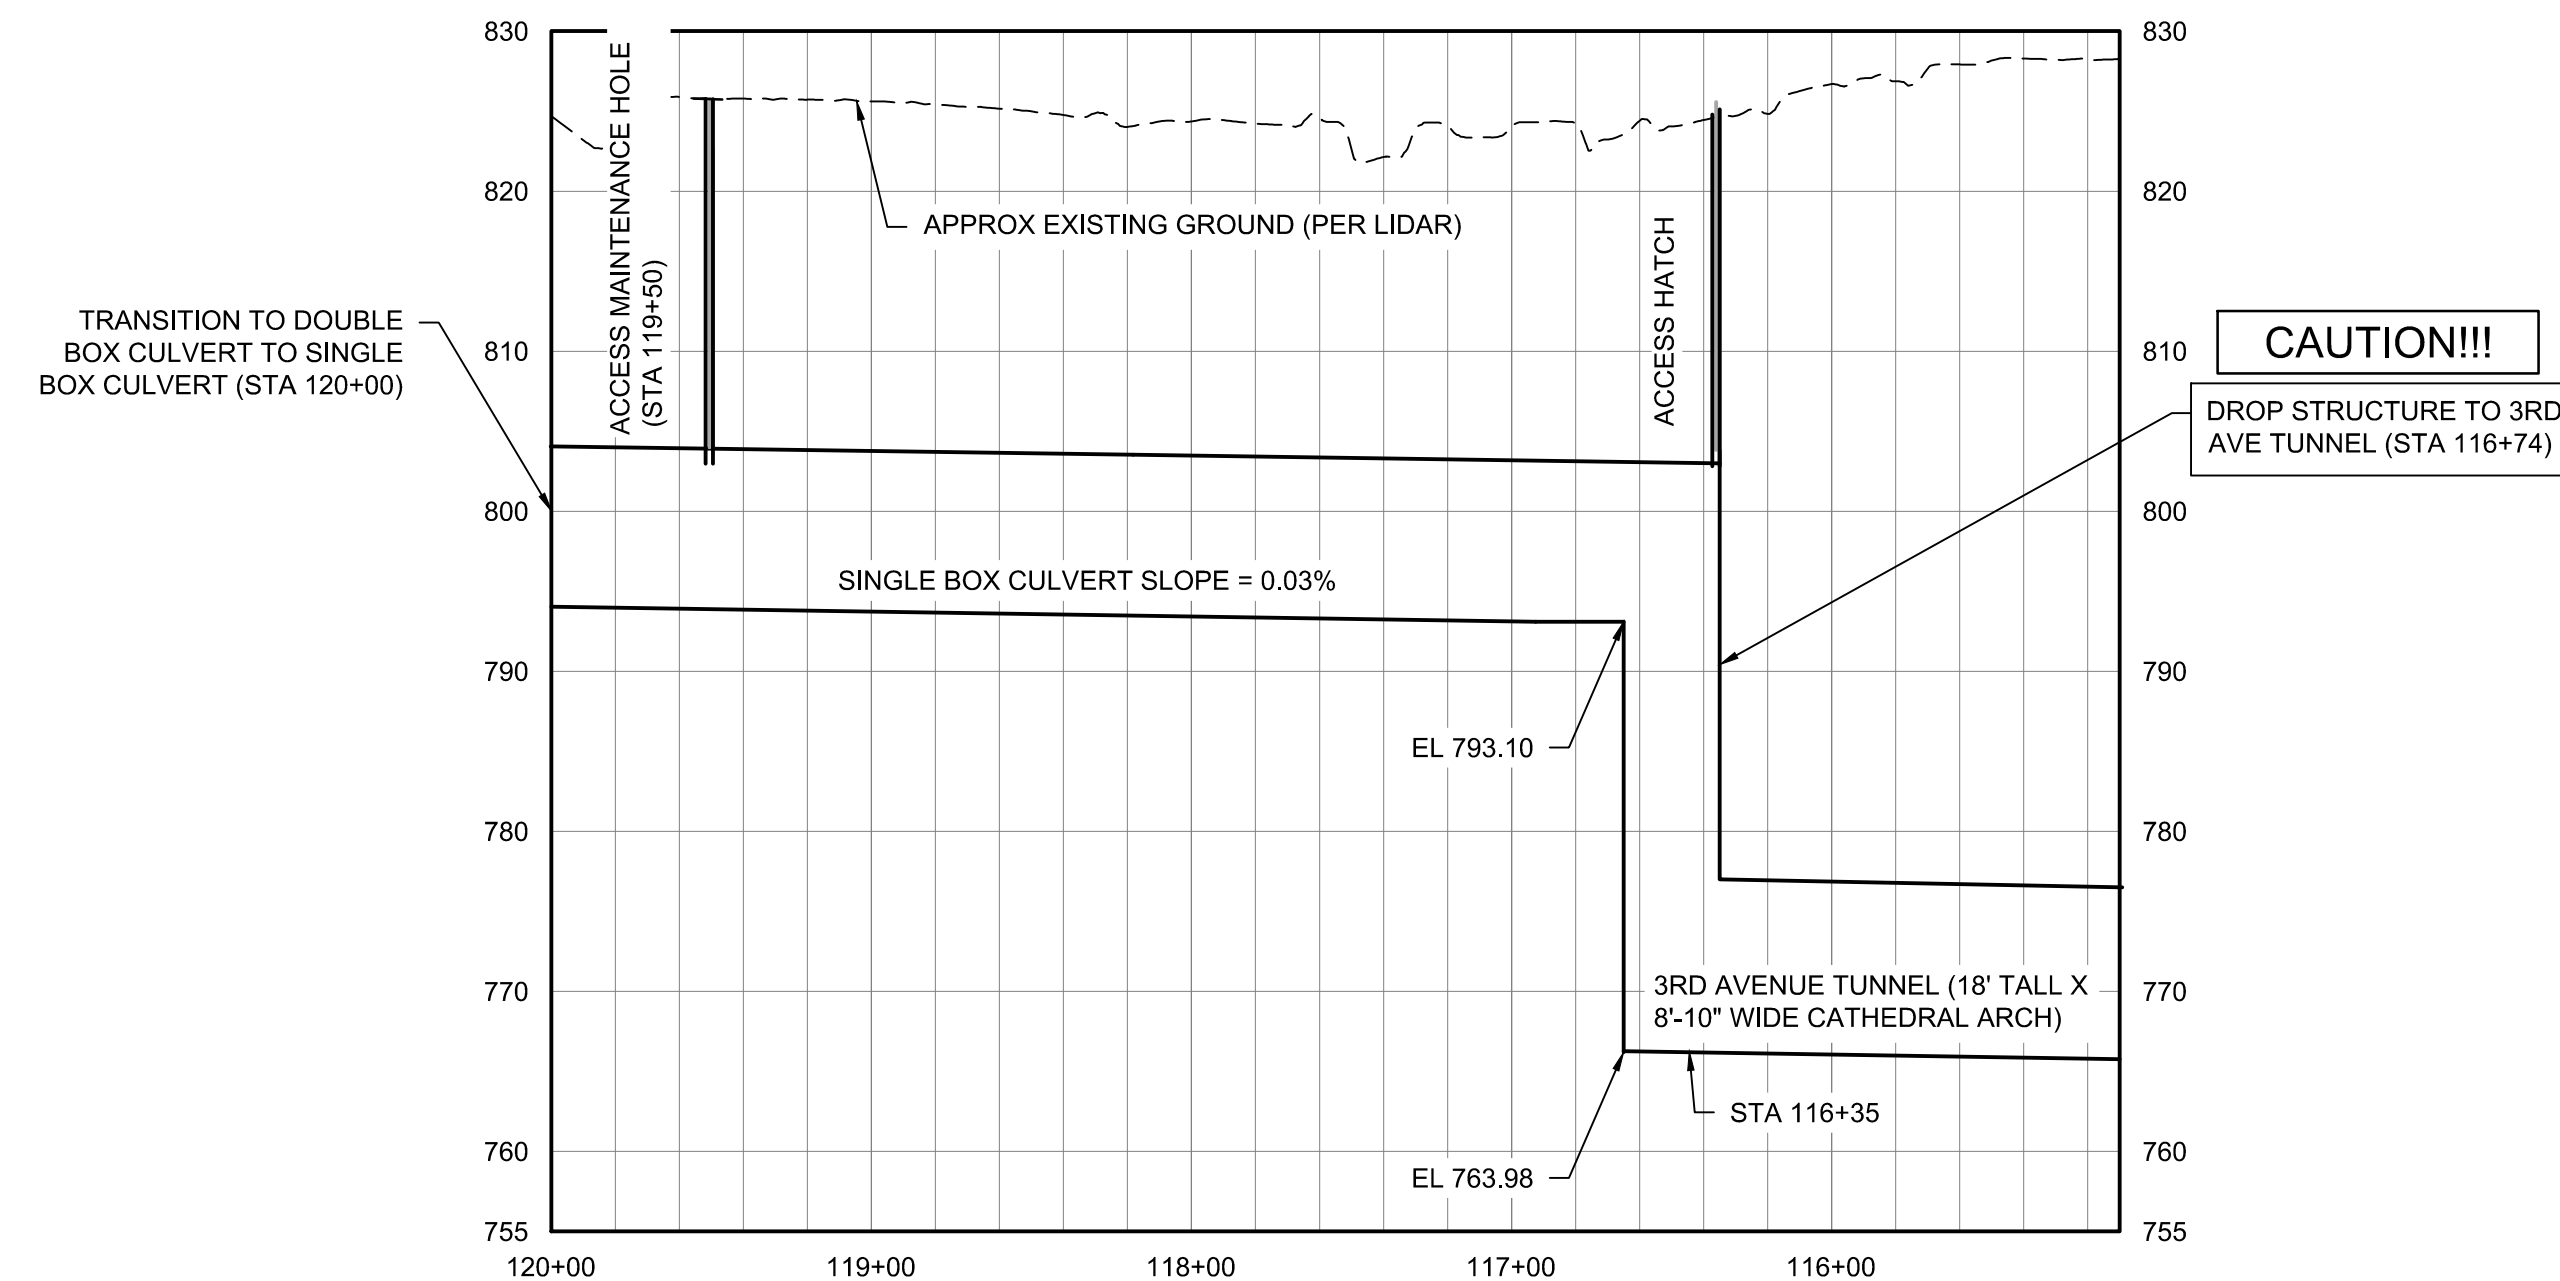
2 PROFILE: STA 120+00 TO 115+10  
 HORZ. SCALE IN FEET VERT. SCALE IN FEET

- REFERENCES TO "LEFT" AND "RIGHT" ARE WITH RESPECT TO FACING DOWNSTREAM.
- REPAIRS SHOWN IN TABLES ARE APPROXIMATE. CONTRACTOR AND ENGINEER TO COORDINATE ON PRIORITY AND PERCENTAGE OF REPAIRS TO EXECUTE DURING CONSTRUCTION.

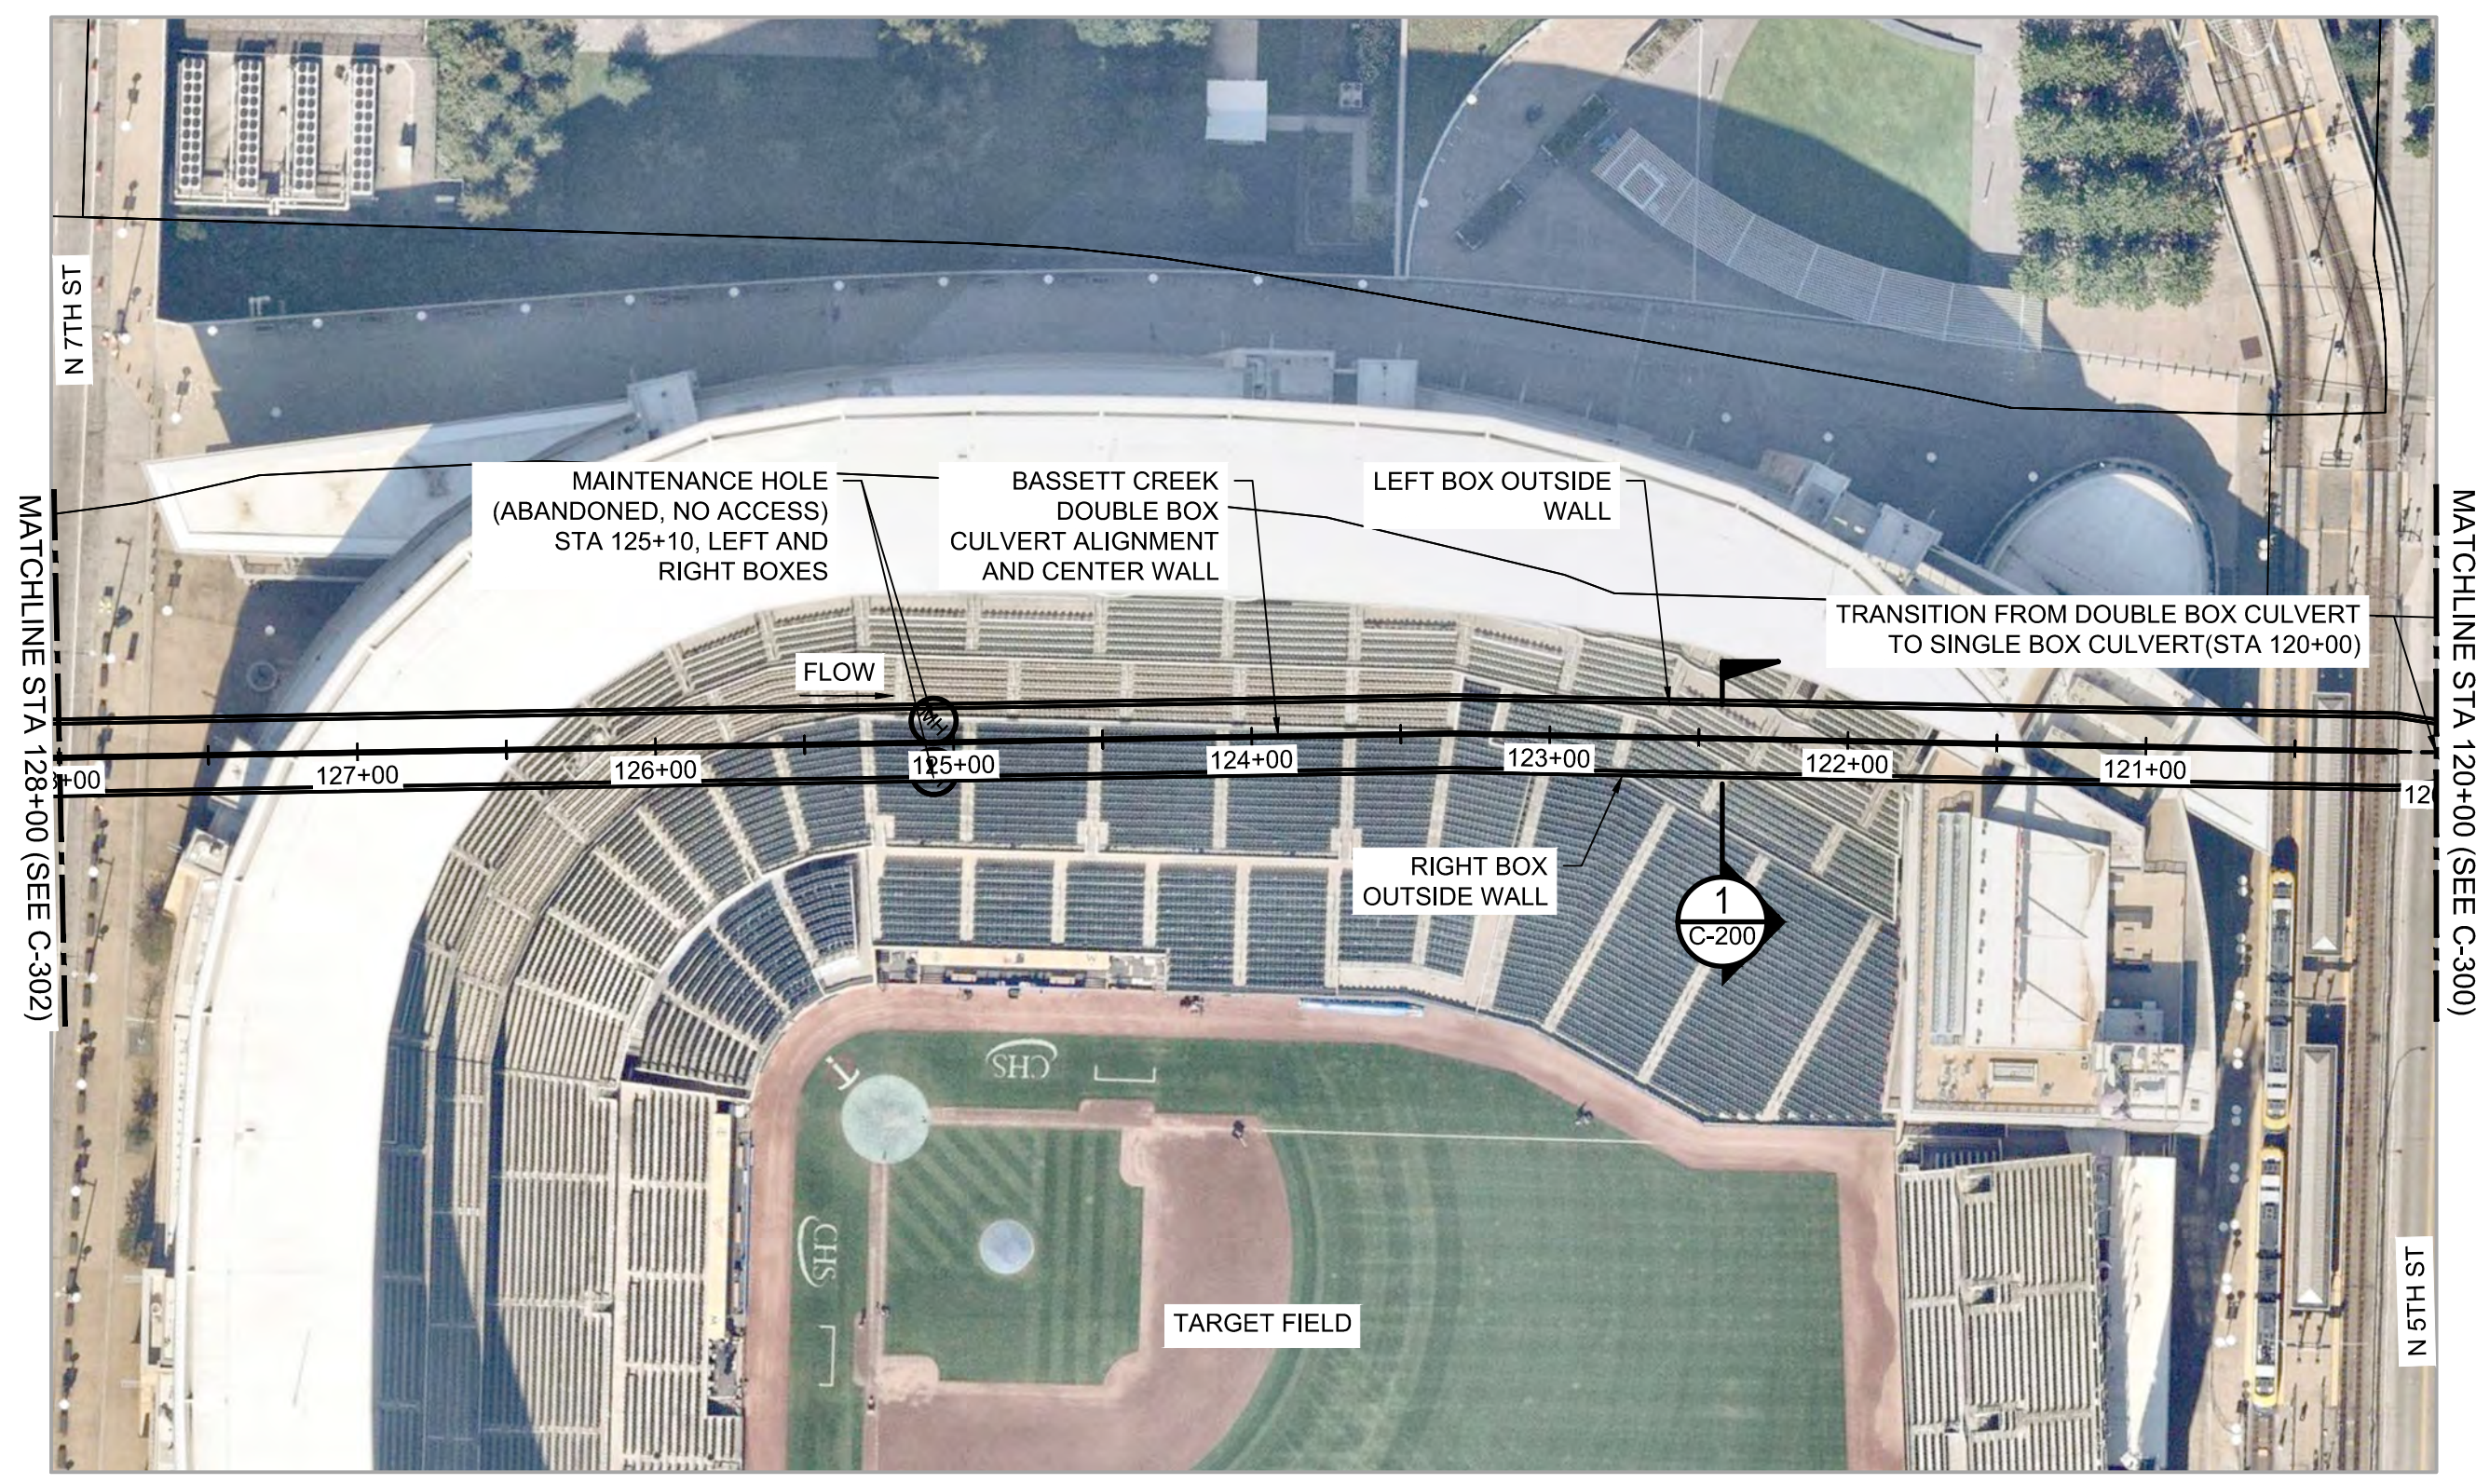
1 PLAN: STA 128+00 TO 120+00  
 0 60 120  
 SCALE IN FEET

- NOTES:
- REFERENCES TO "LEFT" AND "RIGHT" ARE WITH RESPECT TO FACING DOWNSTREAM.
  - REPAIRS SHOWN IN TABLES ARE APPROXIMATE. CONTRACTOR AND ENGINEER TO COORDINATE ON PRIORITY AND PERCENTAGE OF REPAIRS TO EXECUTE DURING CONSTRUCTION.

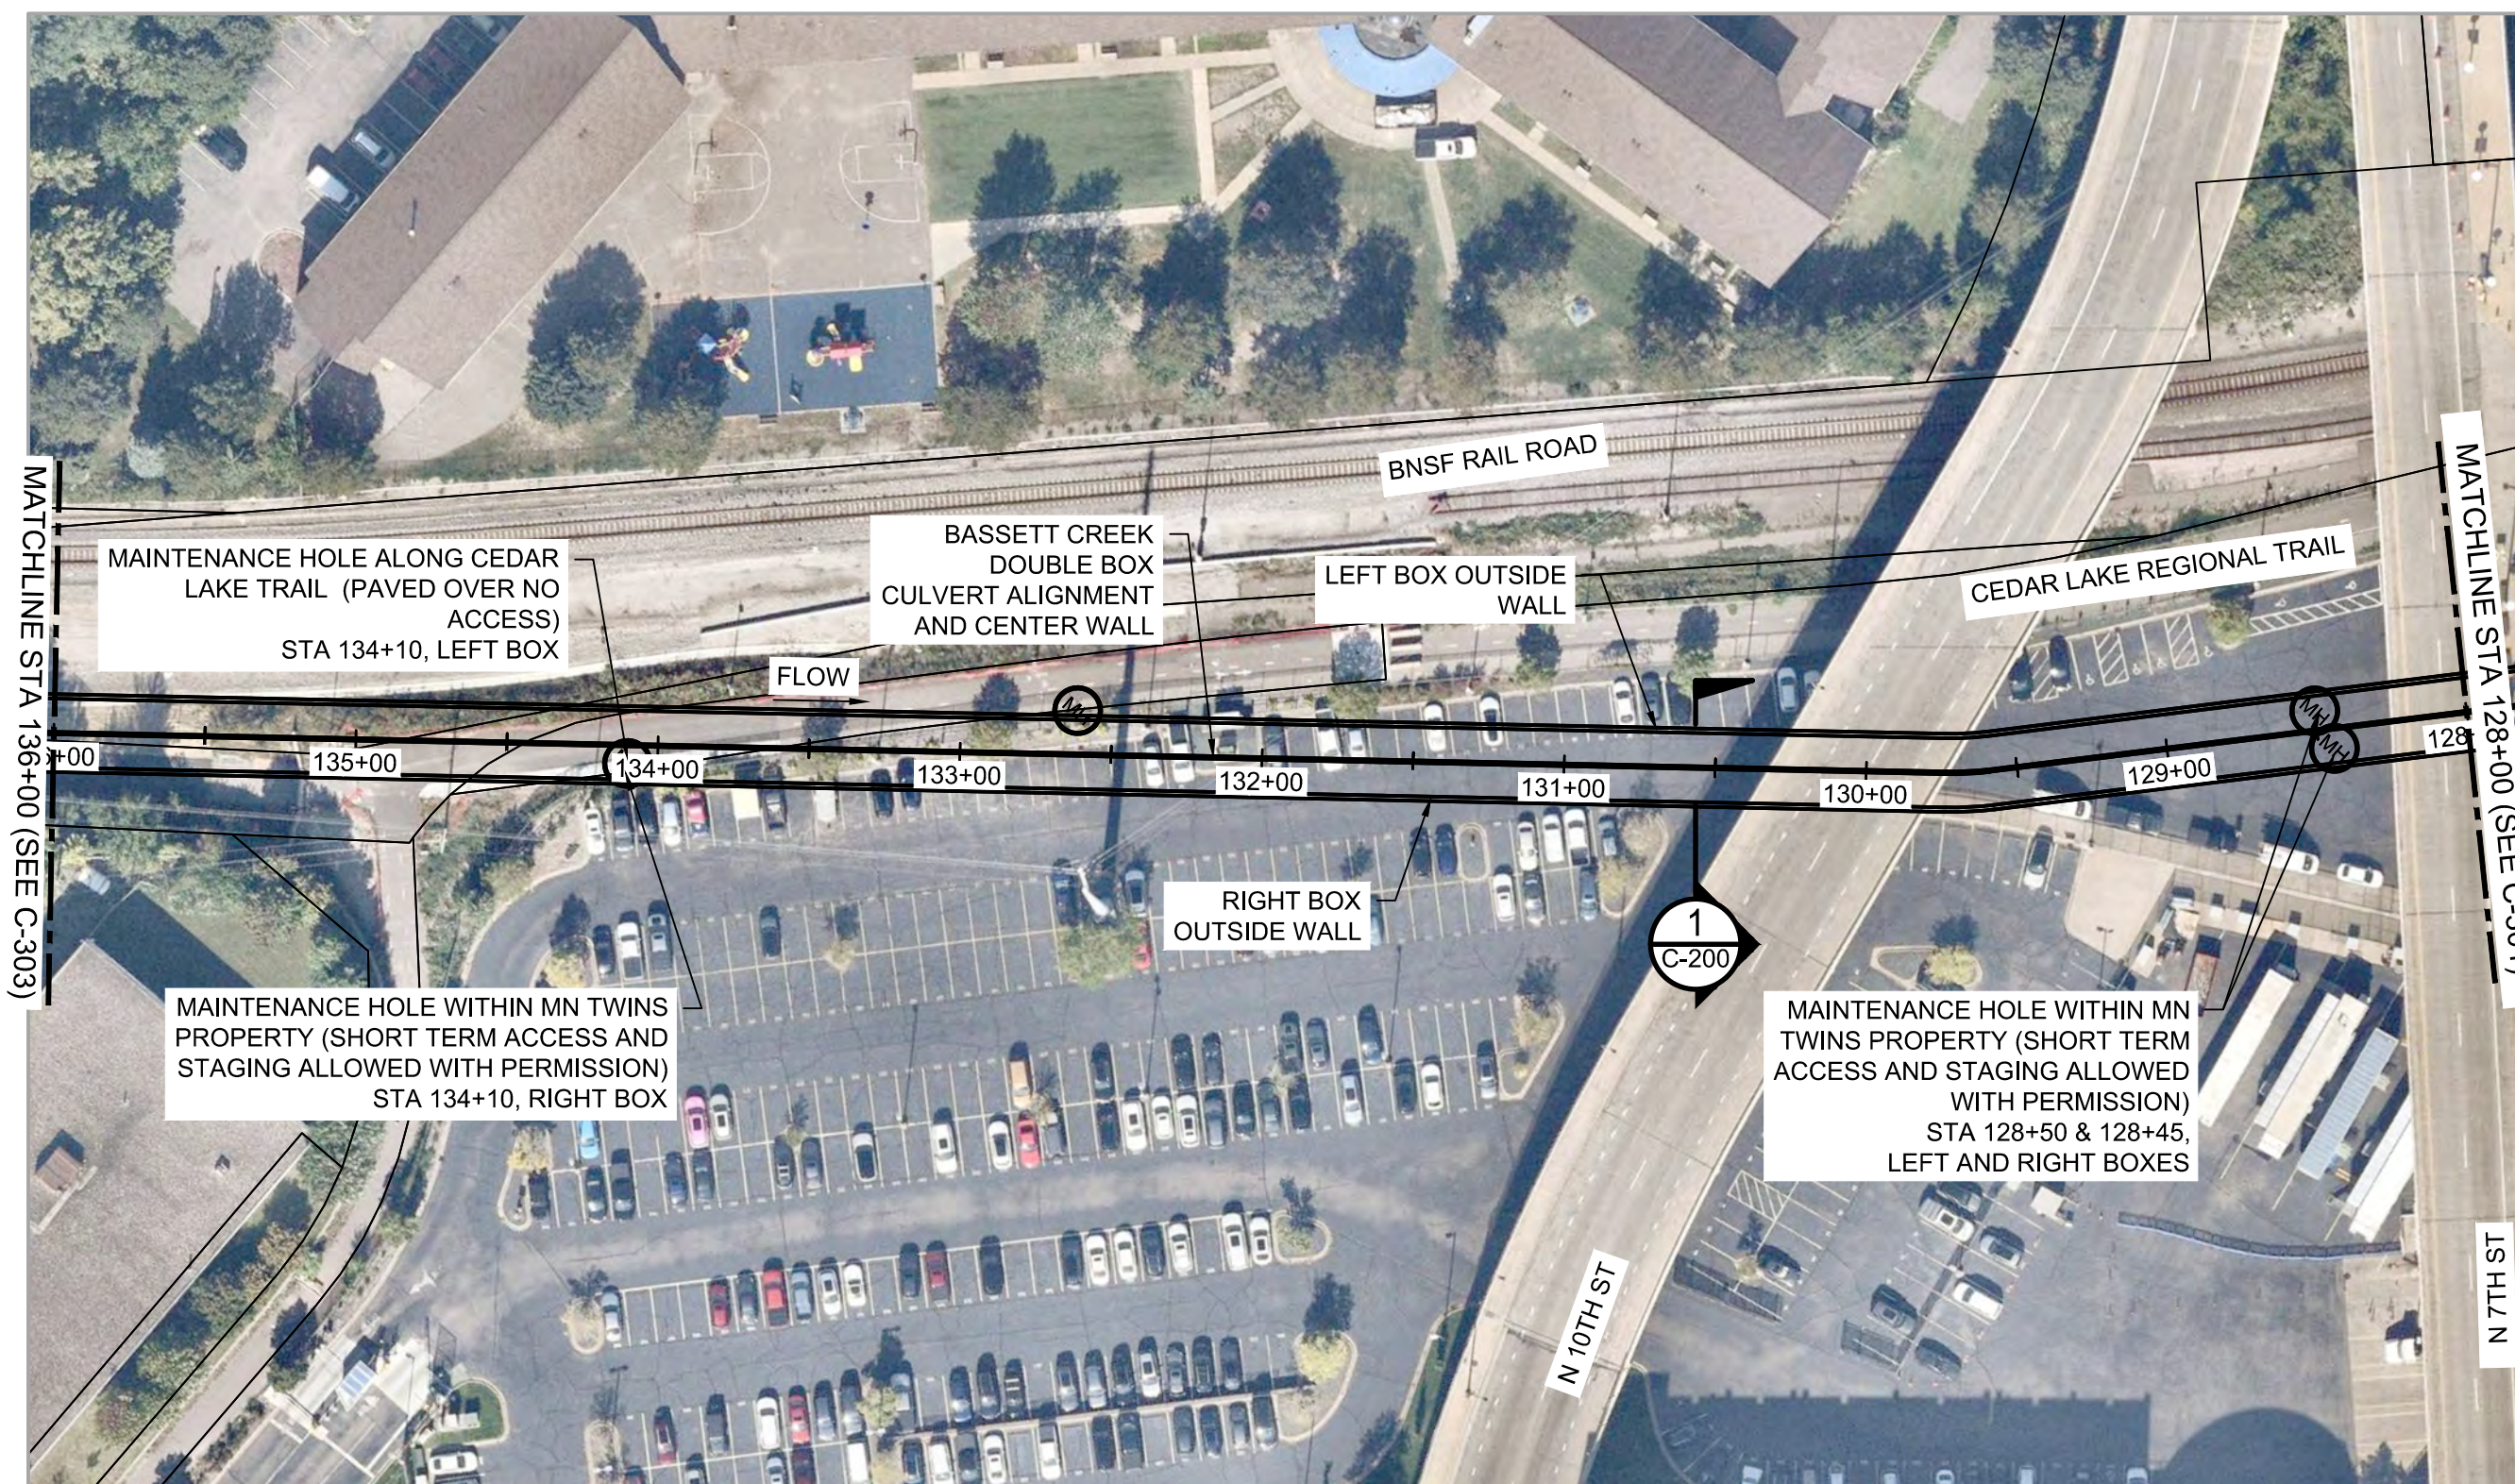
1 PLAN: STA 136+00 TO 128+00  
SCALE IN FEET

- REFERENCES TO "LEFT" AND "RIGHT" ARE WITH RESPECT TO FACING DOWNSTREAM.
- REPAIRS SHOWN IN TABLES ARE APPROXIMATE. CONTRACTOR AND ENGINEER TO COORDINATE ON PRIORITY AND PERCENTAGE OF REPAIRS TO EXECUTE DURING CONSTRUCTION.

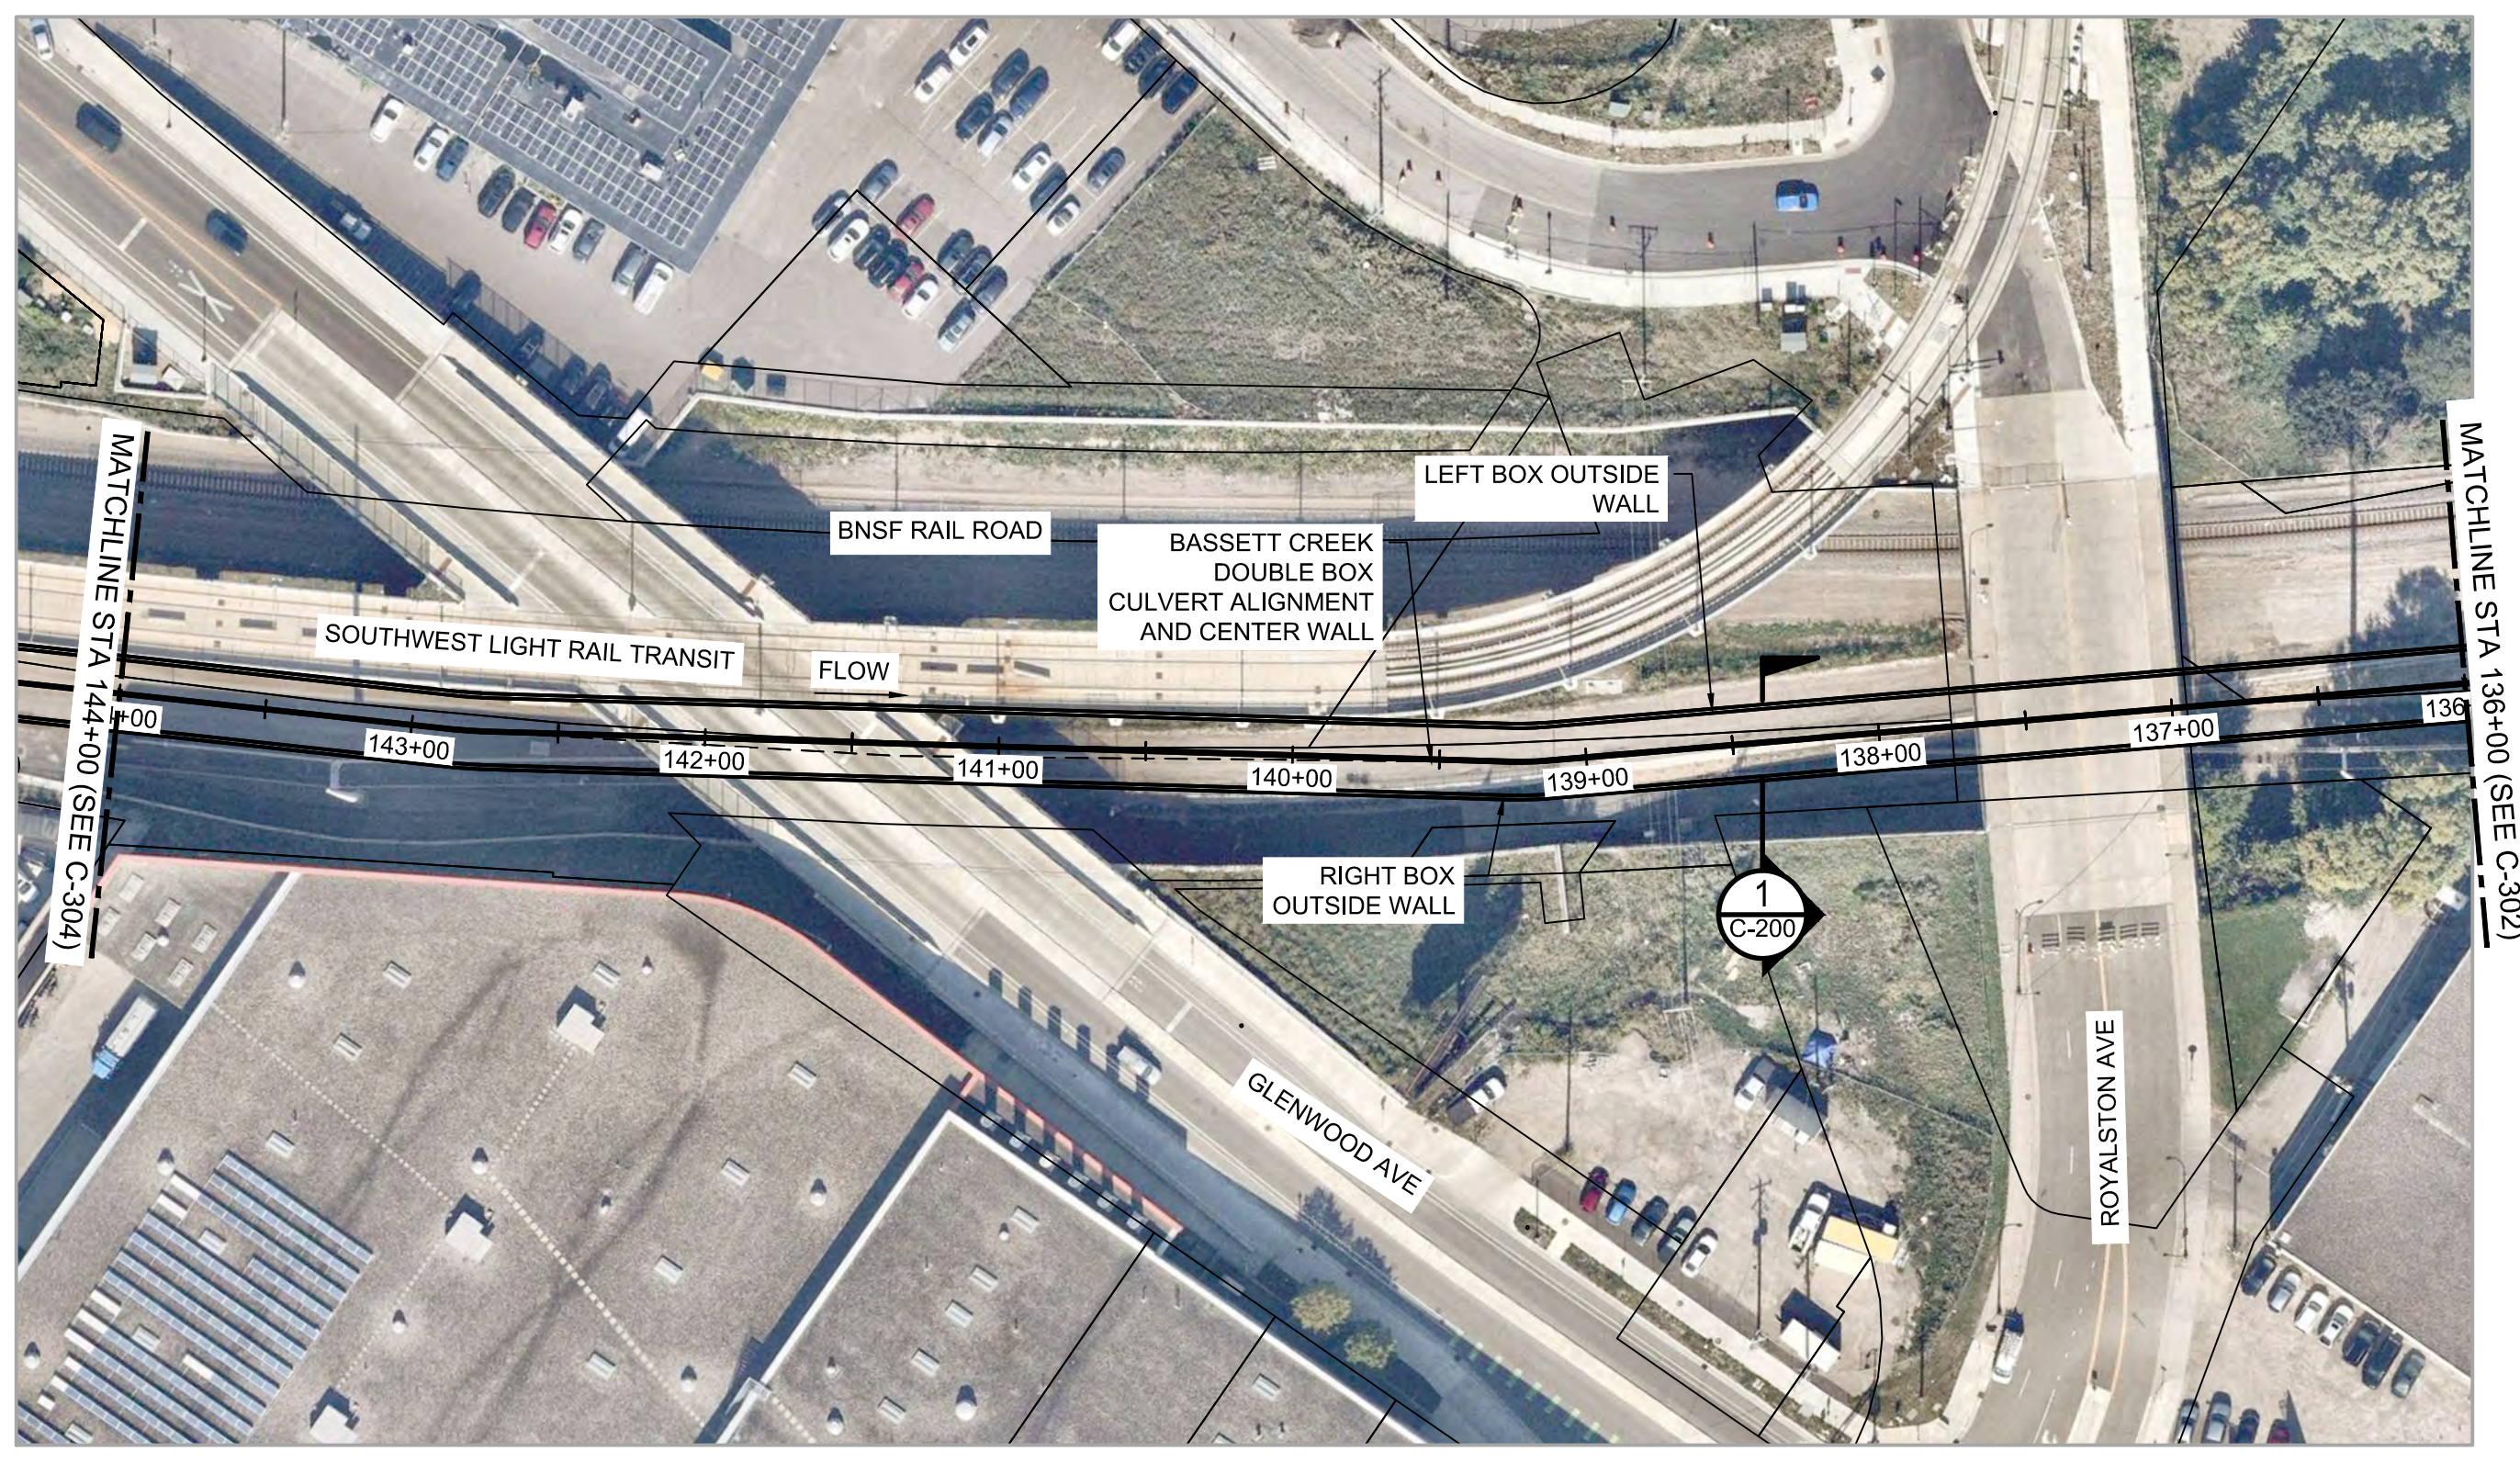
1 PLAN: STA 144+00 TO 136+00  
 SCALE IN FEET

- NOTES:
- REFERENCES TO "LEFT" AND "RIGHT" ARE WITH RESPECT TO FACING DOWNSTREAM.
  - REPAIRS SHOWN IN TABLES ARE APPROXIMATE. CONTRACTOR AND ENGINEER TO COORDINATE ON PRIORITY AND PERCENTAGE OF REPAIRS TO EXECUTE DURING CONSTRUCTION.

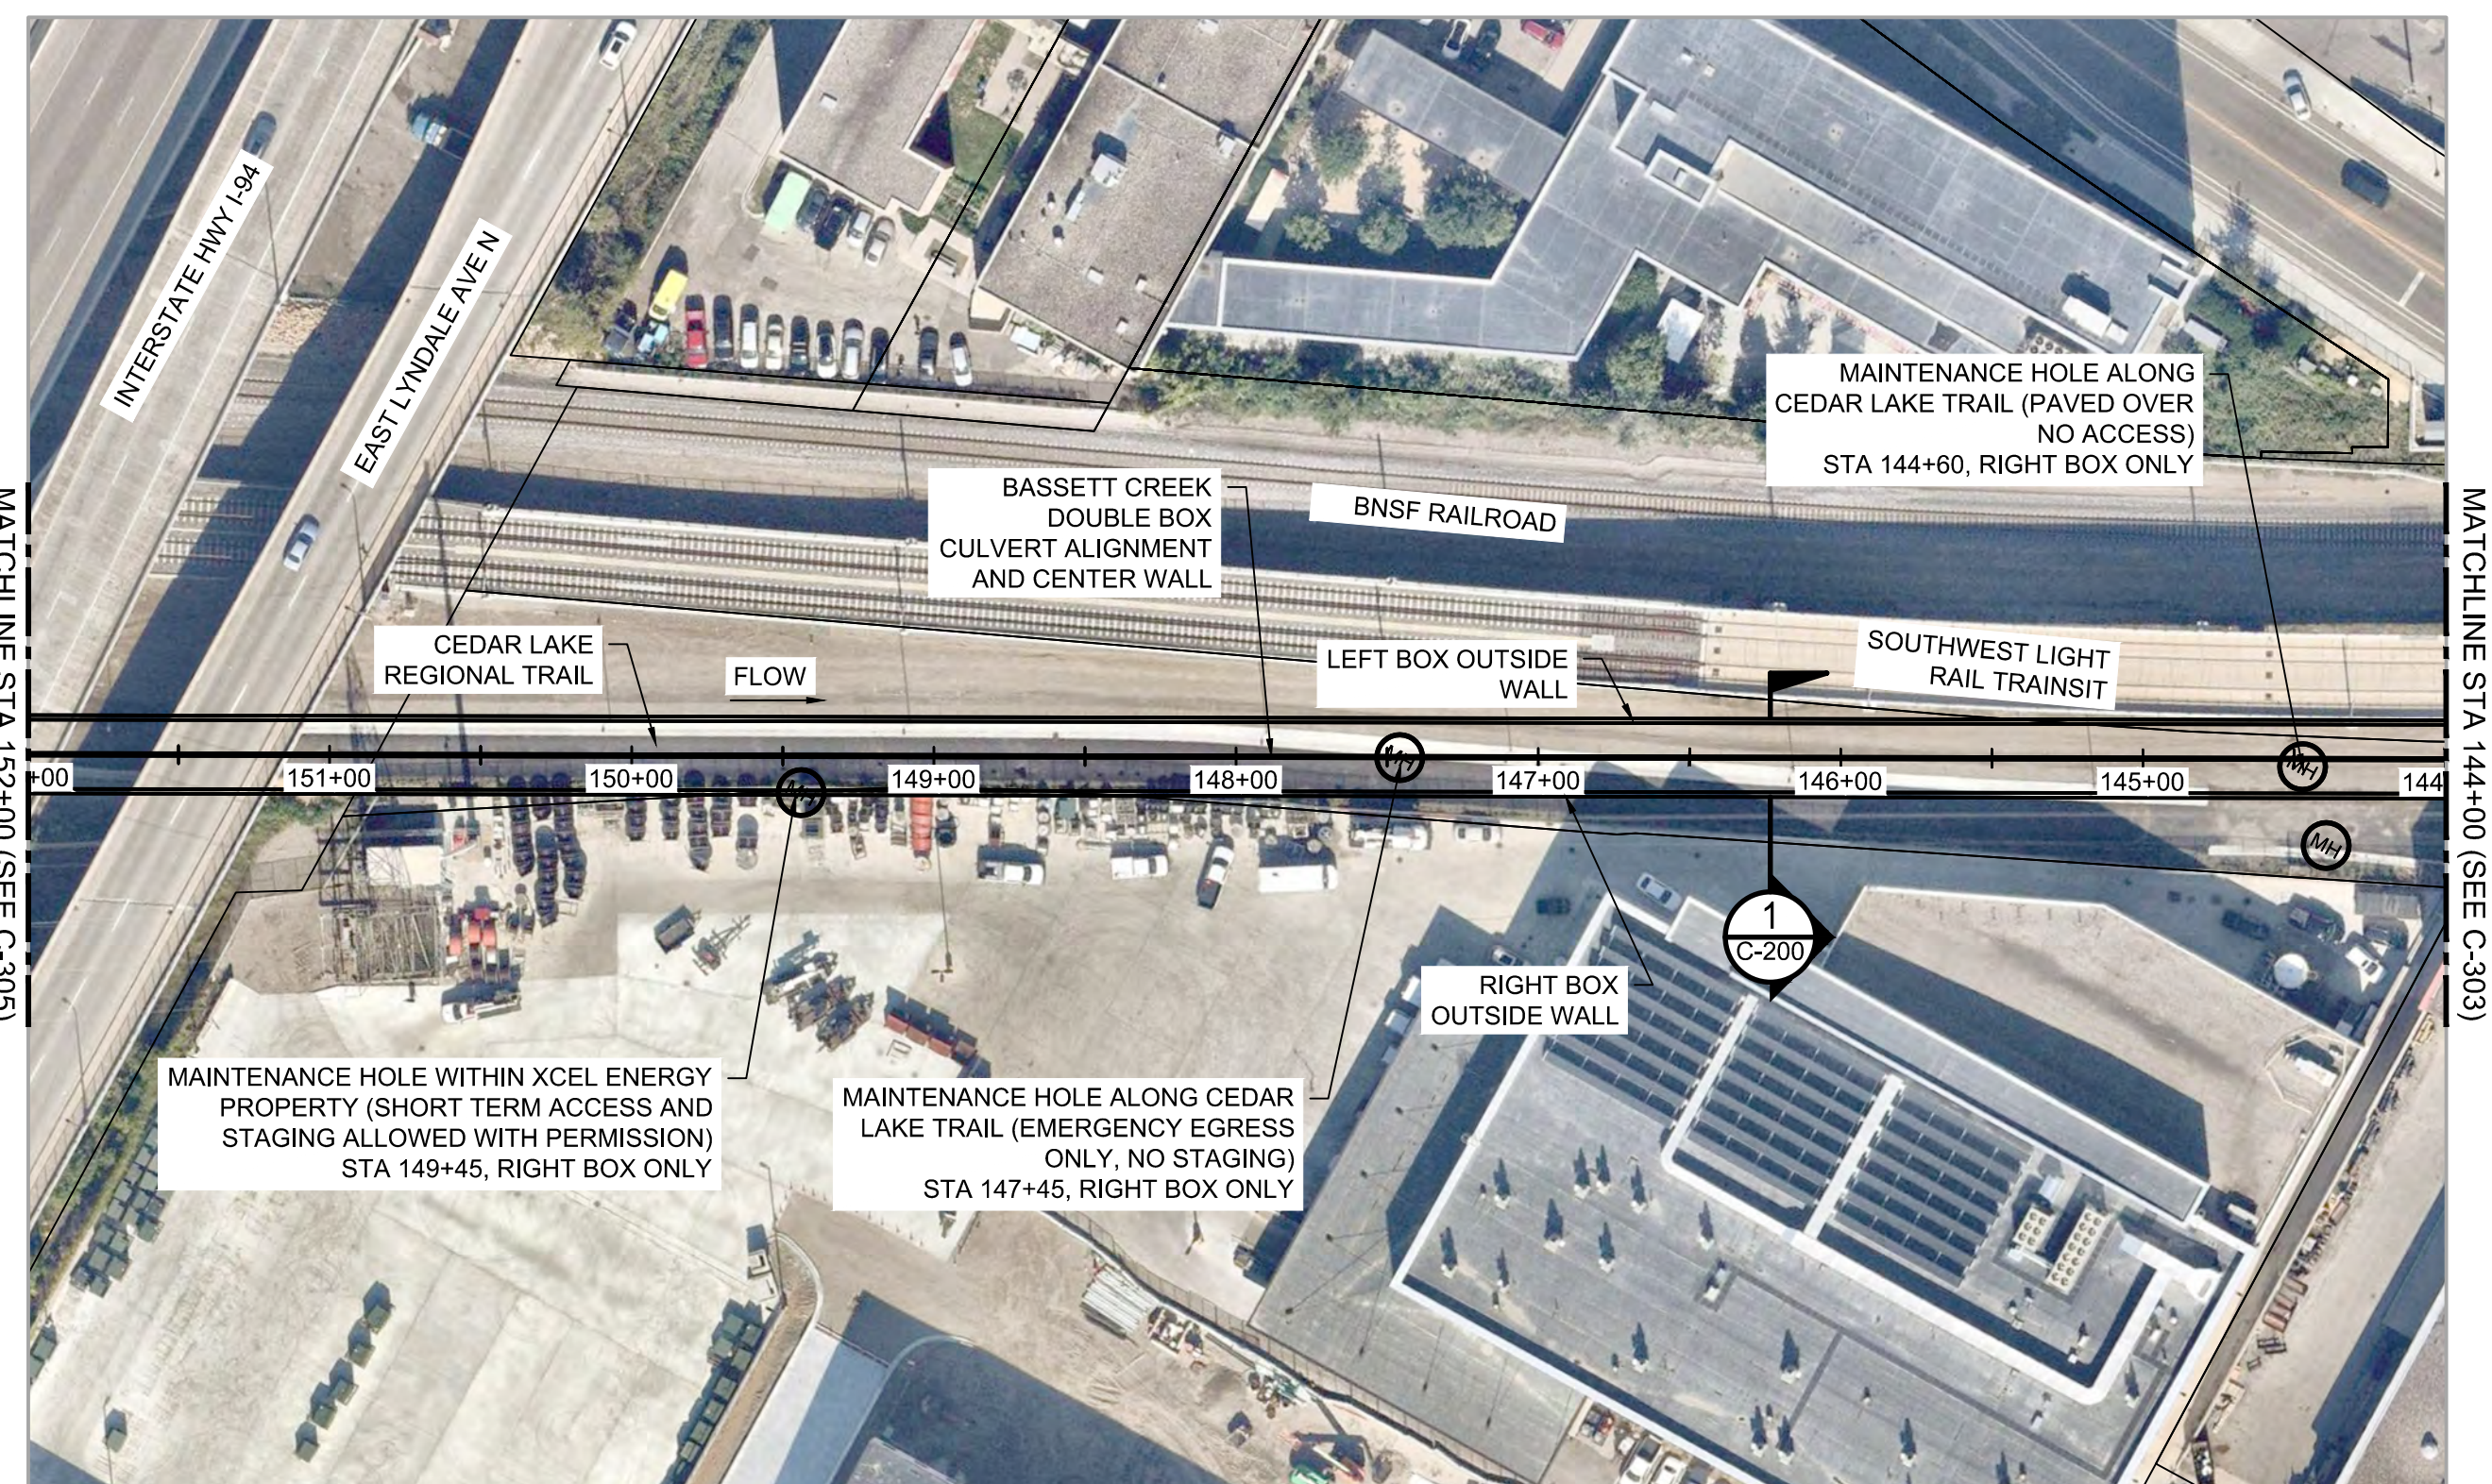
1 PLAN: STA 152+00 TO 144+00  
 SCALE IN FEET

- REFERENCES TO "LEFT" AND "RIGHT" ARE WITH RESPECT TO FACING DOWNSTREAM.
- REPAIRS SHOWN IN TABLES ARE APPROXIMATE. CONTRACTOR AND ENGINEER TO COORDINATE ON PRIORITY AND PERCENTAGE OF REPAIRS TO EXECUTE DURING CONSTRUCTION.

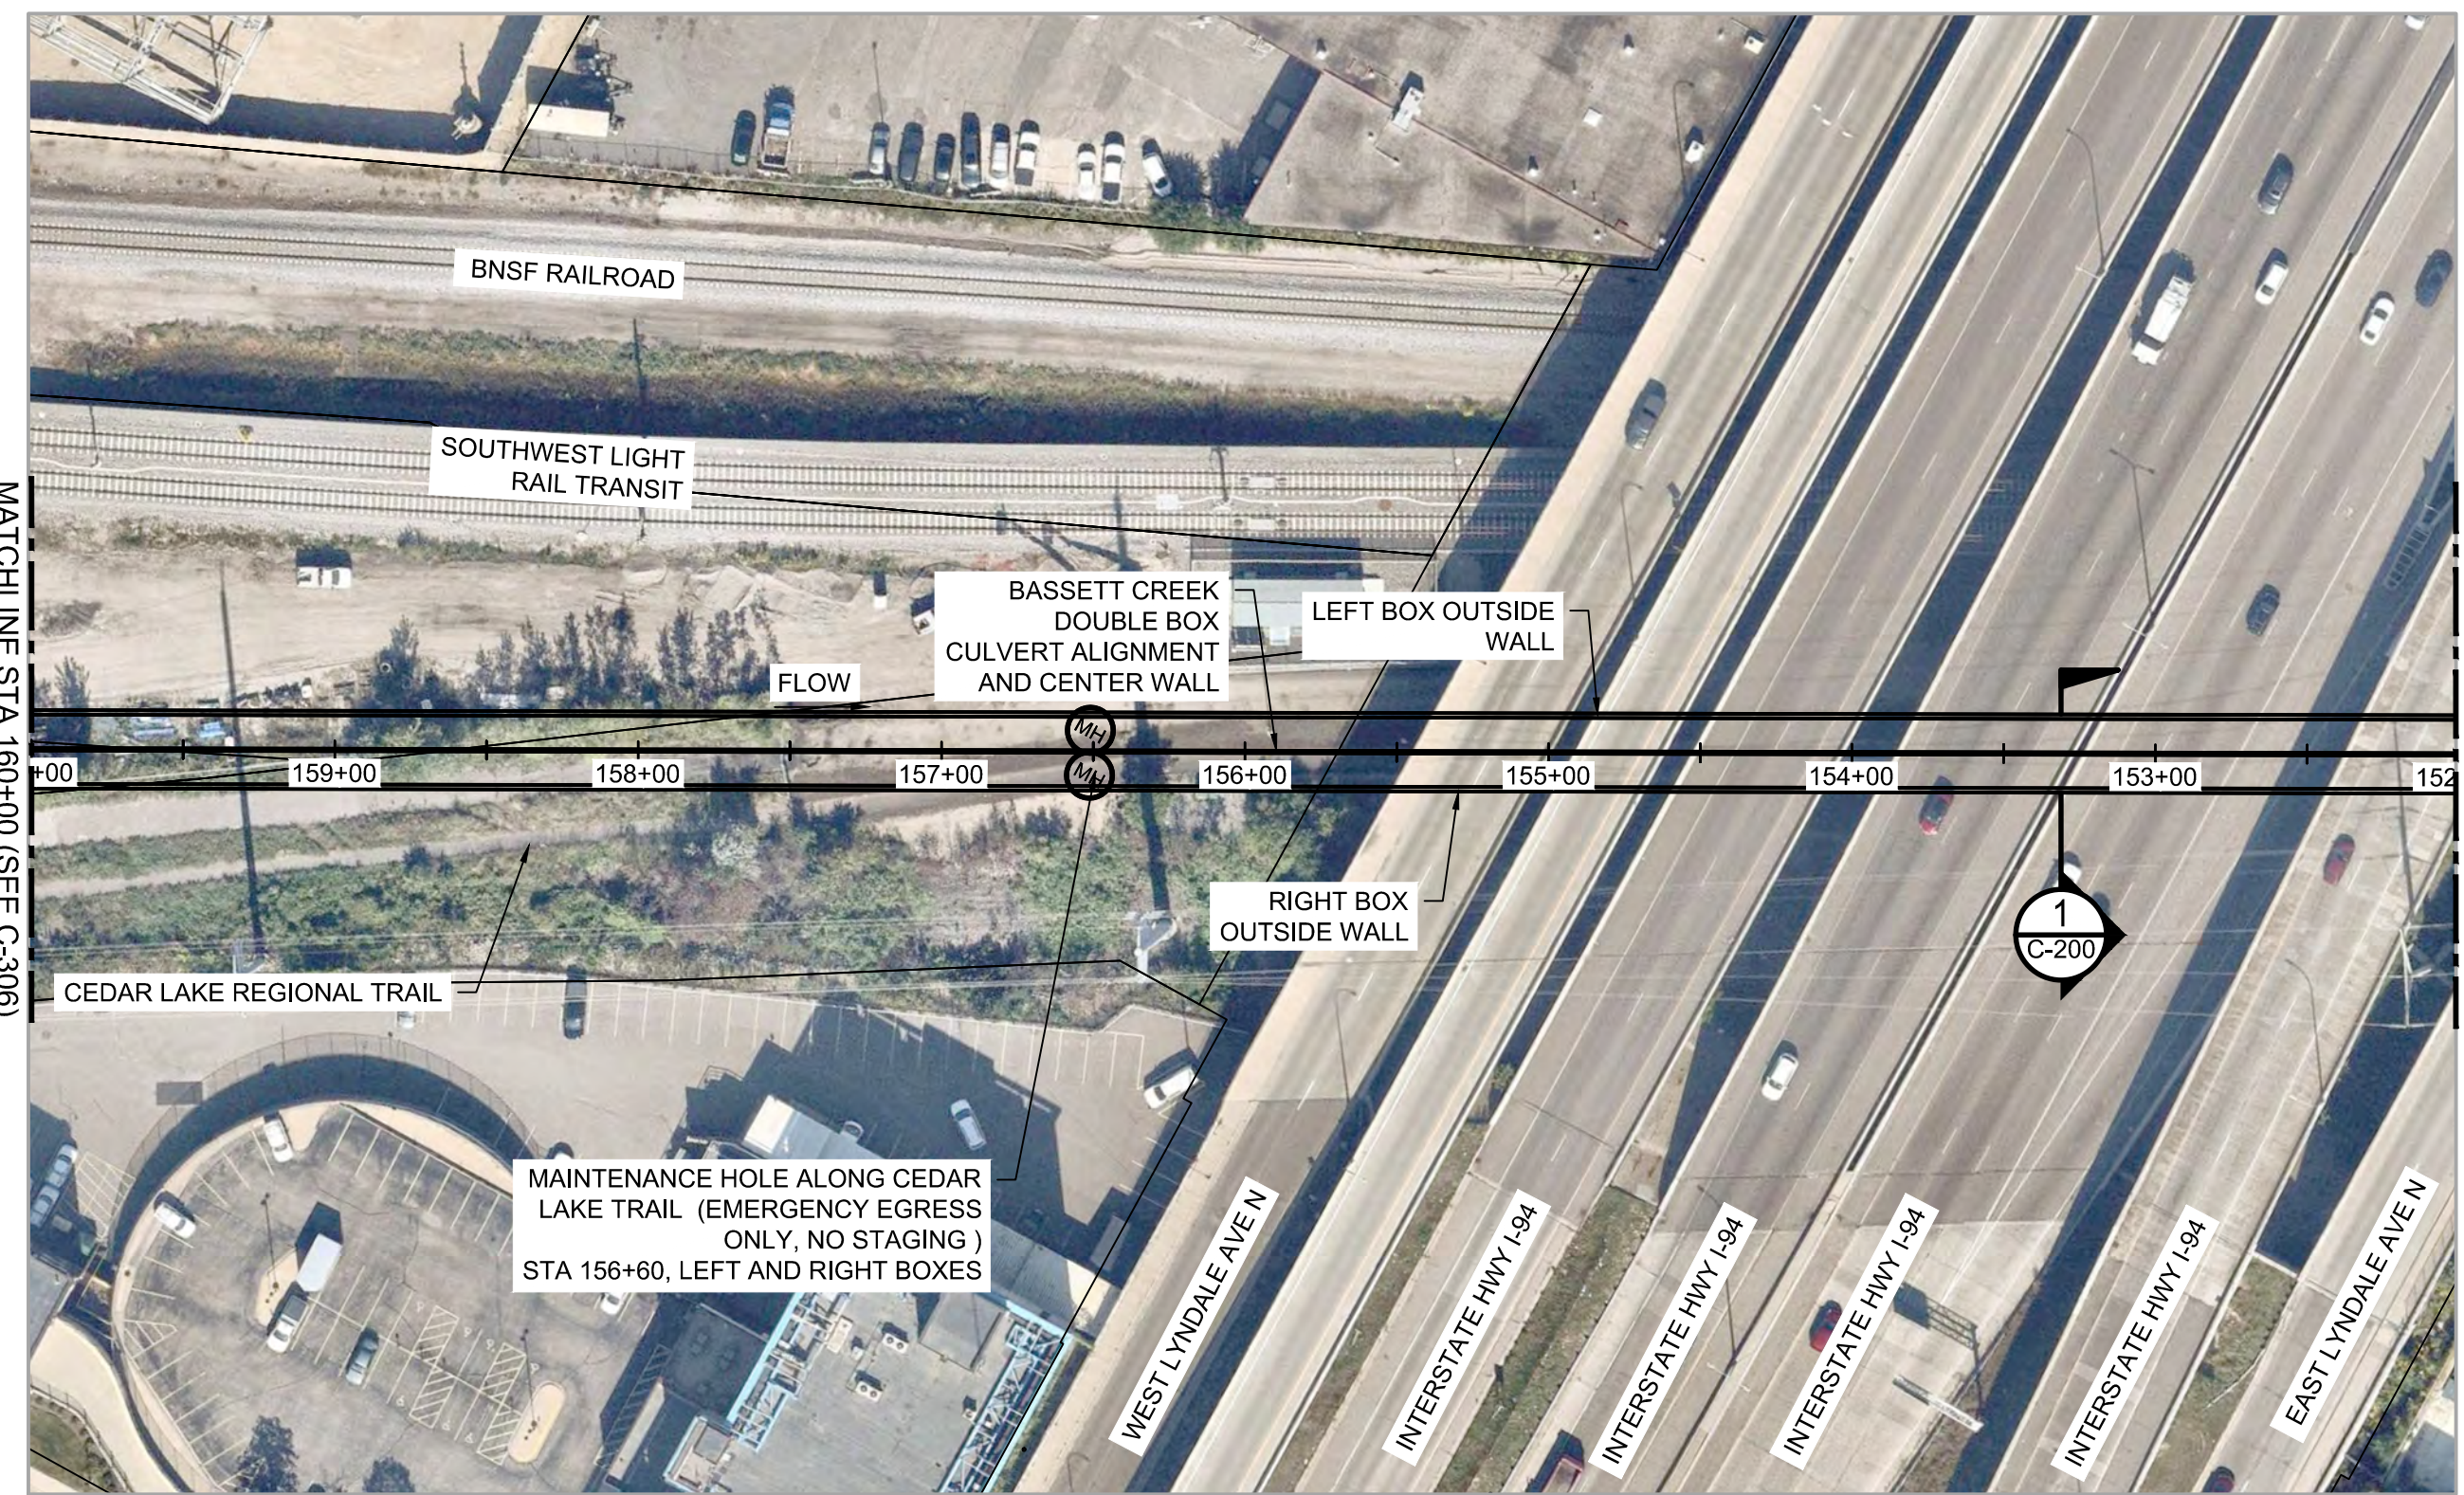
1 PLAN: STA 160+00 TO 152+00  
SCALE IN FEET

- REFERENCES TO "LEFT" AND "RIGHT" ARE WITH RESPECT TO FACING DOWNSTREAM.
- REPAIRS SHOWN IN TABLES ARE APPROXIMATE. CONTRACTOR AND ENGINEER TO COORDINATE ON PRIORITY AND PERCENTAGE OF REPAIRS TO EXECUTE DURING CONSTRUCTION.
