# BASSETT CREEK DOUBLE BOX CULVERT REPAIRS

## BASSETT CREEK WATERSHED MANAGEMENT COMMISSION

### MINNEAPOLIS, MINNESOTA

**BASSETT CREEK DOUBLE BOX CULVERT REPAIRS**  
MINNEAPOLIS, MINNESOTA  
INDEX, LOCATION MAP, AND VICINITY MAP

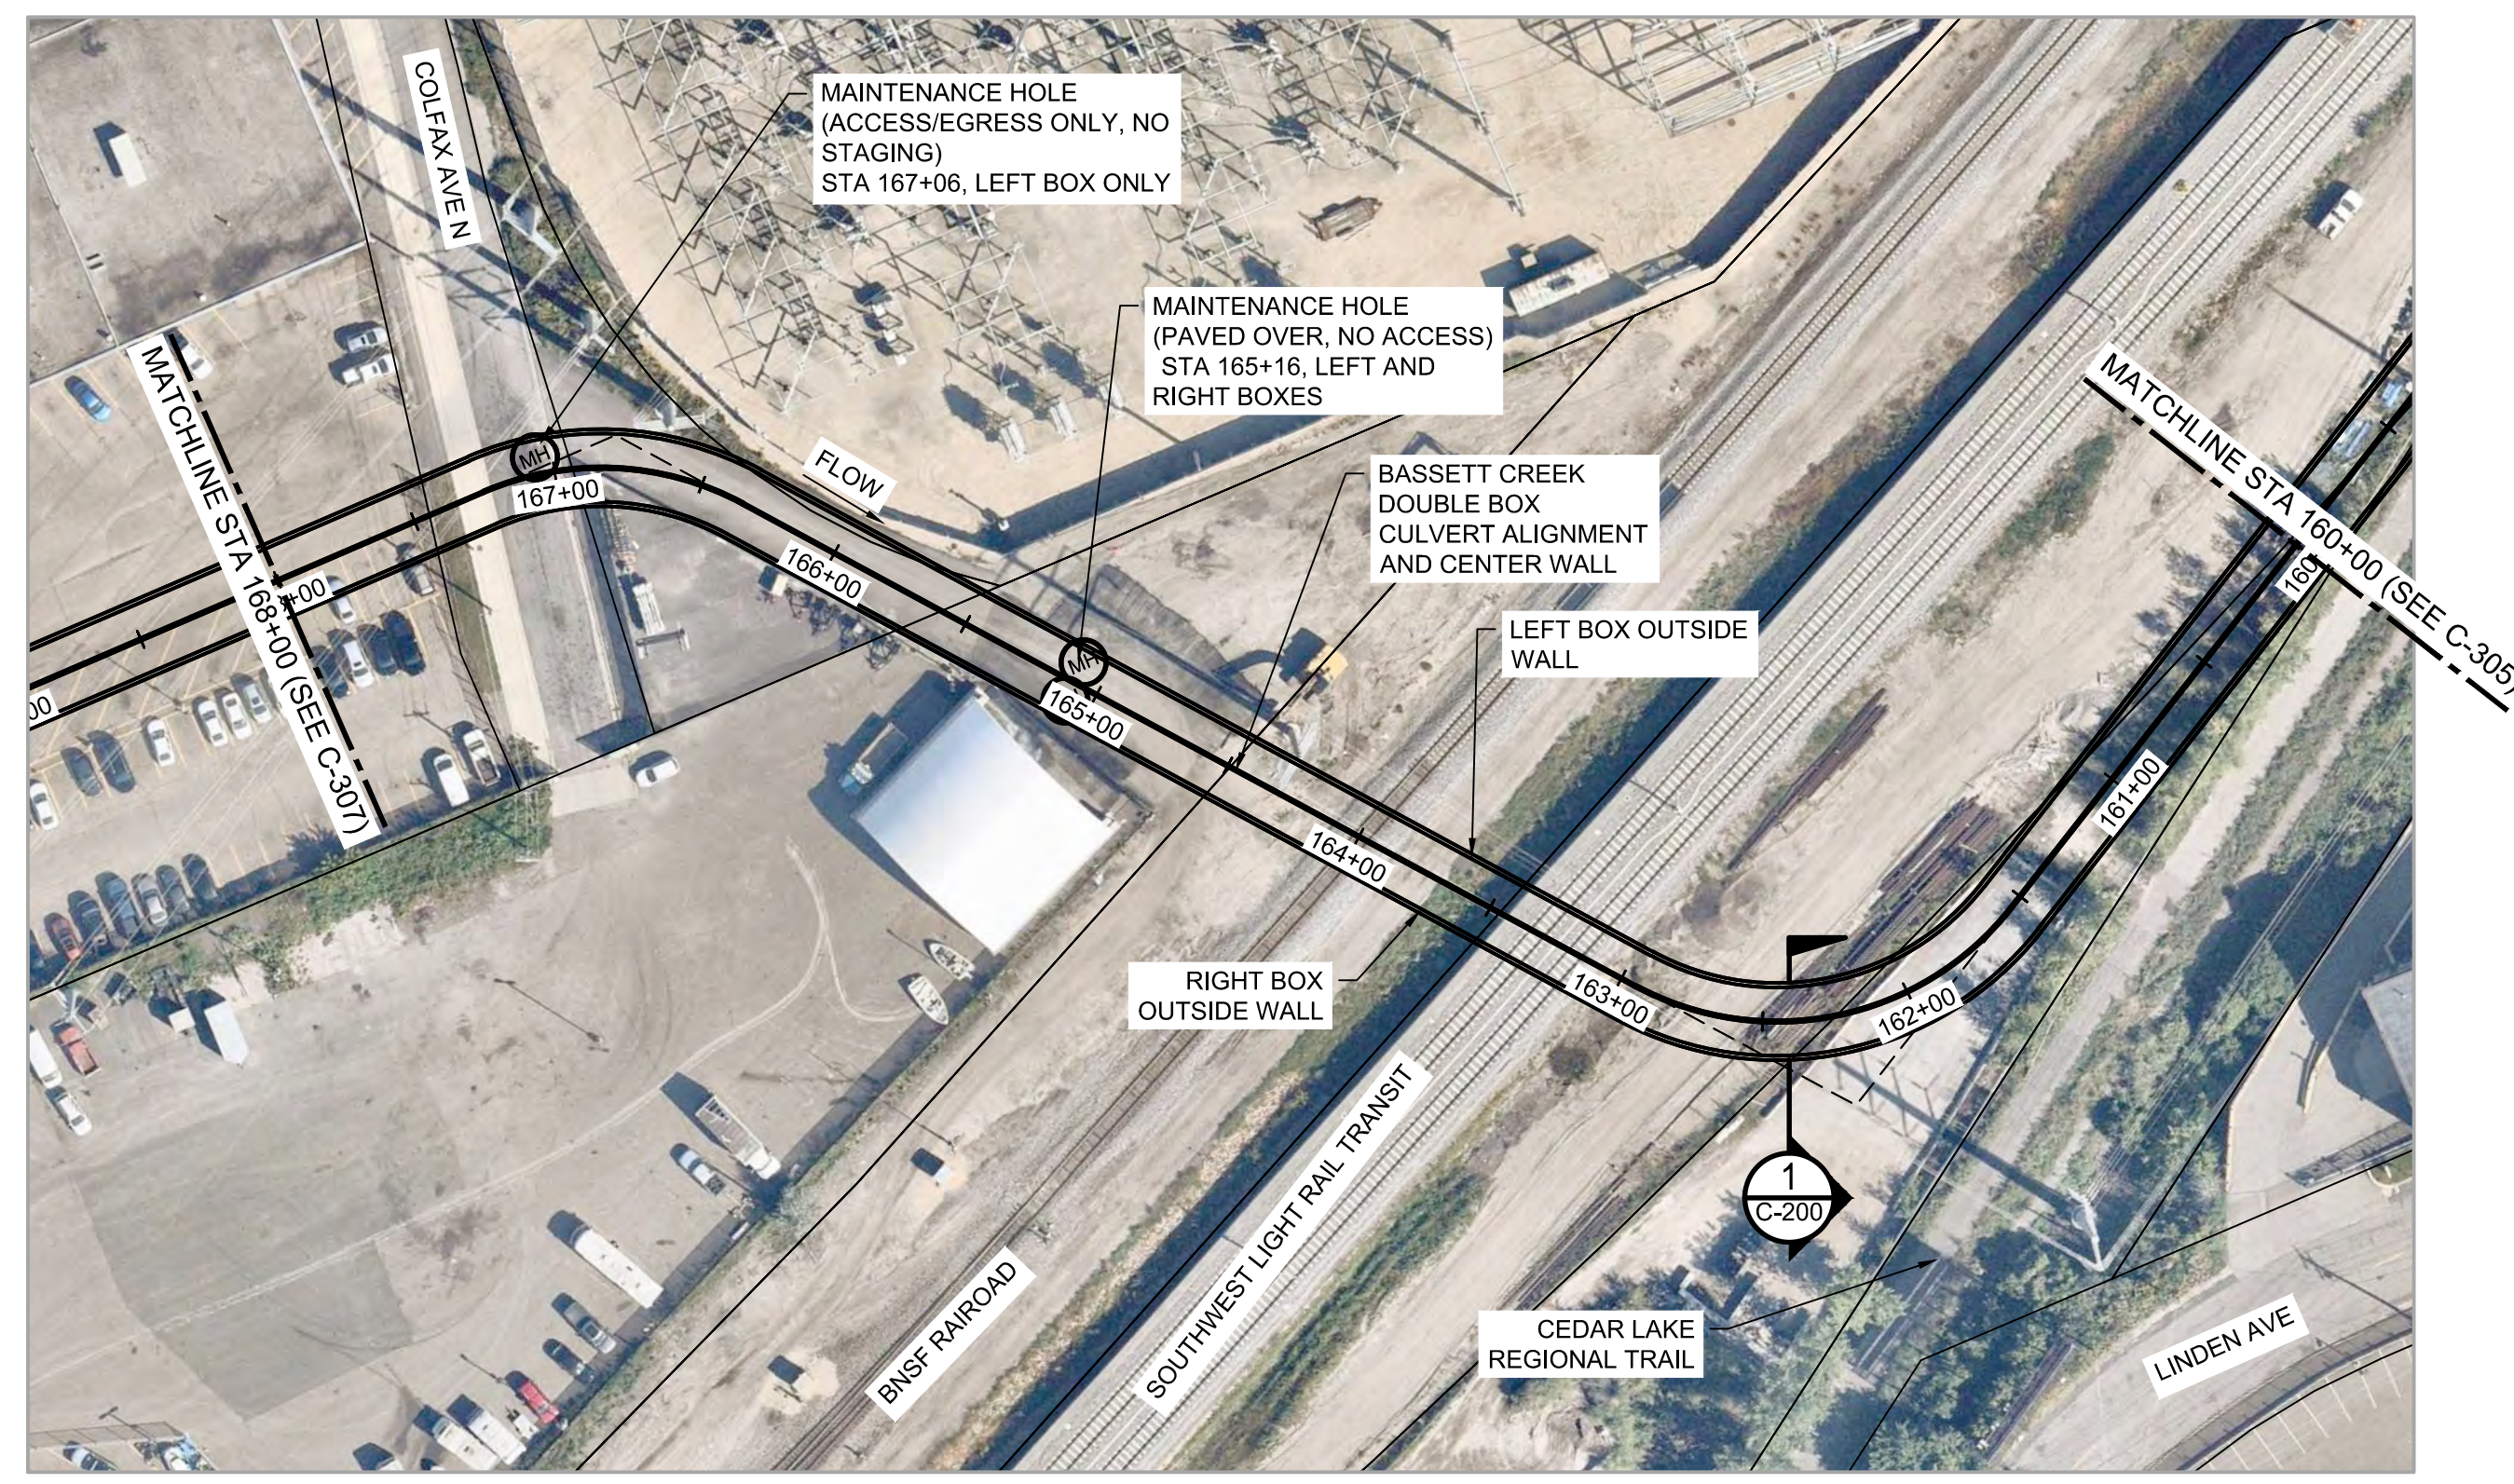
1 PLAN: STA 168+00 TO 160+00  
 SCALE IN FEET

- NOTES:
- REFERENCES TO "LEFT" AND "RIGHT" ARE WITH RESPECT TO FACING DOWNSTREAM.
  - REPAIRS SHOWN IN TABLES ARE APPROXIMATE. CONTRACTOR AND ENGINEER TO COORDINATE ON PRIORITY AND PERCENTAGE OF REPAIRS TO EXECUTE DURING CONSTRUCTION.

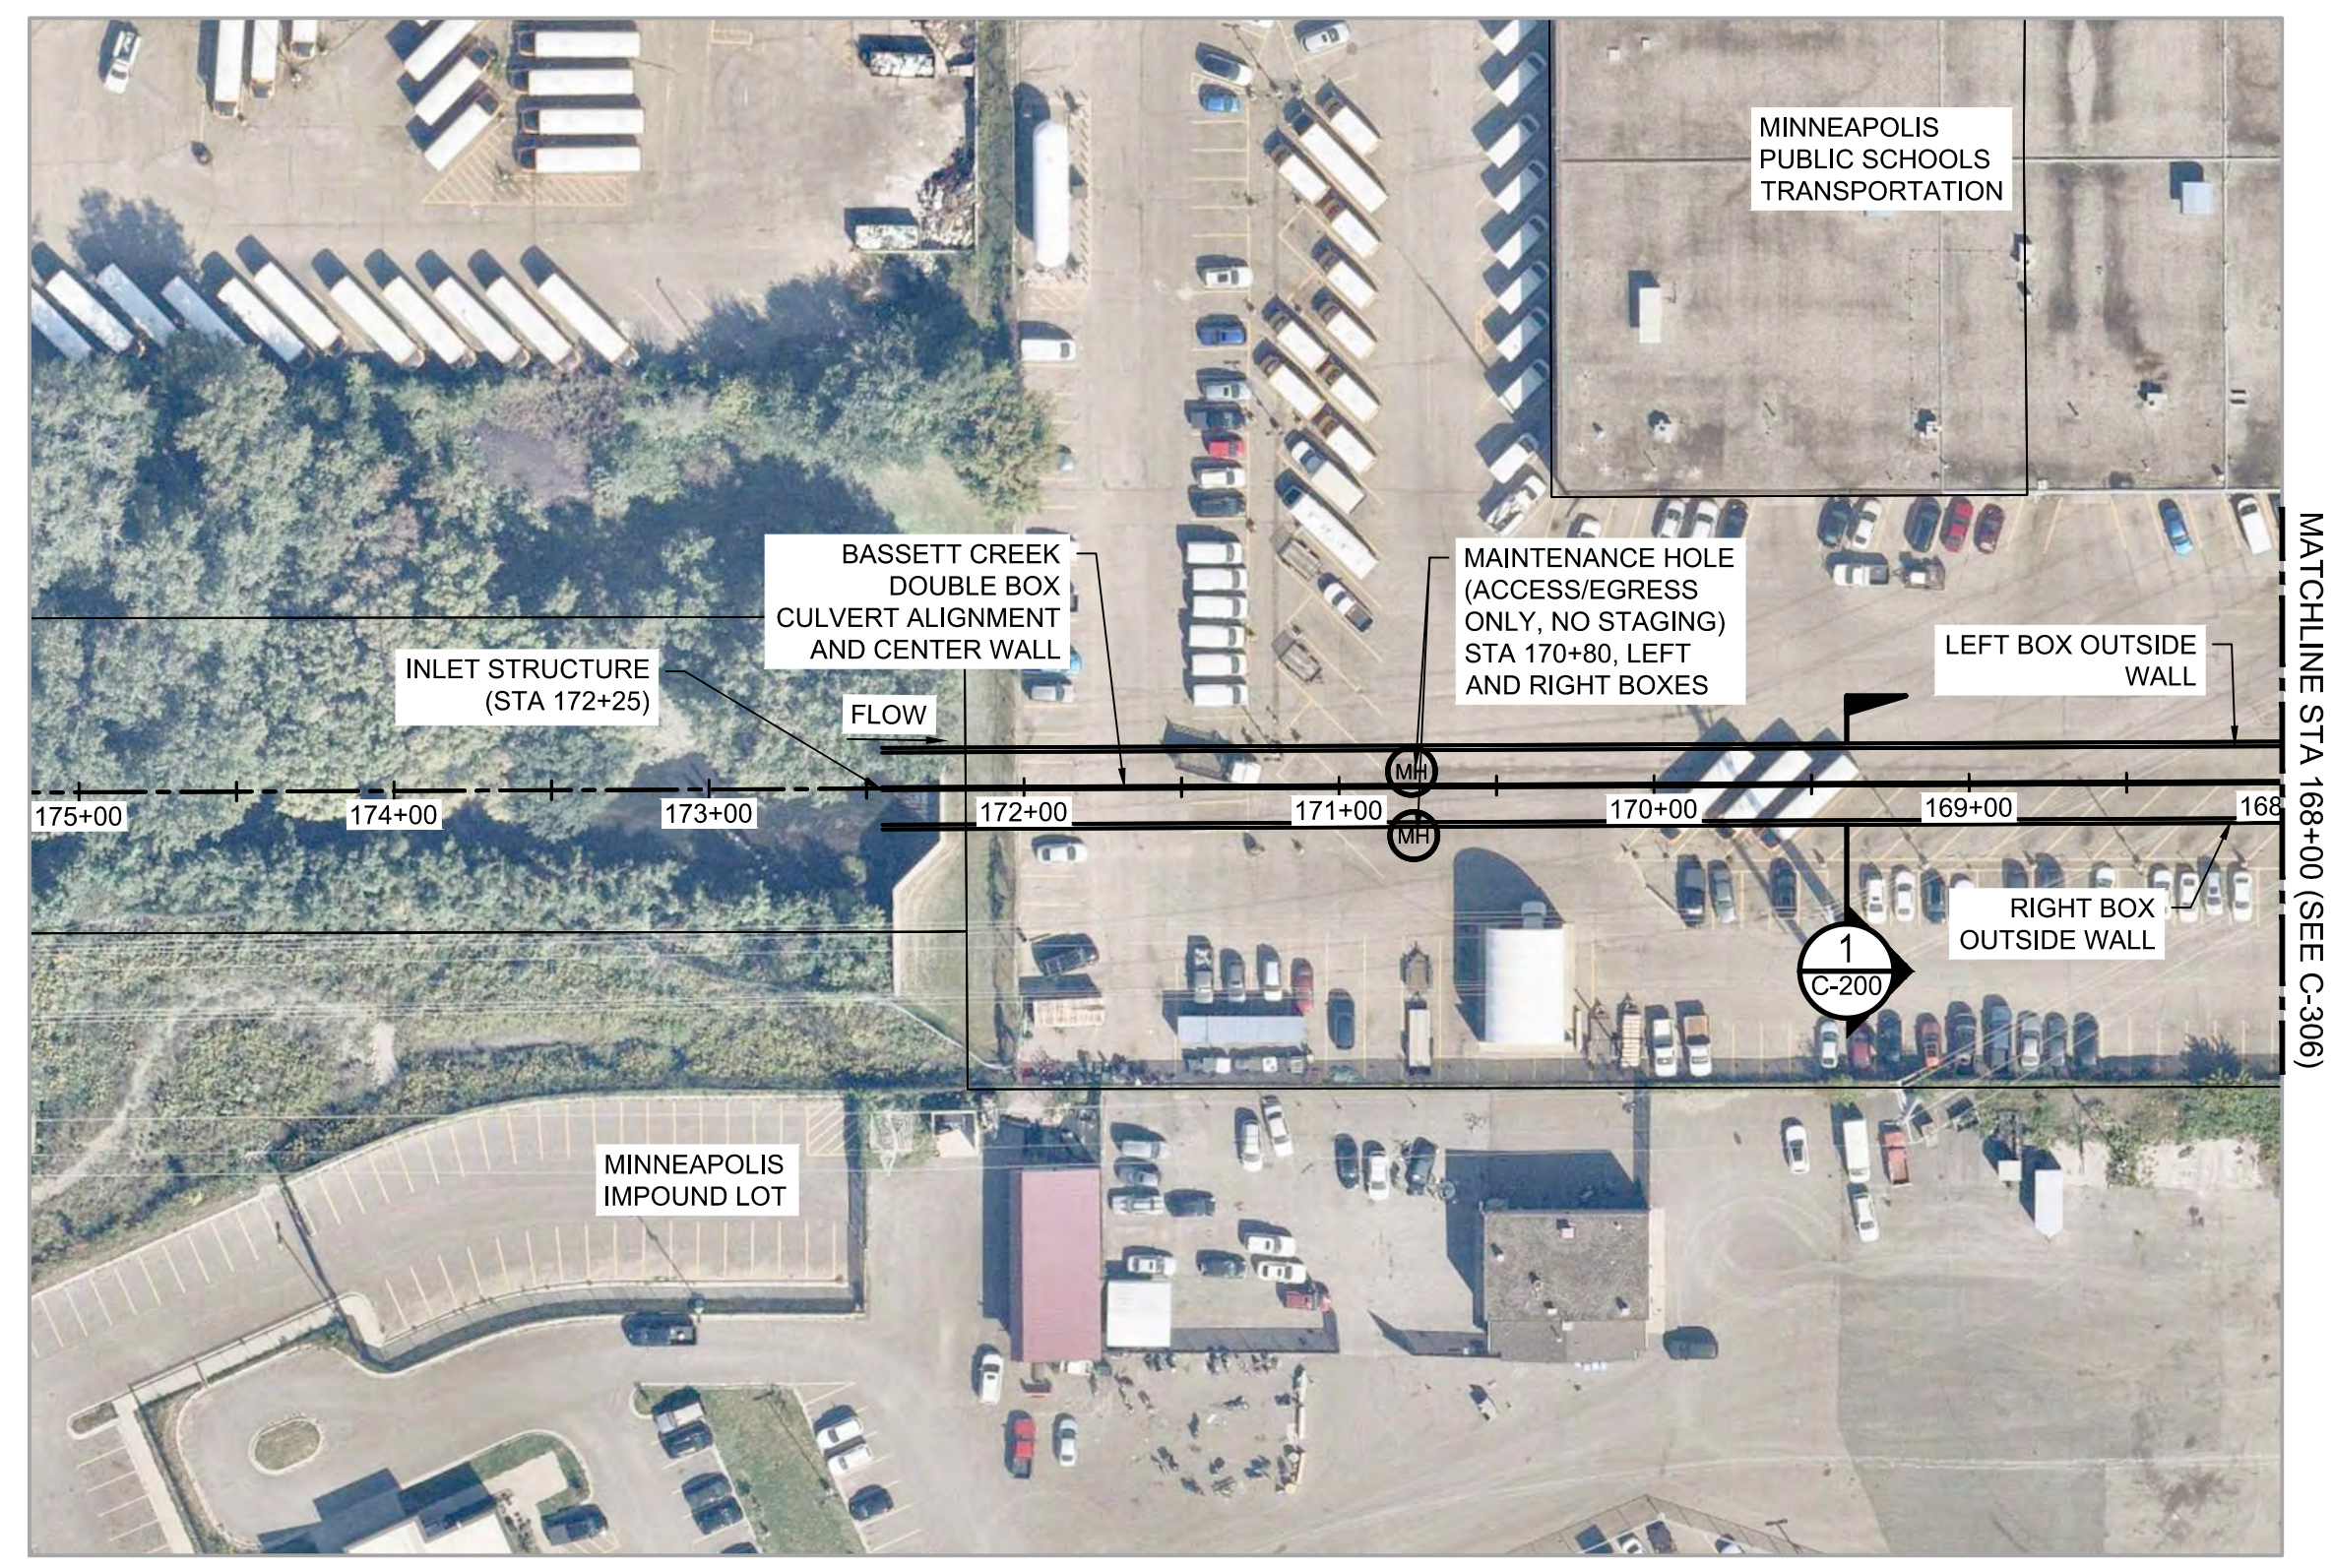
1 PLAN: STA 174+00 TO 168+00  
SCALE IN FEET

- NOTES:
- REFERENCES TO "LEFT" AND "RIGHT" ARE WITH RESPECT TO FACING DOWNSTREAM.
  - REPAIRS SHOWN IN TABLES ARE APPROXIMATE. CONTRACTOR AND ENGINEER TO COORDINATE ON PRIORITY AND PERCENTAGE OF REPAIRS TO EXECUTE DURING CONSTRUCTION.

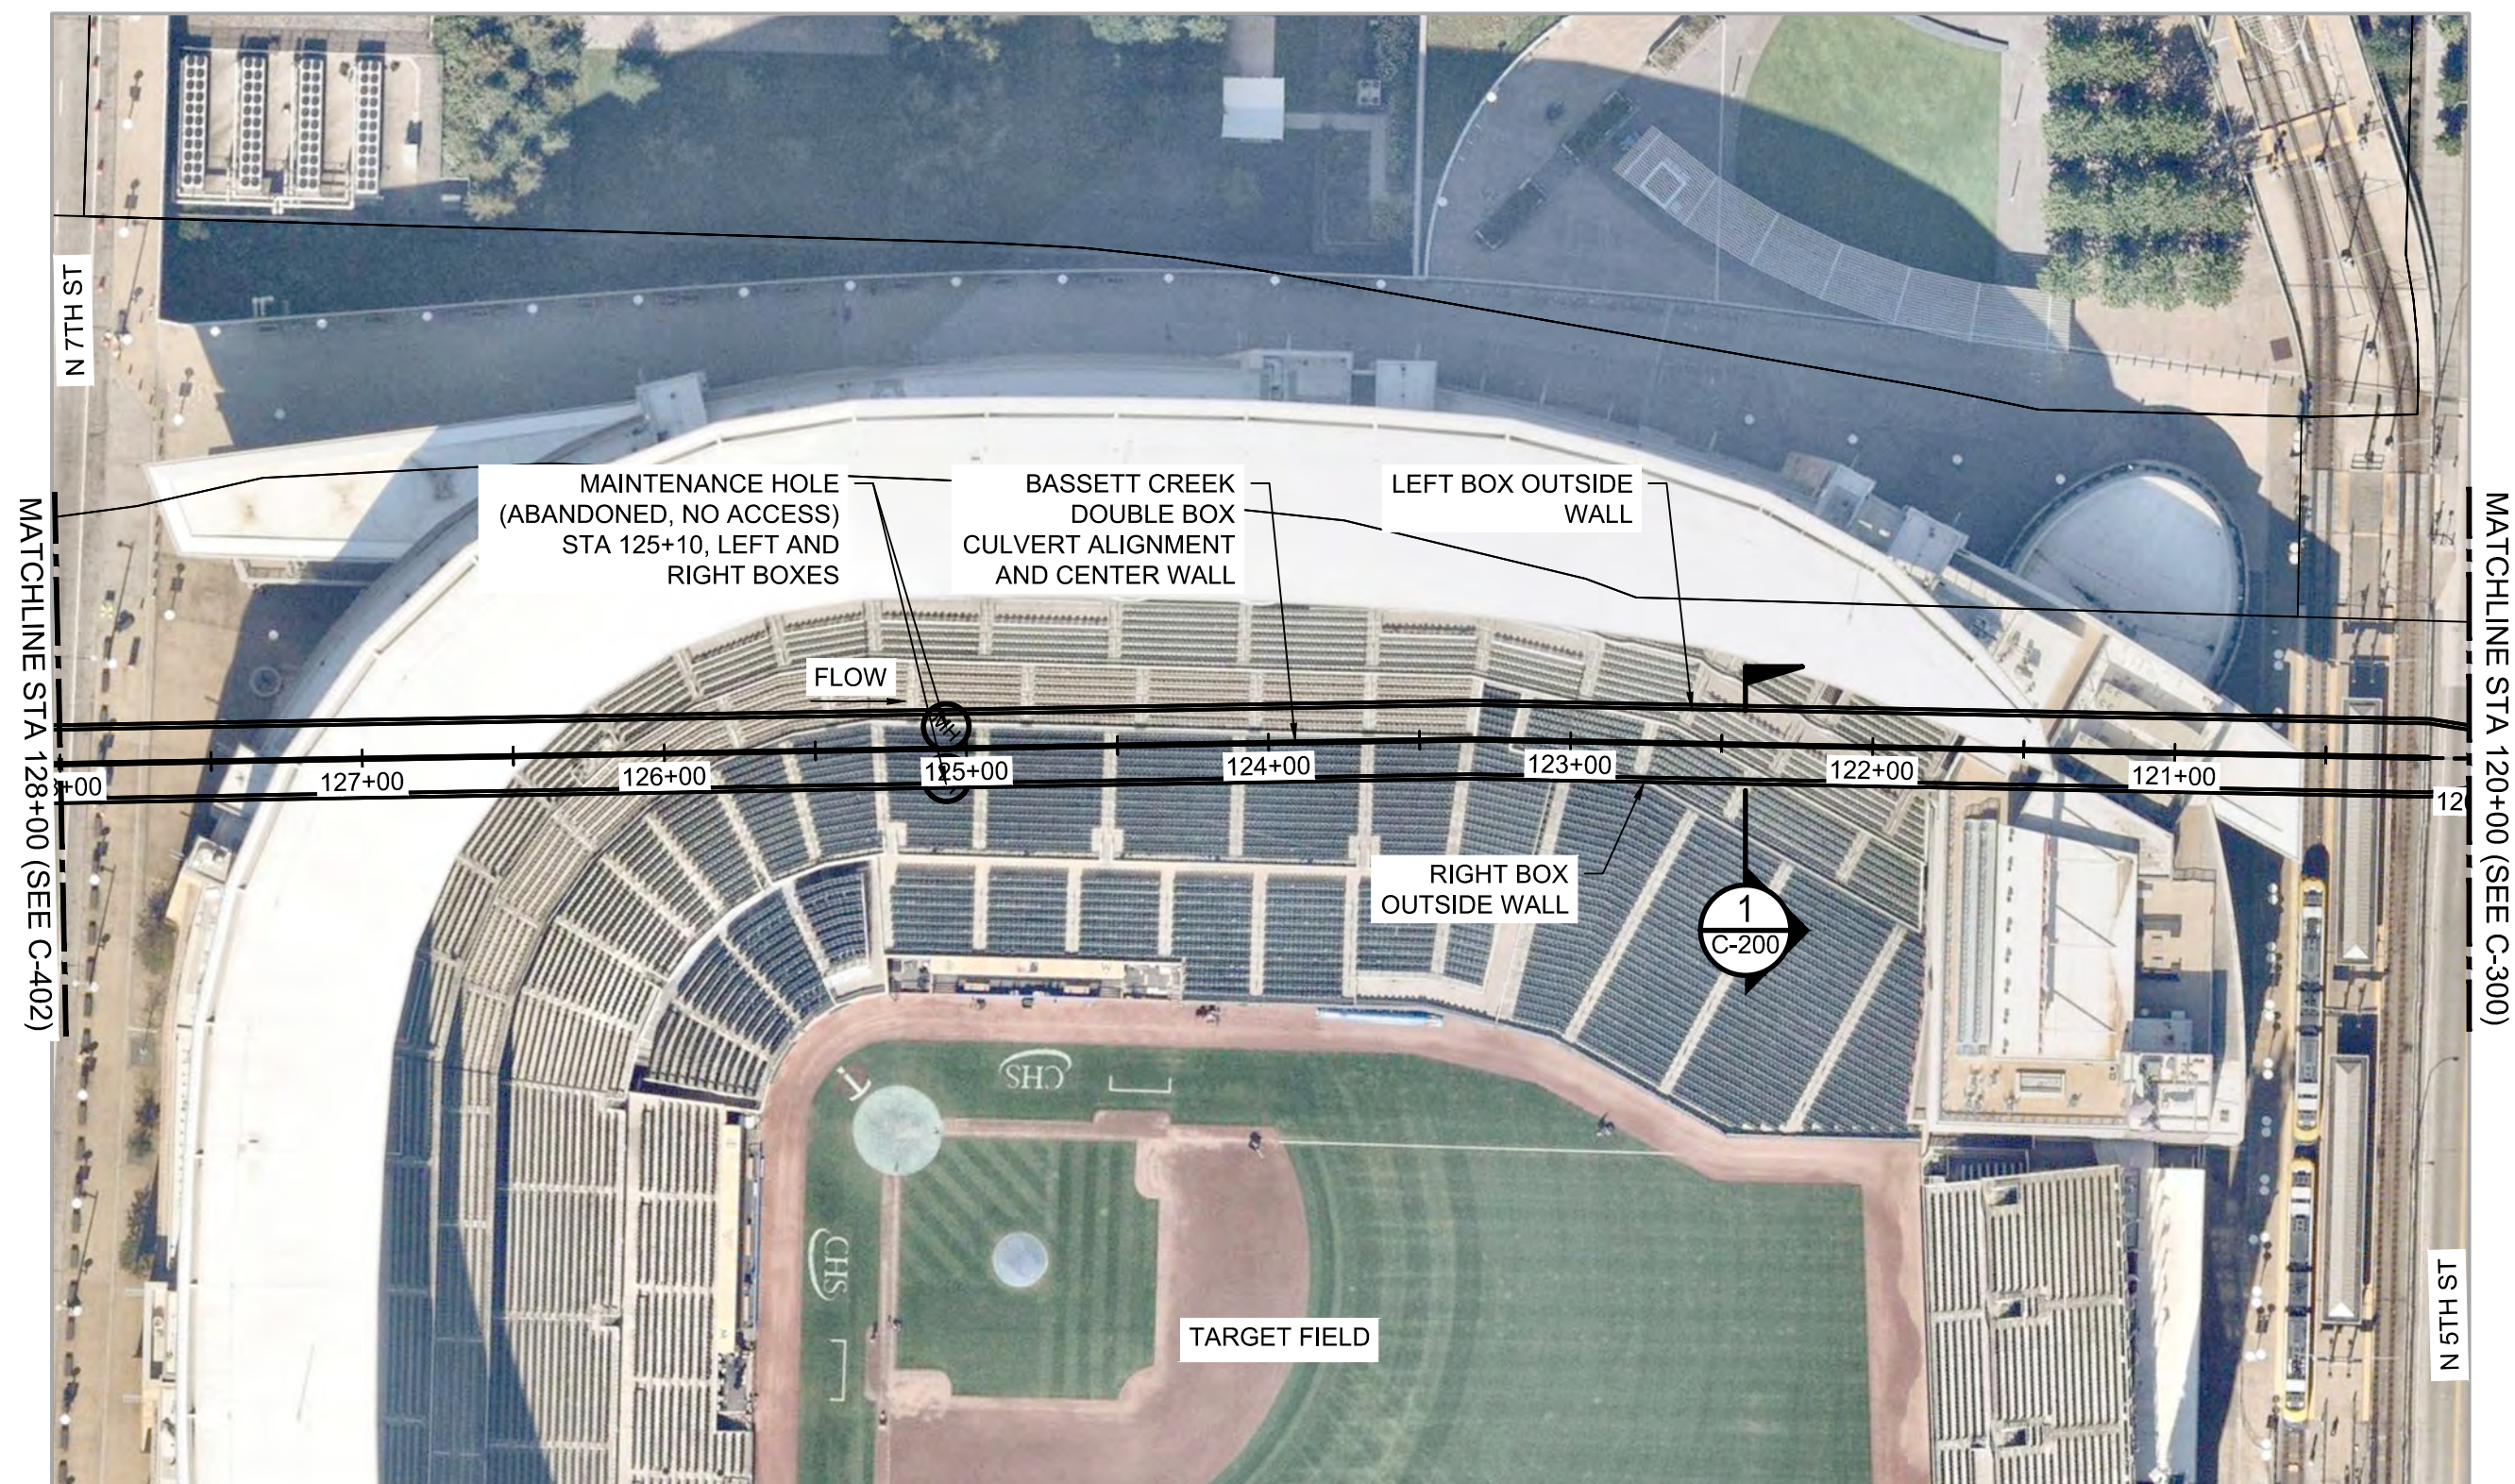
1 PLAN: STA 128+00 TO 120+00

- REFERENCES TO "LEFT" AND "RIGHT" ARE WITH RESPECT TO FACING DOWNSTREAM.
- REPAIRS SHOWN IN TABLES ARE APPROXIMATE. CONTRACTOR AND ENGINEER TO COORDINATE ON PRIORITY AND PERCENTAGE OF REPAIRS TO EXECUTE DURING CONSTRUCTION.

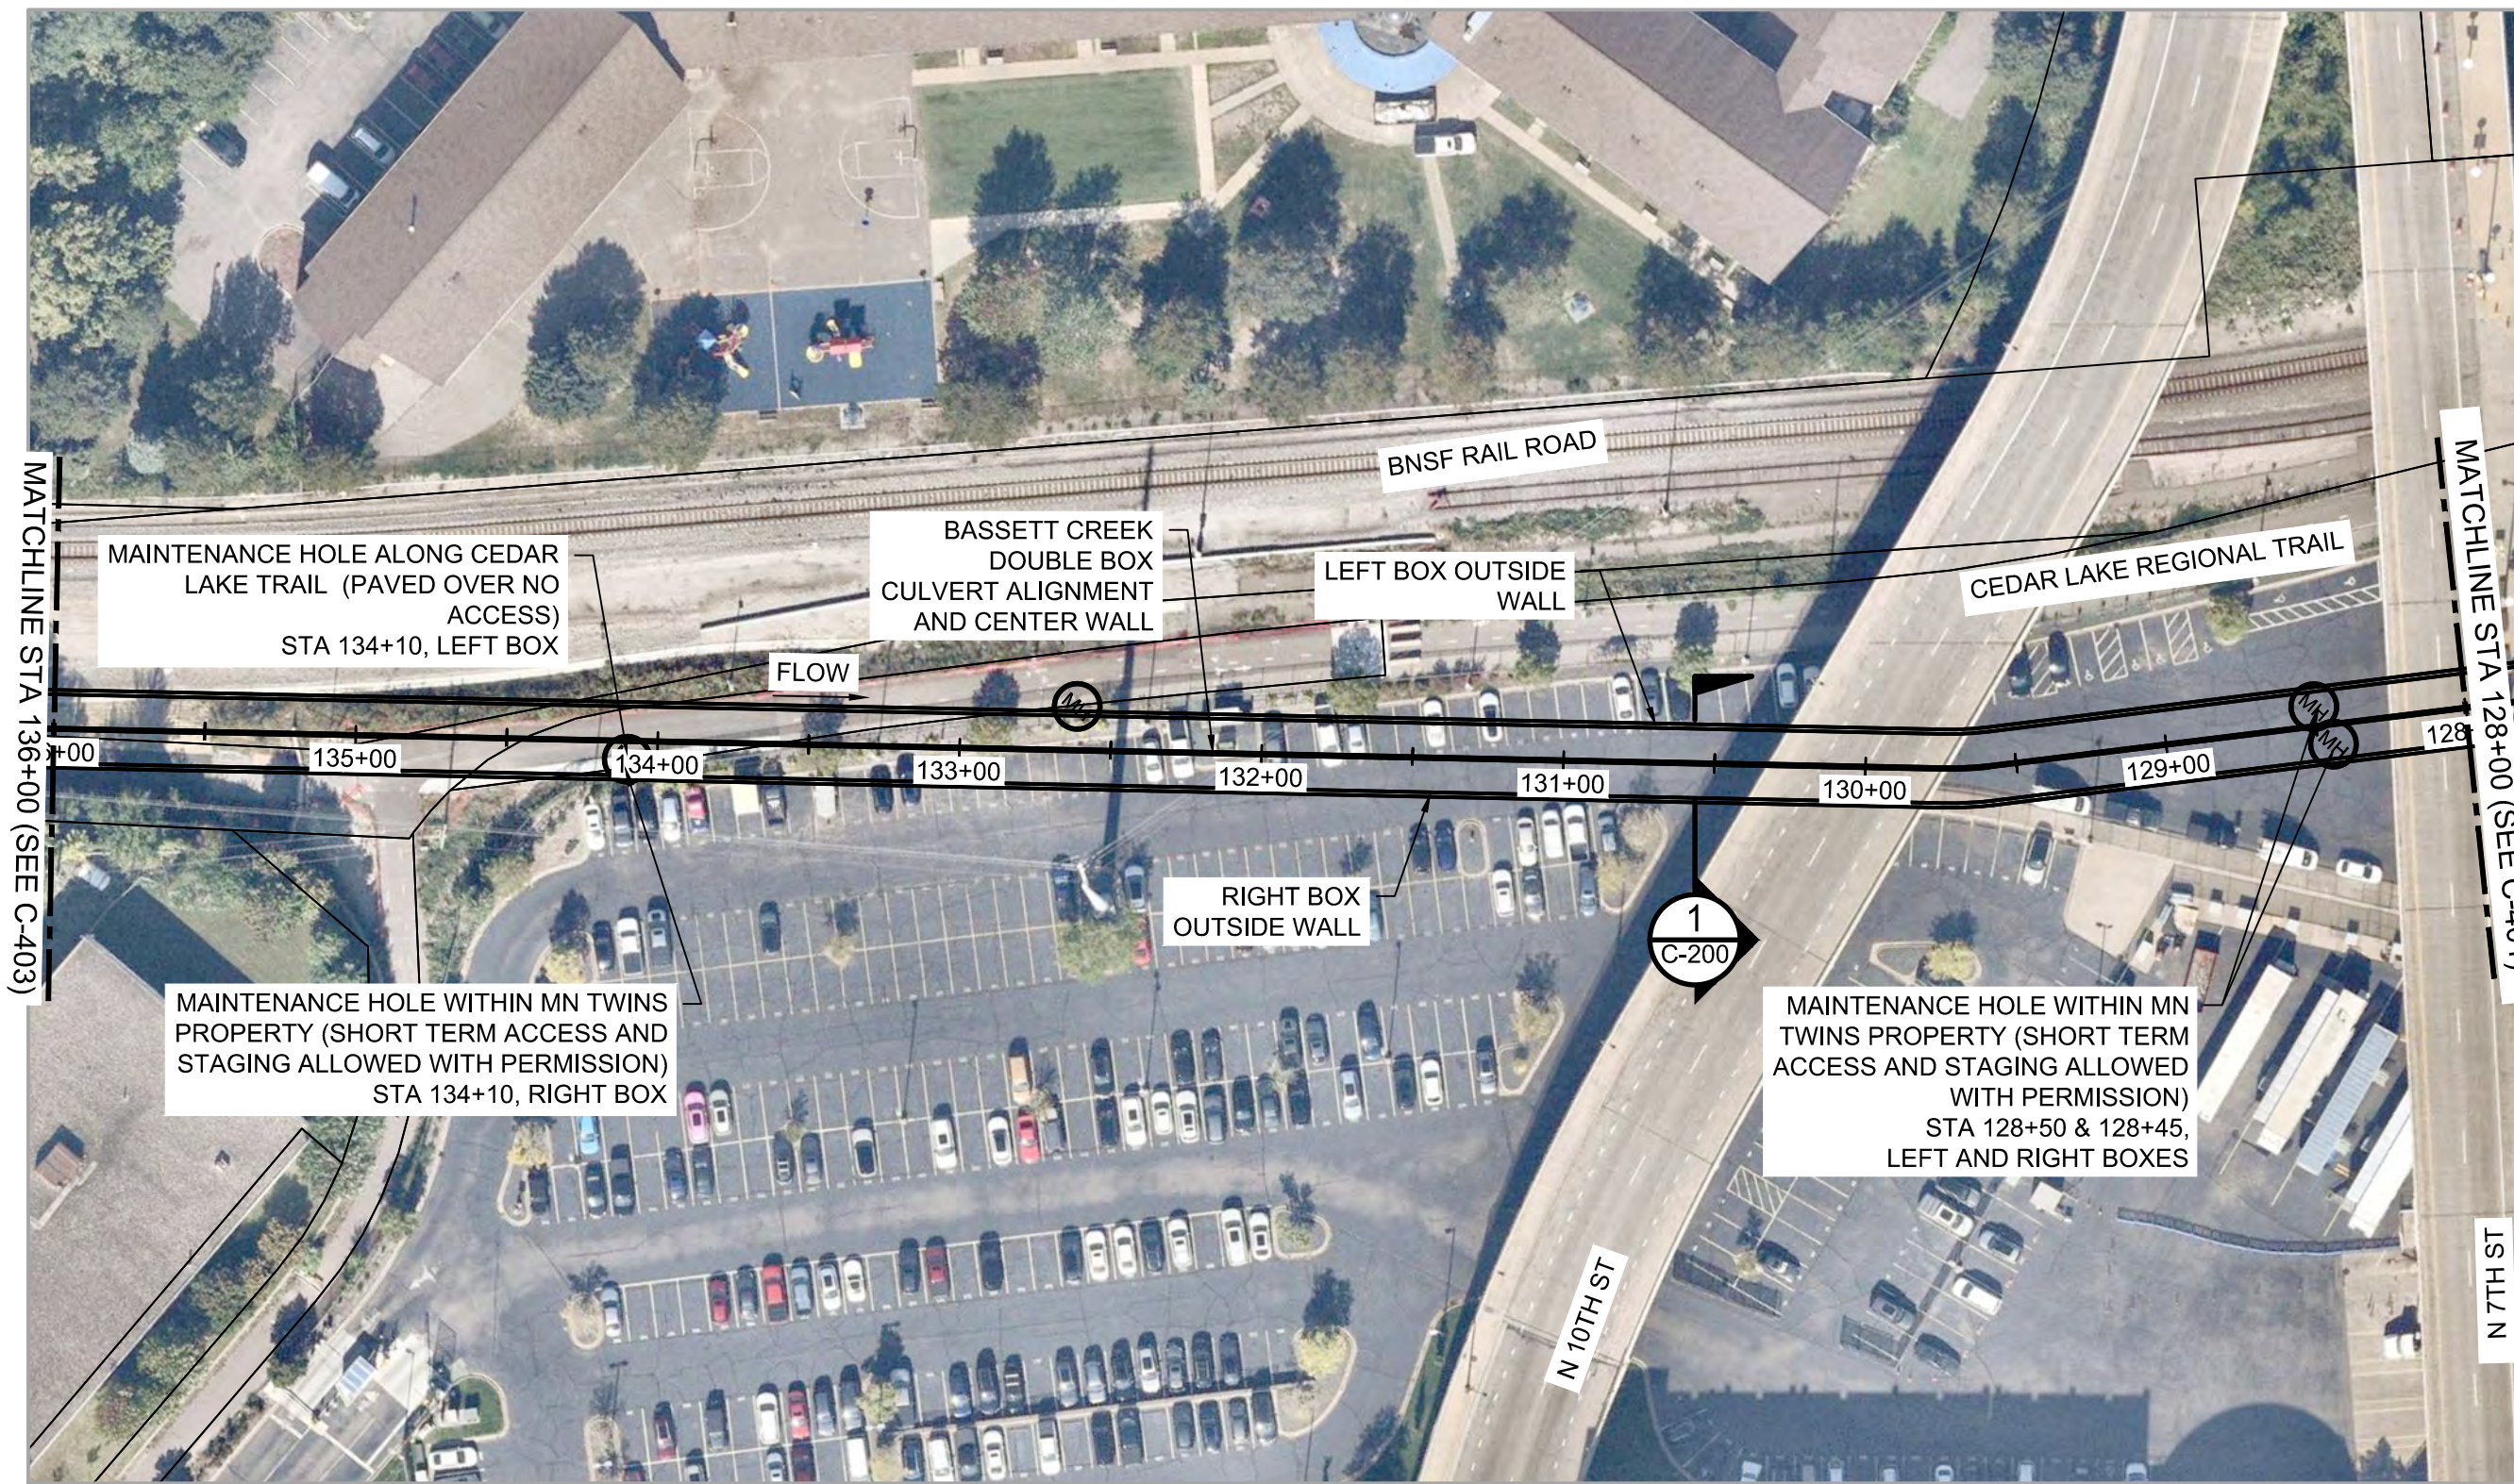
1 PLAN: STA 136+00 TO 128+00  
 SCALE IN FEET

- REFERENCES TO "LEFT" AND "RIGHT" ARE WITH RESPECT TO FACING DOWNSTREAM.
- REPAIRS SHOWN IN TABLES ARE APPROXIMATE. CONTRACTOR AND ENGINEER TO COORDINATE ON PRIORITY AND PERCENTAGE OF REPAIRS TO EXECUTE DURING CONSTRUCTION.

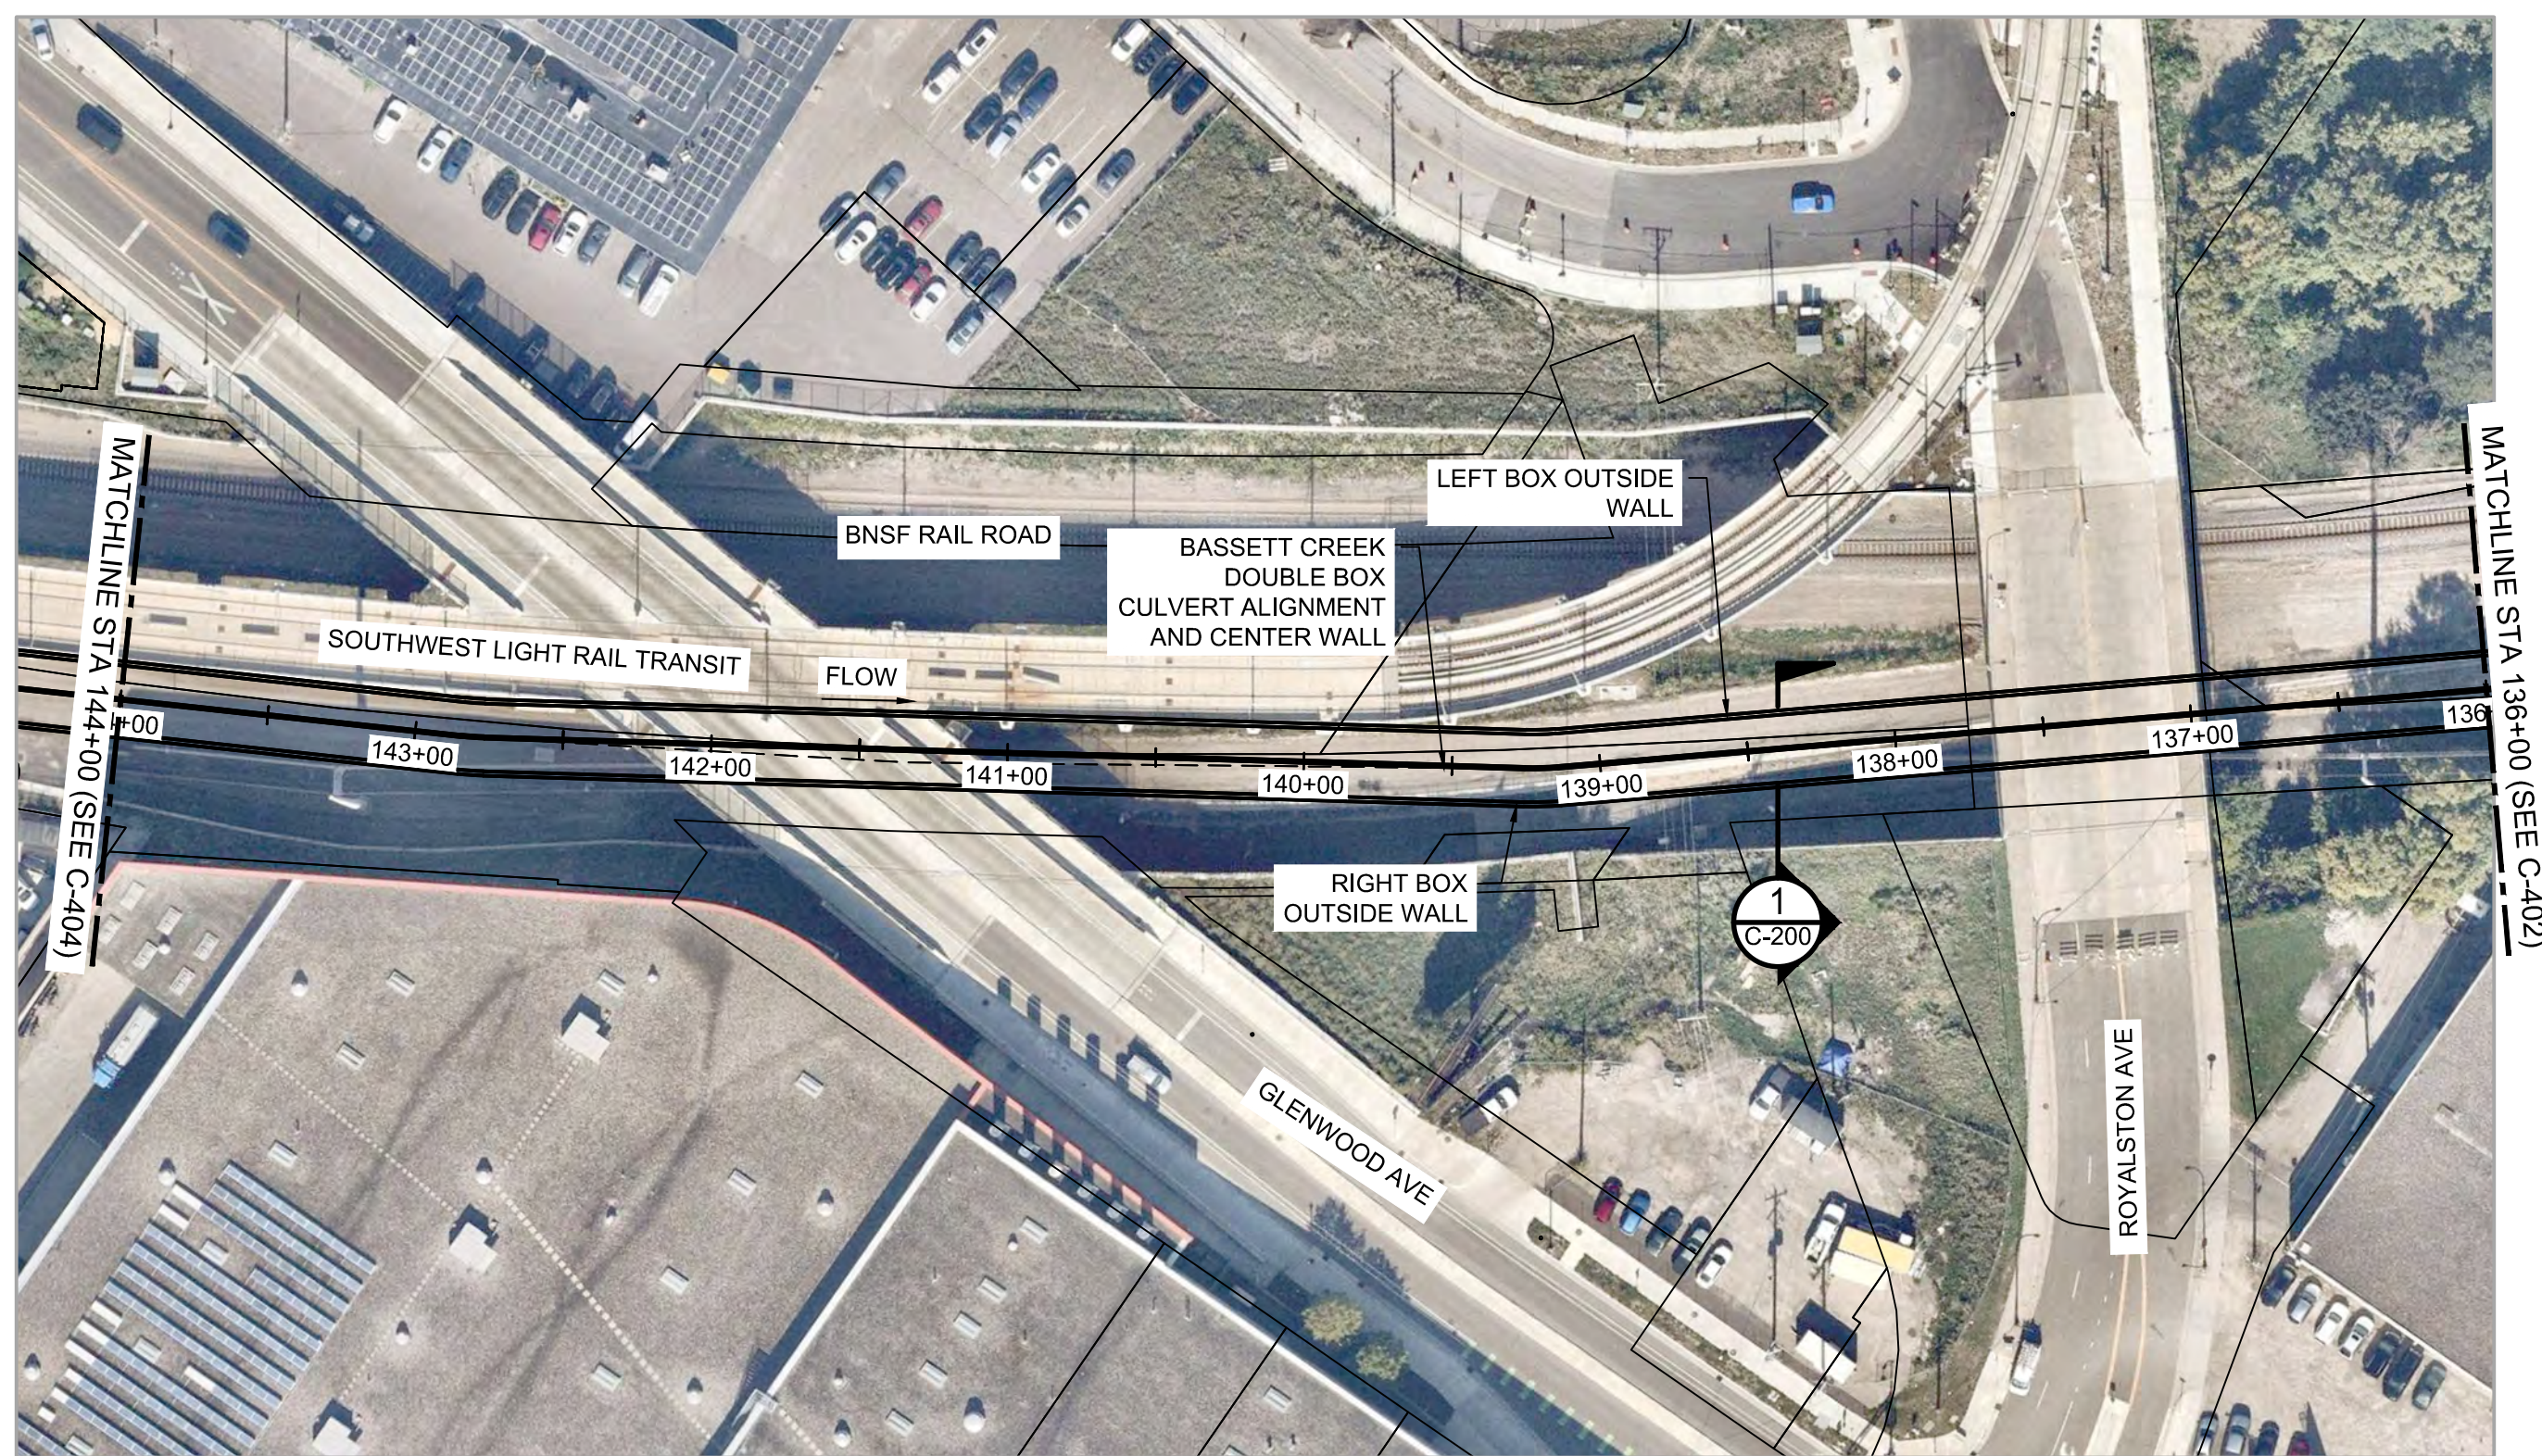
1 PLAN: STA 144+00 TO 136+00  
 SCALE IN FEET

- NOTES:
- REFERENCES TO "LEFT" AND "RIGHT" ARE WITH RESPECT TO FACING DOWNSTREAM.
  - REPAIRS SHOWN IN TABLES ARE APPROXIMATE. CONTRACTOR AND ENGINEER TO COORDINATE ON PRIORITY AND PERCENTAGE OF REPAIRS TO EXECUTE DURING CONSTRUCTION.

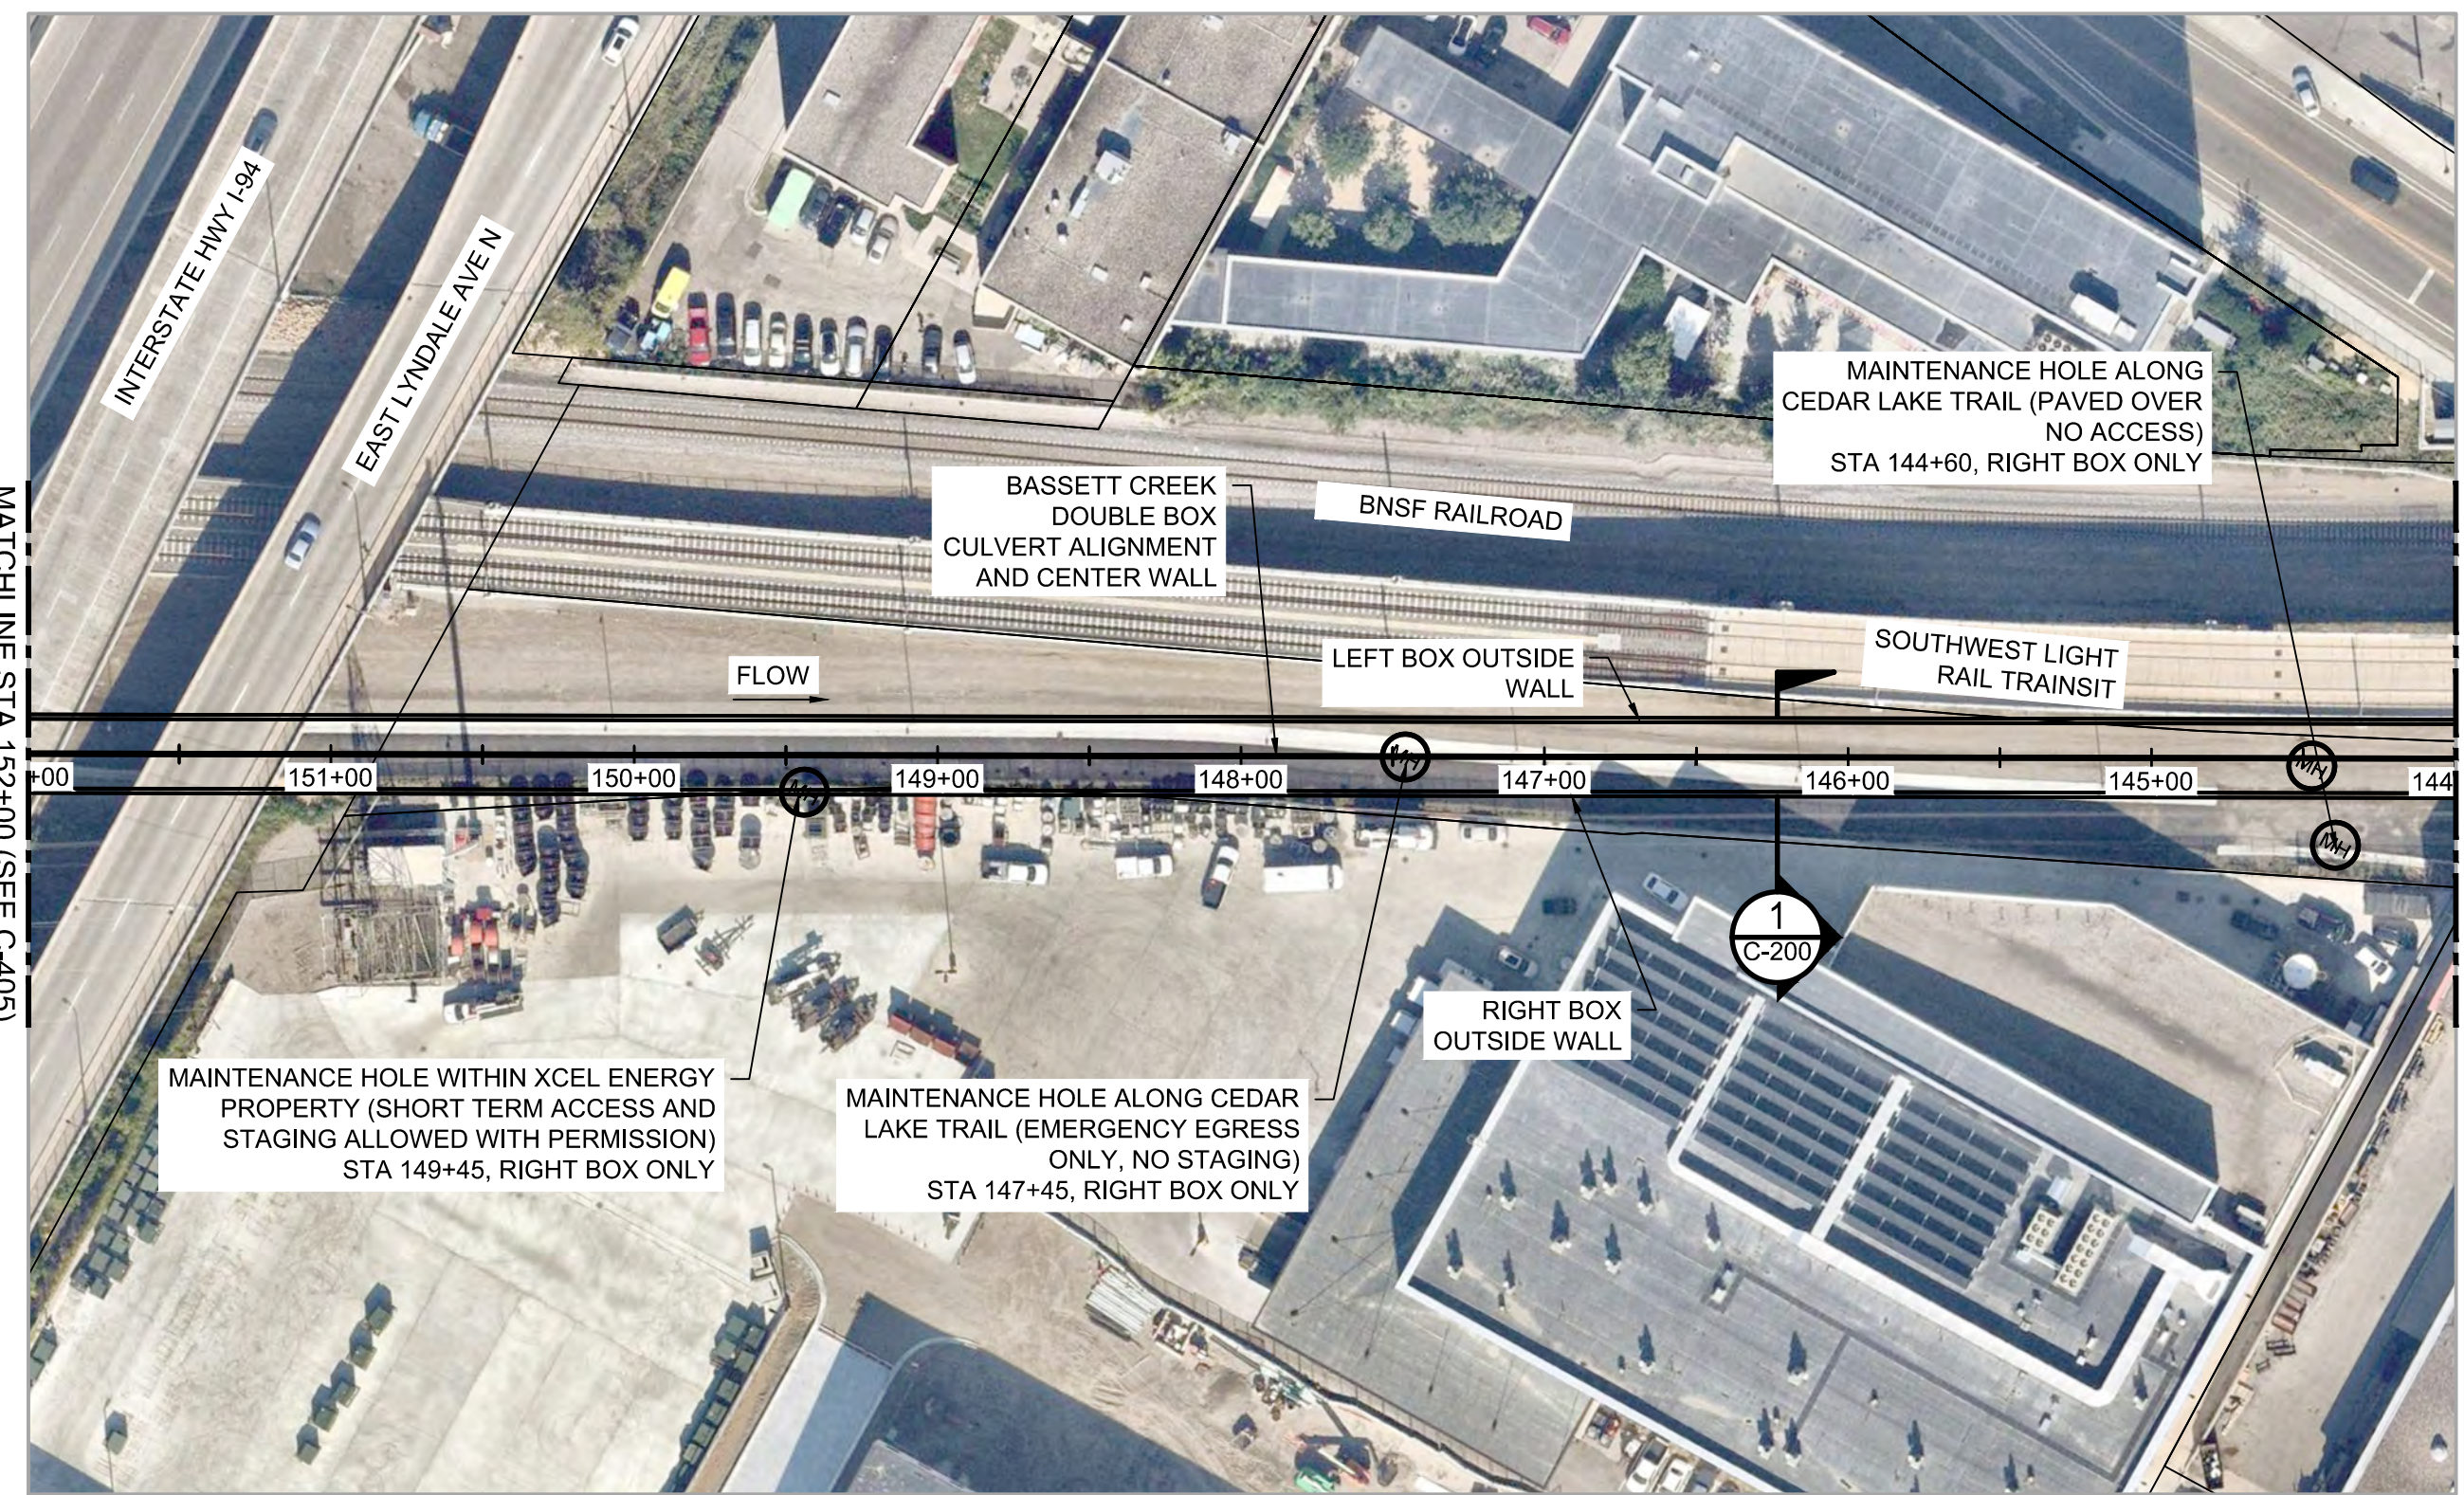
1 PLAN: STA 152+00 TO 144+00  
 SCALE IN FEET

- REFERENCES TO "LEFT" AND "RIGHT" ARE WITH RESPECT TO FACING DOWNSTREAM.
- REPAIRS SHOWN IN TABLES ARE APPROXIMATE. CONTRACTOR AND ENGINEER TO COORDINATE ON PRIORITY AND PERCENTAGE OF REPAIRS TO EXECUTE DURING CONSTRUCTION.
