## 2018 Biotic Index Evaluation of the Main Stem of Bassett Creek

Between 1980 and 2018, the Bassett Creek Watershed Management Commission (BCWMC) has collected benthic macroinvertebrates (bottom-dwelling organisms) from the Main Stem of Bassett Creek on 11 occasions. The purpose of the sampling was to evaluate water quality and detect changes over time.

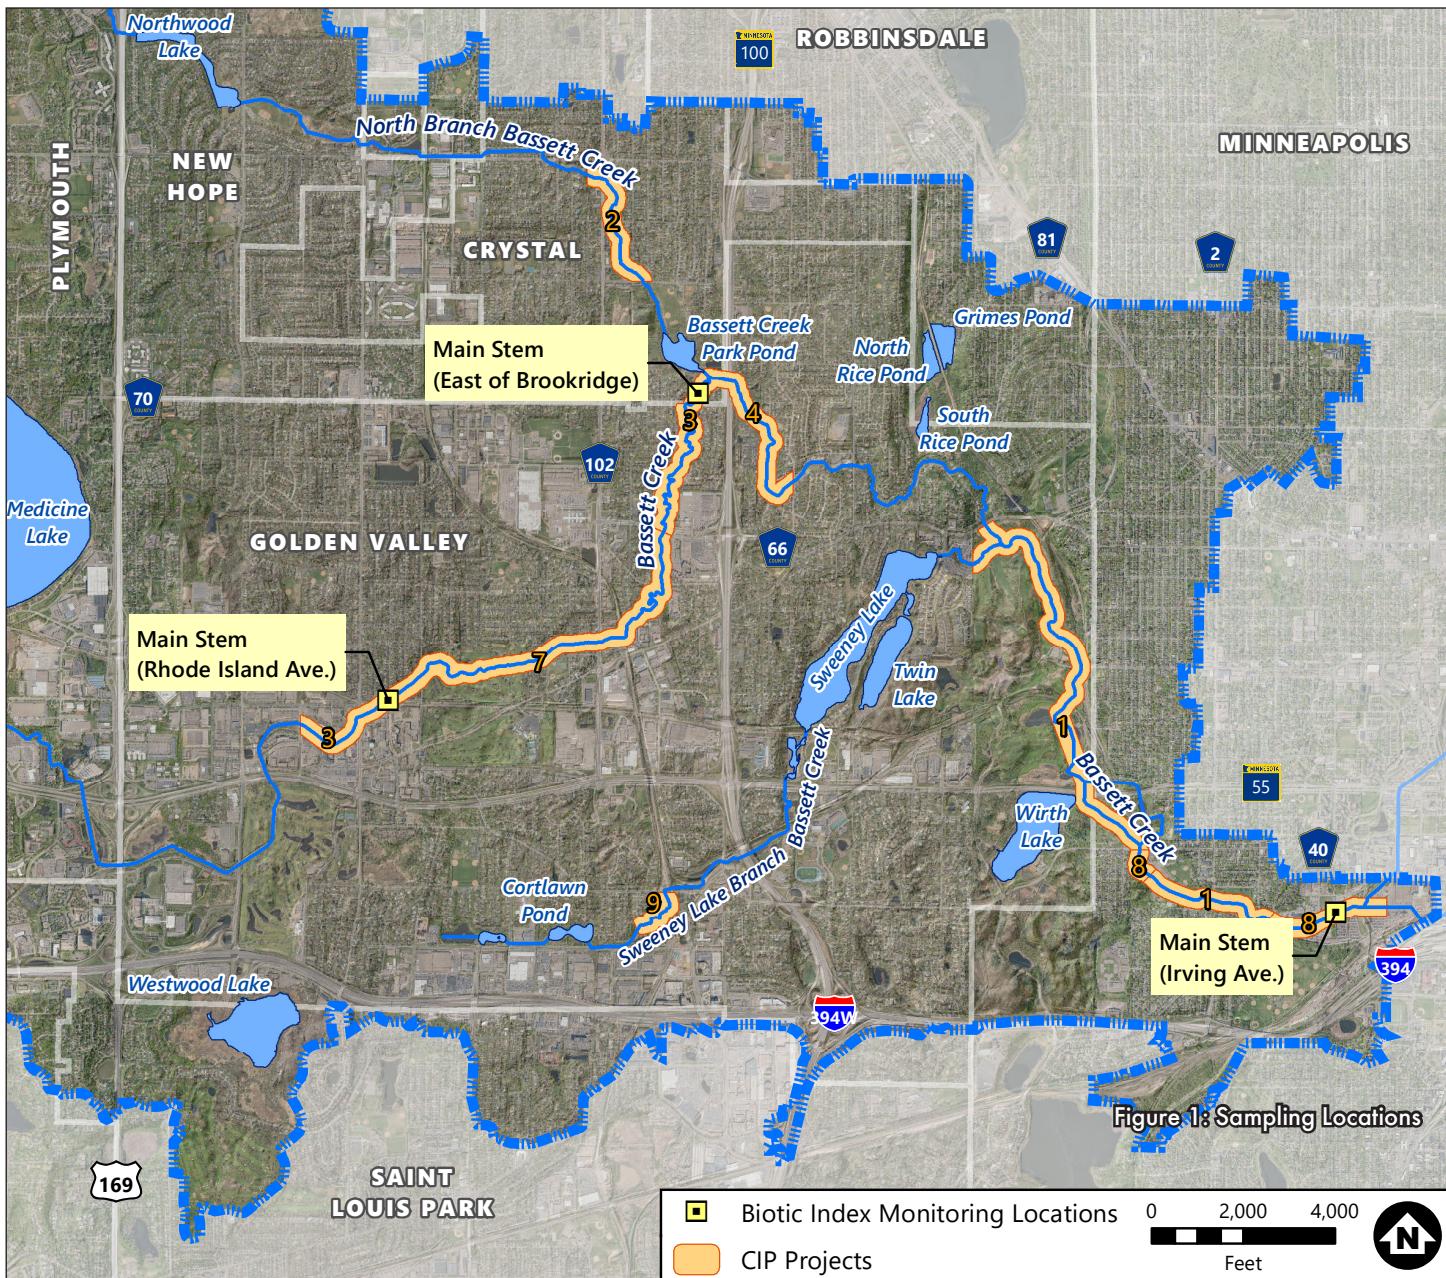
In 2018, the BCWMC monitored the Main Stem of Bassett Creek east of Brookridge Avenue and at Rhode Island Avenue and the Metropolitan Council Environmental Services monitored the Main Stem at Irving Avenue (Figure 1, page 2) for:

Improved M-IBI scores were documented at all Main Stem locations in 2018 (Figure 6). Consistently improving M-IBI scores were documented at the east of Brookridge location since 2012 and at the Irving Avenue location since 2008. The long-term improvements appear to show the positive impacts of multiple stream restoration projects completed from 2012 through 2018 (Figure 1, Table 1).

To determine whether any trends could be detected, HBI scores from 2018 were compared to scores from 1980 through 2015, and ICI scores from 2018 were compared to scores from 1995 through 2015. A trend toward decreasing HBI scores (improving oxygen conditions) was documented on the Main Stem at the Irving Avenue location. The trend was statistically significant (i.e., there was a 5 percent or less probability that the change was due to chance). The improved HBI score at this location appears to be the result of the Main Stem stream restoration project from Golden Valley Road to Glenwood Avenue, completed in 2015 (Figure 1 and Table 1). The project stabilized the stream bank and was expected to reduce total suspended solids.

As shown in Figure 6, none of the Main Stem locations monitored from 2006 through 2018 met the MPCA M-IBI impairment standard. Thus, Bassett Creek would be considered biologically impaired. However, improved M-IBI scores were documented at all Main Stem locations in 2018 (Figure 6). Improving M-IBI scores were documented consistently at the east of Brookridge location since 2012 and at the Irving Avenue location since 2008. The long-term improvements appear to reflect the positive impacts of multiple stream restoration projects completed from 2012 through 2018 (Figure 1 and Table 1):

The Rhode Island Avenue location has consistently supported climber taxa. However, the number of climbers decreased from five in 2008 to three in 2012. A stream restoration project from Wisconsin Avenue to 10th Avenue from December 2012 through November 2013 (#3 on Figure 1) and from 10th Avenue to Duluth Street from winter 2015–2016 through 2018 (#7 on Figure 1) improved habitat and appeared to result in an increase in the number of climber taxa at the Rhode Island location. After completion of the projects, the number increased to four in 2015 and seven in 2018, resulting in a score of 5.4 (Figure 8). This is the only time during the period examined that the score exceeded the impairment threshold of 3.7 (Figure 8).

Main Stem stream restoration projects (#1, #3, #4, and #7 on Figure 1 and Table 1) appear to have increased the number of taxa at Main Stem locations and improved distribution. The number of taxa at all Main Stem locations in 2018 was the highest to date (Figure 10). 2018 was also the first time that a score greater than zero was observed for the DomFiveChPct metric at any of the Main Stem locations (Figure 11).

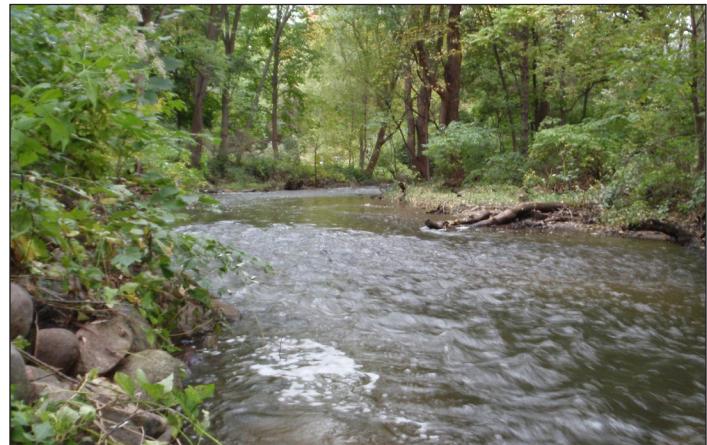
Figure 2: Main Stem of Bassett Creek east of Brookridge in 2015

Figure 3: Main Stem of Bassett Creek east of Brookridge in 2018

The BCWMC completed habitat surveys of the Main Stem at Rhode Island Avenue and east of Brookridge in 2015 and 2018 using the MPCA quantitative habitat survey methods. The survey results are summarized in Table 2. Flows and water depths were higher in 2018 than 2015 (Table 2, Figures 2 through 5). The habitat survey results indicate the Main Stem stream restoration project from 10th Avenue to Duluth Street improved habitat at the Rhode Island Avenue and east of Brookridge locations. Project construction began in the winter of 2015 and concluded in 2018 with the establishment of native vegetation along the restored stream banks. Habitat improvements at Rhode Island Avenue documented by the 2018 survey include the following:

Habitat improvements east of Brookridge documented by the 2018 survey include:

- A decrease in the average embeddedness of coarse sediment
- A decrease in the percent of transects with right-bank erosion
- A decrease in the average length of bank erosion per transect for the left bank
- An increase in the amount of overhanging vegetation (as represented by the “percent length of transect over at least 10 cm of water with overhanging vegetation” metric).

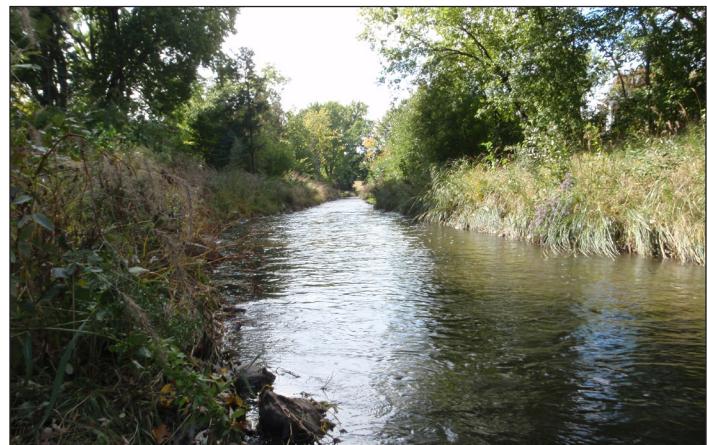
Figure 5: Main Stem of Bassett Creek at Rhode Island Ave. in 2018

- A decrease in the average depth of fine sediment
- A decrease (to none) in percent of transects with left-bank erosion
- A decrease in percent of transects with right-bank erosion
- A decrease in the average length of bank erosion per transect for both the left bank and right bank
- An increase in the average amount of algae
- An increase in the average number of aquatic plants
- An increase in the amount of overhanging vegetation and submergent vegetation (as represented by the “percent length of transect over at least 10 cm of water with overhanging vegetation and submergent vegetation” metric).

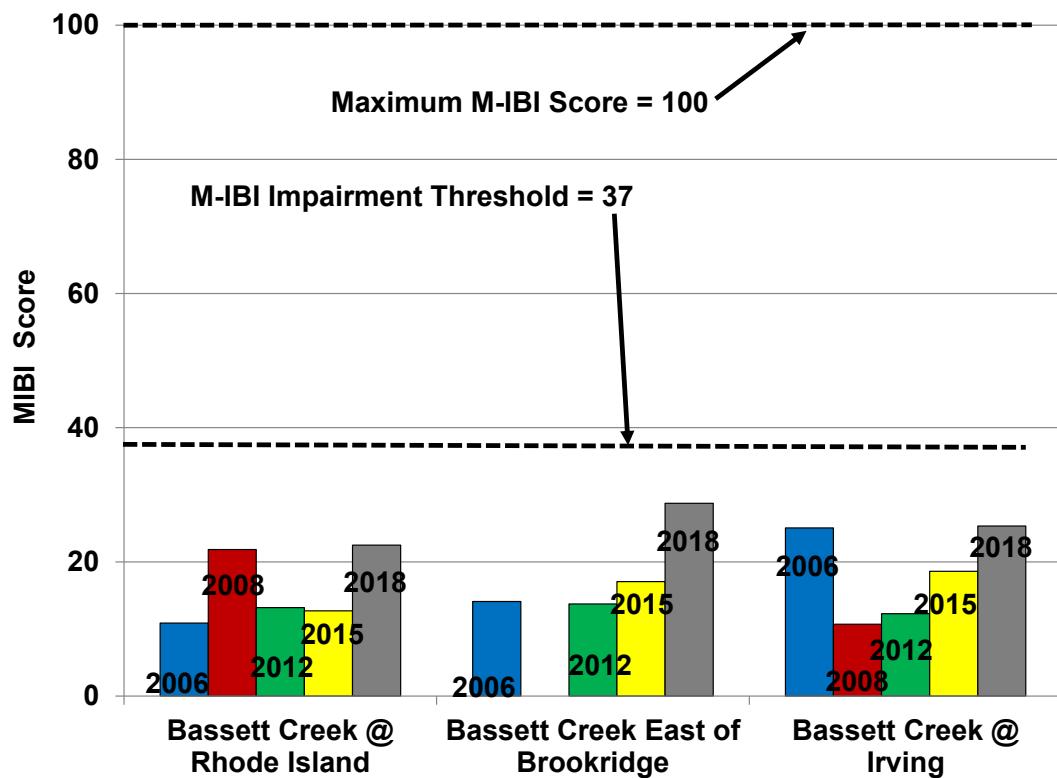
**Figure 6: 2006–2018 M-IBI scores from Main Stem Bassett Creek**

The M-IBI helps identify biologically impaired rivers and streams by assessing the health of their macroinvertebrate communities. The BCWMC used the M-IBI to assess the Main Stem of Bassett Creek from 2006 through 2018 to determine whether it met the MPCA standard for macroinvertebrates (Figure 6).

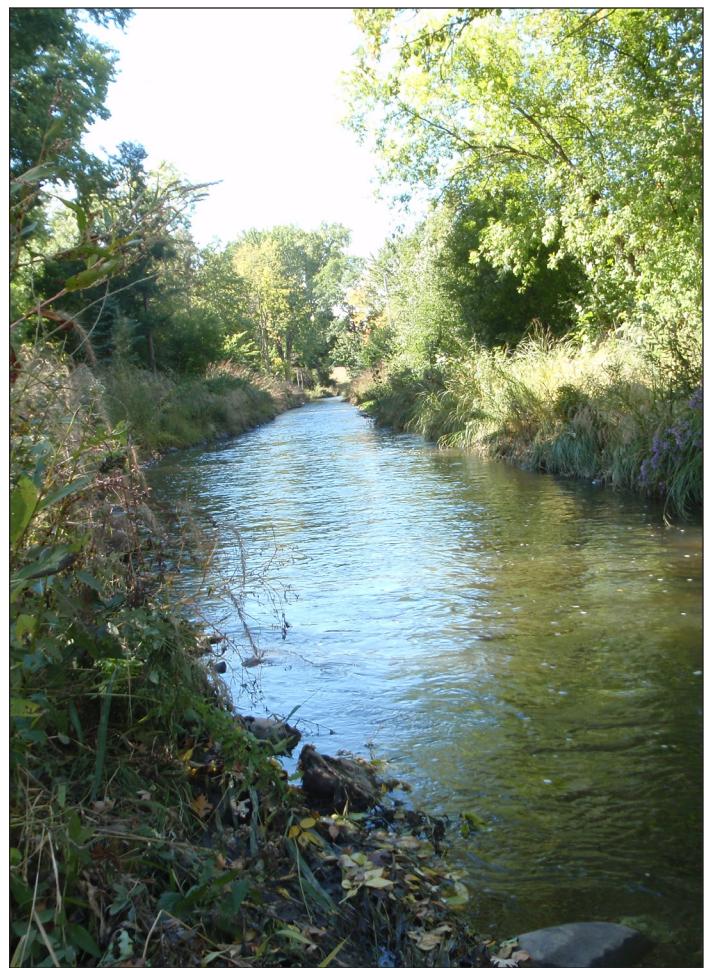
Figure 7: In addition to increased overhanging vegetation, the Rhode Island Avenue location had increased algae, submerged vegetation, and woody debris—all conducive to Climbers.

- Increased overhanging vegetation at both the east of Brookridge Avenue and Rhode Island Avenue (Figure 7) locations.
- Increased algae, aquatic plants, submerged vegetation, and woody debris at the Rhode Island Avenue location (Figure 7).

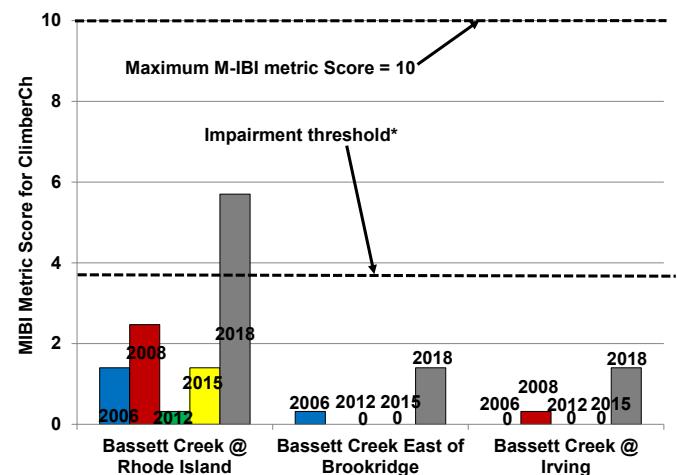
\*Average metric score required to meet M-IBI impairment threshold (37) = 3.7

Figure 8: Above: ClimberCh scores from three monitoring stations. Scores at two of the three locations failed to meet the M-IBI impairment threshold (3.7). Left: The climber Belostoma (giant waterbug)

Main Stem locations east of Brookridge and at Irving Avenue had one or two climber taxa in 2012 and 2015 (a score of 0 for both years). An increase to four climber taxa at both locations in 2018 improved the score to 1.4 (Figure 8).

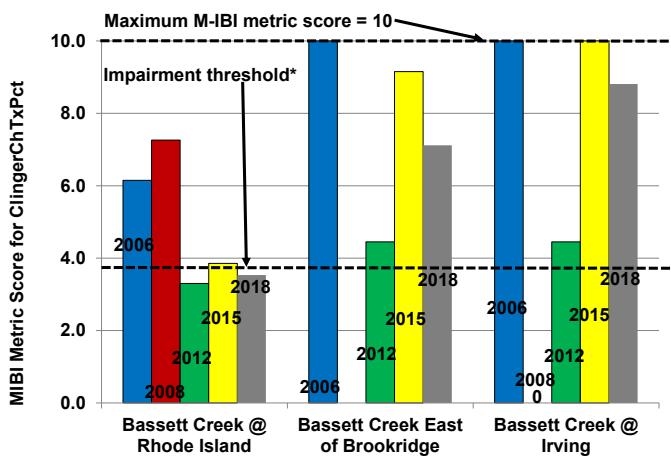
\*Average metric score required to meet M-IBI impairment threshold (37) = 3.7

**Figure 9:** Above: ClingerTxPct scores from three monitoring stations. Scores at one of the three locations failed to meet the M-IBI impairment threshold (3.7) in 2018. All three locations had reduced scores in 2018. Left: The clinger *Baetis flavistriga* (mayfly nymph)

During the period examined, the Main Stem of Bassett Creek generally supported a healthy number of clinger taxa. All scores for this metric have been better than the impairment threshold at the east of Brookridge location since 2006 and at the Irving Avenue location in 2006 and from 2012 to 2018 (Figure 9). Scores at the Rhode Island Avenue location were better than the impairment threshold in 2006 and 2008, but declined in 2012. Scores improved in 2015 and 2018 indicating stream restoration projects from Wisconsin Avenue to 10th Avenue and 10th Avenue to Duluth Street (# 3 and # 7 on Figure 1) improved habitat for clingers at this location. The 2018 score of 3.5 was close to the impairment threshold of 3.7 (Figure 9.) Improved habitat and sediment reductions from the stream restoration project completed at Rhode Island Avenue in 2018 are expected to increase future scores.

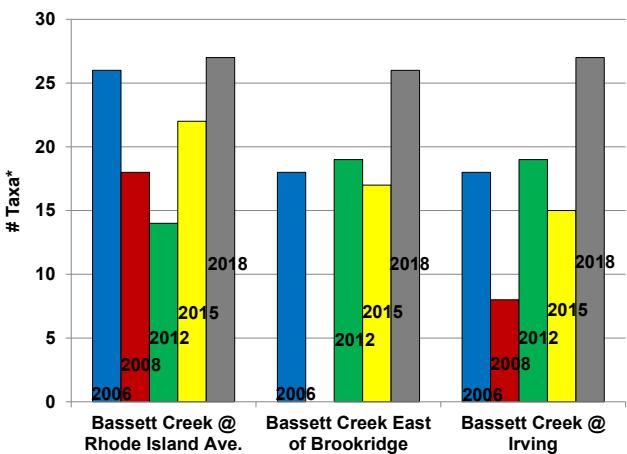
\*#Taxa is the # of different family, genus, and species found in each sample.

**Figure 10: Number of taxa at three Main Stem locations**

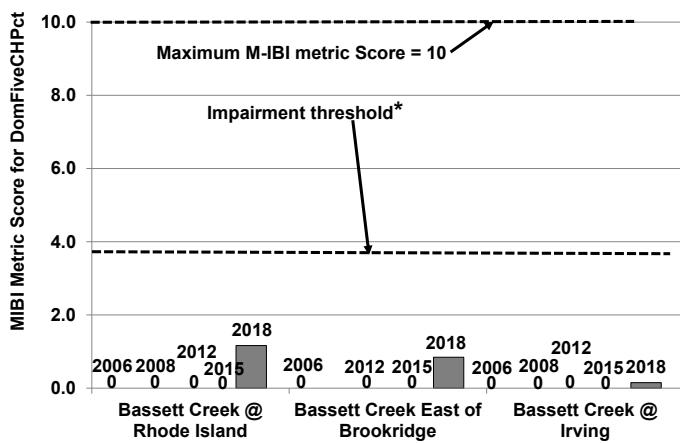
\*Average metric score required to meet M-IBI impairment threshold (37) = 3.7

**Figure 11:** Above: DomFiveChPct scores from three monitoring stations. Scores at all three locations failed to meet the M-IBI impairment threshold (3.7). Left: One of the five dominant taxa, *Baetis Gammarus* (amphipod crustacean)

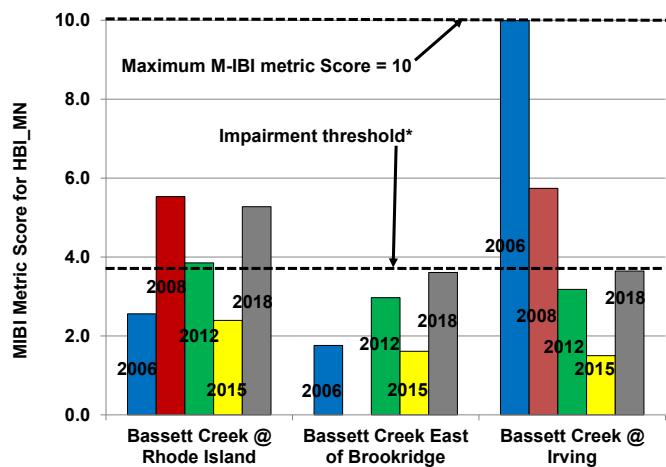
\*Average metric score required to meet M-IBI impairment threshold (37) = 3.7

**Figure 12:** Above: HBI\_MN scores from three monitoring stations. Scores increased in 2018, but failed to meet the M-IBI impairment threshold (3.7) at two locations. Left: *Sphaerium* (fingernail clam)

The overall work of the BCWMC and member cities to reduce pollution and improve water quality (including BCWMC CIP projects, city projects, development requirements, education, and non-structural BMPs) may have contributed to improvements to HBI\_MN, with scores at all three locations more than doubling in 2018. The 2018 score of 5.3 at Rhode Island Avenue was better than the impairment threshold of 3.7, while scores of 3.6 east of Brookridge and at Irving Avenue were only slightly below the impairment threshold (Figure 12).

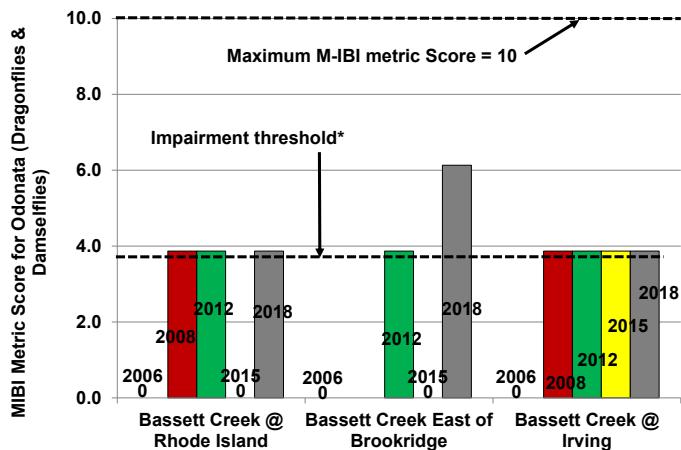
\*Average metric score required to meet M-IBI impairment threshold (37) = 3.7

**Figure 13:** Above: Odonata scores from three monitoring stations. Scores at all three locations met the M-IBI impairment threshold (3.7). Left: Odonata Calopteryx (damselfly larvae)

In 2018, scores at all three Main Stem locations were better than the impairment threshold (Figure 13). Rhode Island Avenue and east of Brookridge locations have generally supported Odonata since 2008; however, in 2015 both locations had scores of 0. After completion of a stream restoration project from 10th Avenue to Duluth Street from the winter of 2015–2016 through 2018 (#7 on Figure 1 and Table 1) scores increased to 3.9 at the Rhode Island location and 6.1 at the east of Brookridge Avenue location (Figure 13). Scores at Irving Avenue have been stable (3.9) and better than the impairment threshold since 2008 (Figure 13).

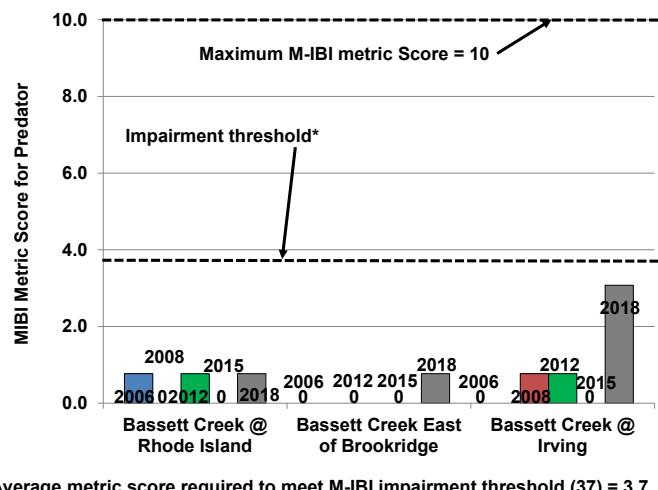
\*Average metric score required to meet M-IBI impairment threshold (37) = 3.7

**Figure 14:** Above: Predator scores from three monitoring stations. Scores at all three locations failed to meet the M-IBI impairment threshold (3.7). Left: The predator Liodessus (beetle)

Although scores for the Predator metric were less than the impairment threshold in 2018, scores at all three locations improved from a 2015 score of zero. This improvement appears to be a positive result of Main Stem stream restoration projects #1 and #7, (Figure 1 and Table 1). The 2018 score of 0.8 at the east of Brookridge location was the only predator metric score greater than zero at this location during the entire period examined (Figure 14). The 2018 score of 3.1 at Irving Avenue was more than three times greater than all previous scores for this metric (Figure 14), and the score of 0.8 at Rhode Island Avenue was greater than the score of 0 in 2015 and similar to scores in 2006 and 2012 (Figure 14).

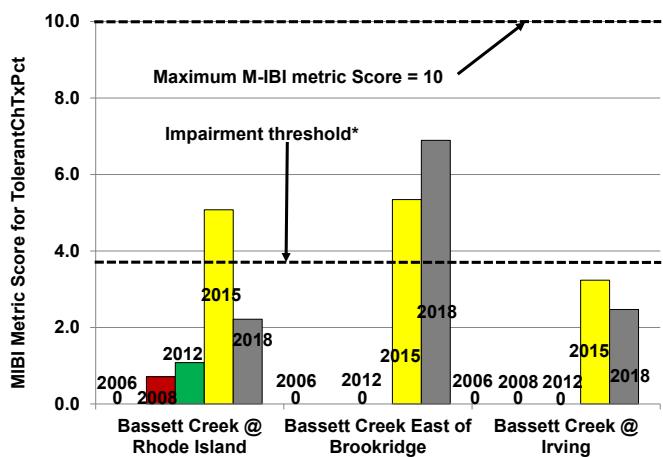
\*Average metric score required to meet M-IBI impairment threshold (37) = 3.7

**Figure 15:** Above: Tolerant2ChTxPct scores from three monitoring stations. Scores at two of the three locations failed to meet the M-IBI impairment threshold (3.7). Left: Simulium (blackfly larvae)

Main Stem stream restoration projects (#1, #3, #4, and #7 on Figure 1 and Table 1) appear to have reduced the relative percentage of tolerant taxa in the stream by creating conditions favorable for less-tolerant taxa. Scores of 5.3 and 6.9 were observed at the east of Brookridge location in 2015 and 2018, both better than the impairment threshold of 3.7 and the first scores above zero at these locations during the period examined (Figure 15). Scores of 3.2 (2015) and 2.5 (2018) at the Irving Avenue location were the first scores above zero at this location during the period examined (Figure 15). Scores of 5.1 (2015) and 2.2 (2018) at the Rhode Island location were the highest scores at this location during the period examined (Figure 15).
